## Assessment of Hydrogen Embrittlement Susceptibility in Nickel 725 Under Various Surface Conditions

# **Assessment of Hydrogen Embrittlement Susceptibility in Ni 725 Under Various Surface Conditions**

Master's thesis in Mechanical and Industrial Engineering

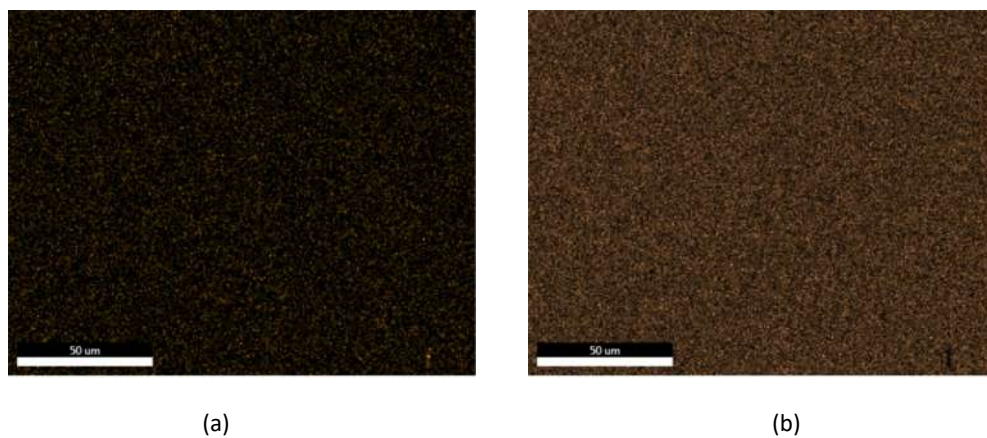
**Figure 4.1.9:** EDS elemental maps of the gold-sputtered Ni 725 gauge surface prior to tensile testing.(a) Ni map (b) Au map.
