POLITECNICO DI TORINO

Master Degree Thesis

Euro NCAP 2020: the evolution of partial overlap frontal tests and its impact on effective vehicle safety

A simulation analysis of the Euro NCAP ODB and MPDB procedures

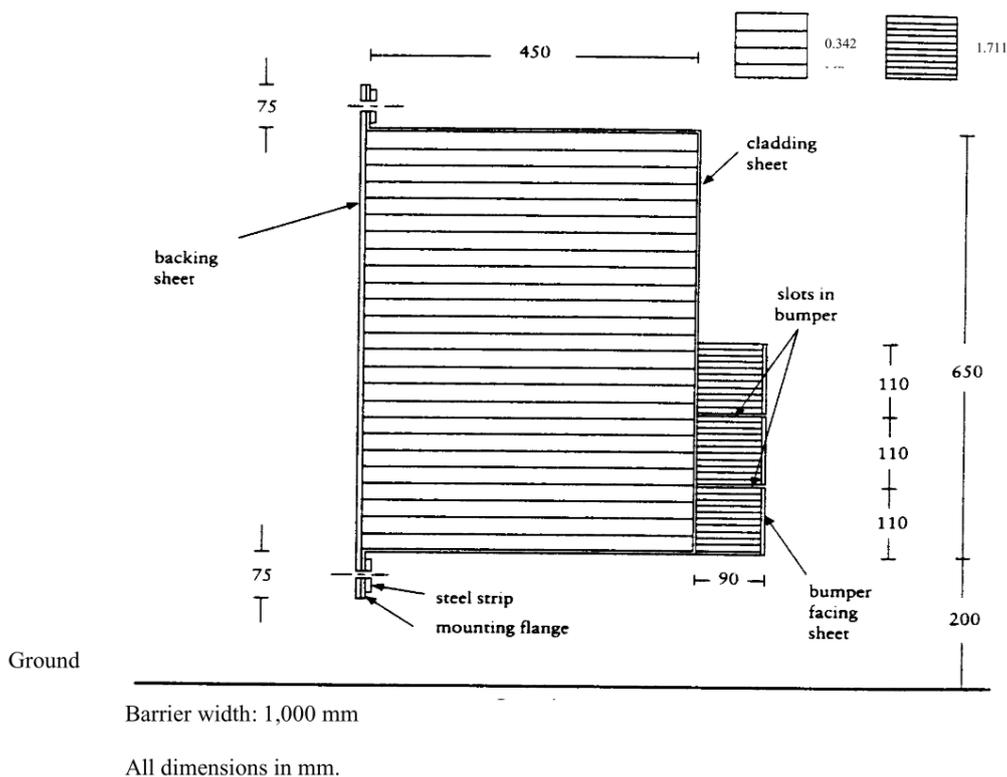
Figure 2.4: ODB Normal element with bumper [4]

For these reasons, the EECV working group designed a test with a limited overlap, set at 40% with the goals of loading mainly one side of the front crash structure and avoiding high engine loading, hence creating a more realistic condition. With regards to the impact face, a deformable barrier was required, aimed at reproducing the softer and more complex shape of a partner vehicle. Hence, several tests were carried out and it was concluded that the most suitable design would be a 450mm deep, 50psi aluminium honeycomb block with a smaller 250psi aluminium block attached to the lower part of the front face, as show in Figure 2.5. This barrier was denominated "normal element with bumper" [4]. In terms of positioning, the deformable face was placed on an "infinitely" rigid block at a height of 200mm from ground level.

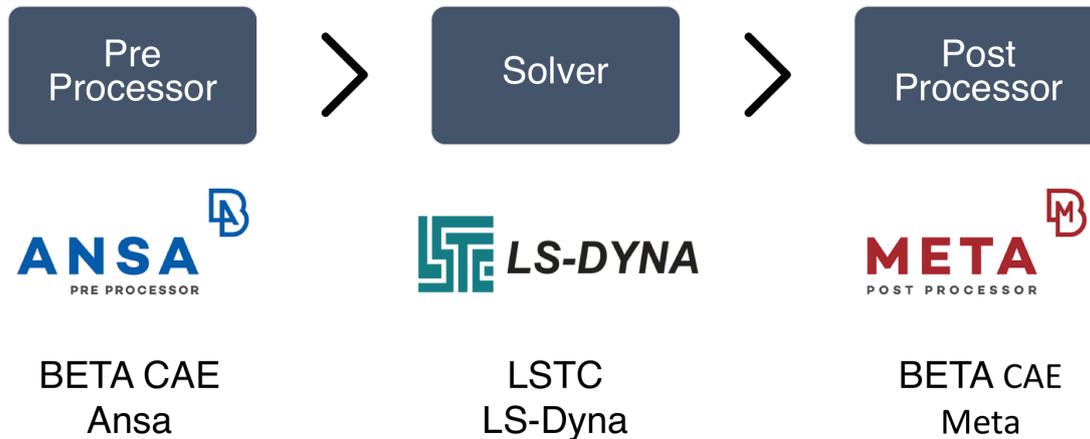
Figure 3.1: The simulation process - softwares utilised

First of all, a pre-processor is required to create the context in which the simulation will be evaluated: models of the vehicle and of the barrier are here placed in relation to each other with the required geometrical parameters, the initial and boundary conditions such as initial velocity, gravitational load and contact definitions are also set. More importantly, the pre-processor can be used to modify the geometry of the utilised model and to perform the discretisation of the components into a finite element mesh. Finally, the control parameters required for correct performance of the solver are input, both in terms of basic conditions such as timestep size and simulation duration, and more advanced settings to ensure flawless advancement of the simulation steps. In addition, the data logging functions are set up so that the output files of the solver contain exactly the parameters required for the post-processing. All in all, the pre-processor can be seen as an user entrance interface to the solver, where parameters that would have to be manually encoded in the input file of the simulation can be defined in a more user friendly manner. For the study here reported, the software chosen for this part of the work was ANSA Pre-processor, created and distributed by BETA CAE Systems [43]. The choice was made mainly due to the advantages in terms of compatibility with the solver of choice, discussed next in this chapter, flexibility and advanced functionalities for model preparation and modification.

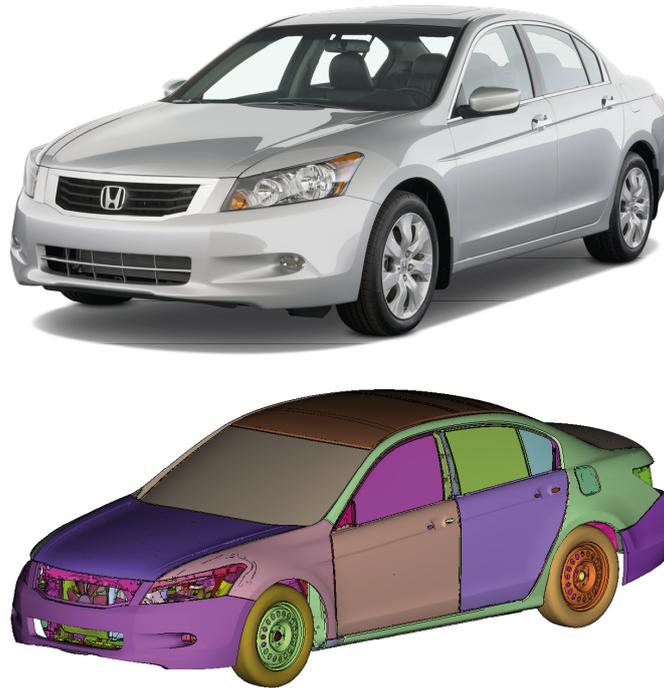
Figure 3.6: 2011 Honda Accord - Physical [13] and CAE models

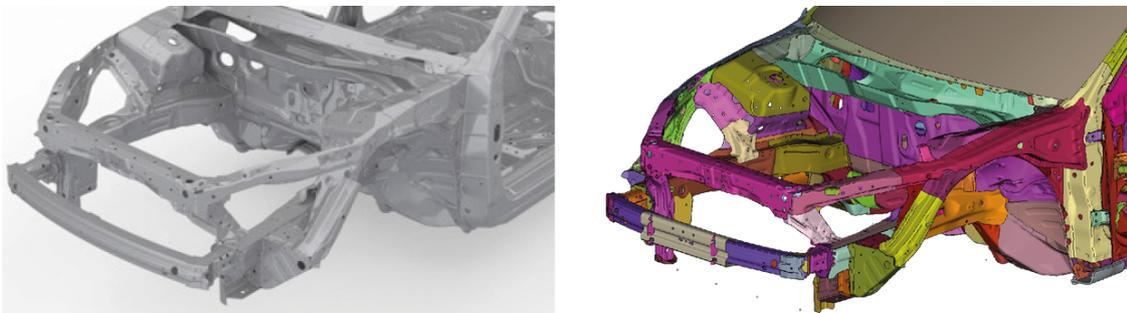
Figure 3.9: Honda Accord - BIW front section physical [15] and CAE models

connected. It can be noted how from the main load path, a connection with the upper shotguns is created in order to share the load between the two paths and exploit the role of both the underfloor rails and the a-pillars. Additionally, a large engine subframe is present and its size and shape allow it to be loaded early in the crash event, unloading some of the energy on the engine mounts that will detach when reaching a pre-set load limit and make the engine drop towards the ground. This more complex front end design was denominated by honda the Advanced Compatibility Engineering™(ACE™) body structure [47], which is the result of a study to improve the vehicle's compatibility during frontal impacts. For this reason, this model is expected to perform positively not only with respect to occupant protection, but also in terms of PDB deformation. As the upper load path terminates at the a-pillars, the main rails continue towards the rear of the vehicle, with c-sections placed above the floor of the vehicle, inside the cabin. These bend and join with the sills in correspondence of the B-pillars. Secondary rails reinforce the central tunnel and the rear engine subframe mounting points, while additional elements transfer part of the load to the sills at their frontmost part. The rear structures are designed as an extension of the sills until the rear cross beam (Figure 3.10c). In addition, the C-pillars continue along their line until the end of the luggage compartment (Figure 3.10b), to finally join with a large panel also connected to the rear cross beam.

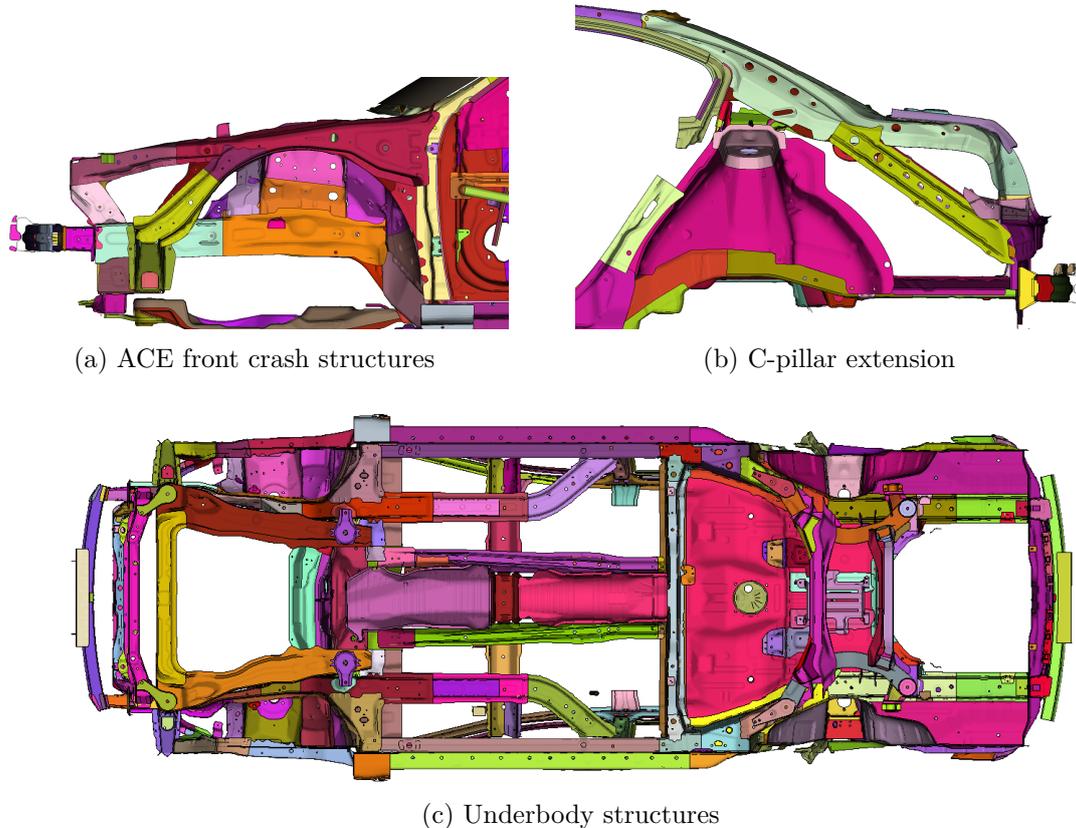
Figure 3.10: Honda Accord - model details

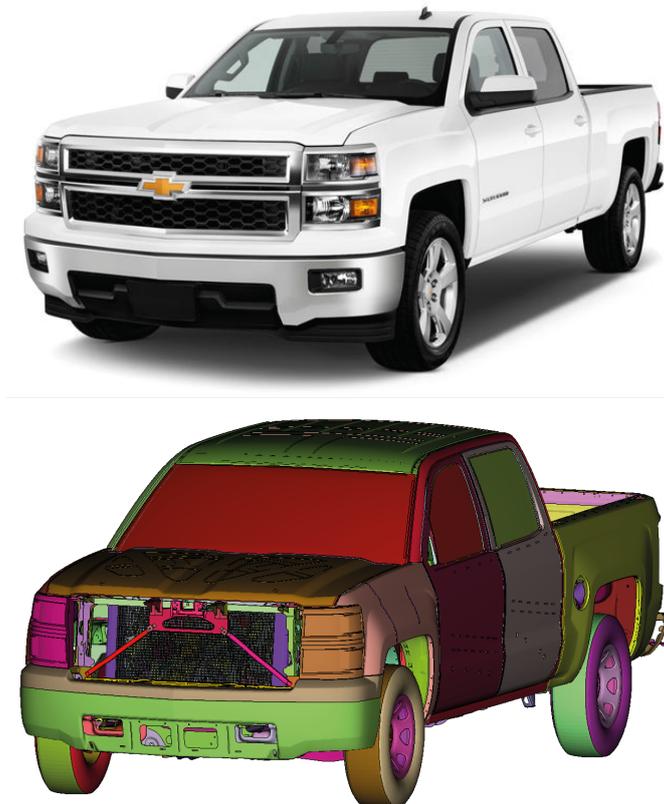
Figure 3.11: 2014 Chevrolet Silverado - Physical [16] and CAE models

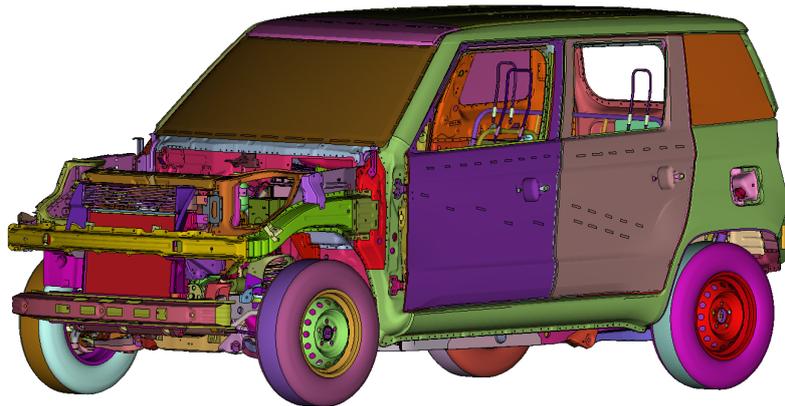
Figure 3.16: U Model - CAE model

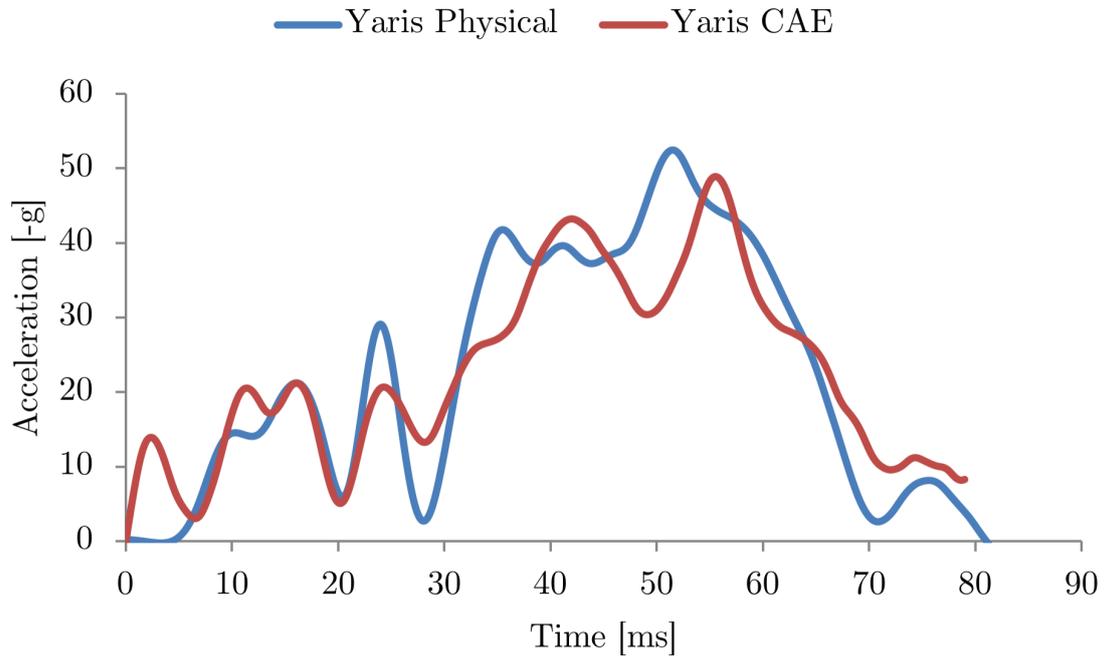
Figure 4.2: Yaris FWRB - acceleration

As reported in Table 4.2, the CAE model underestimates the peak acceleration by roughly $3.6g$, which is equal to less than 7% difference out of the $52.5g$ experienced in the physical test. During the vehicle design process, this is seen as a positive results as a difference below 10% means that using the simulation with a reasonable safety factor will result in a high level of confidence that the structures will perform as expected. However, the difference in the peak can be blamed both on the level of accuracy of the calculation process itself, and on the amount of missing components in the front part of the vehicle. As expected, the diminished compacting effect of the rigid parts in the engine bay allows better employment of the crash structures and results in lower maximum acceleration, which also occurs later in the crash event as shown in Figure 4.2. Analysing in more detail the pulse, it is possible to appreciate how the shape and timing of most of the peaks is consistent with the physical test. This is especially true for the first, second and third lower peaks, which occur with exact timing. These correspond to the first engagement of the cross beam and crash boxes, their collapse, followed by the onset of deformation of the main crash structures. The main peaks region represents the actual progressive failure of the crash structures and bottoming out of the engine, hence in this part a level of discrepancy is understandable, due to the aforementioned reasons. One section that cannot be easily explained, however, is that occurring in the CAE model during the first $5ms$: in this timeframe, only the front part of the plastic bumper is in contact with the barrier and deflects, no structural element is loaded and forces on the crash structures are still irrelevant. The narrow peak of $13g$ seems unreasonable. The section here analysed could also partially explain the reduced peak later in the crash: the bottoming out of the structure will occur with less residual energy, since part of it has been consumed in the earlier stages.

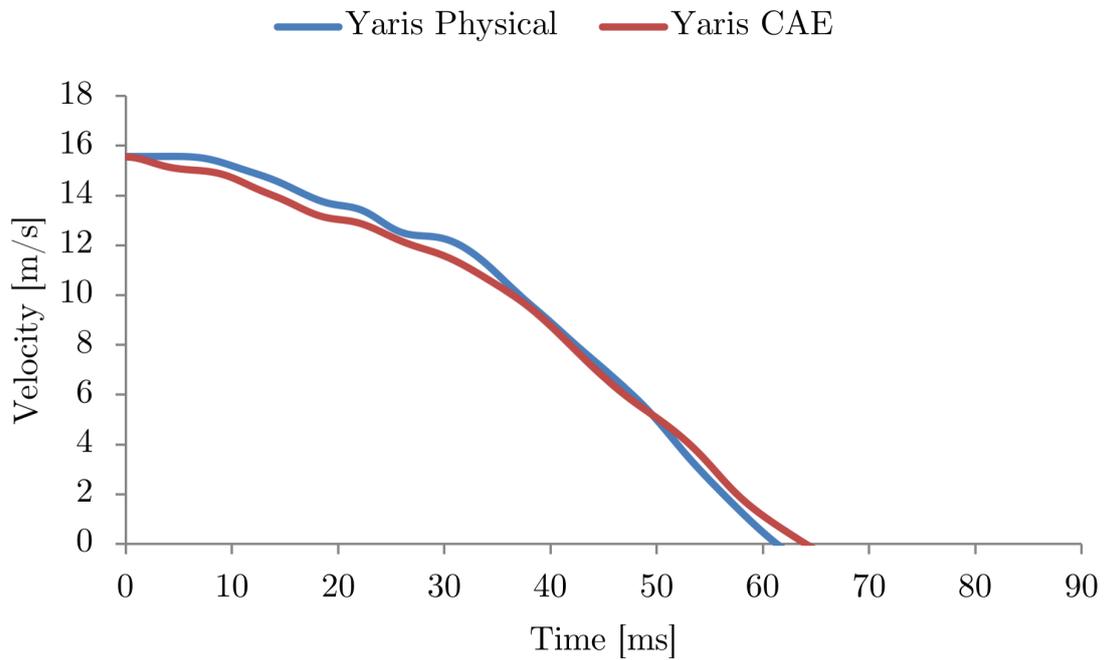
Figure 4.3: Yaris FWRB - velocity

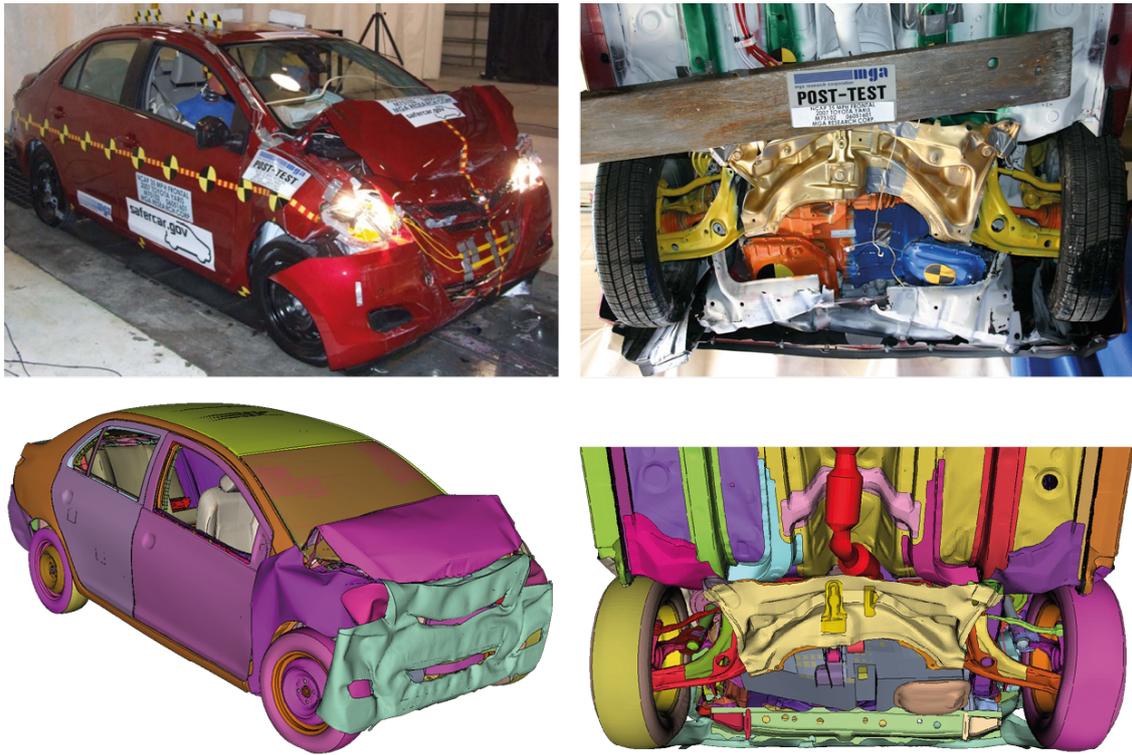
Figure 4.6: Yaris FWRB - three quarters and underbody comparison

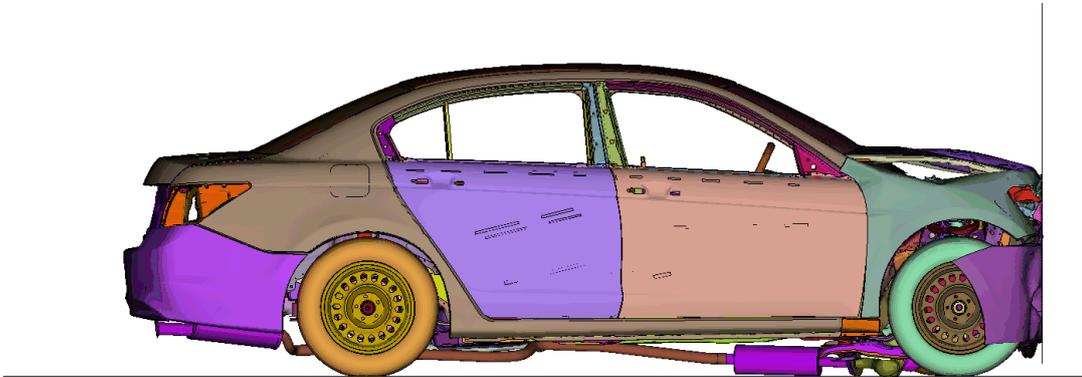
Figure 4.10: Accord FWRB - simulation snapshot

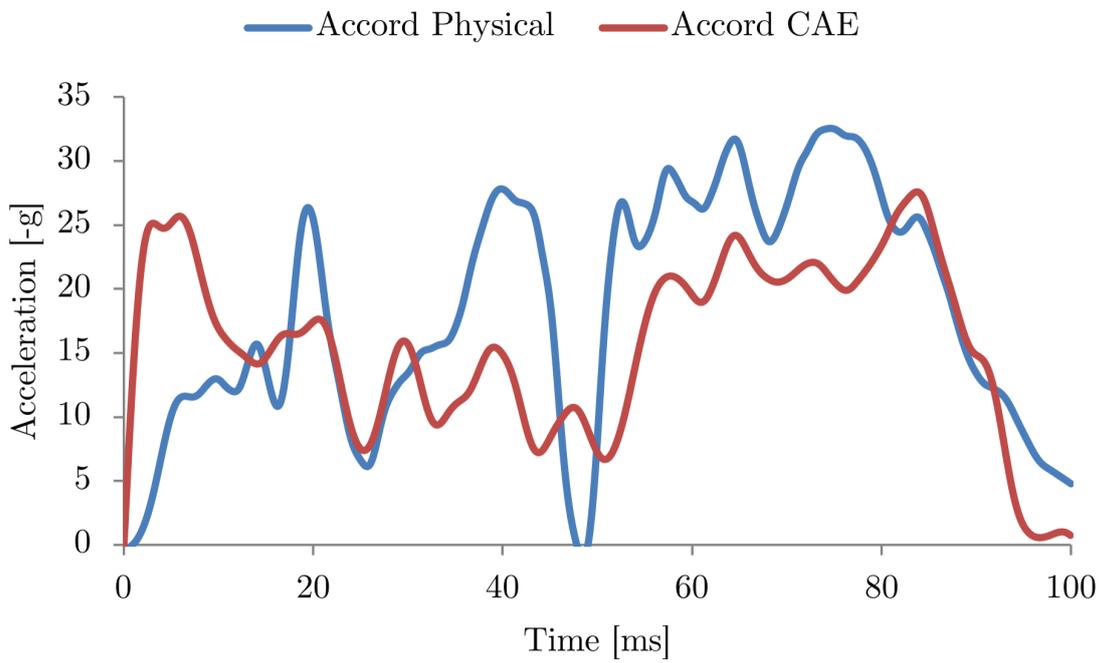
Figure 4.11: Accord FWRB - acceleration

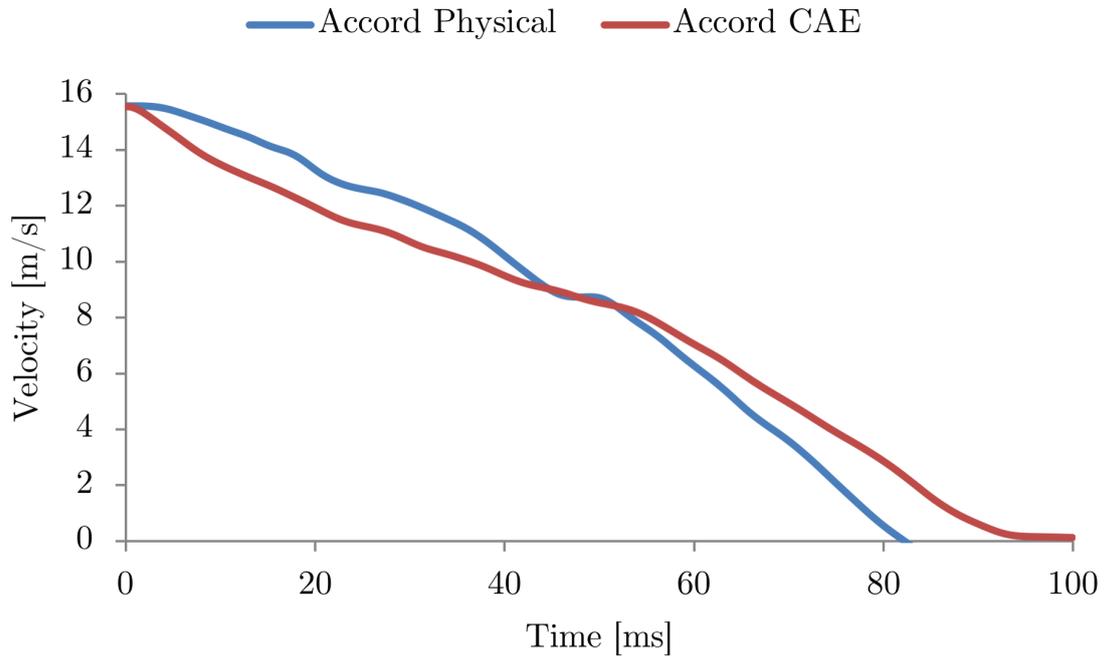
Figure 4.12: Accord FWRB - velocity

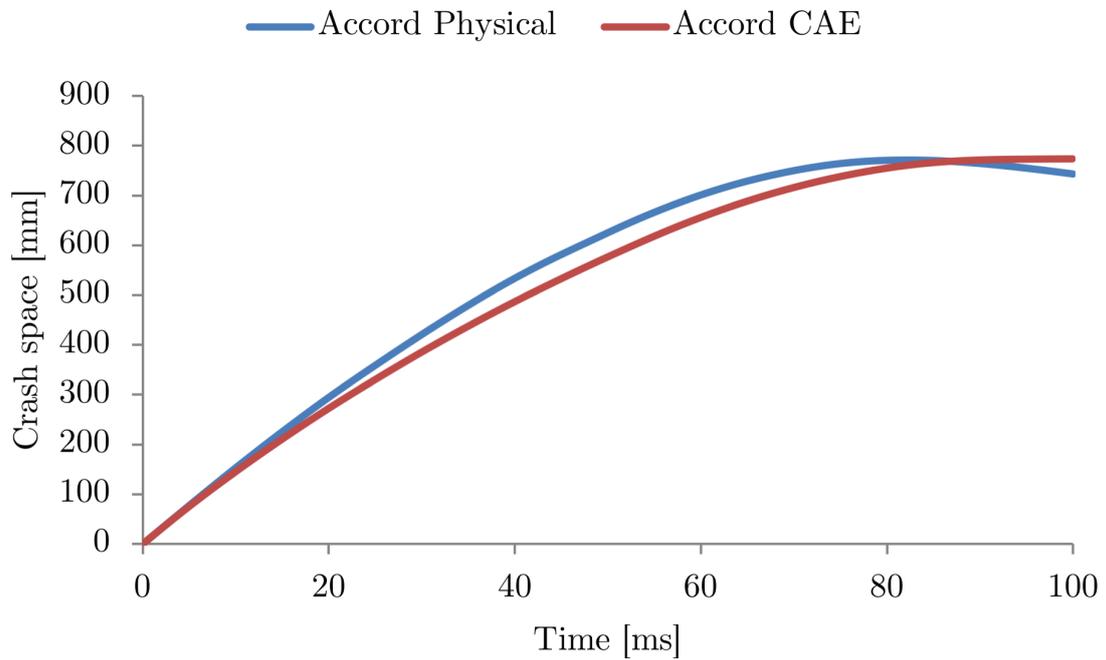
Figure 4.13: Accord FWRB - crush space

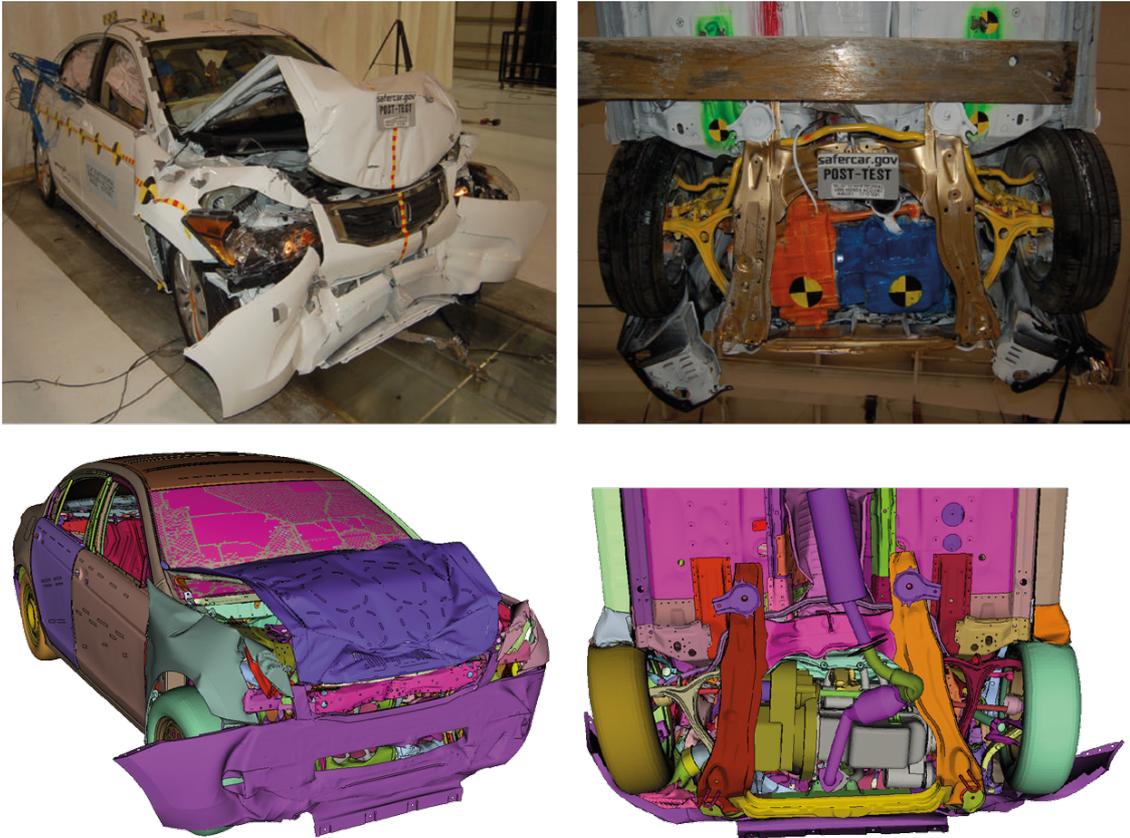
Figure 4.16: Accord FWRB - three quarters and underbody comparison

- the **engine subframe** (Figure 4.16) in the physical test does not rupture its chassis mounts but deforms heavily, bending towards the top of the vehicle. In the CAE model, the mounts detach and the whole subframe moves backwards along the underbody by a considerable distance;
- the **bonnet** does not deform in a comparable manner: the behaviour of the hinges in the simulation leads to the metal impacting the windscreen and damaging it, while in reality this does not occur. The CAE bonnet is also much less deformed in terms of bending

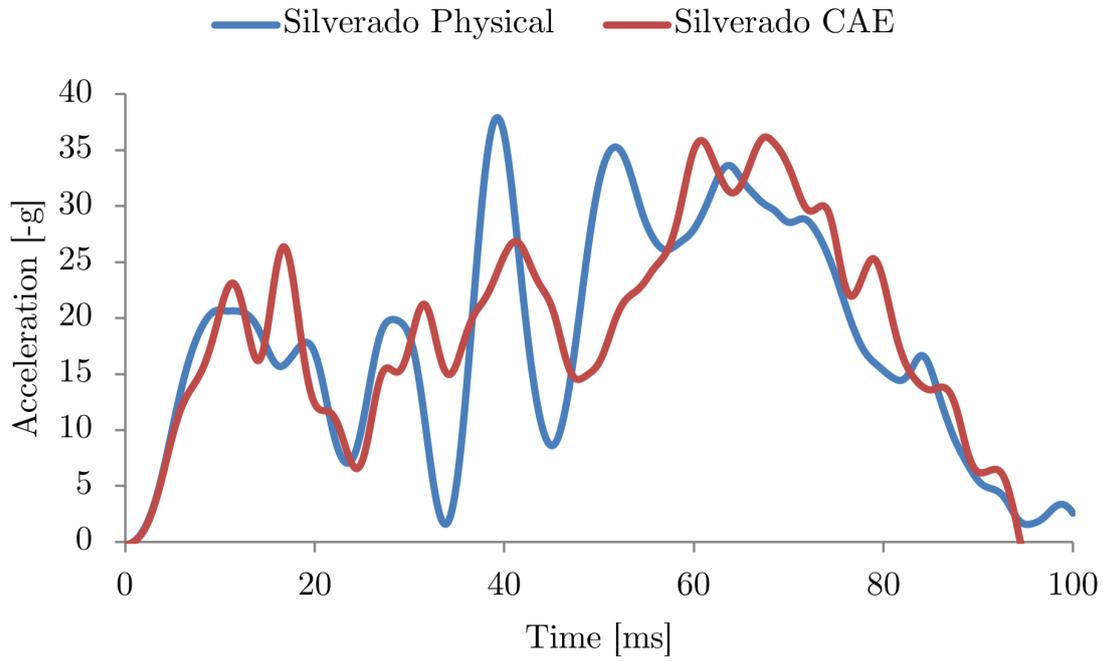
Figure 4.18: Silverado FWRB - acceleration

Out of the three models, the Chevrolet Silverado shows arguably the best results in terms of dynamic data. The peak acceleration is closer than that reported for the Yaris, as the difference is of $1.7g$, equal to 4.5% . Looking at the pulse in Figure 4.18, the first and second peaks (and dips) are reproduced with a good level of accuracy by the simulation, only with a slight overestimation of the initial acceleration due to failure of the front structures. The second peak also shows that the front part of the main rails of the model deforms slightly more progressively. The first substantial difference between the two events appears at around $40ms$, when the front structures reach the point of attachment of the engine cradle: in the simulation, this impact causes a mild and progressive peak as the rails and the cradle bend; in the physical test, it is assumed that the components in the engine bay pack against the engine and, in combination with a stiffer structure, cause a spike to the maximum acceleration experienced. It would be interesting to be able to analyse this particular phenomenon using footage of the crash test, but unfortunately high frame rate-high quality versions are not available for analysis. The spike at $40ms$ is followed by a second peak corresponding with the backwards movement of the engine and its subsequent

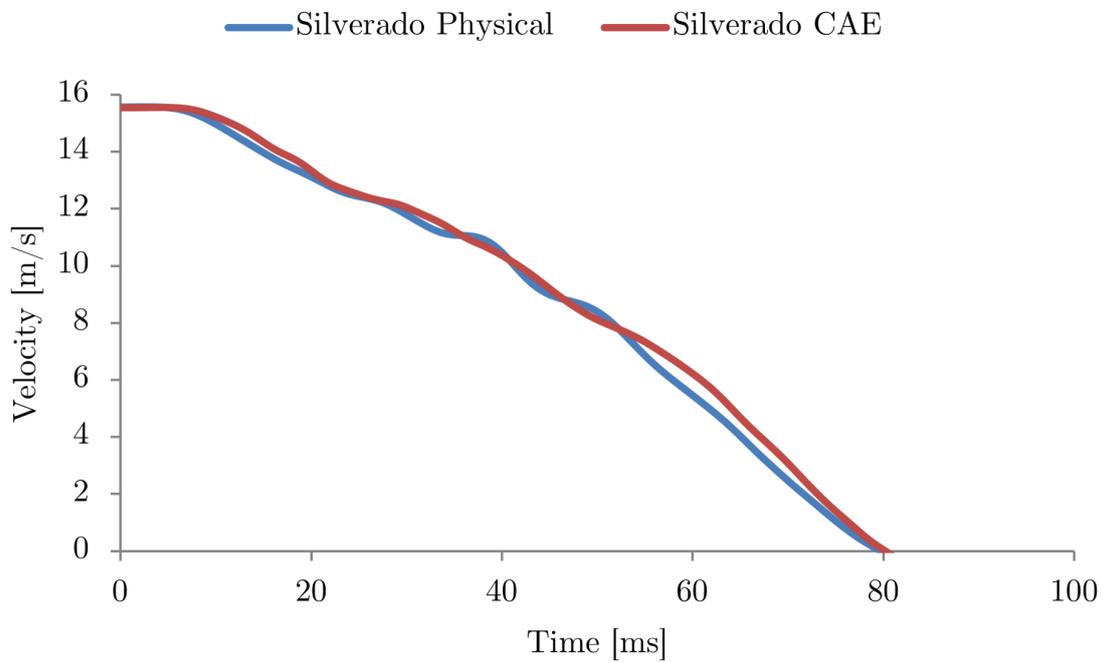
Figure 4.19: Silverado FWRB - velocity

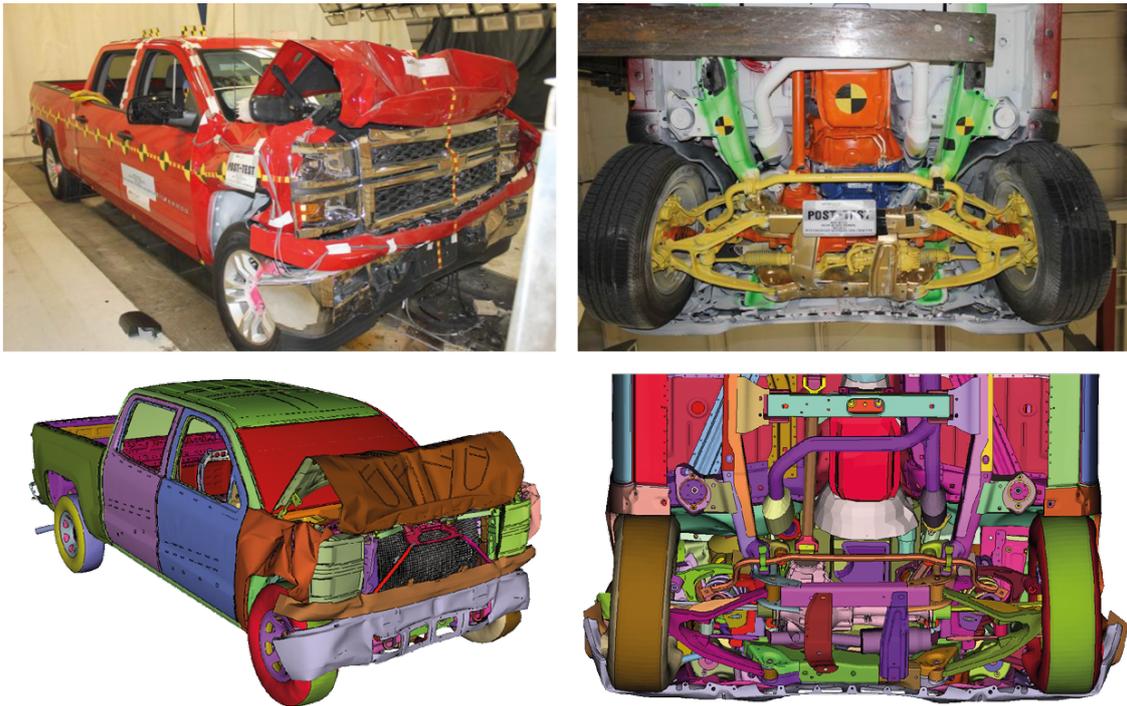
Figure 4.23: Silverado FWRB - three quarters and underbody comparison

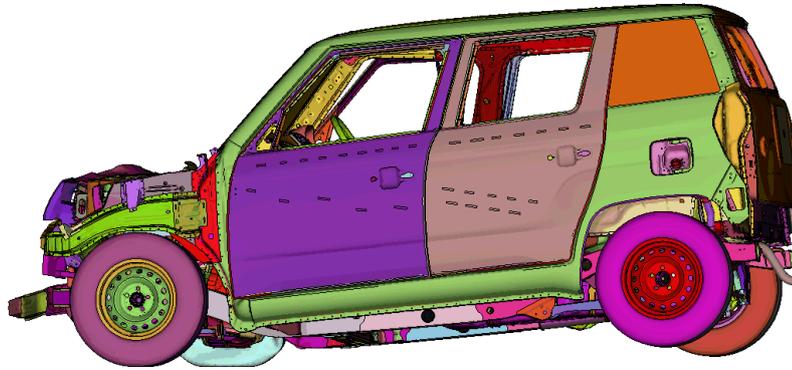
Figure 4.24: U Model ODB 56km/h - simulation snapshot

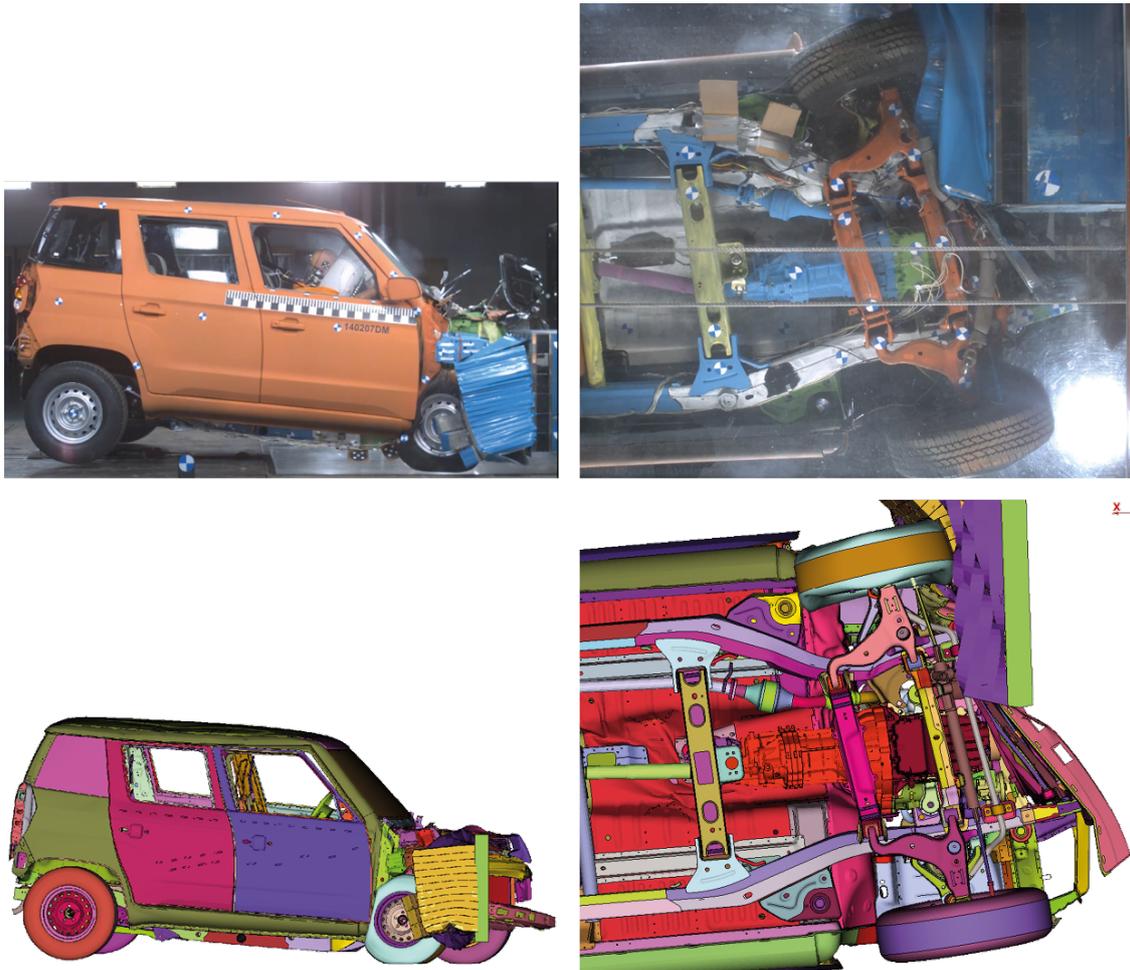
Figure 4.25: U Model ODB 56km/h - RHS and underbody comparison

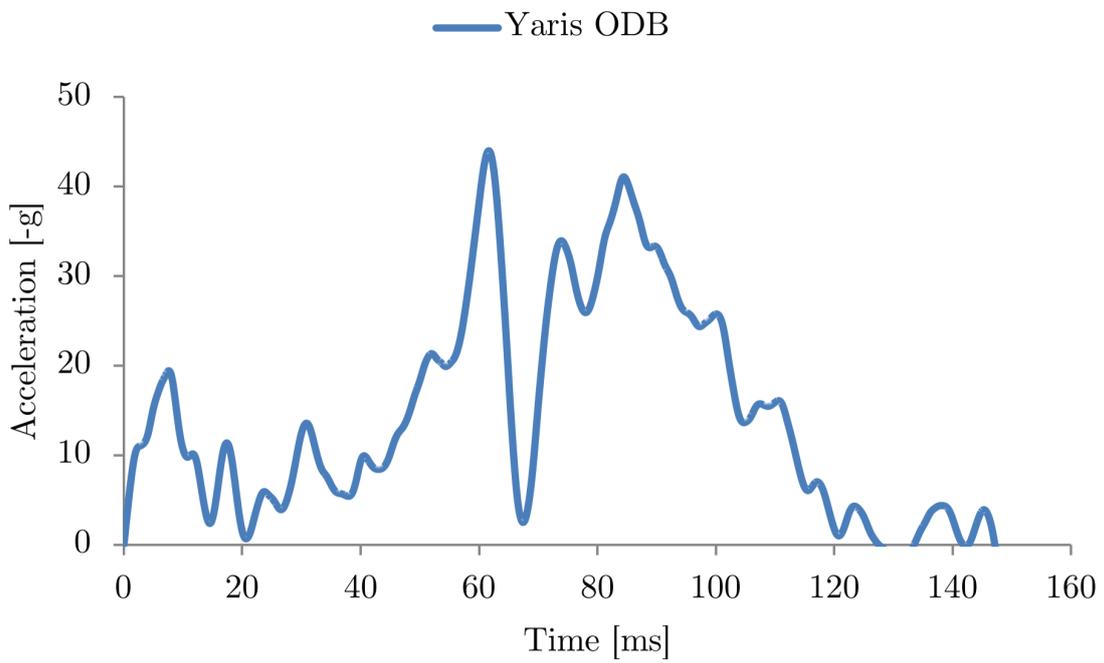
Figure 5.3: Toyota Yaris ODB - acceleration

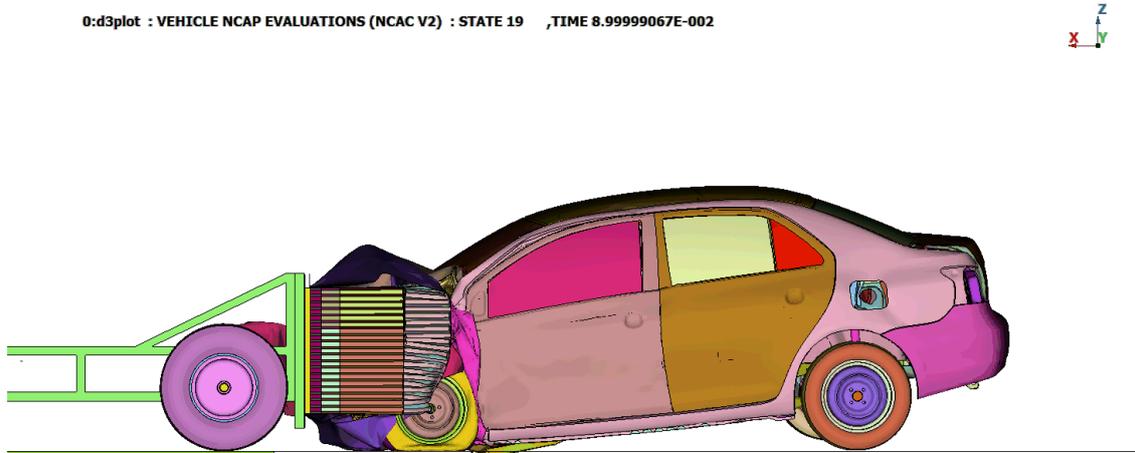
Figure 5.10: Toyota Yaris MPDB - simulation snapshot

Finally, the vehicle is pushed backwards at the end of the impact by the trolley, while the trolley continues to move forwards in its direction of movement, until it reaches rest.

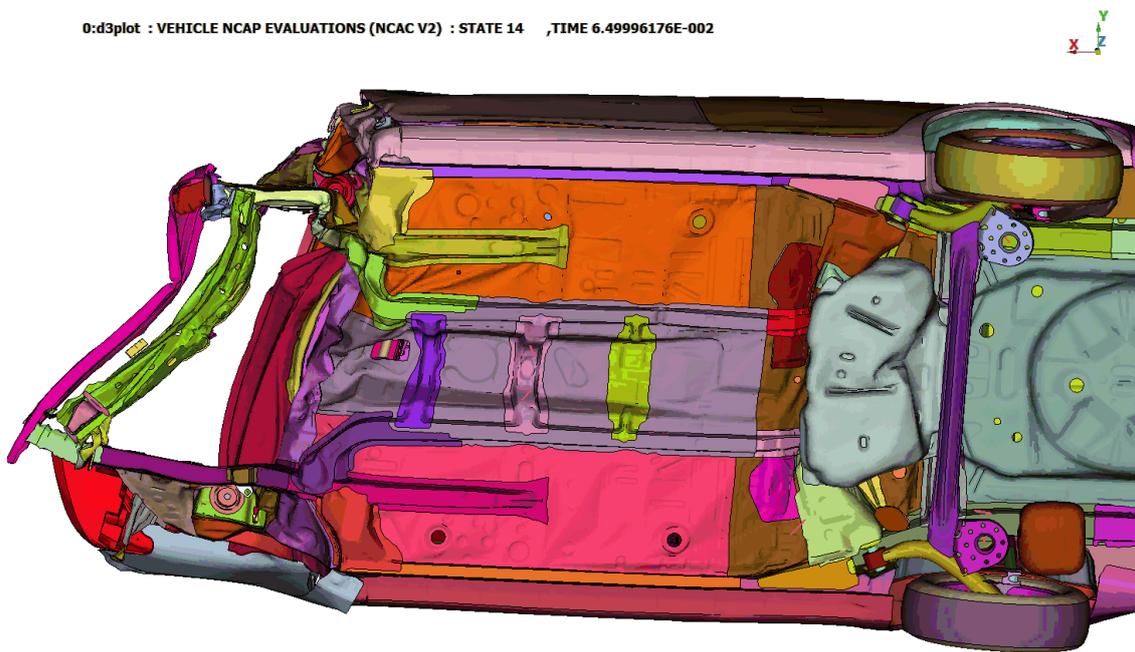
Figure 5.11: Toyota Yaris MPDB - structural collapse detail

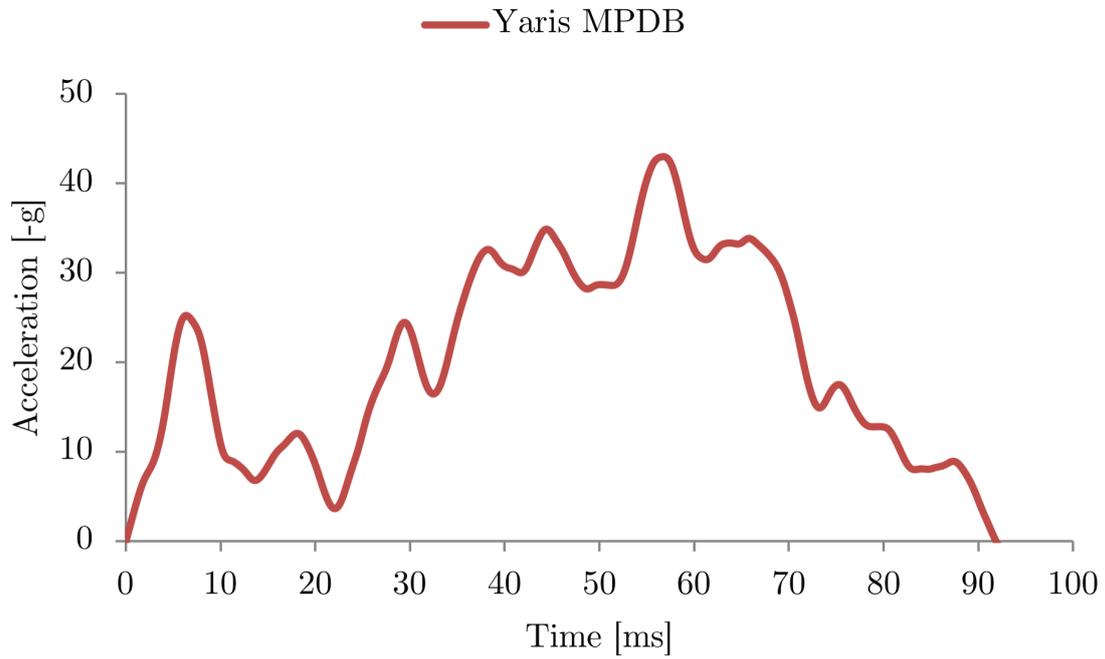
Figure 5.12: Toyota Yaris MPDB - acceleration

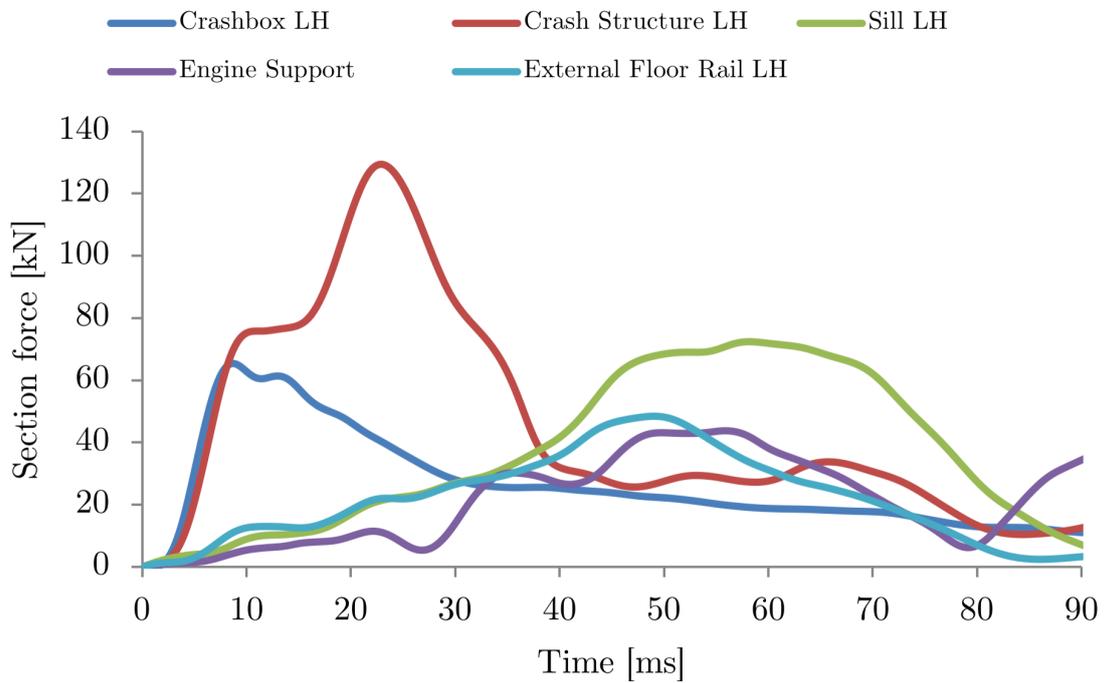
Figure 5.13: Toyota Yaris MPDB - section forces

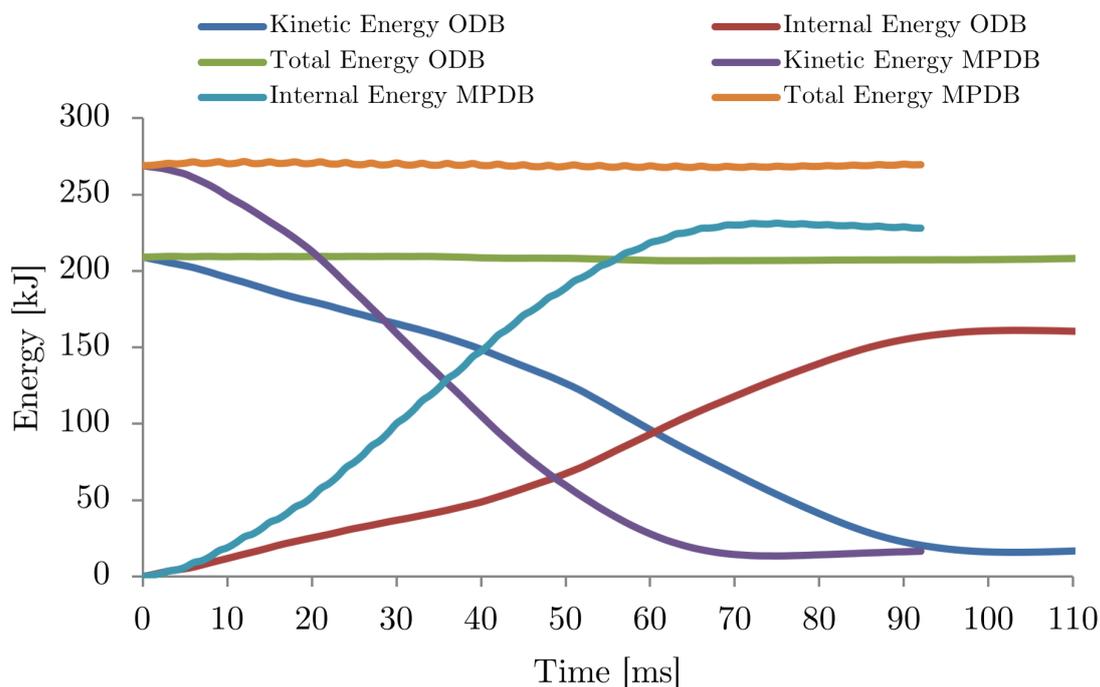
Figure 5.19: Toyota Yaris - comparison between ODB and MPDB energy content

Comparing the results from the two tests, the first consideration to make is in regard to the difference in energy between procedures. The ODB test total energy is roughly $215kJ$, while for the MPDB the level was at $265kJ$, resulting in a difference of $50kJ$ or around 19%. The energy of the impact is also dissipated much quicker in the MPDB, as shown in Figure 5.19: the current test takes between 100 and 110ms to reach stability, while this occurs in the new procedure in just 70-80ms. In these terms, it is possible to see how the MPDB is much harsher for a vehicle of this segment, even with non extreme weight deficit of around $100Kg$ compared to the impactor in test conditions - $1345Kg$ vs. $1452kg$.

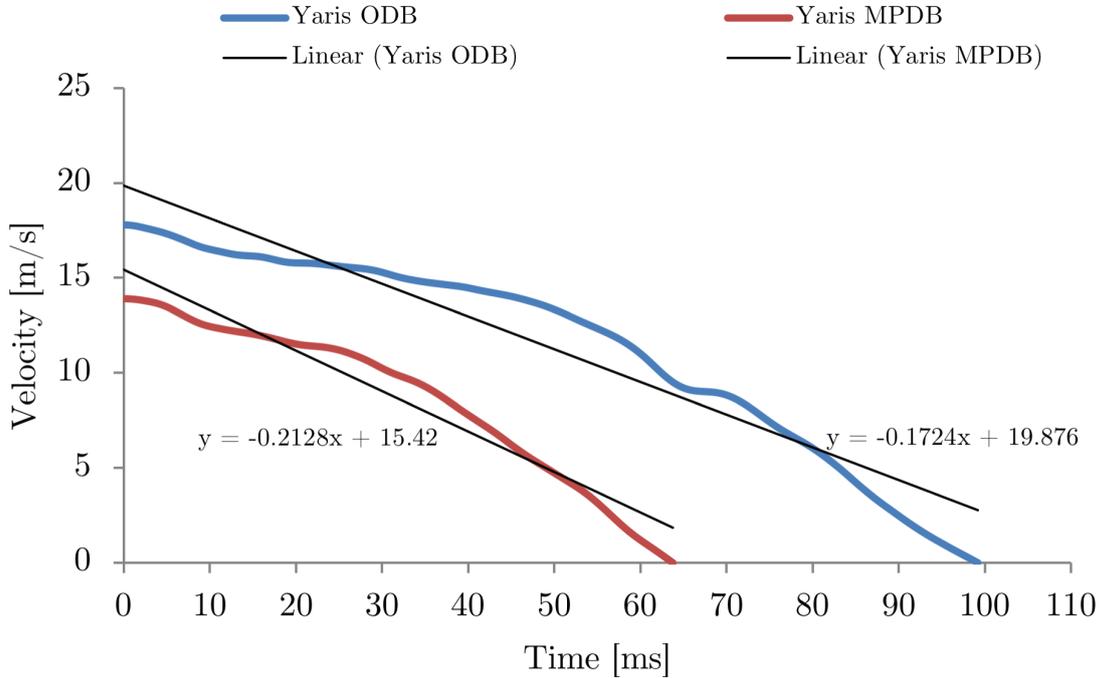
Figure 5.22: Toyota Yaris - velocity trend comparison

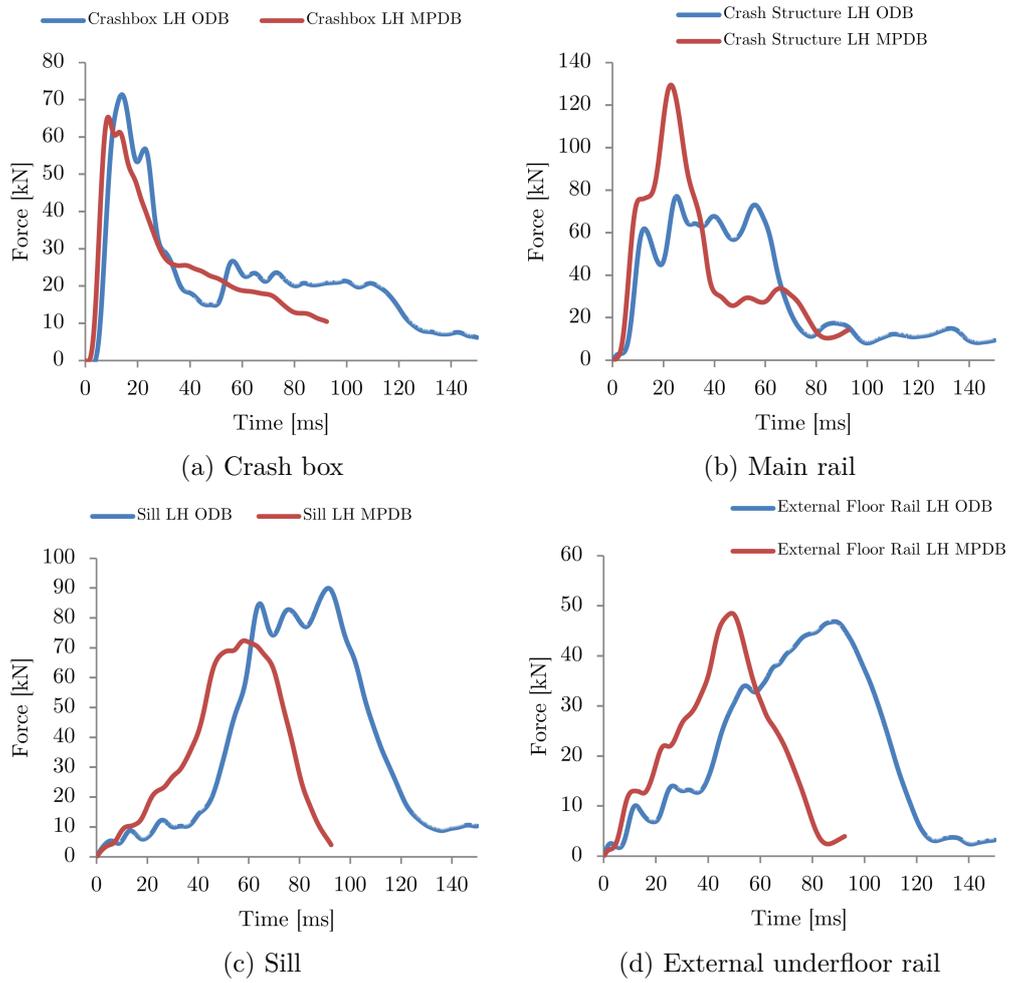
Figure 5.23: Toyota Yaris - section forces comparison

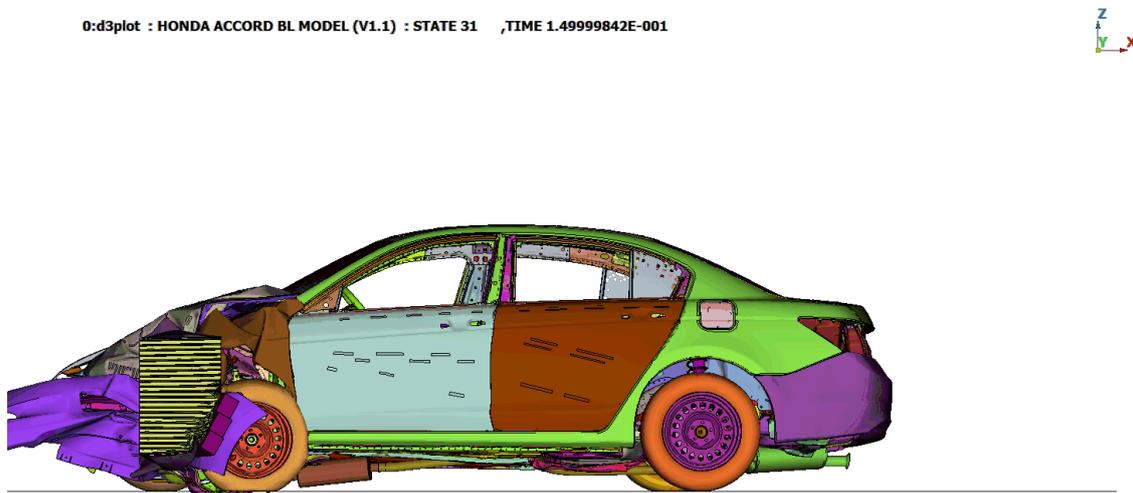
Figure 5.30: Honda Accord ODB - simulation snapshot

At $60ms$, after further pushing on the barrier, the several failure points of the main rail make it bend out of shape completely - partly downwards and outwards, partly inwards; the upper structures fail bending downwards and the whole frontal part is at this point a flat and compact metal shield pushing on the remaining branches of box section.
