POLITECNICO DI TORINO

Master Degree Thesis

Euro NCAP 2020: the evolution of partial overlap frontal tests and its impact on effective vehicle safety

A simulation analysis of the Euro NCAP ODB and MPDB procedures

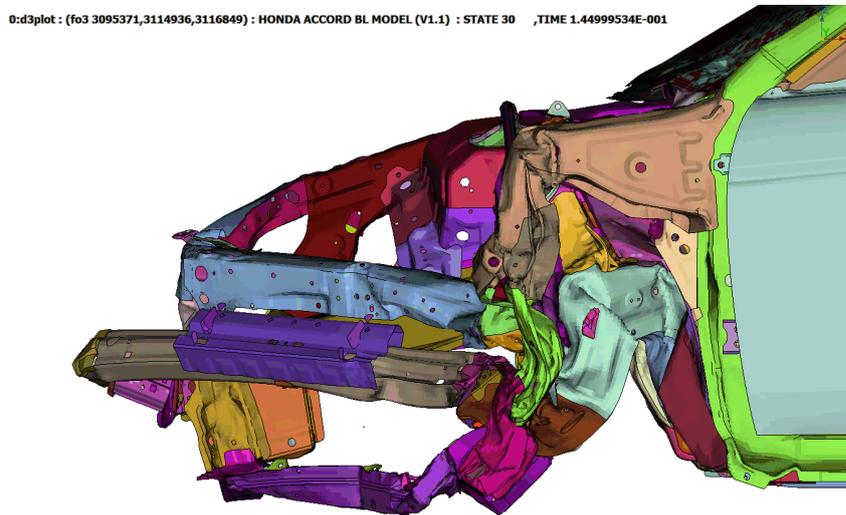
Figure 5.31: Honda Accord ODB - structural collapse detail

In the final stages of the crash, the shortening of the engine compartment causes the engine to push with more energy on the firewall, causing it to deform slightly in its top part. However, at this point the amount of energy left is not enough to cause major failures. Finally, the wheel, which has been pushed outwards during the event by the deformation of the upright mounting points, is squeezed between the barrier and the sill and the whole structure of the cabin lifts by a few tens of *mm*. One important factor to be noted is that the vehicle never punctures the barrier, but makes use of two thirds of the honeycomb's width compacting it evenly. The vehicle bumper, main structures and the bumper element of the barrier remain in line for most of the impact, pushing one on the other. Furthermore, at the end of the crash the upper structures still have a branch which has not been crushed, while the space in the engine compartment is reasonable. These two final considerations show that, overall, the ACE system seems to work properly both for occupant and for partner protection. This will be further emphasized by the level of intrusions explained in the next subsection and by the partner protection analysis in Chapter 6.

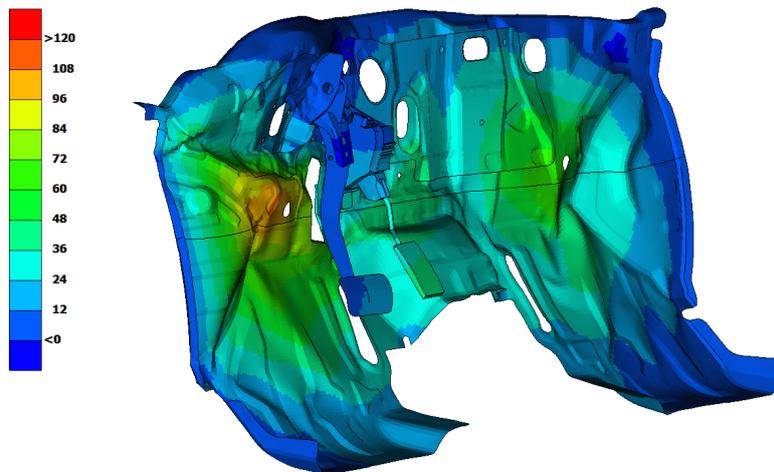
Figure 5.39: Honda Accord - ODB firewall deformation

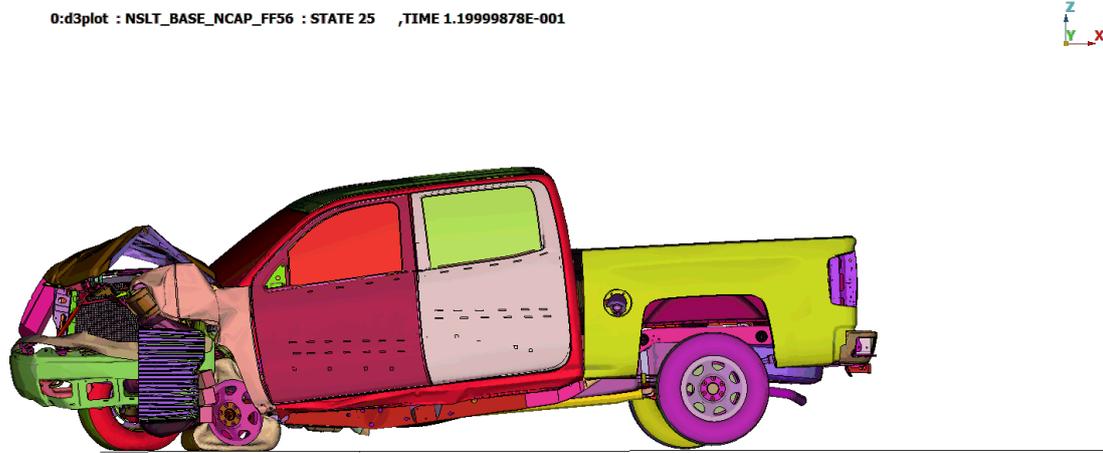
Figure 5.43: Chevrolet Silverado ODB - simulation snapshot

In conclusion, the peak acceleration achieved is quite high, and it appears to be mostly due to the fact that the foremost part of the main rails does not absorb a considerable amount of energy at the beginning of the crash, leaving a large portion of it to be dissipated by the area where the engine is located. As a consequence, the force with which the block is pushed into the firewall is too high to cause only minor deformation. Hence, not only the firewall is deformed, but also the main rail buckles right underneath the cabin, which will surely affect it, as will be discussed in the next paragraphs.

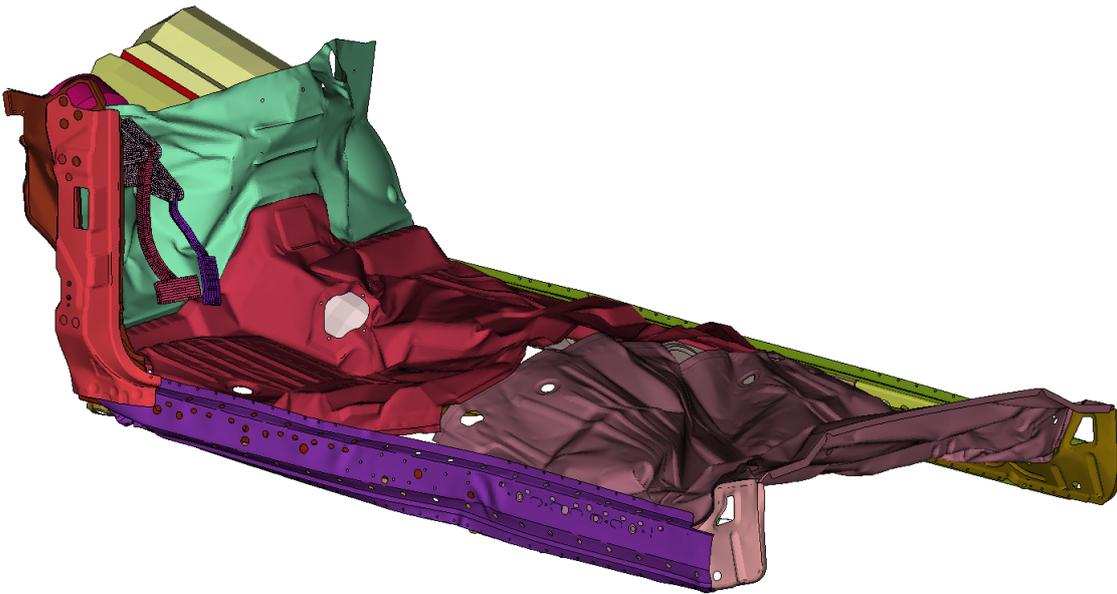
Figure 5.48: Chevrolet Silverado ODB - overall cabin deformation

lower part is dragged backwards by the cabin's mounting point, the twist of the cabin itself makes the top part of the component move slightly forwards. The resulting door opening deformation is however small and the cabin remains sealed all around. The only opening occurs at the sill, more due to its twist than to door damage.

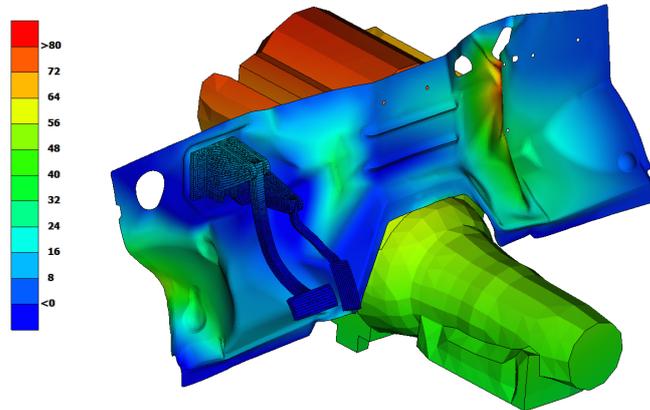
Figure 5.55: Chevrolet Silverado MPDB - driver side firewall intrusion

With regards to intrusion, Table 5.9 depicts a very clear picture of the situation: the cabin undergoes virtually no deformation in all its parts, apart for the firewall. The engine is driven against the firewall at the end of the crash due to the failure of the structure maintaining the cradle in position. The offset of the barrier, as in ODB, pushes the block at an angle and this hits the firewall first on the passenger side, hence the greater intrusion level. The pedal attachment point is completely untouched and the pedals do not move. The only area where the intrusion can be considered relevant is the central one, which corresponds to the space between passenger and driver and would not interest the survival space in a significant manner. This behaviour is expected to be true even when the vehicle is completely equipped with dashboard and interior trim. For what concerns the rest of the cabin, the door openings are not affected, the A-pillar doesn't move and also the floor is for the most part as it was prior to the impact. The rear area of this component shows a level of deformation which seems unreasonable, as there is no displacement in the components surrounding it and the damage appears since the very first *ms* of impact.

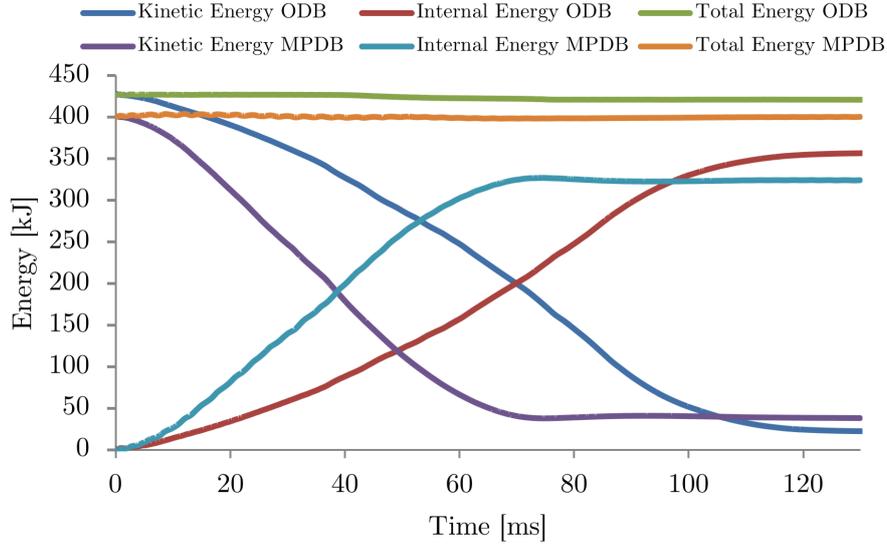
Figure 5.57: Chevrolet Silverado - ODB vs MPDB energy content

With regards to dynamic data, the first evident difference is the peak acceleration achieved in the two tests: the MPDB reaches a value around 26% lower than ODB, with a peak of $36g$ against $49g$. In both procedures the maximum point is reached at the very end of the crash, but while in the current one it is due to the engine loading heavily the firewall, in the future test this occurs due to the final loading of the main rail. In terms of average

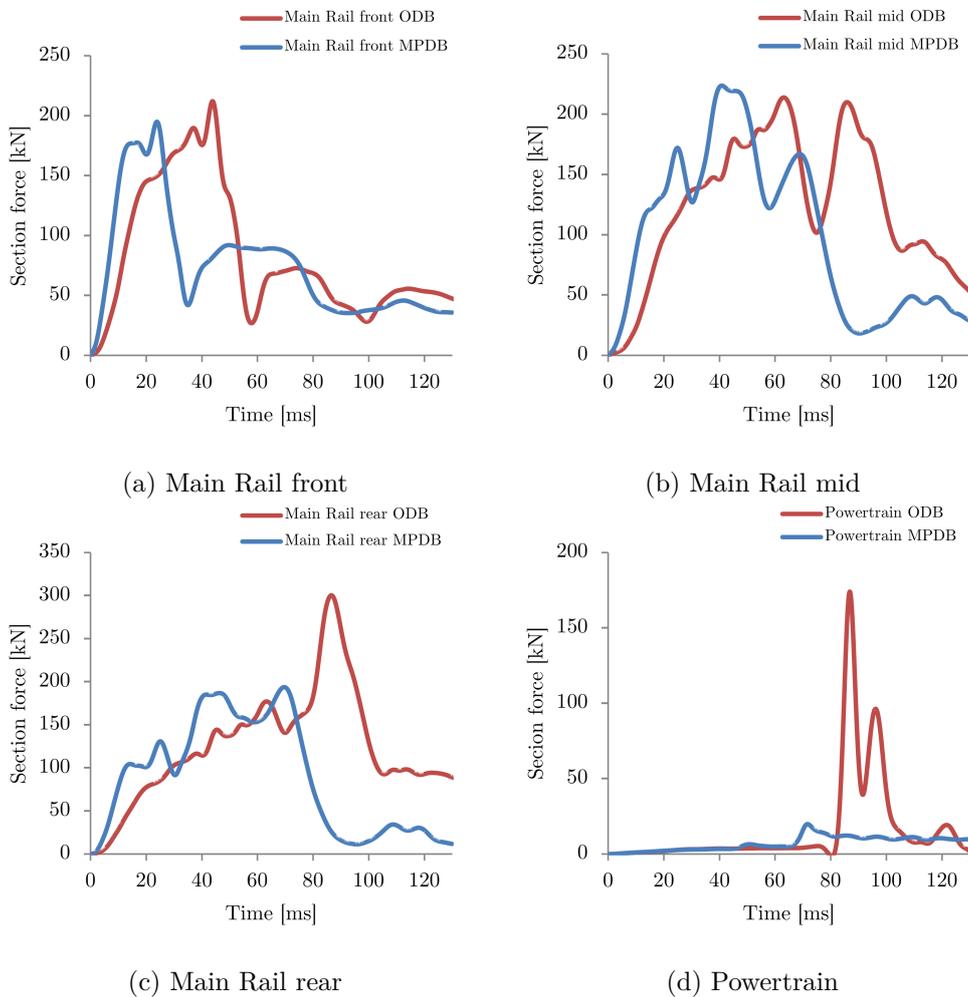
Figure 5.61: Chevrolet Silverado - section forces comparison

The comparison of section forces shown in Figure 5.61 supports what has been said above. In fact, both the front part and mid part of the main rail show the same maximum level of force sustained before buckling, the main difference being the timeframe in which the loading and buckling occur. In addition, the mid part of the structure fails in three fast, consecutive instances when loaded by the mobile barrier, while in the ODB it loads slowly and fails once - the second time corresponds to the loading of the rear section. The real differences begin to show when looking at the just mentioned rear section and at the powertrain loading. The level of force sustained by the former part is considerably higher in ODB, with a difference of more than $110kN$, which is more than enough to cause catastrophic failure. Similarly, a discrepancy of more than $160kN$ is registered for the powertrain loading, which justifies the completely different behaviour in terms of intrusion as the extra force is only counterbalanced by the cabin.

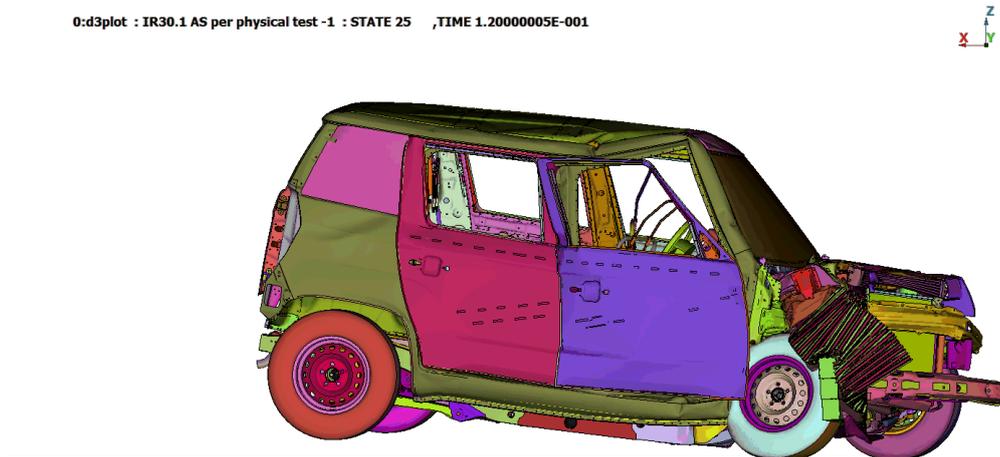
Figure 5.63: U Model ODB - simulation snapshot

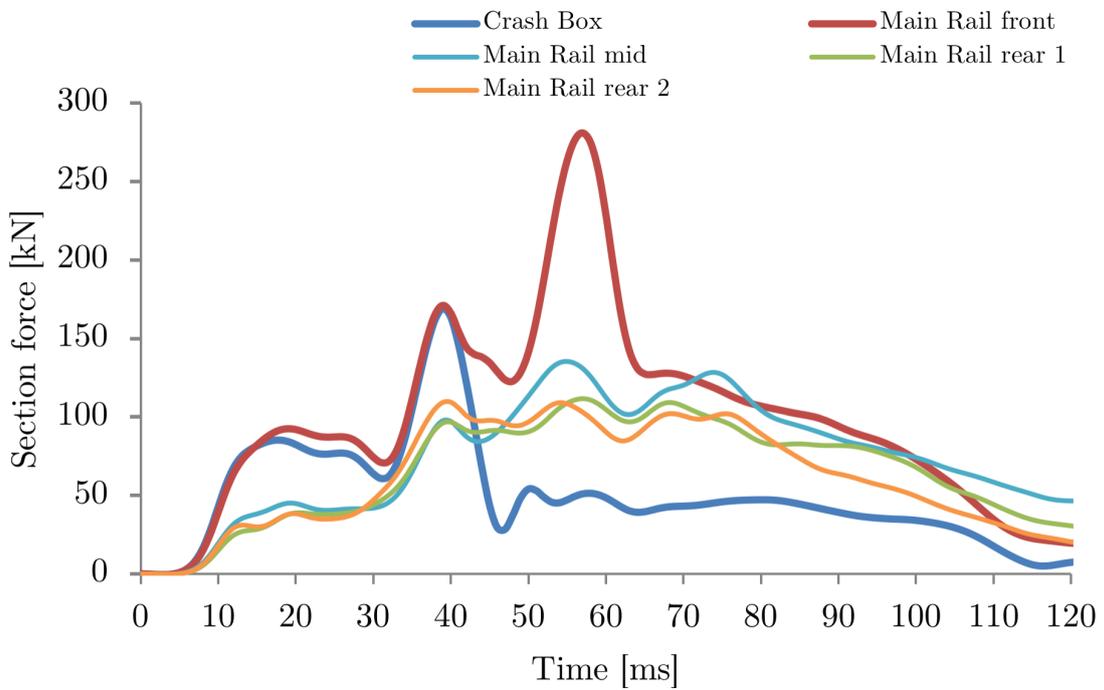
Figure 5.66: U Model ODB - section forces

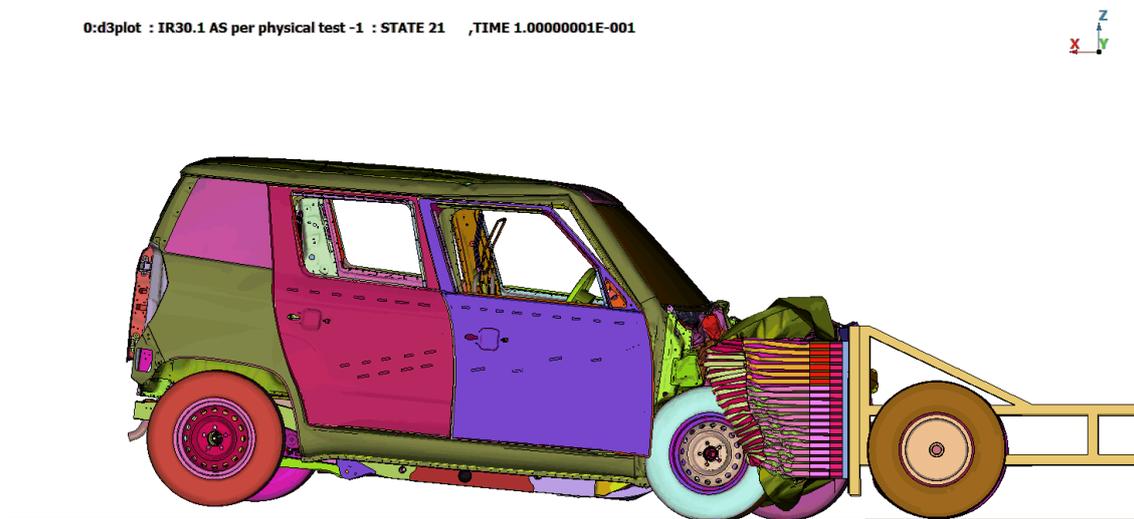
Figure 5.70: U Model MPDB - simulation snapshot

in correspondence with the lower $15g$ peak at $20-25ms$. Next, the main rail starts taking most of the load and immediately fails both at the cabin mounting point (major damage) and at the lower wishbone support (minor denting). For this reason the oscillation visible between 30 and $40ms$ occurs. At this point the wheel is pushed against the sill and the engine starts loading the firewall, the main rail is not sustaining a high level of force and the left hand side rail, which has been loaded since the beginning, reaches the axial point of failure in two points: the first at the rear engine cradle attachment, and the second on the top face of the box section, just under the cabin. The final peak of acceleration of $35g$ occurs as the engine and the wheel load firewall and A-pillar, dissipating the final portion of energy. During this final section the passenger compartment starts deforming noticeably, with the roof partially collapsing above the driver's door. The deformation is plastic only to a certain extent, as during the unloading phase part of the roof rail springs back. By the end of the event, the main rail has punctured the barrier reaching the end of the second honeycomb block, just a few millimetres in front of the last core. Also, the top part of the PDB pushes against all the components in the engine bay located above the wheelarch, deforming around them, hence at the end of the crash the honeycomb has reached a point very close to the A-pillar and firewall.

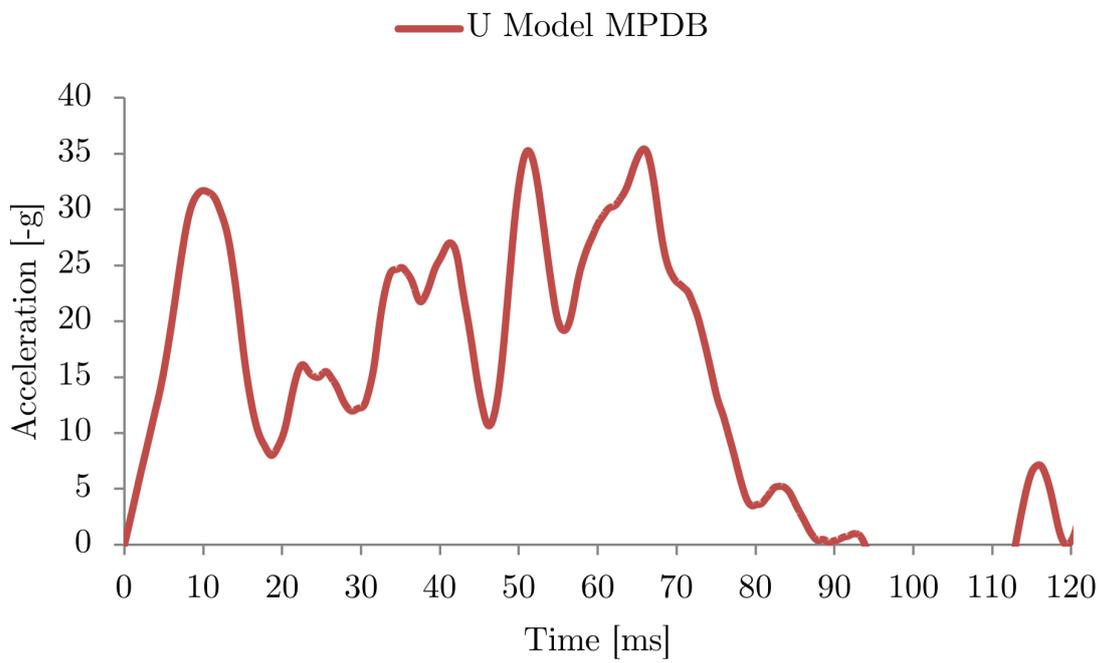
Figure 5.72: U Model MPDB - acceleration

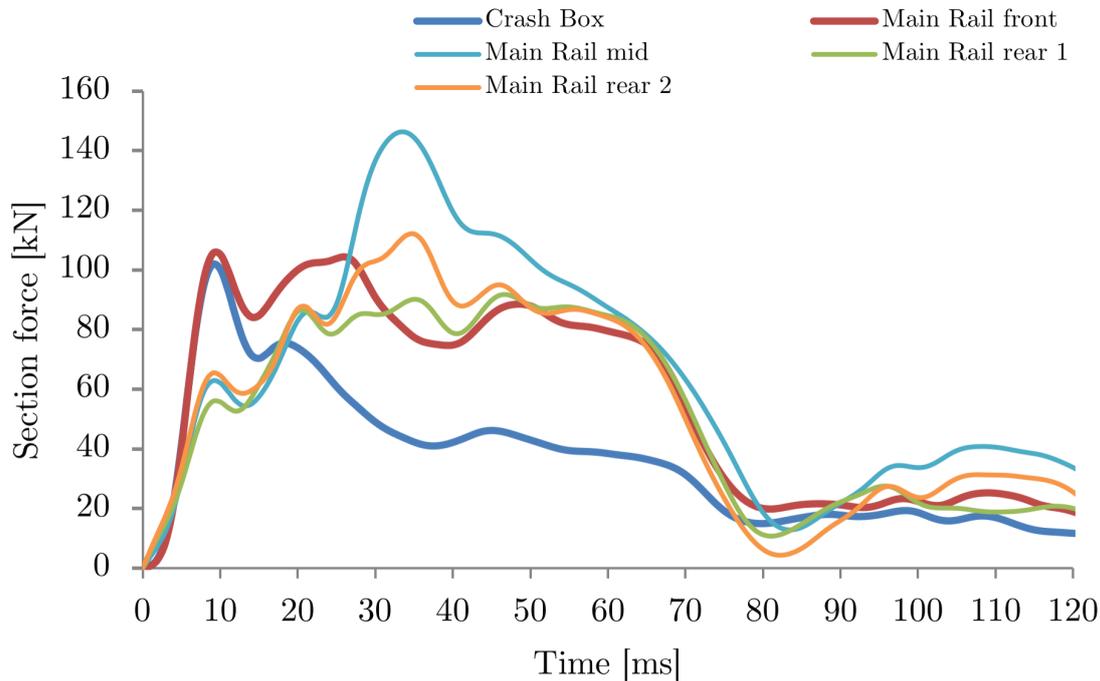
Figure 5.73: U Model MPDB - section forces

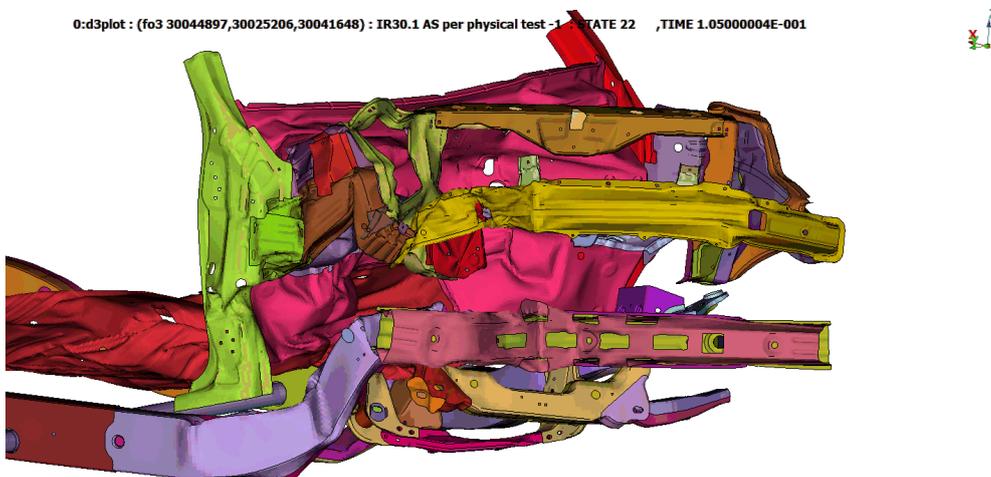
Figure 5.77: U Model ODB - structural damage

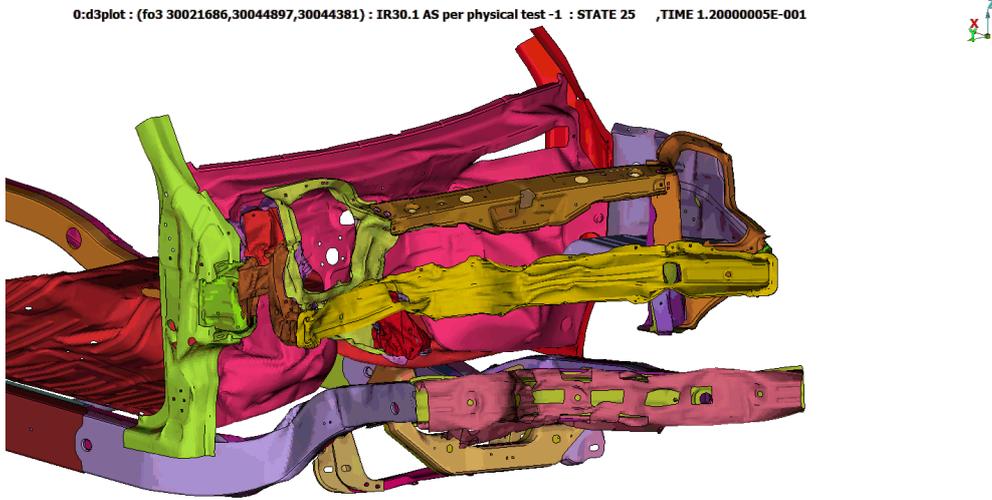
Figure 5.78: U Model MPDB - structural damage

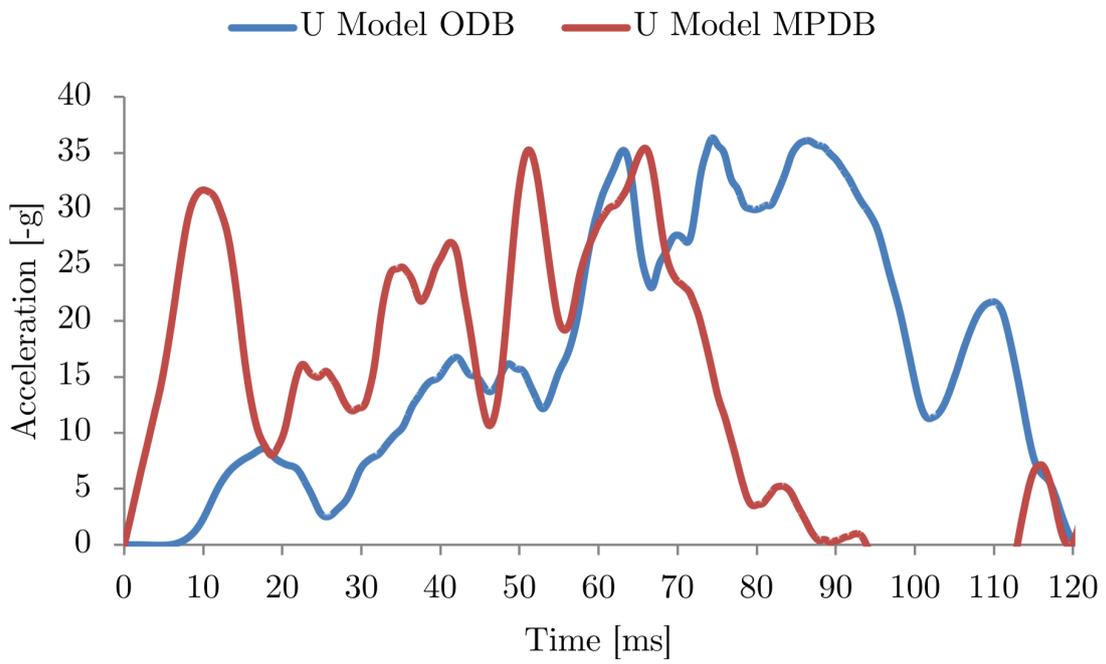
Figure 5.79: U Model - crash pulse comparison

ODB	MPDB	Difference	% Difference
Peak acc. [$-g$]	36.32	35.40	0.92	2.52
Mean acc. [$-g$]	15.96	20.76	-4.80	-30.11
Time to zero velocity [s]	103.10	69.50	33.60	32.59

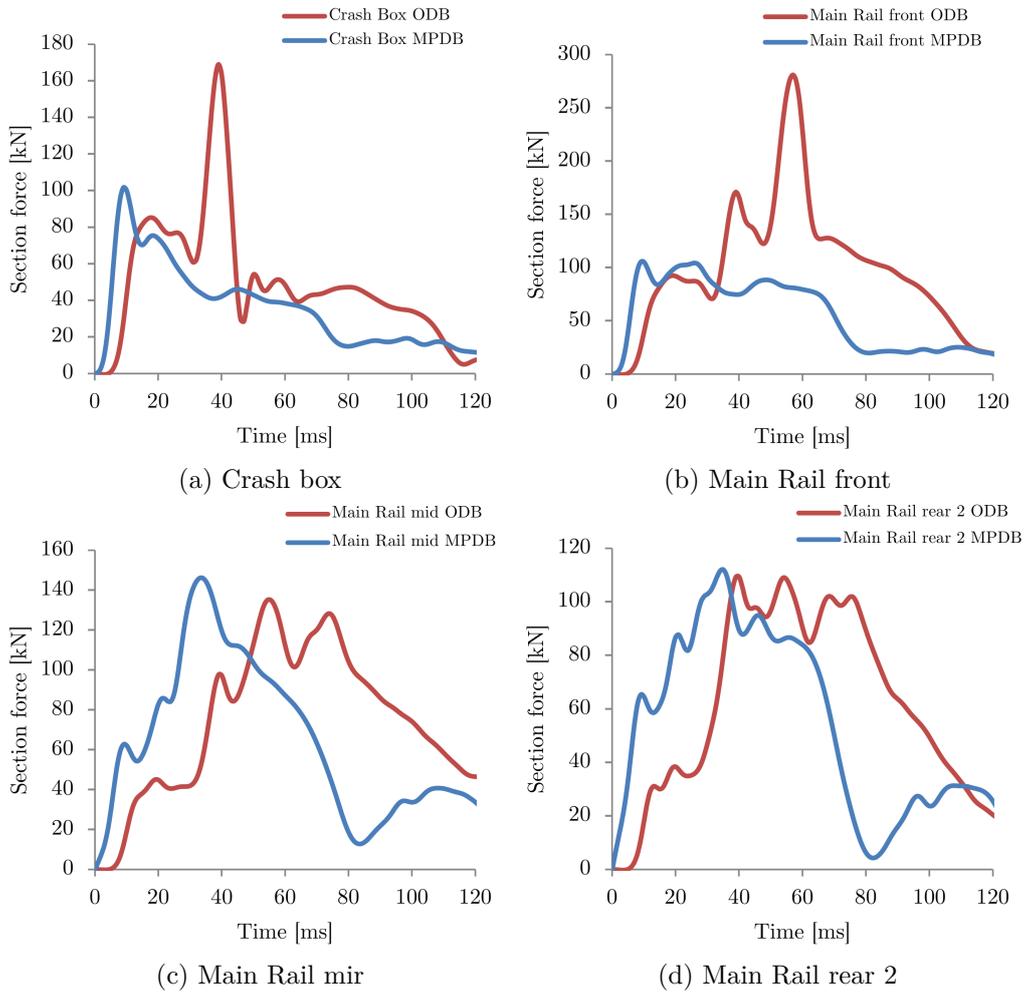
Figure 5.81: U Model - RHS section force comparison

The section forces comparison shown in Figure 5.81 highlights better the trends analysed in the previous paragraph, concerning the right hand side crash structures. The crash box in the MPDB procedure clearly has to support a much lower loading compared to that seen in ODB and its point of failure is not under the maximum allowable load that the component was designed for, but due to an incorrect failure mode. The front part of the main rail also sees a much lower force, which justifies the lower level of deformation in this section of the structure. Finally, the rear section forces appear to be similar in the peak force under which they collapse. A more interesting trend, however, is presented in Figure 5.81: it is possible to see how the left hand side rail is loaded in a relevant way during the MPDB impact. During the initial phases of the crash, this part of the structure is experiencing about 60% of the force of the directly loaded rail; in the final part of the crash, the structure is loaded again to about half the values seen by the rear segment of the rhs structures. In the ODB, on the other hand, this does not occur at all: the loads are extremely low for the whole duration of the impact, up until the point where the rail is pulled towards the centreline of the vehicle and fails due to bending. The overall contribution of this structure towards energy absorption and limitation of the damage to the cabin seems to be vastly different between the two tests. This trend was visible in the previous vehicles as well, but its significance was absolutely marginal, while in this case it is definitely worth noting. Regarding the section force trends for the locations further down the rail, the same behaviour can be found, but the difference between the two tests goes diminishing due to decreased values seen in the MPDB, while the ones for ODB remain very low throughout.

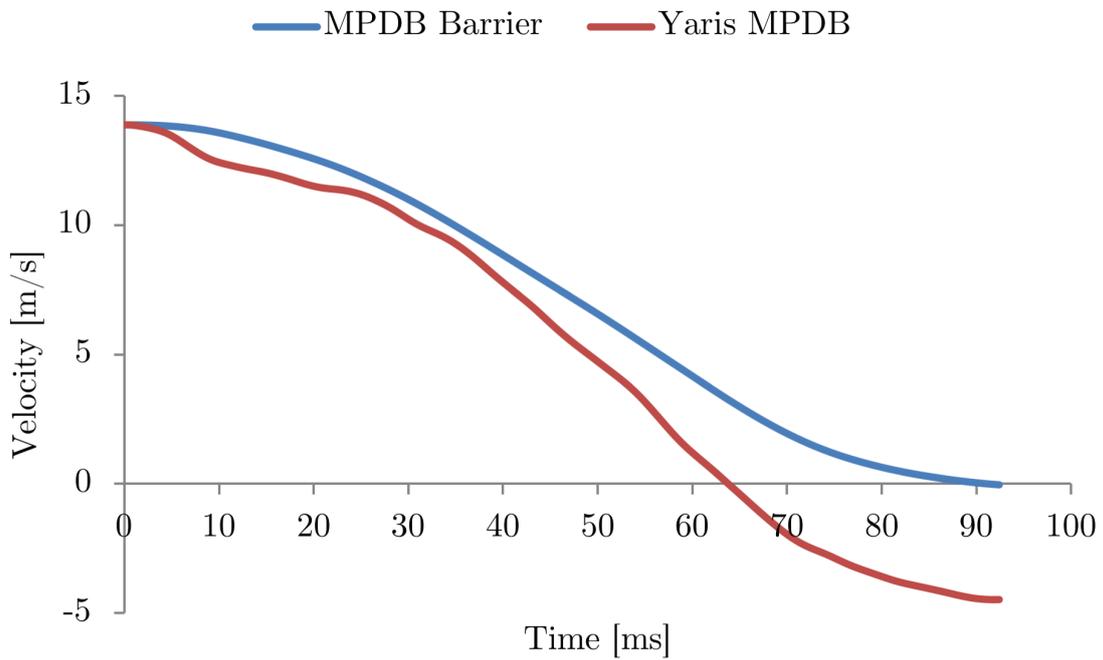
Figure 6.4: Toyota Yaris - barrier and vehicle velocity comparison

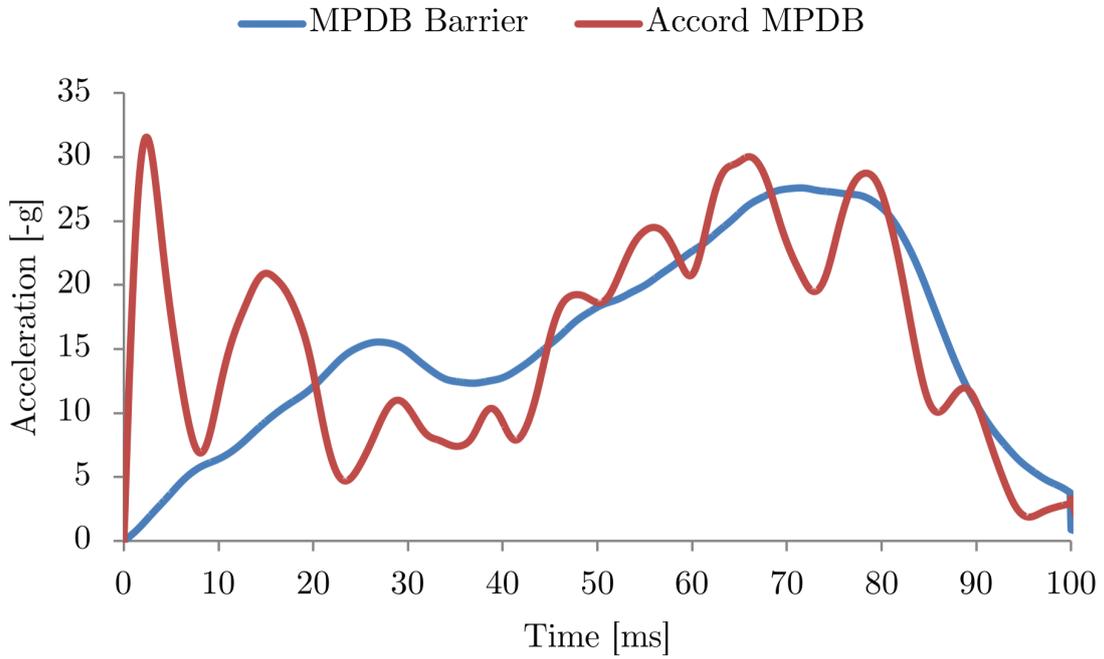
Figure 6.7: Honda Accord - barrier and vehicle acceleration comparison

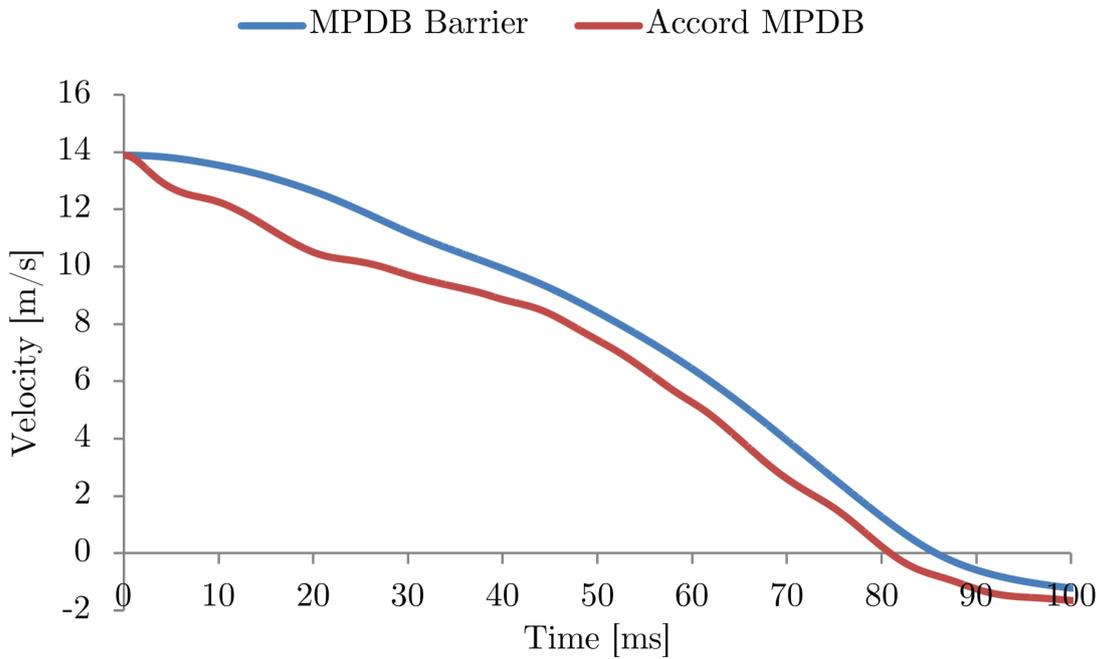
Figure 6.8: Honda Accord - barrier and vehicle velocity comparison

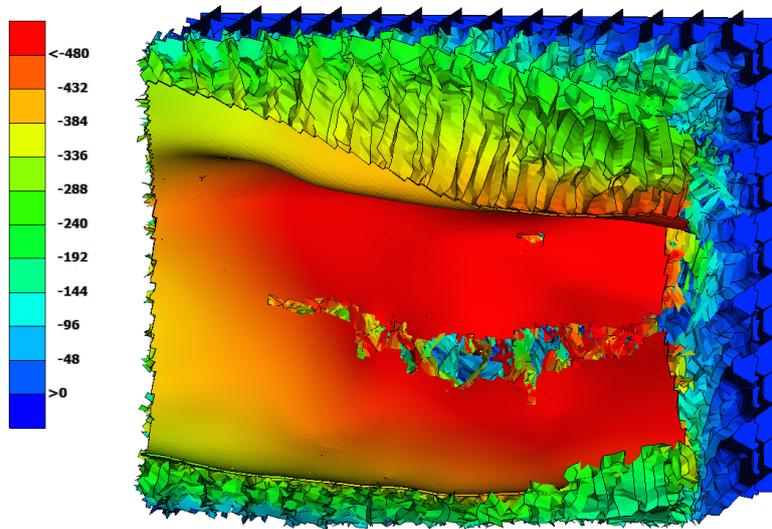
Figure 6.9: Chevrolet Silverado - barrier deformation in area of interest

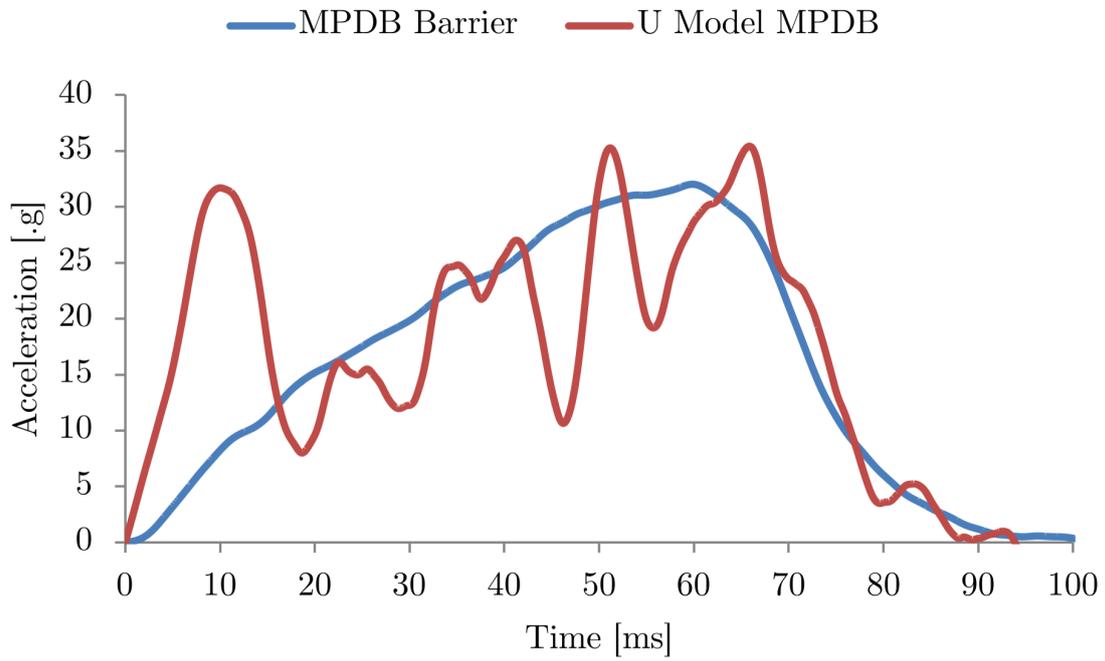
Figure 6.15: U Model - barrier and vehicle acceleration comparison

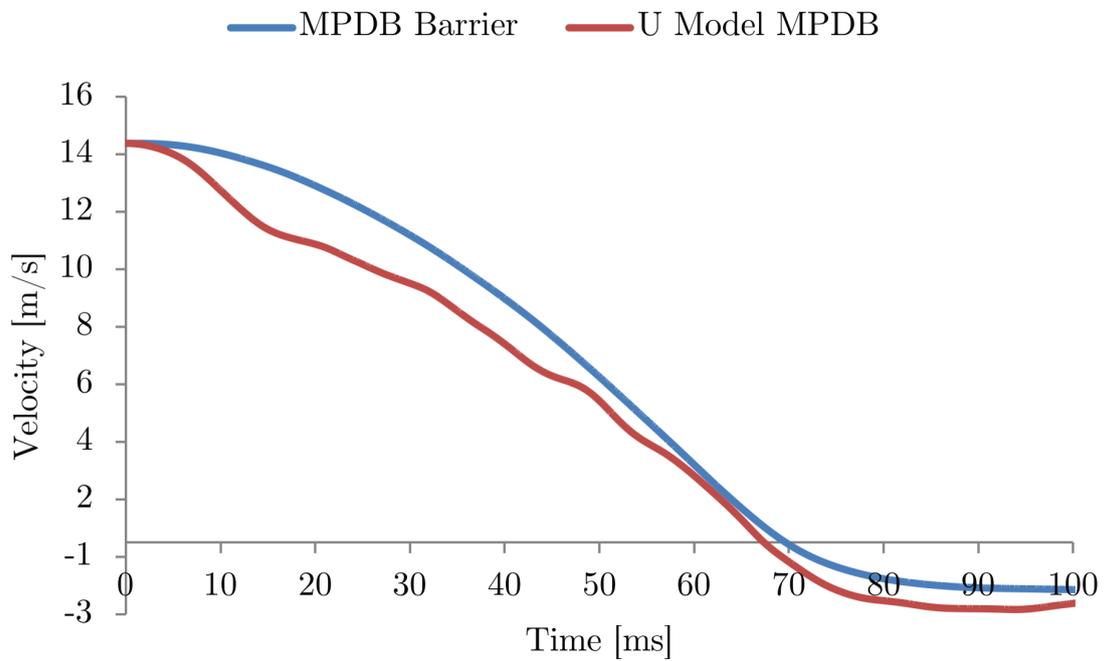
Figure 6.16: U Model - barrier and vehicle velocity comparison

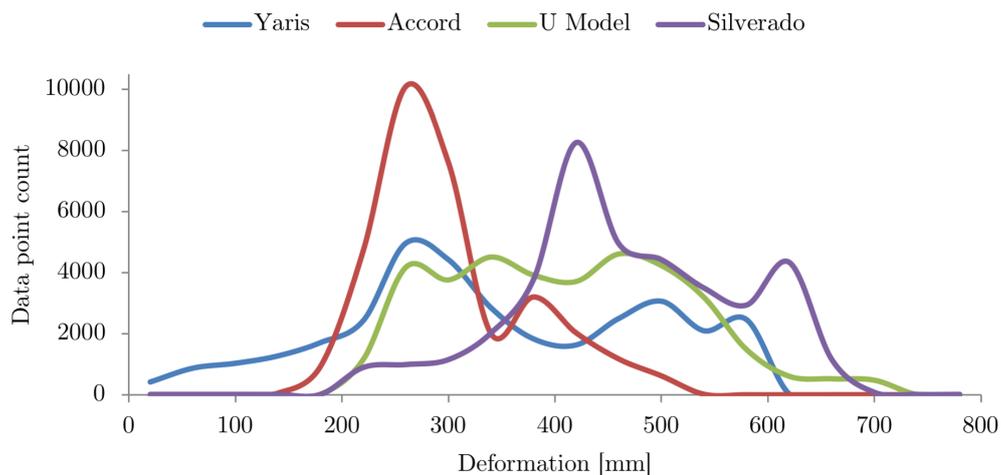
Figure 6.17: Comparison between analysed vehicles

In conclusion, this part of the study has shown some interesting trends in relation to the partner protection assessment that will be included in the new Euro NCAP procedure. Although the parameters are still not finalised, it is safe to assume that the analysis methods used for this work are close to those that will be implemented by the consumer safety assessment programme. A part that was unfortunately completely missing from literature is the relationship between the results obtained through the mean and standard deviation calculations and the thresholds that will be put in place, meaning that it is hard to relate these results with the specific rating that would be given. Nonetheless, it has been possible to understand that the major factor in partner protection is in fact the design of the frontal structures of the vehicle, rather than it being primarily related to the mass of the vehicle and the stiffness of the front rails. This was demonstrated by the Toyota Yaris, which, despite being light, achieved extremely poor results both in terms of mean deformation and standard deviation. This was due to the incorrect behaviour of its main rail and the presence of only one load path. On the opposite end of the scale, the Honda Accord showed the ability to achieve positive results all around, thanks to the more complex front end design which was the only example of a first step towards compatibility-driven structural engineering. Its increased mass also didn't produce significantly higher acceleration pulses through the trolley. With regards to the other two vehicles analysed, their shortcomings were very evident and highlighted the fact that the ladder chassis design will pose a very difficult challenge for the future, if they will be used in partner protection assessments. Furthermore, the Silverado, although not being a vehicle present on European roads, could be in a way compared to the vast majority of the light commercial vehicles circulating on EU roads due to its chassis design and overall mass, with the main difference being the distance of the cabin from the leading edge of the bonnet. Its performance in the compatibility assessment highlights how important it will be to modify the structural designs of those types of vehicles too, in order to achieve an overall higher safety level of the circulating fleet.

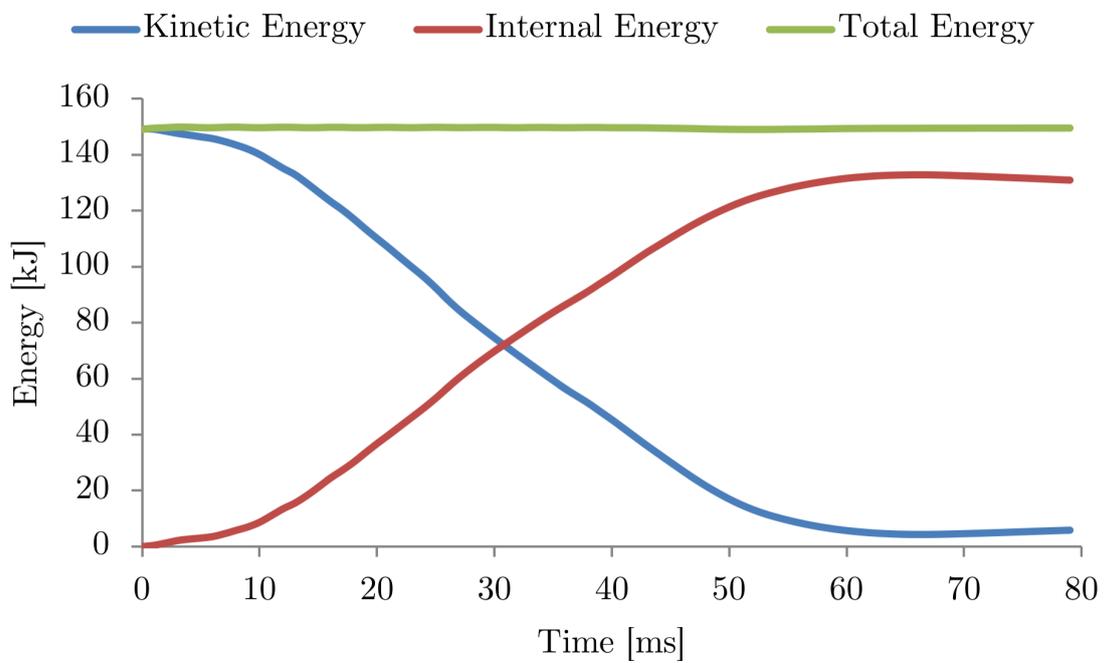
Figure A.1: Toyota Yaris FWRB - simulation energy

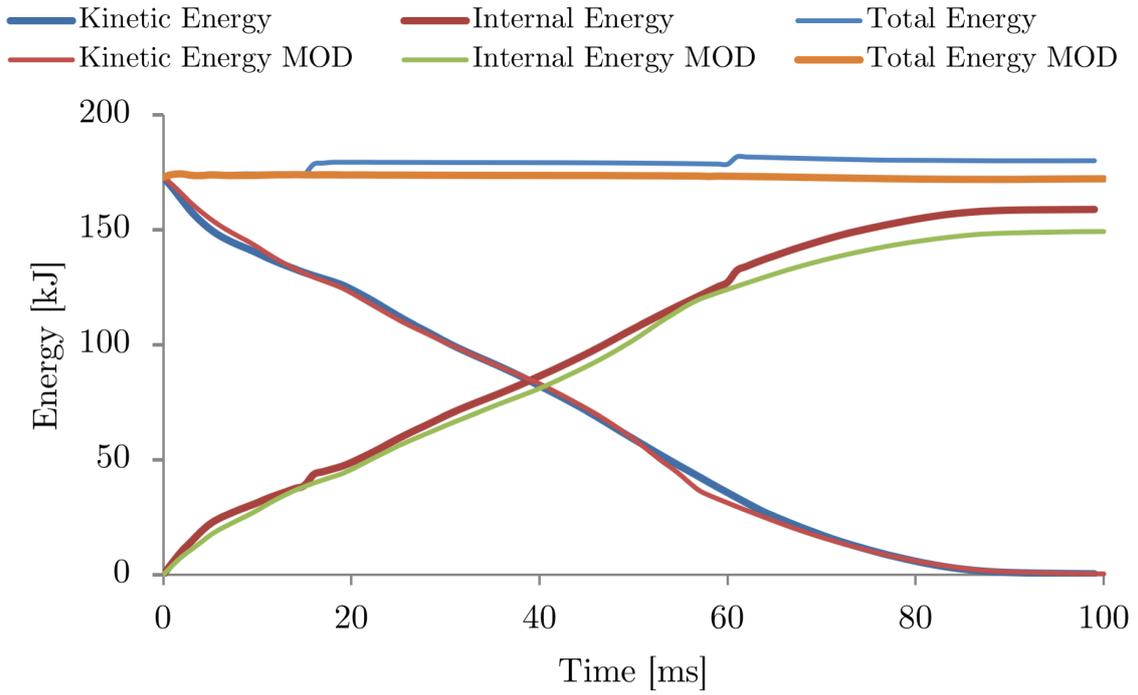
Figure A.2: Honda Accord FWRB - simulation energy

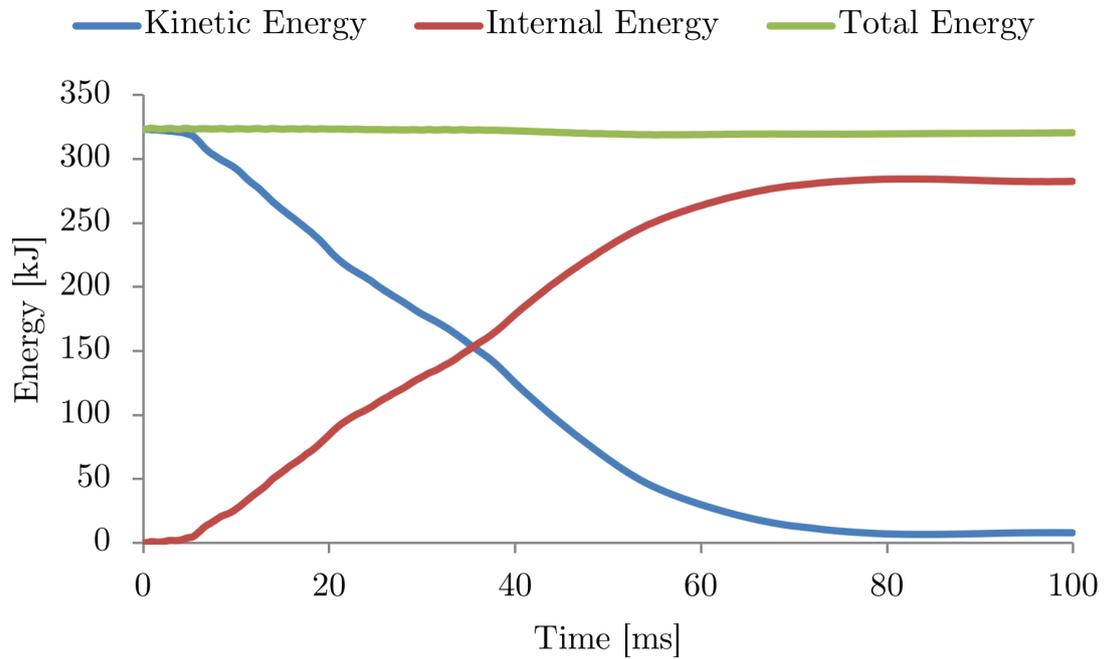
Figure A.3: Chevrolet Silverado FWRB - simulation energy

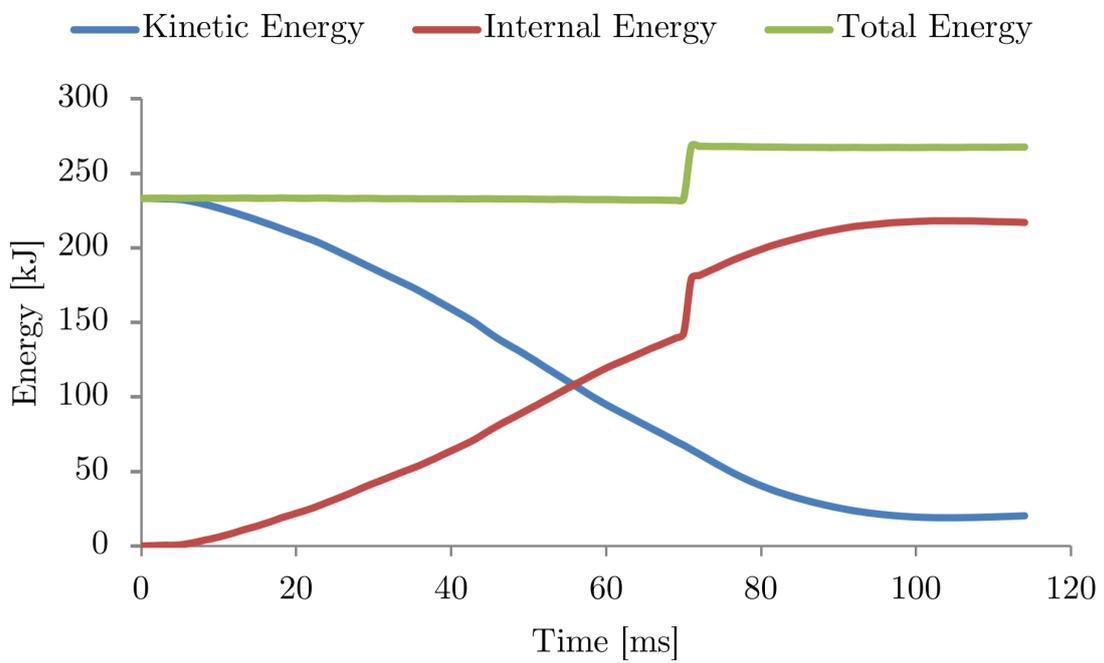
Figure A.4: U Model ODB 56km/h - simulation energy

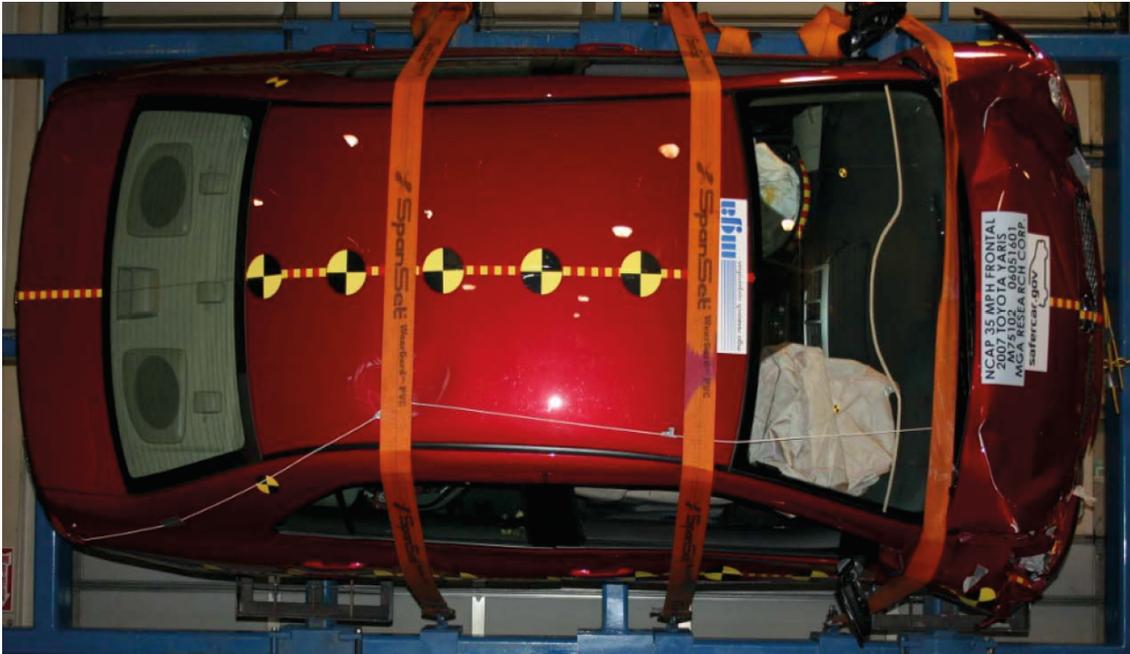
Figure B.3: Toyota Yaris FWRB - top view comparison
