POLITECNICO DI TORINO

Master Degree Thesis

Euro NCAP 2020: the evolution of partial overlap frontal tests and its impact on effective vehicle safety

A simulation analysis of the Euro NCAP ODB and MPDB procedures

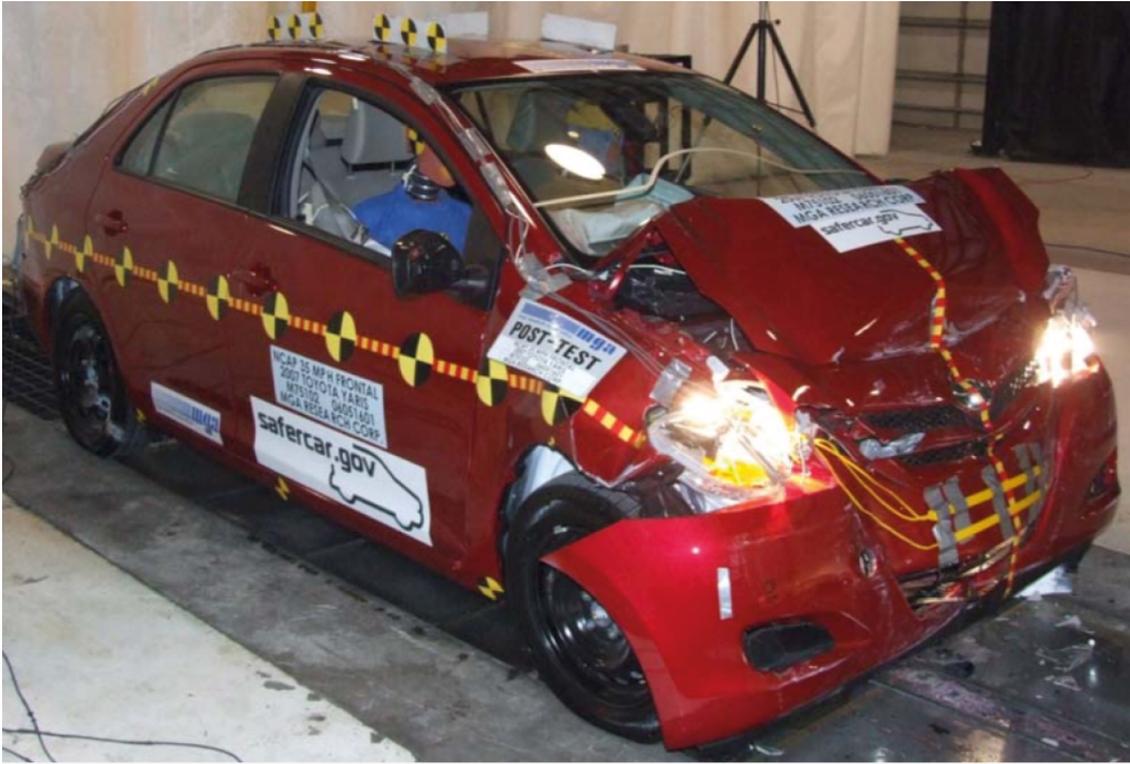
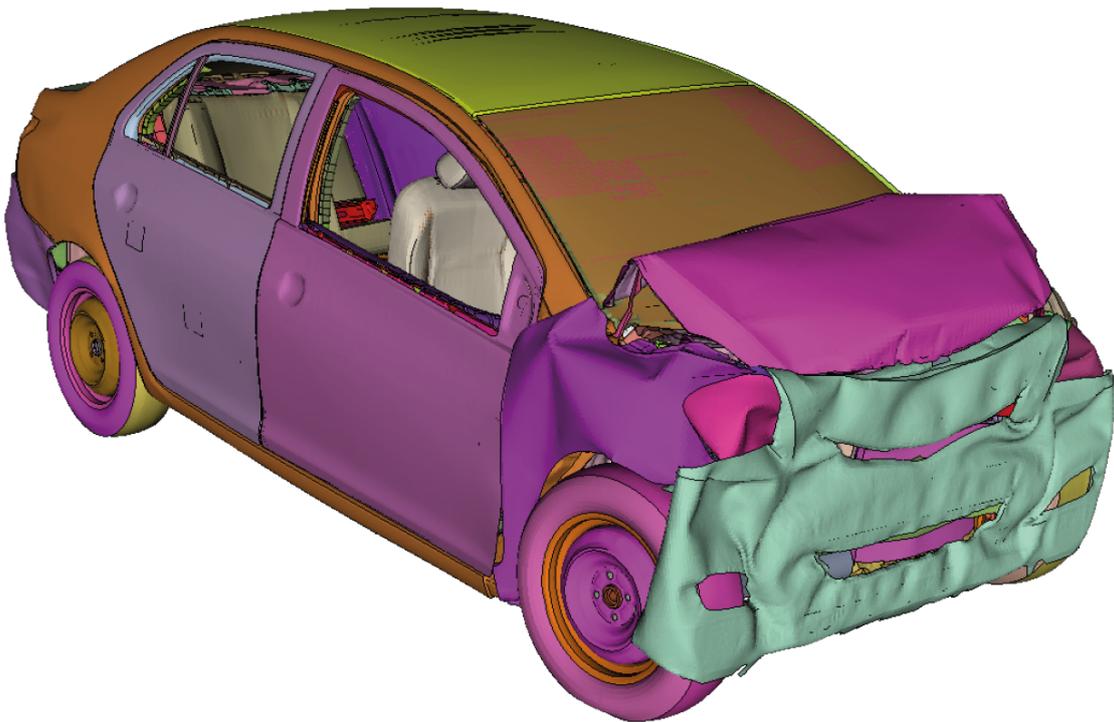
Figure B.4: Toyota Yaris FWRB - three quarter view comparison

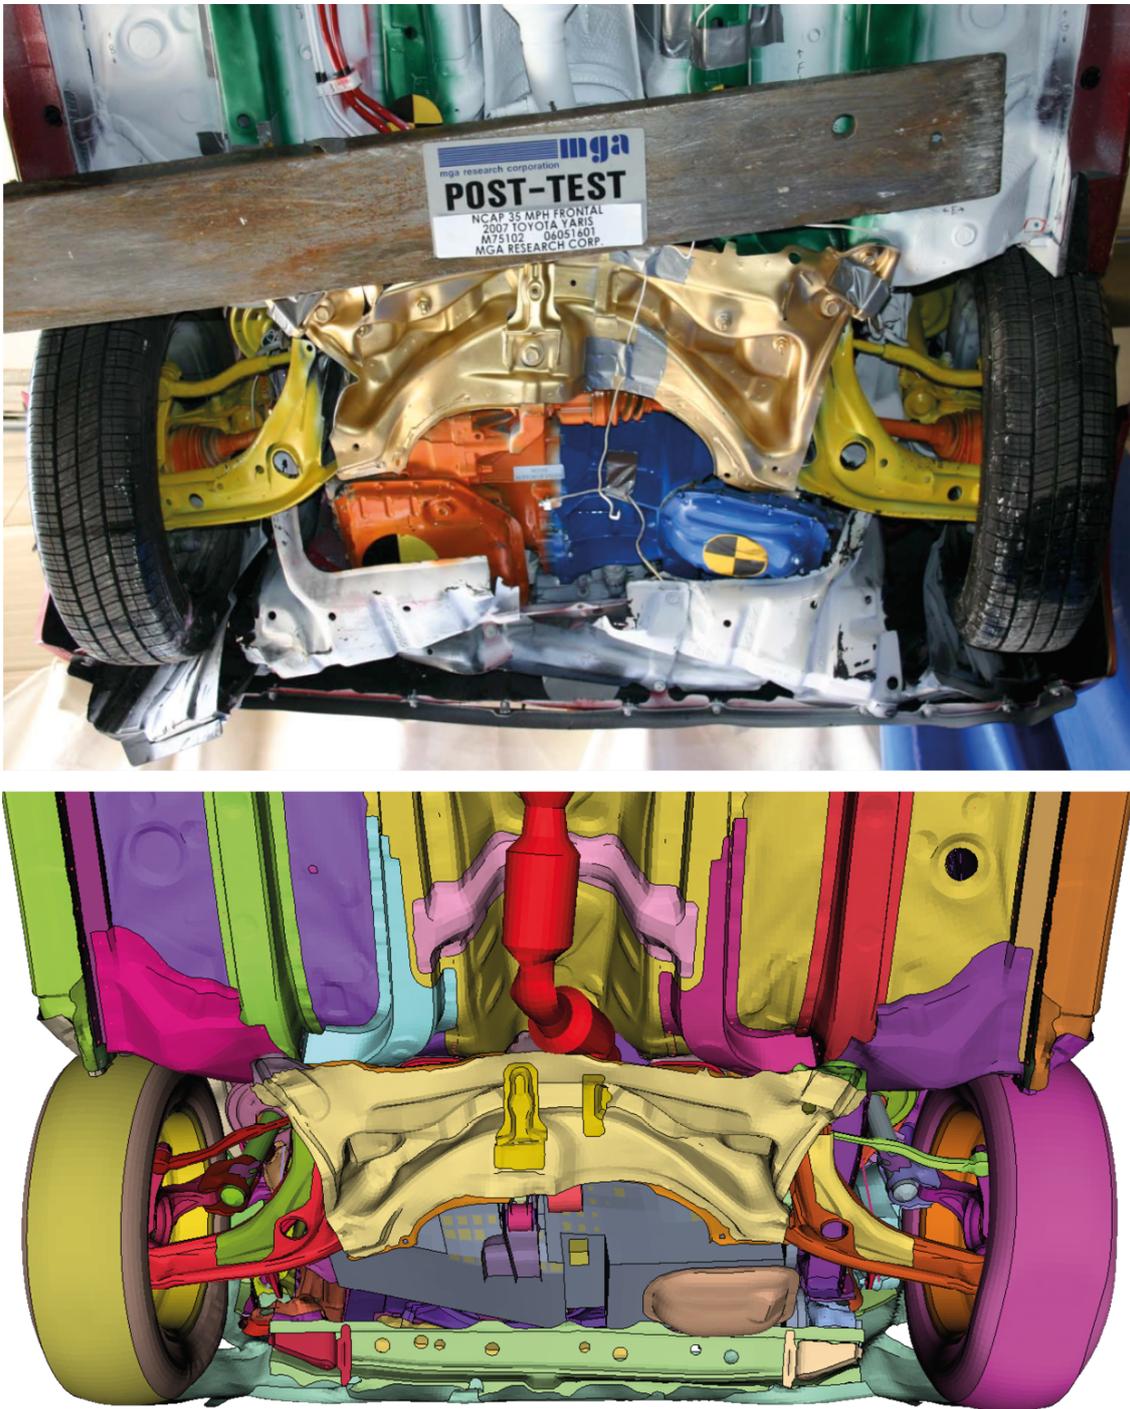
Figure B.5: Toyota Yaris FWRB - underbody comparison

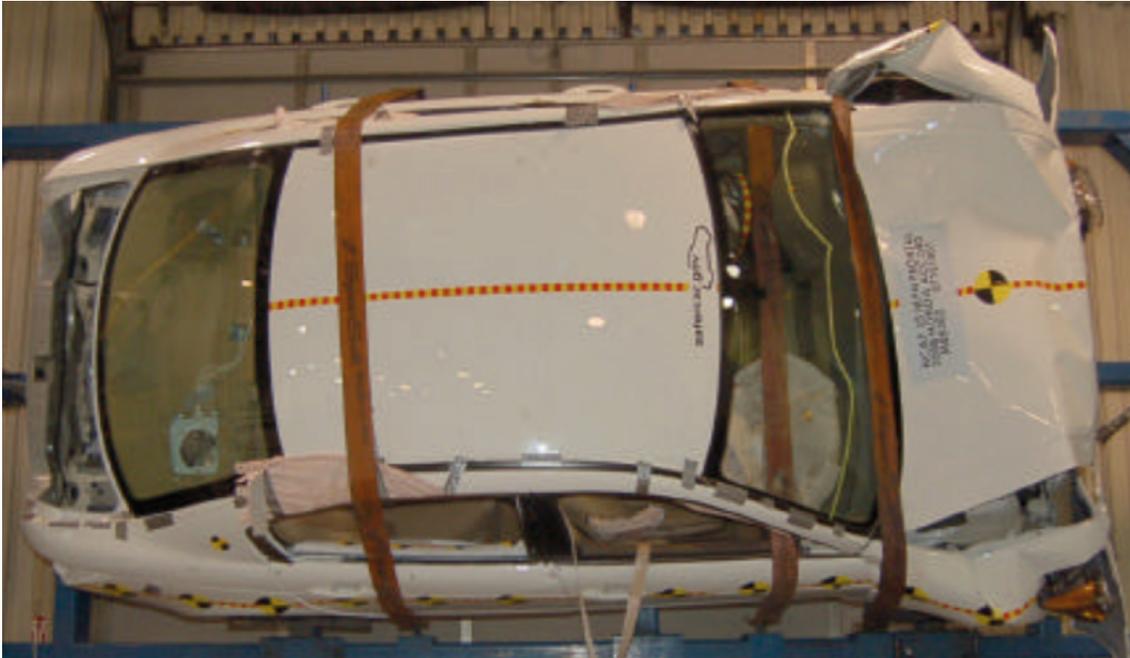
Figure B.8: Honda Accord FWRB - top view comparison

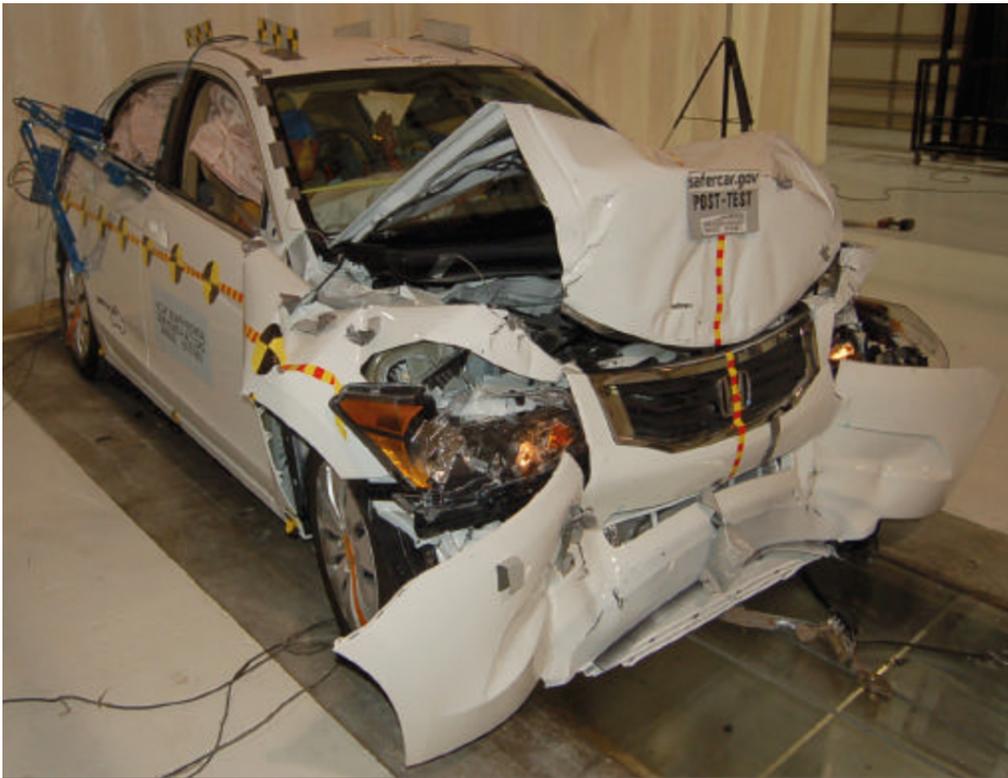
Figure B.9: Honda Accord FWRB - three quarter view comparison

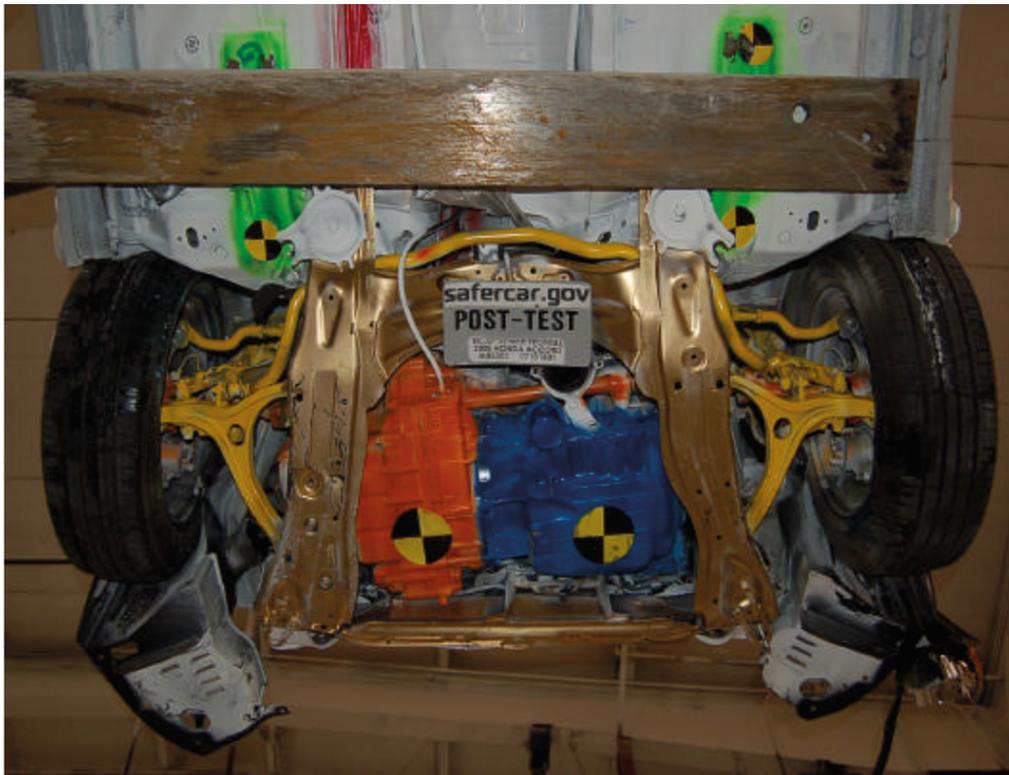
Figure B.10: Honda Accord FWRB - underbody comparison

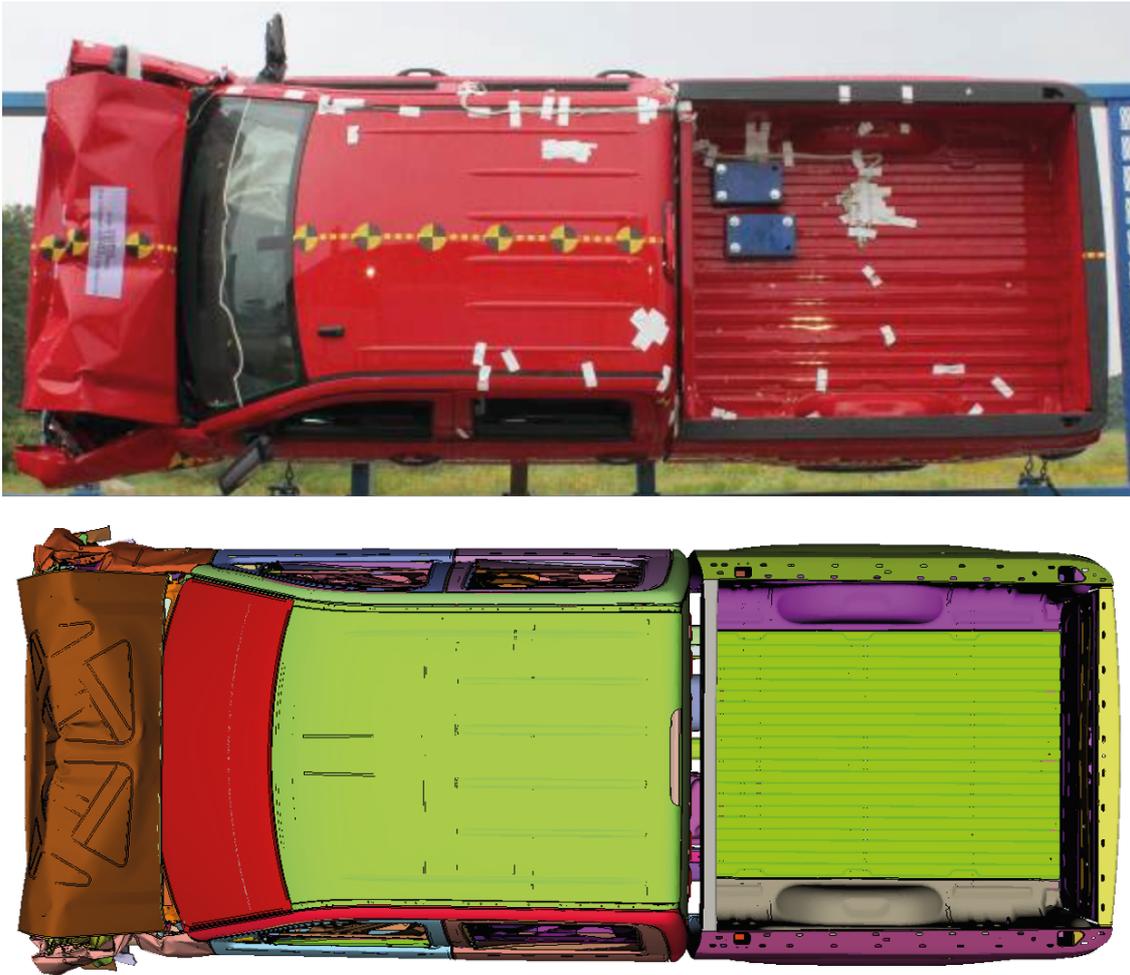
Figure B.13: Chevrolet Silverado FWRB - top view comparison

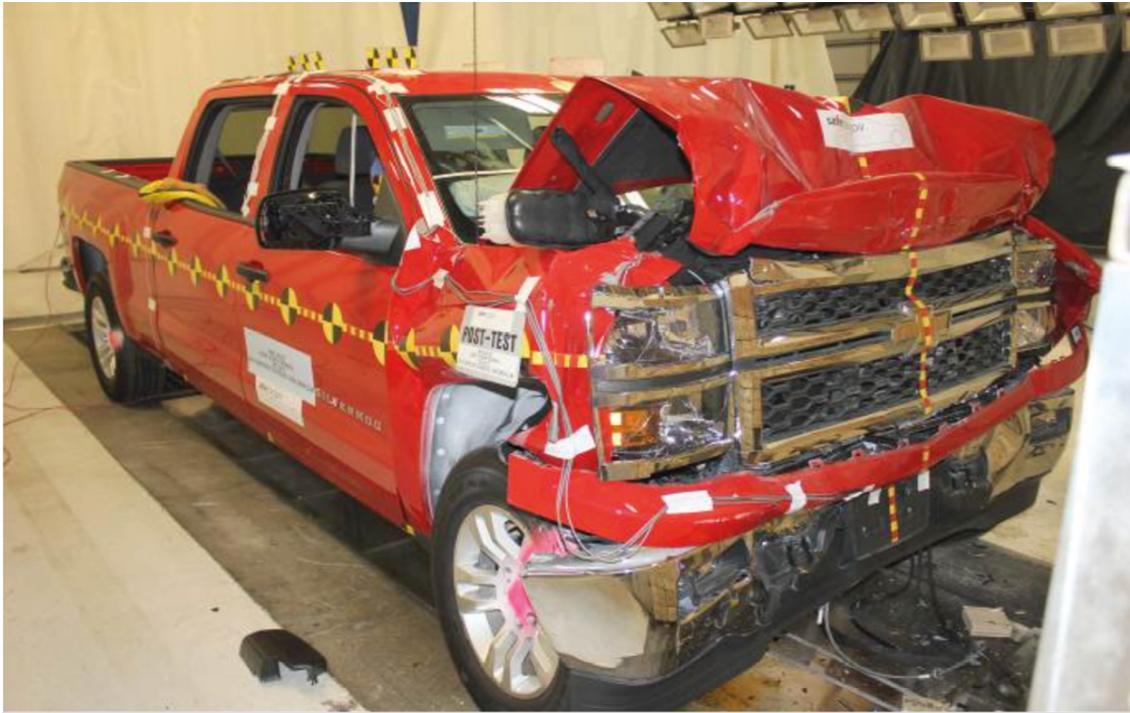
Figure B.14: Chevrolet Silverado FWRB - three quarter view comparison

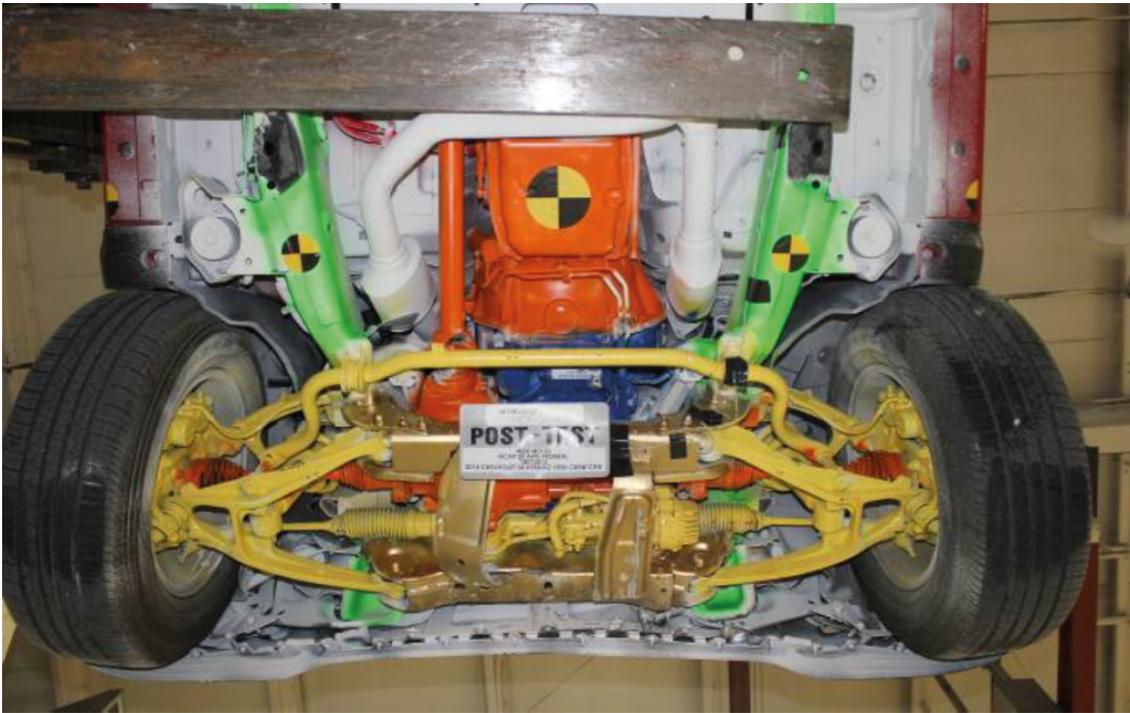
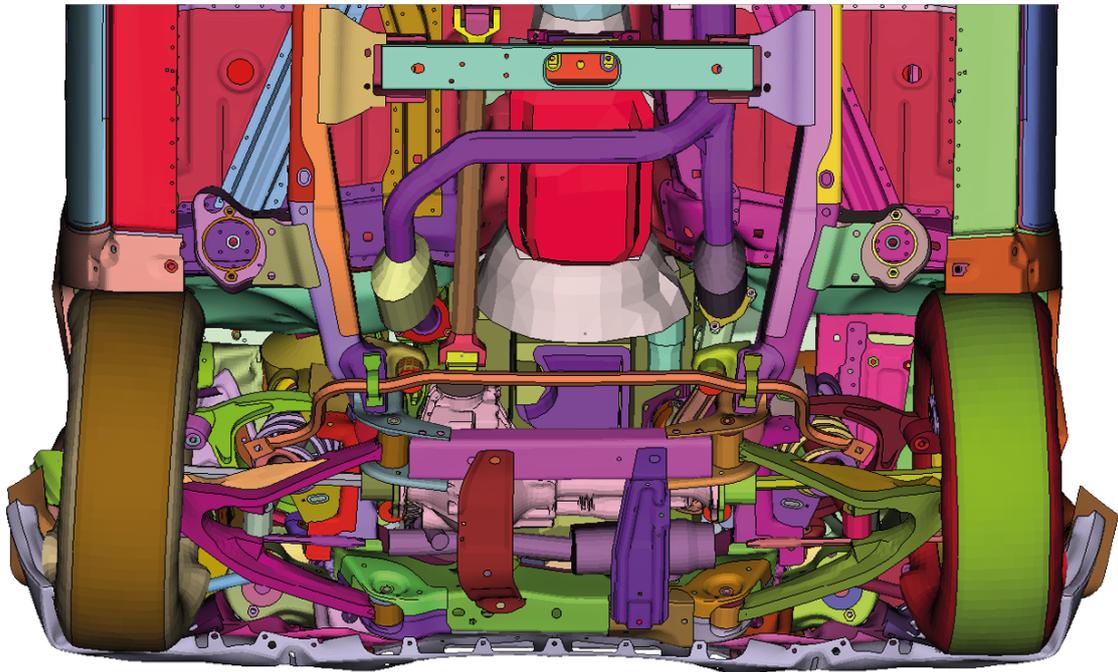
Figure B.15: Chevrolet Silverado FWRB - underbody comparison
