POLITECNICO DI TORINO

TESI MAGISTRALE

Technical aspects related to the Brenner Base Tunnel jobsite: disassembly of a
Double Shield TBM and back analysis on the cutter discs wear

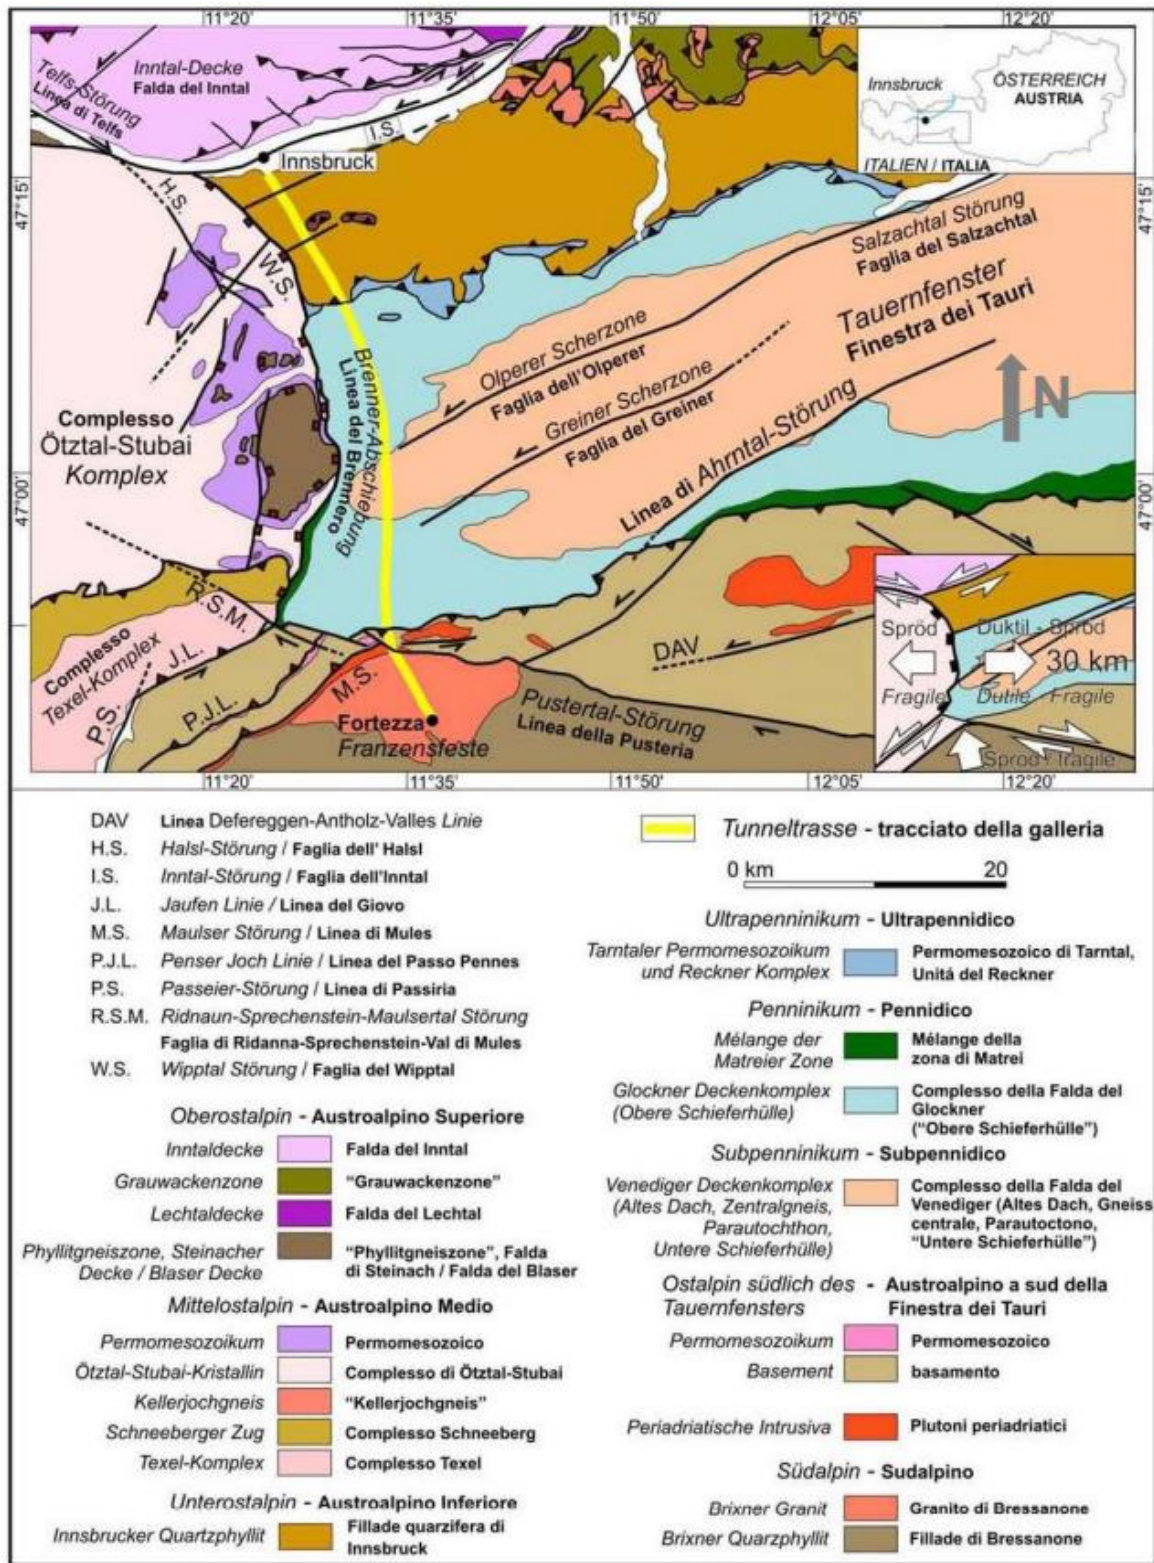
Figure 7 - General geological order (Mancktelow, 1980)

In the figure below (Figure 7) is exposed the general geological order related to the area of the entire tunnels system.

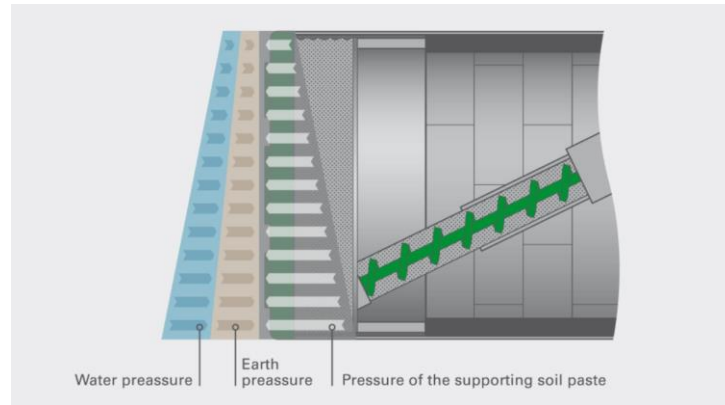
Figure 10 - Earth Pressure Balance system (Herrenknecht, 2022)

The EPB Shield is mainly used for soft and cohesive soils. The principal characteristic of this TBM type is the ability to turn the excavated material into a soil paste that is used as plastic support medium. A rotating cutting wheel equipped with tools is pressed against the tunnel face and excavates the material. The soil enters the excavation chamber through openings and there is mixed with soil paste already present by means of mixing arms. The bulkhead, placed behind the cutter wheel, transfers the pressure of the thrust cylinders to the soil paste. When the pressure of the soil paste in the excavation chamber is equal to the pressure of the tunnel face (surrounding soil and groundwater), the necessary balance has been achieved. For this purpose, the screw conveyor speed, which aim is to bring the excavated material from the bottom of the excavation chamber to the conveyor belt, is regulated and matched with the advanced speed in order to keep steady equilibrium between the quantity of soil removed by the screw conveyor and the quantity of soil accumulated during the shield tunneling process. In this way there is a pressure acting against the tunnel face and it avoids the uncontrolled inflow of soil into the machine and creates conditions for rapid tunnelling with minimum settlement.

The application range for this type of TBM is strictly related to the soil conditioning. Indeed, changing the plasticity, the texture and the water permeability by injecting conditioning materials such as water, bentonite or foam is possible to achieve good advance rates even in heterogeneous soils or in unstable geological conditions.

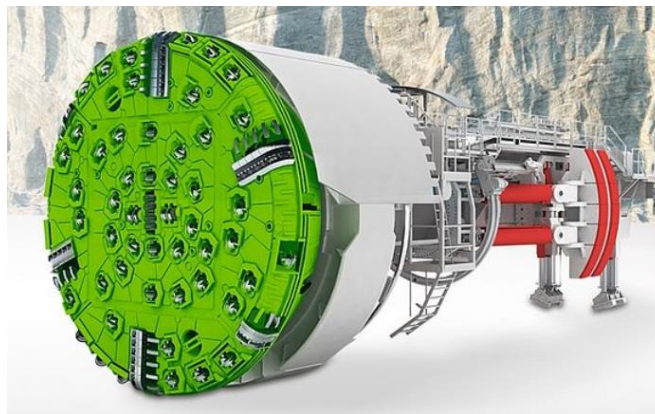
Figure 12 - Gripper TBM (Herrenknecht, 2022)

Gripper TBMs are open-mode TBM and do not have a closed shield skin. This type of TBM is mainly used for fast mechanized tunnelling in hard rock. The typical process is without the use of segments and hence medium to high rock strengths are required for high advance rate. During the excavation process, the cutterhead is pressed against the tunnel face by means of thrust cylinders. Due to the rolling movement of the cutters present on the cutterhead, chips of rock are broken out of the rock. Some buckets installed at the cutterhead take up the excavated

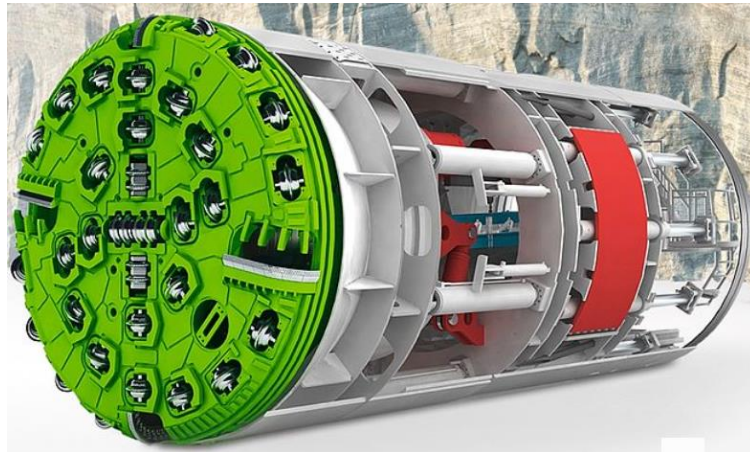
Figure 14 - Double Shield TBM (Herrenknecht, 2022)

The Double Shield TBMs unify the principles of Gripper TBM and Single Shield TBM in one machine. For this reason, this type of TBM can be considered the most technically sophisticated among the TBM machine already presented. In good geological conditions this type of TBM allows the installation of concrete segments during the excavation. Due to this characteristic, this TBM is the best one to use for excavating long tunnels in hard rock. The Double Shield Tunnel Boring Machine consists of two main components: a front shield with the cutterhead and the main drive and a gripper shield with a gripper unit and auxiliary thrust cylinders. Those two shields are connected by the main thrust cylinders which are protected by the telescopic shield where the shield skins of the front and of the gripper shield overlap. In stable rocks, the machine is braced radially against the tunnel with the gripper shoes. In this way the front shield can be advanced independently of the gripper shield using the main thrust cylinders. The reaction forces

are in this case transferred to the rock instead of to the last erected ring as happen in the Single Shield TBM. During the excavation and ring-building phase the auxiliary thrust cylinders are used only to keep the installed ring in place. When the stroke is completed, the gripper shoes are loosened and the gripper shield is pushed behind the front shield using the auxiliary thrust cylinders. The time requested for the regripping is very small with respect to the excavation time: it means that we can assume the excavation almost continuous using this Tunnel Boring Machine. Another key point for this TBM is the tunnelling the geological fault zones. In these sections the use of gripper shoes is not possible, and the thrust forces are applied using the auxiliary thrust cylinders: in this way the tunnelling is the same as explained for the Single Shield TBM. Thanks to this combined method of Gripper and Single Shield TBM, it is often used for long drives in hard rock, especially when the geology is not homogeneous. Additionally, it can be used in all kind of rock, stable and unstable and with a diameter vary between 2.8 m to 12.5 m. (Herrenknecht, 2022)

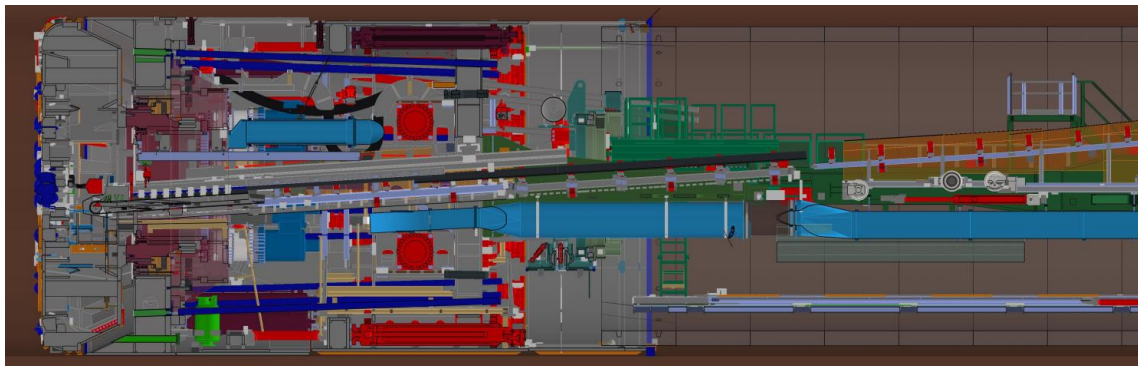
Figure 19 - Starting conditions for the shield disassembly (Herrenknecht, 2022)

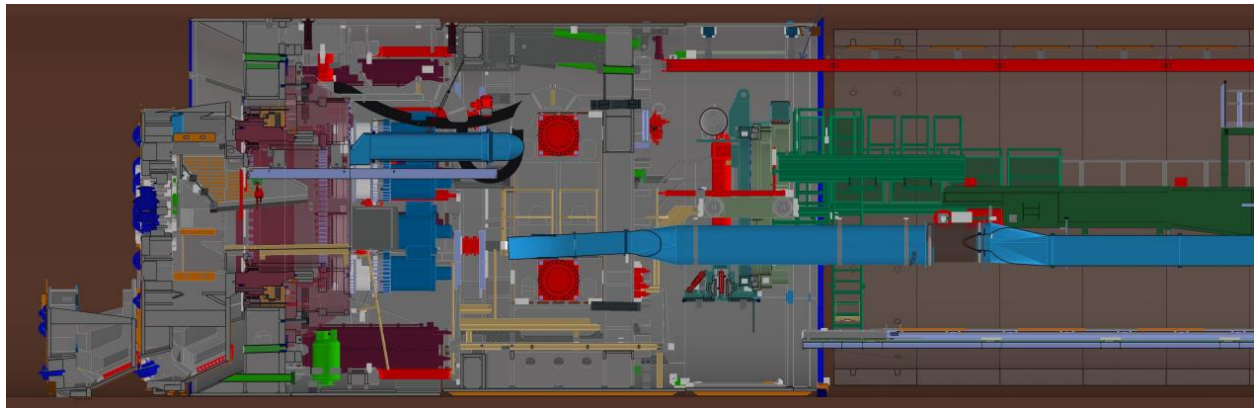
Figure 22 - Crane runway installation ("HK 5102-091-001-01 Shield Disassembly", Herrenknecht, 2022)

Once the thrust cylinders and the machine conveyor belt have been removed from the shield area and since the erector is no longer used for the disassembly intention, the suggestion of the disassembly project is to install a crane runway (Figure 22). The crane runway should be installed after the remotion of thrust cylinders and conveyor belt in order to have sufficient space to set up the beam. The number of plates necessary to be used to secure the monorail is dependent on the geology surrounding the TBM in the last tunnelling meters and on the maximum weight to be lifted.

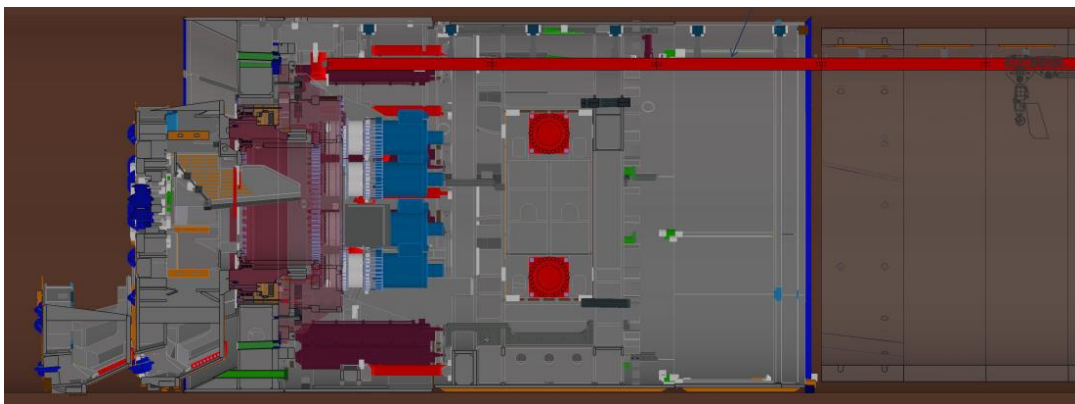
Figure 25 - Lengthen of the crane runway ("HK 5102-091-001-01 Shield Disassembly", Herrenknecht, 2022)

After the removal of the erector and of the erector beam, the following step is to lengthen the crane runway towards the tunnel face, as shown in the figure below (Figure 25). For this goal some parts of the top of the shield must be cut by fire cutting in order to allow the installation of the beam.

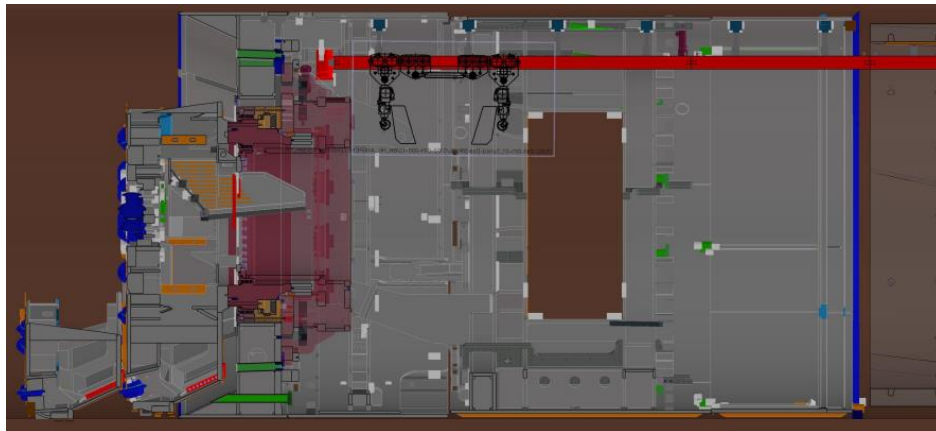
Figure 26 - Gripper shoes and advance cylinders disassembly ("HK 5102-091-001-01 Shield Disassembly", Herrenknecht, 2022)

Afterwards, it is planned to disassemble and to pull out the two torque cylinders. When the disassembly of the torque cylinders is complete, the shield area behind the main drive is totally empty.

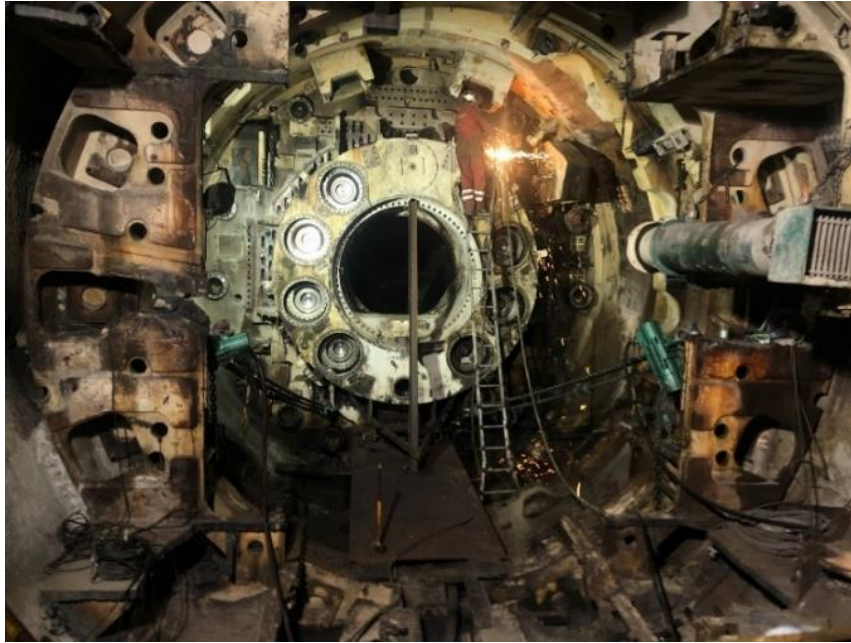
Figure 40 - separation of the main drive from the cutterhead flange

- 1) Removal of the inner bearings in order to lighten the whole main drive.
- 2) Assembly of a steel platform at the base of the main drive, which allowed the rolling of trolley device installed on the bottom side of the main drive (Figure 40 & Figure 41).

- 3) Installation of a safety device to avoid the back tilting of the main drive (Figure 40). This expedient is a set of five steel beams merged to create a kind of safety easel for the main drive itself.
- 4) Separation of the main drive from the cutterhead flange by means of the fire cutting.
- 5) Pulling back and rotation of the main drive thanks to the steel platform and to the two sets of trolley devices mounted on the bottom of the bearing. This operation was performed by means of two air chain hoists with a capacity of 15 tons each one.

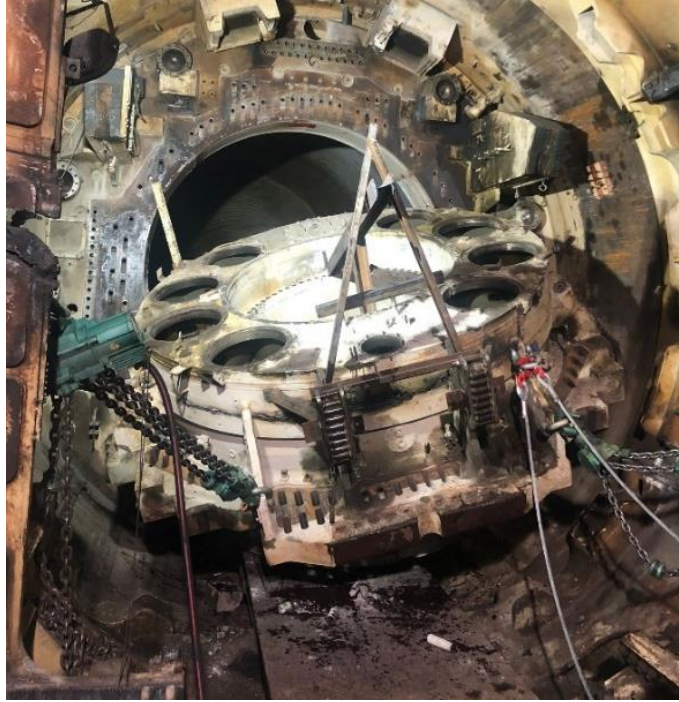
Figure 41- main drive lying on the shield floor, trolley and easel devices

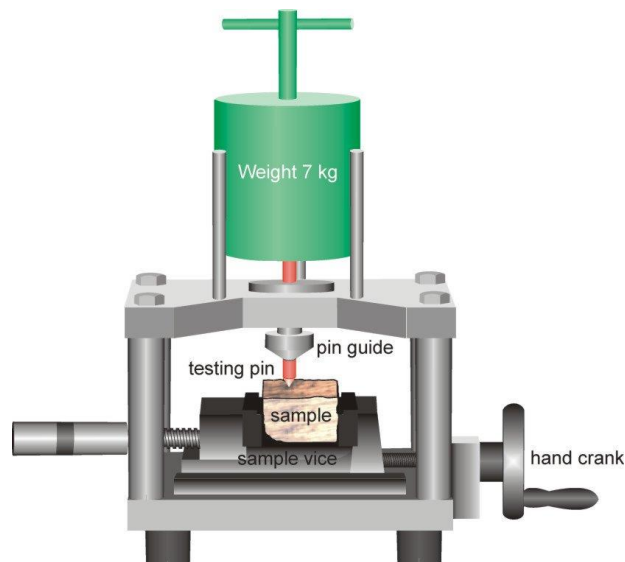
Figure 42 - CAI test equipment (Thuro, 2010)

The testing principle is based on a steel pin with defined geometry and hardness that is scratched on the surface of a rough rock sample over a distance of 10 mm under static load on 70 N. In the original Cerchar equipment setup, the pin and the dead load are moved across the rock surface. The pin is made of a standard steel and has a 90° conical tip. It should have a diameter of at least 6 mm and the length should be such at the visible part of the pin at least 15 mm.

The rock sample is placed in the equipment and firmly clamped using a rigid vice. The device is rigid and also fixed to avoid any lateral movement. The dead load is then placed on the top of the pin and the pin is carefully lowered to the rock surface. The test is then carried out by relative displacement of the pin on the rock surface across 10 mm at given time intervals. After the test, the pin is removed and the tip flat wear is measured.

The CAI is then calculated from the measured diameter of the resulting wear flat on the pin.

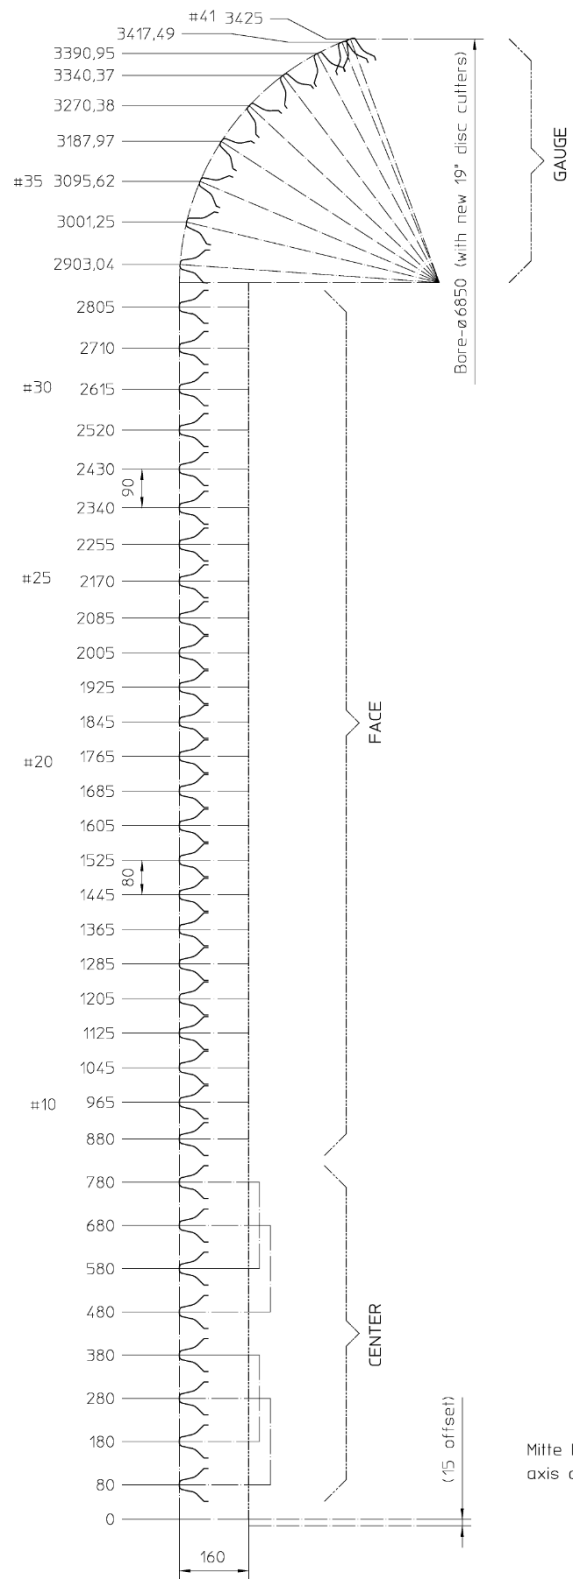
Figure 45 - Cutterhead lateral view TBM S-1054 – cutter position (Herrenknecht , 2017)

In the successive graphs are reported the circumference and the area of influence for each track, for the TBM S-1054 and TBM S-1071/TBM S-1072 respectively.

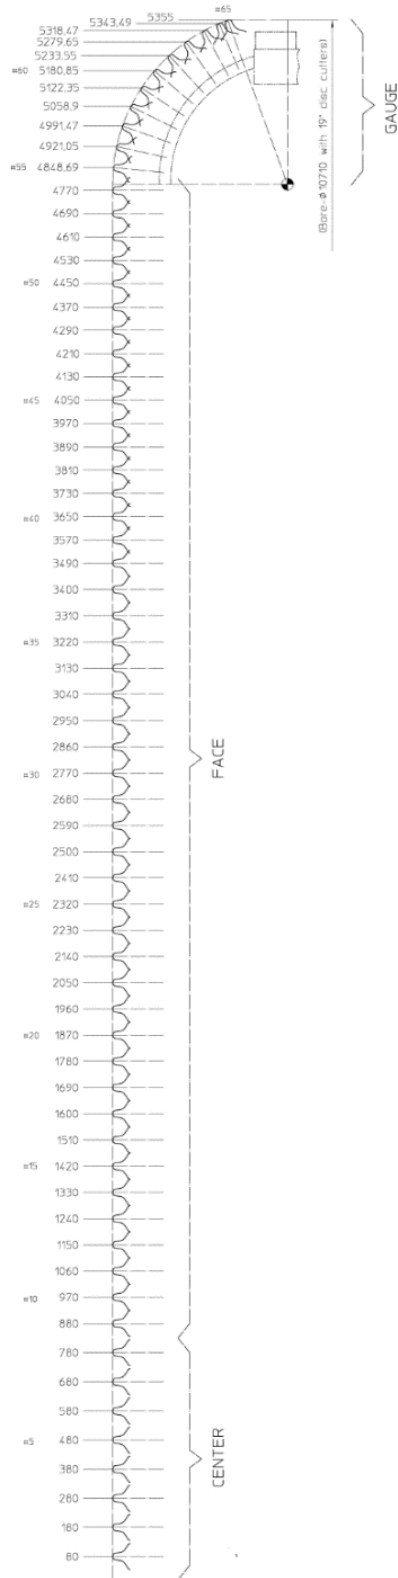
Figure 46 - Cutterhead lateral view TBM S-1071 & TBM S-1072 – cutter position (Herrenknecht, 2017)

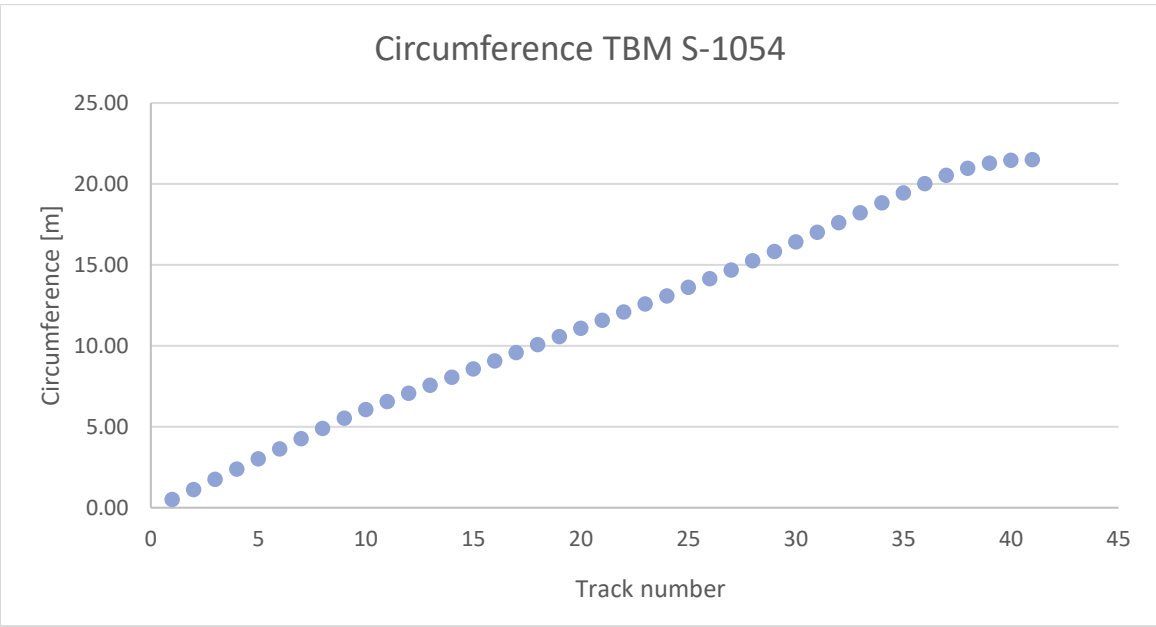
Figure 47 - Circumference per each track number (TBM S-1054)

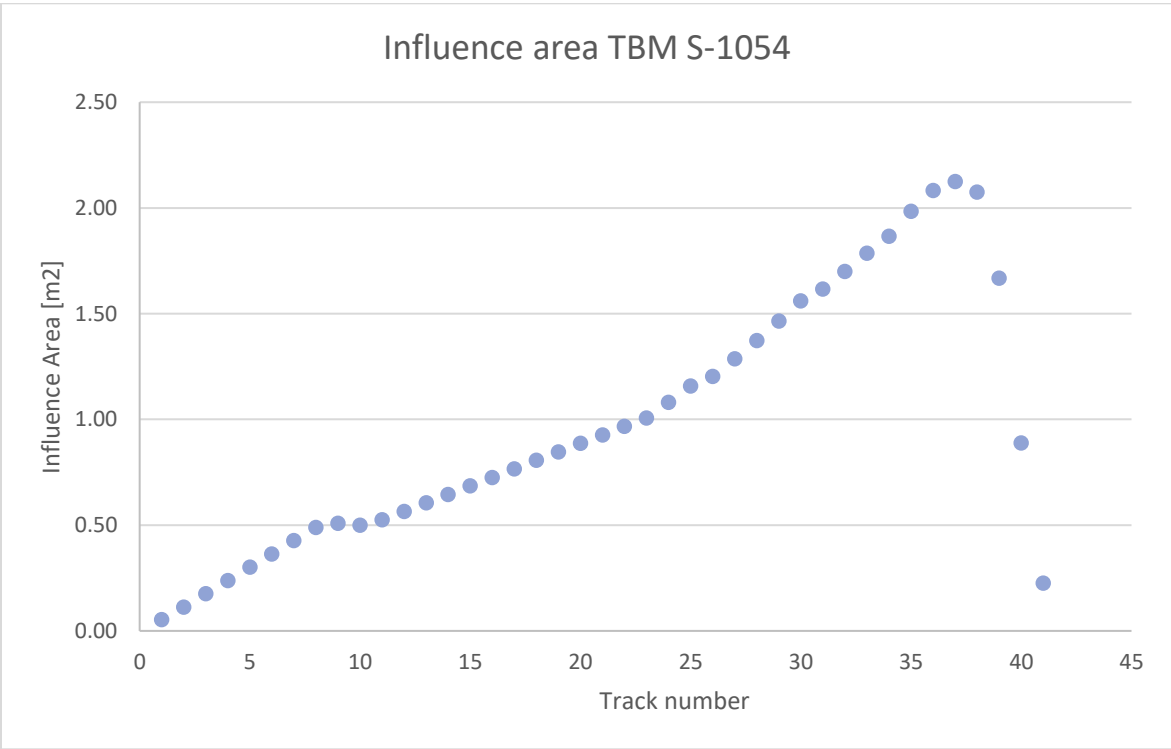
Figure 48 - Influence area per each track number (TBM S-1054)

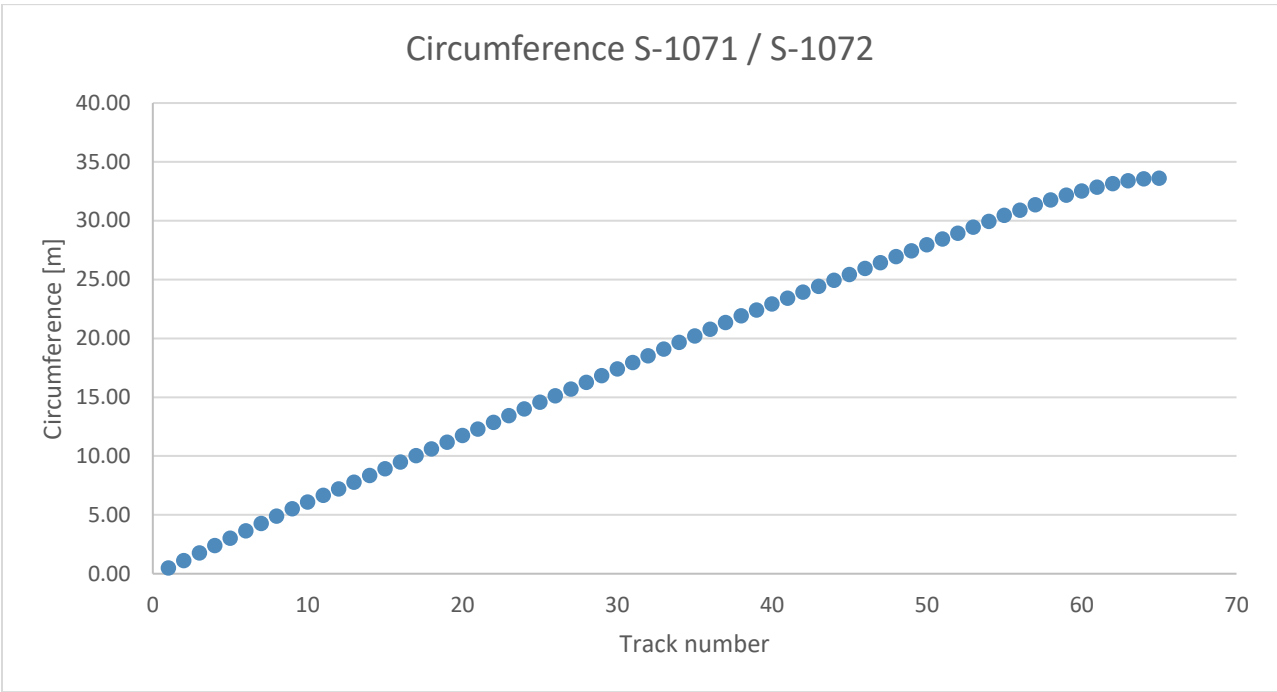
Figure 49 - Circumference per each track number (TBM S-1071 & TBM S-1072)

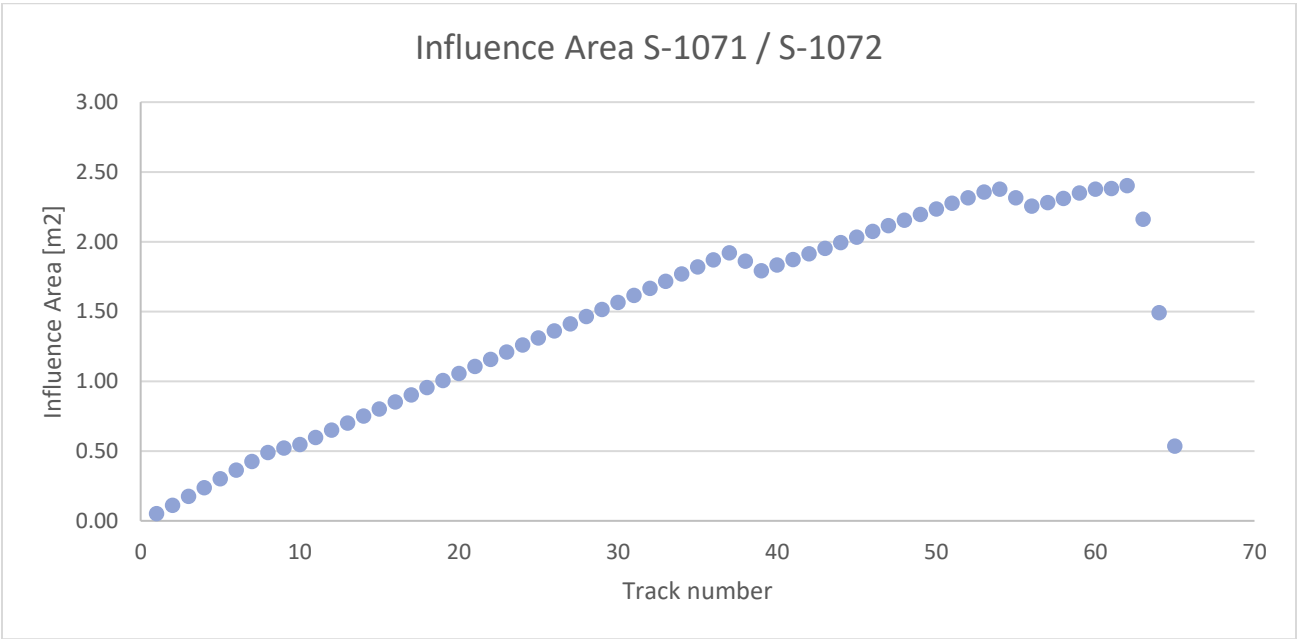
Figure 50 - Circumference per each track number (TBM S-1071 & TBM S-1072)

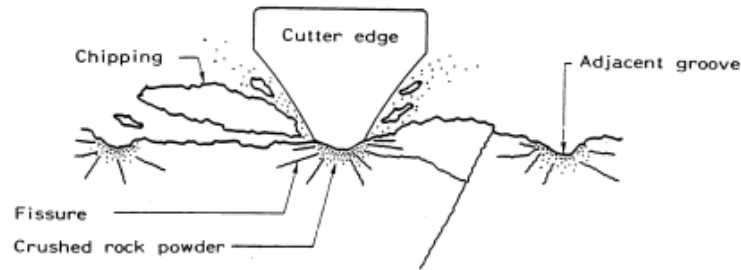
Figure 51 - Failure mechanism for disc cutters ("Boreability Testing", Blindeheim and Bruland)

generally meaning inefficient boring and low overall rate of penetration. Furthermore, local weaknesses in the rock mass will influence the cutting, by allowing easier cracking or chipping, or by increasing the size of the pieces that break loose. The crack formation takes place radially from the cutter edge, into the rock or to the next groove, parallel to the high compressive stresses from the cutter edge. (Bruland & Blindheim)

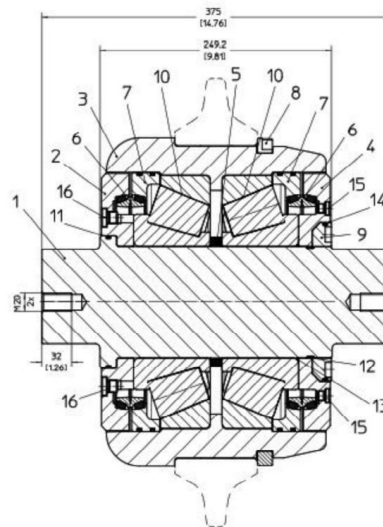
Figure 52 - Section of a cutter disc (Herrenknecht, 2021)

- 1) Cutter Shaft
- 2) Cutter Retainer
- 3) Cutter Hub
- 8) Cutter Split Ring
- 10) Cutter Bearing
-) Cutter Ring (project dependent)

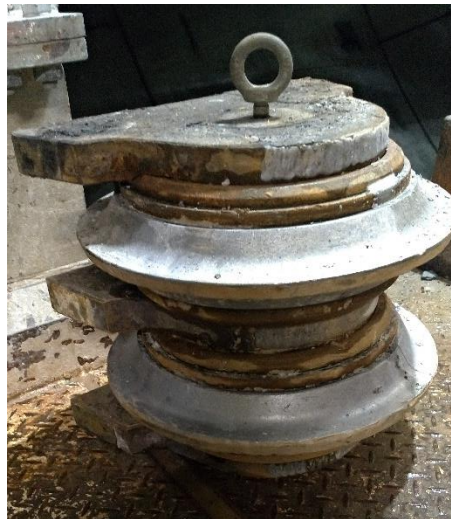
Figure 53 - Double ring cutter

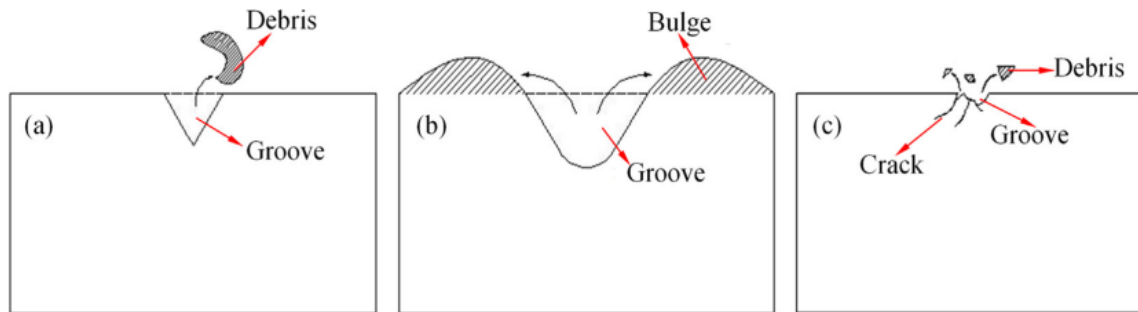
- Micro cutting: the material is cut away from the worn surface by abrasive particle
- Furrow deformation: the material is ploughed on both sides of the groove
- Brittle fracture: the material is detached from the worn surface due to micro cracks propagation and instant peeling.

Figure 54 - Abrasive wear mechanism: a) Micro cutting; b) Furrow deformation; c) Brittle fracture. ("Experimental study on wear of TBM disc cutter rings with different kinds of hardness", Zhang et al., 2018)

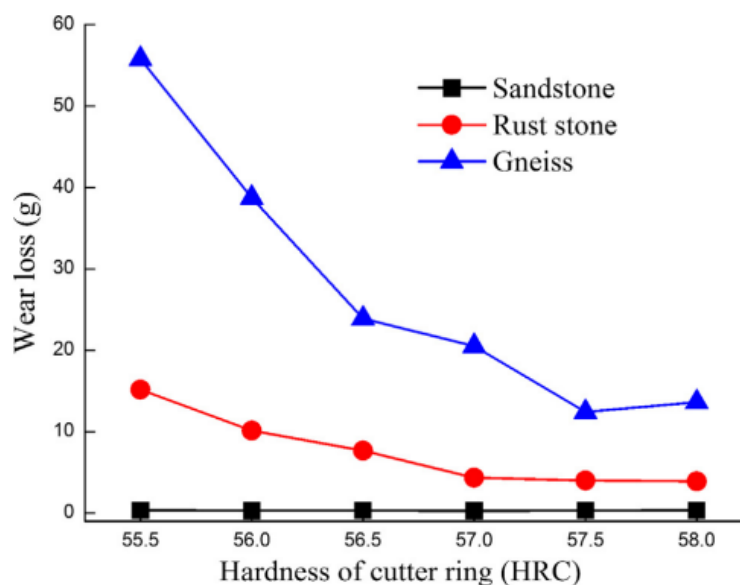
Figure 55 - Hardness of cutter ring ("Experimental study on wear of TBM disc cutter rings with different kinds of hardness", Zhang et al., 2018)

hardness. This type of behavior can be explained because when the hardness is increased to 58.0 HRC, the impact toughness of the cutter ring decreases, leading to poor fracture resistance. Then, the wear mechanism of the cutter ring shows slight micro cutting and severe brittle fracturing due to the high vibration and drastic load caused by gneiss, which has high mechanical strength and large CAI of the rock types studied in this research, resulting in an increase in wear loss. Due to the presence of hard rock to be excavated, in particular for the last area excavated by the TBM S-1054 and partially by the S-1072 and will be excavated by the TBM S-1072, this behavior can be similar to what actually happens in the last part of the tunnelling. (Zhang, 2018)

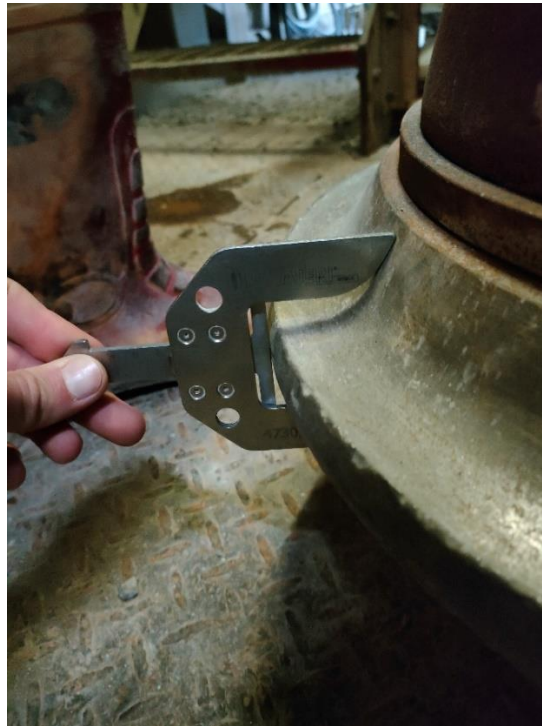
Figure 56 - Wear gauge template for cutter ring wear measurement

The cutter disc wear must be verified daily during the maintenance shift. The measurement of the wear is performed with a wear gauge (Figure 56)

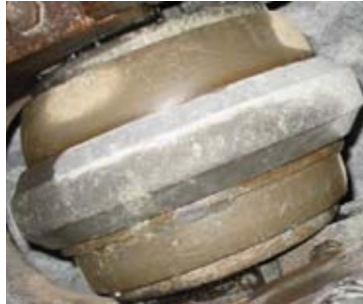
1) Normal wear

Figure 57 - Cutter normal wear (Herrenknecht, S-1054 TBM GL Brenner Basis Tunnel Lot 2-3 Mauls/Mules, 2017)

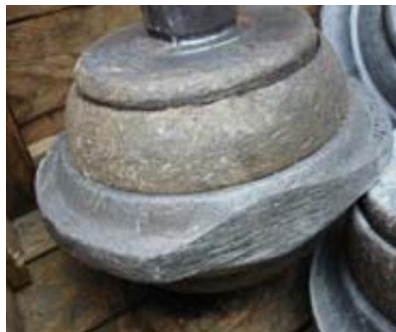
2) Clogging bearing

Figure 58 - Cutter clogging bearing (Herrenknecht, S-1054 TBM GL Brenner Basis Tunnel Lot 2-3 Mauls/Mules, 2017)

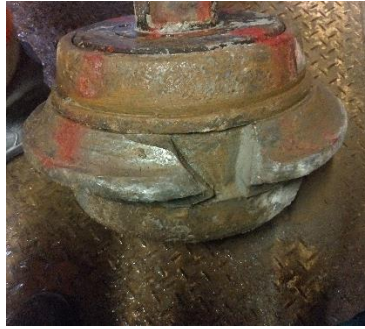
3) Fissures or breakage at the cutting ring

Figure 59 - Cutting ring breakage

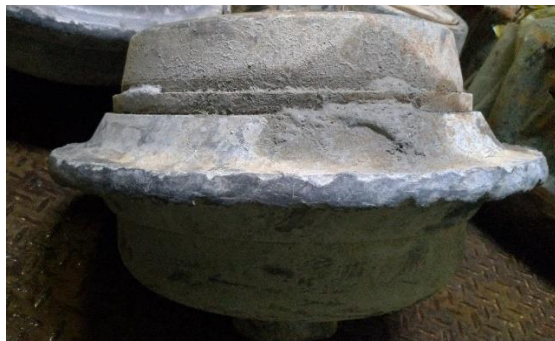
4) Chipping – parts of cutting ring broken

Figure 60 - Cutting ring chipping

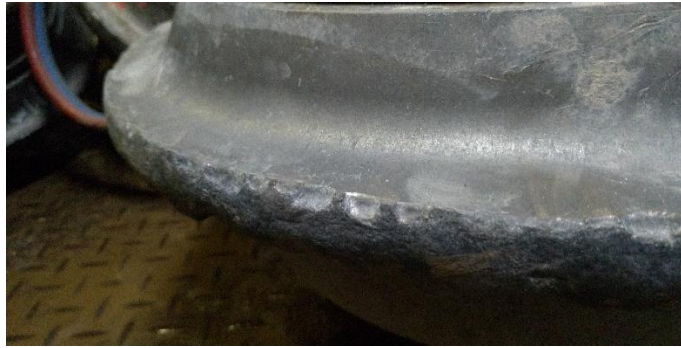
5) Mushrooming – severe deformation of the cutting ring

Figure 61 - Cutting ring mushrooming

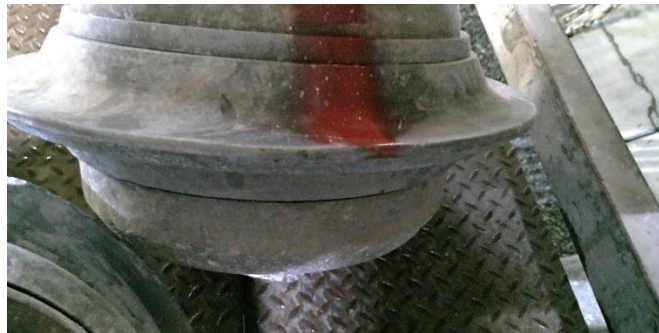
6) Defective roller casing

Figure 62 - Defective roller casing

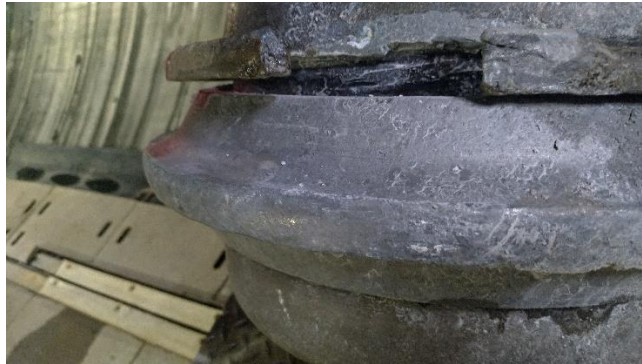
7) Circlipping - Lost or worn-out circlip

Figure 63 - Circlipping

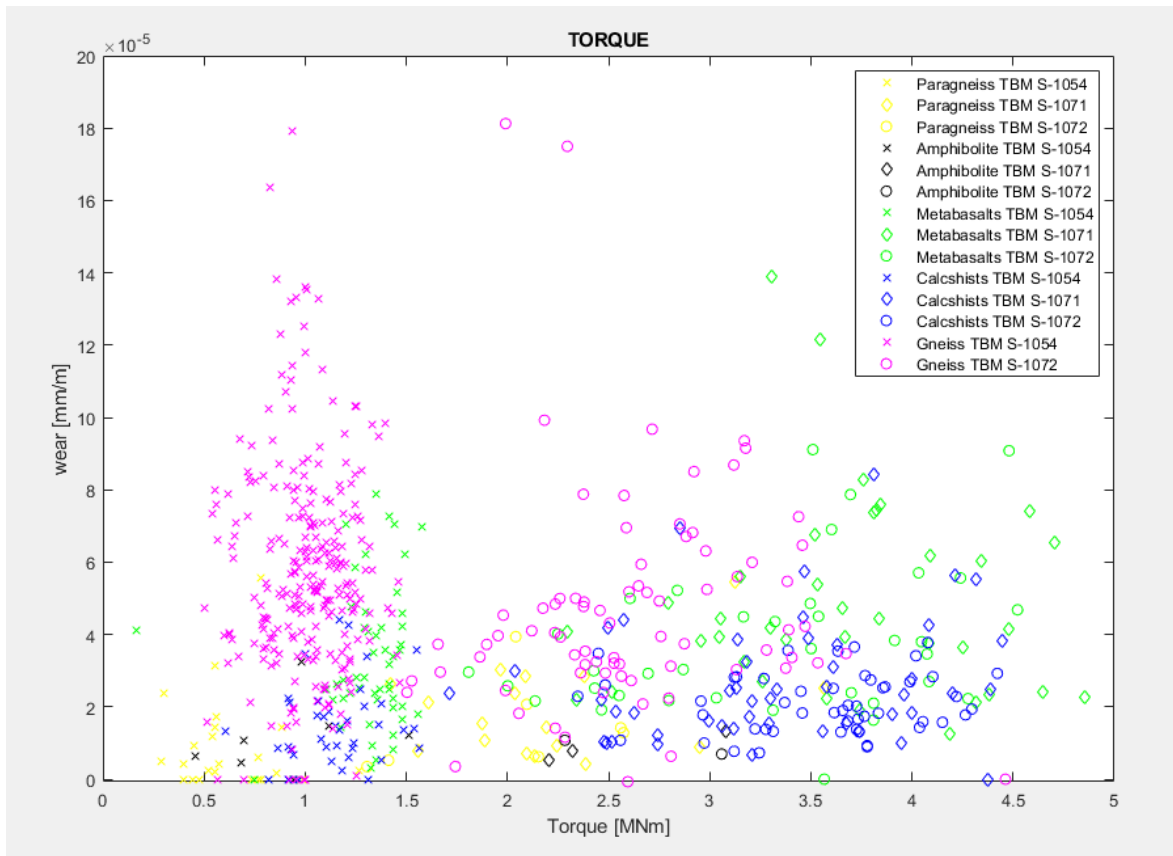
Figure 69 - Cutter ring wear [mm/m] vs torque [MNm] depending on the TBM and the geology

The first parameter examined is the torque. It is not properly a parameter chosen by the TBM driver operator and hence it depends on the mutual correlation of the other parameters chosen.

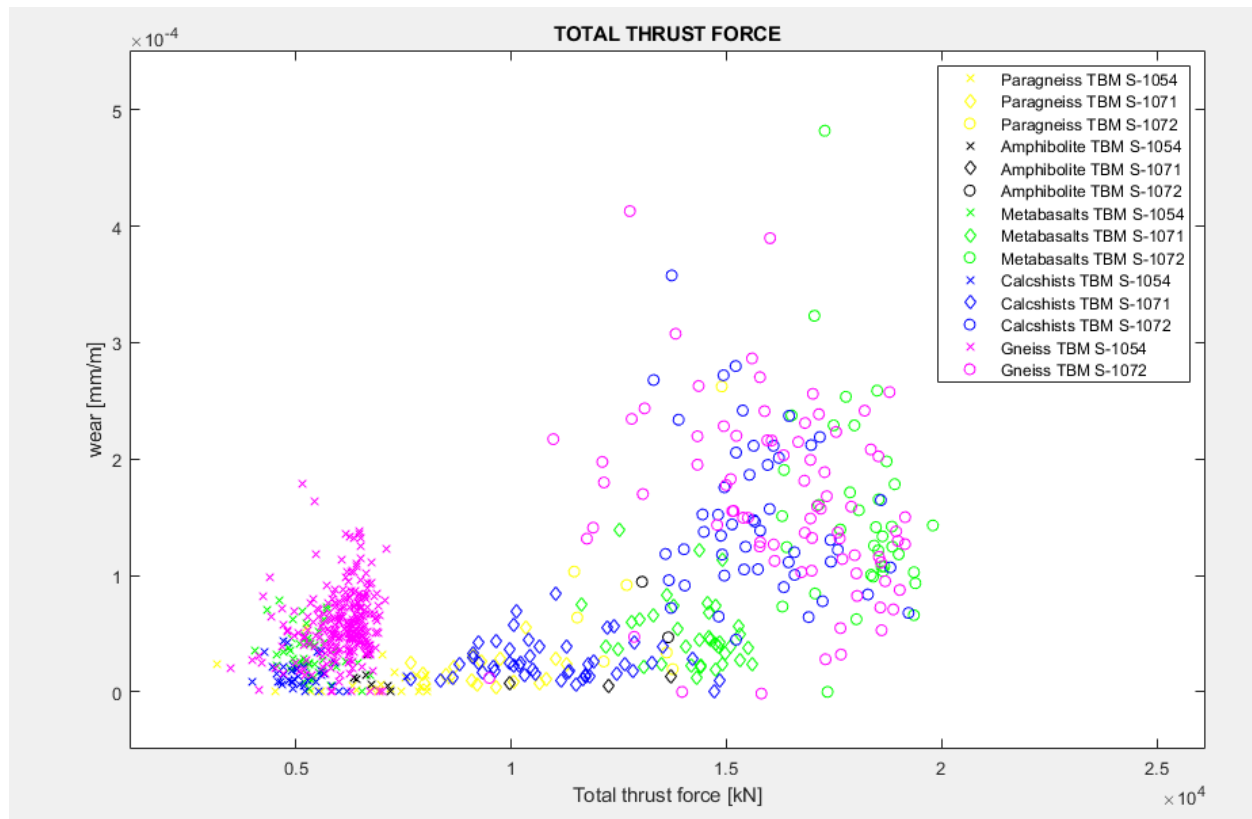
Figure 70 - Cutter ring wear [mm/m] vs total thrust force [kN] depending on the TBM and the geology

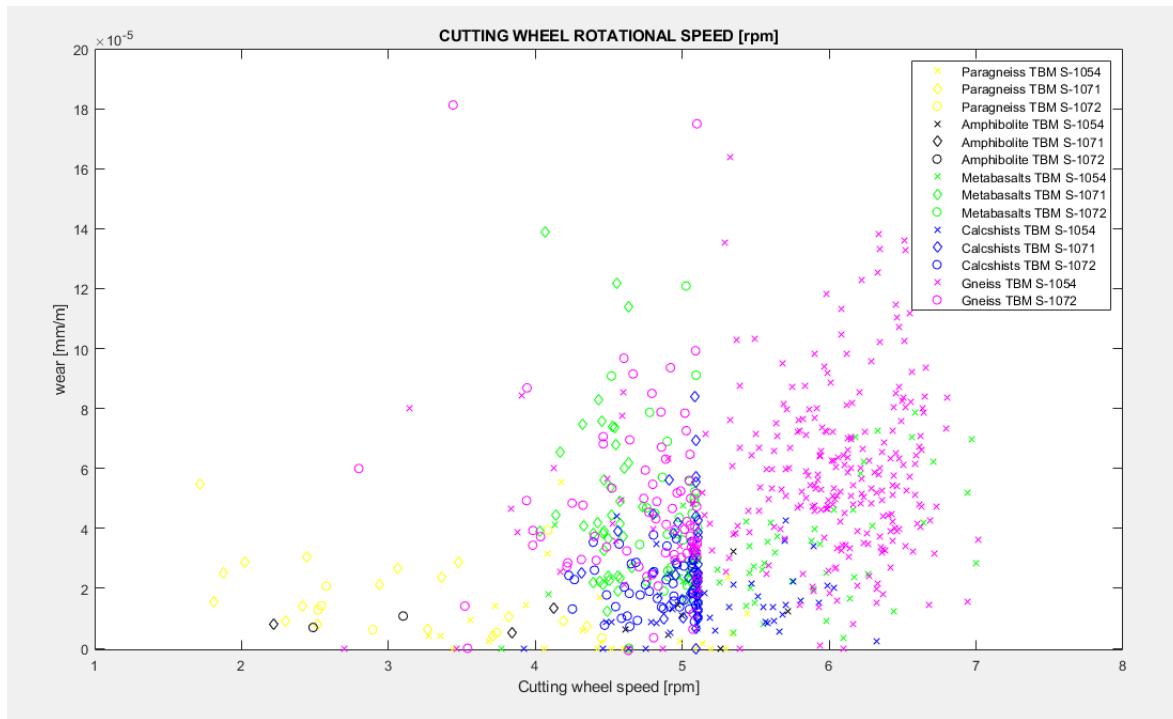
Figure 71 - Cutter ring wear [mm/m] vs cutting wheel rotational speed [rpm] depending on the TBM and the geology

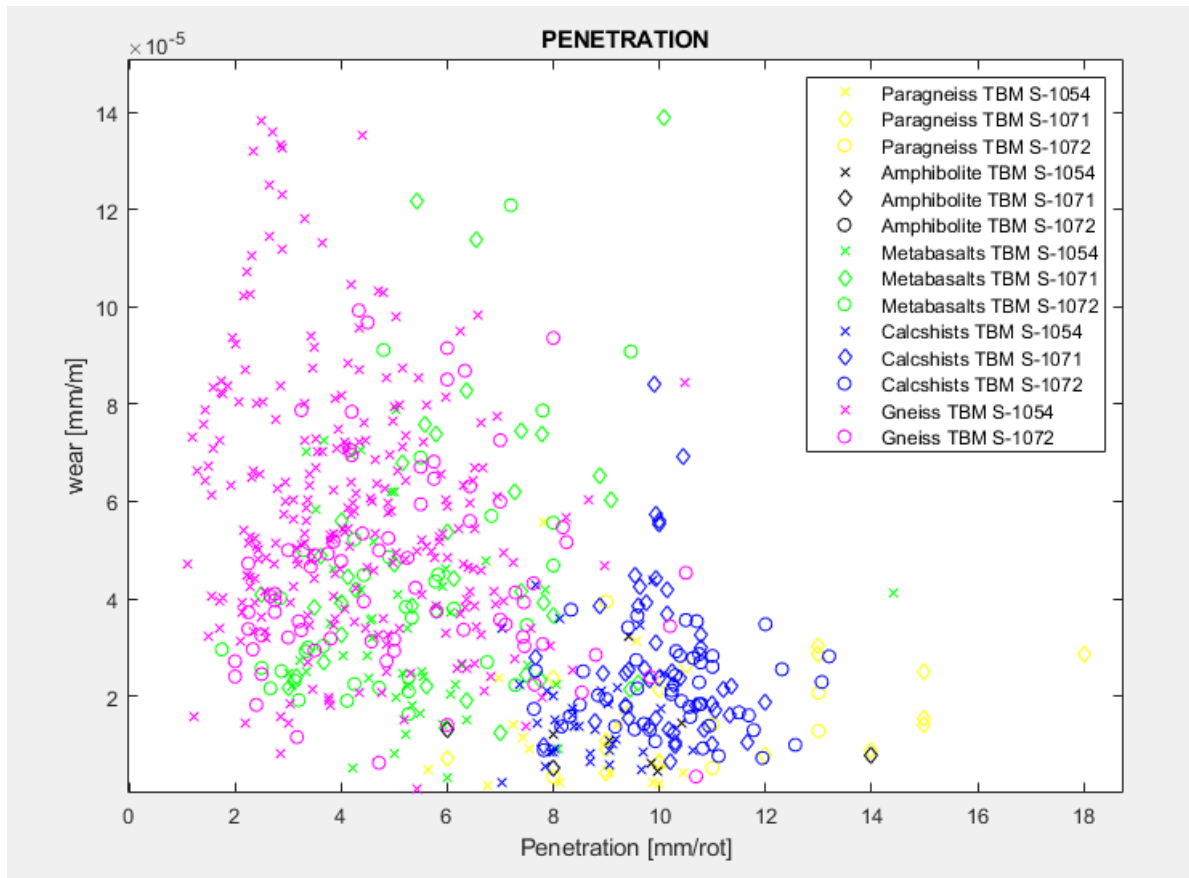
Figure 72 - Cutter ring wear [mm/m] vs penetration [mm/rot] depending on the TBM and the geology

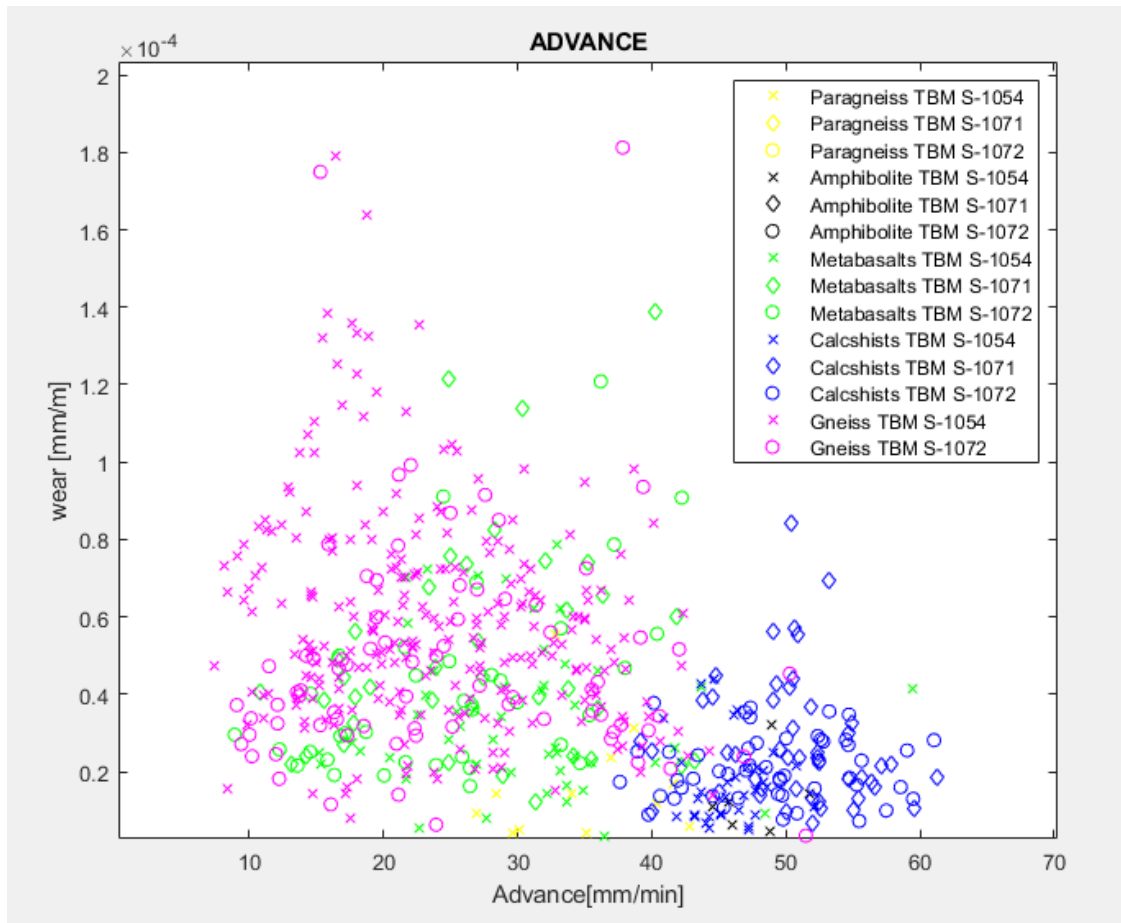
Figure 73 - Cutter ring wear [mm/m] vs advance speed [mm/min] depending on the TBM and the geology

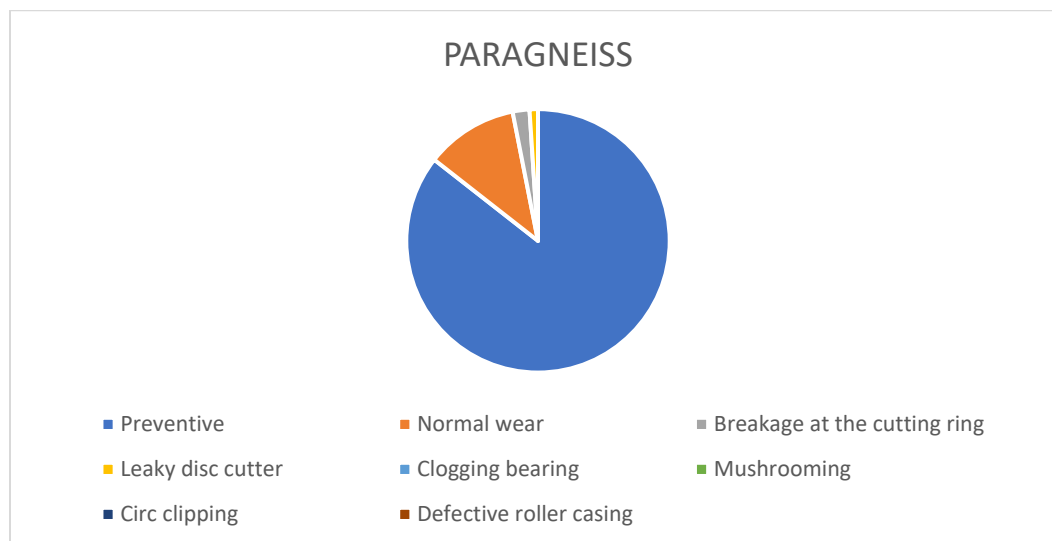
Figure 75 – Disc replacement causes during the tunnelling in the Paragneiss
