POLITECNICO DI TORINO

TESI MAGISTRALE

Technical aspects related to the Brenner Base Tunnel jobsite: disassembly of a
Double Shield TBM and back analysis on the cutter discs wear

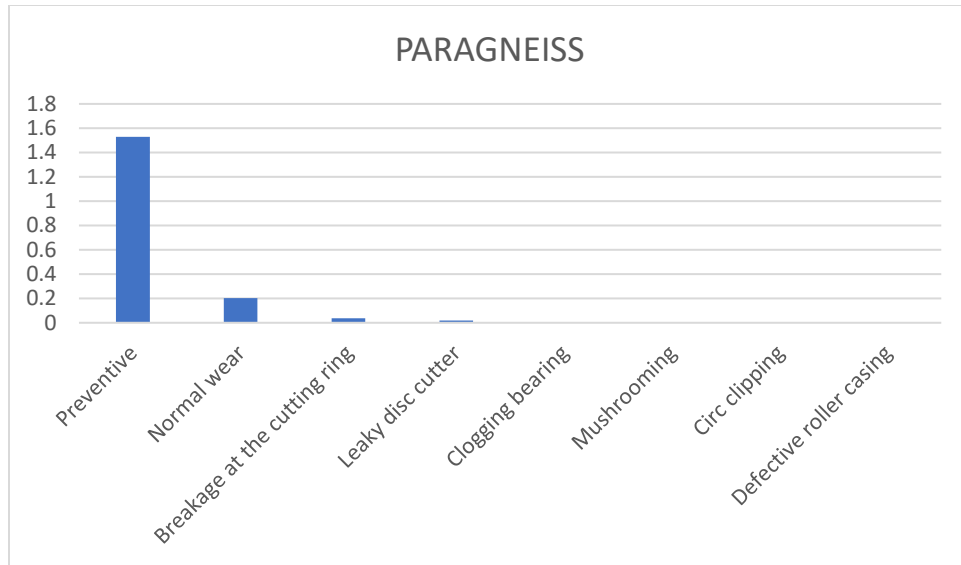
Figure 76 - Different frequencies of cutter tools substitution related to the excavation in Paragneiss

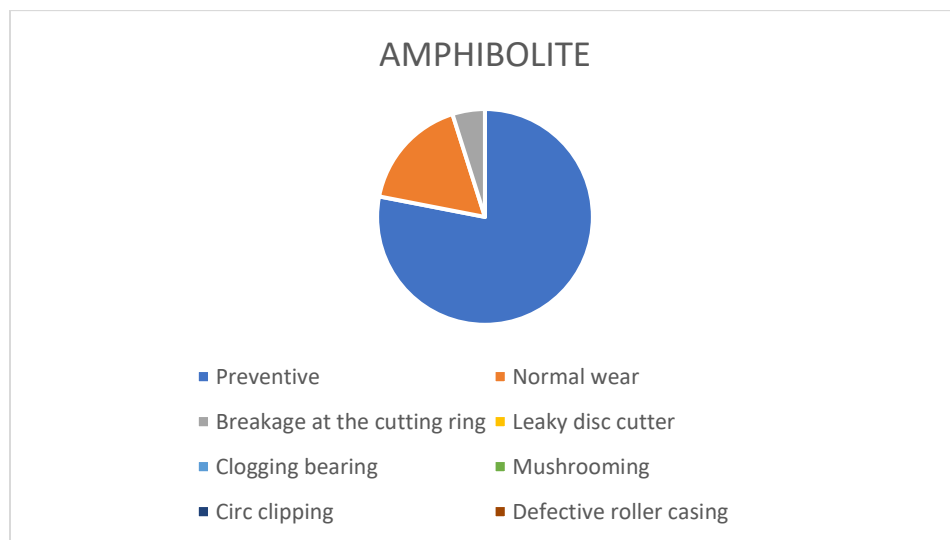
Figure 77 – Disc replacement causes during the tunnelling in the Amphibolite

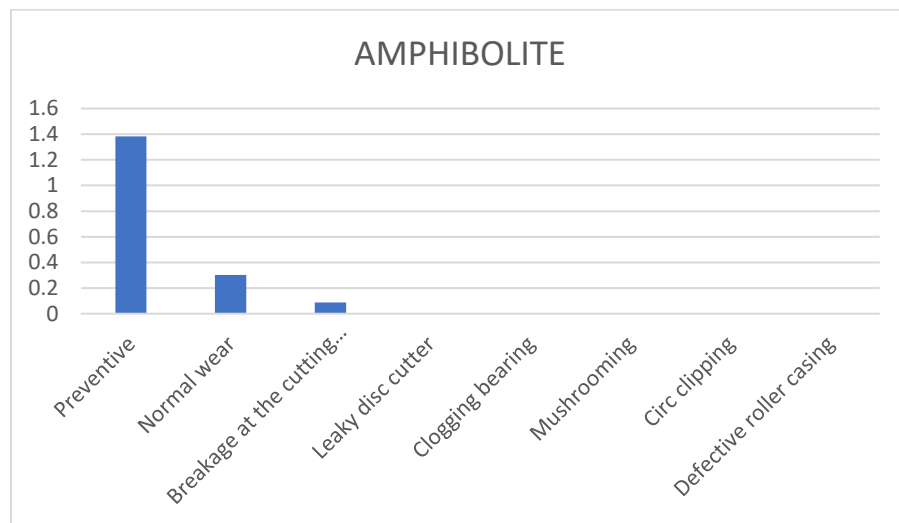
Figure 78 - Different frequencies of cutter tools substitution related to the excavation in Amphibolite

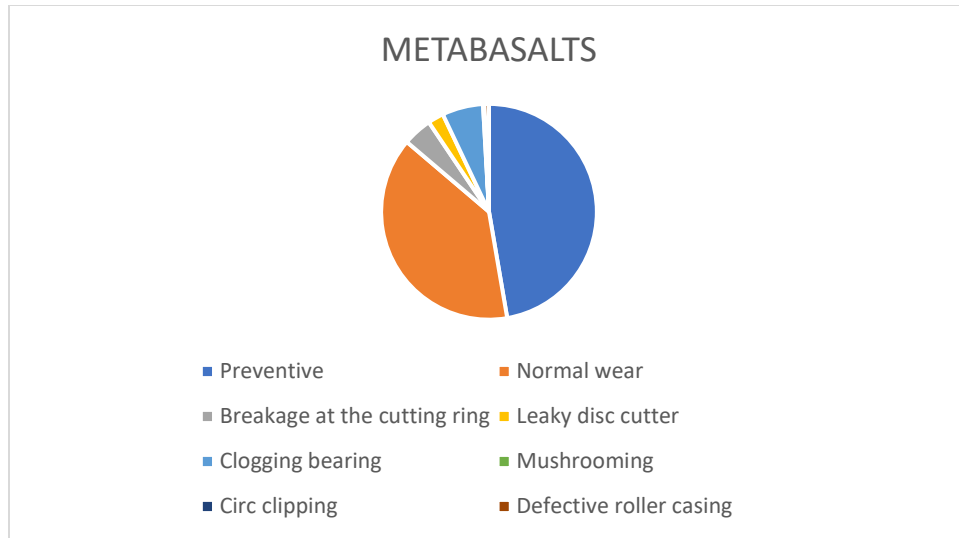
Figure 79 – Disc replacement causes during the tunnelling in the Metabasalts

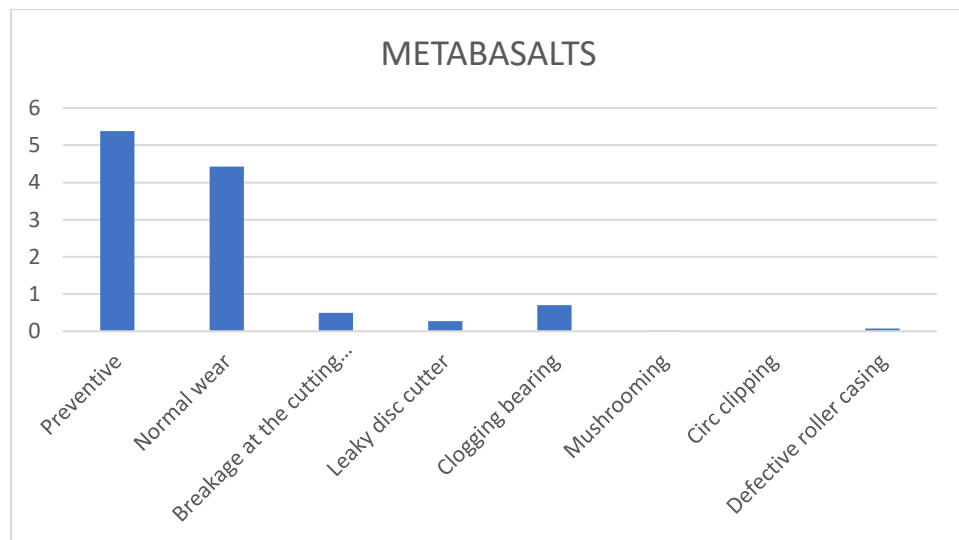
Figure 80 - Different frequencies of cutter tools substitution related to the excavation in Metabasalts

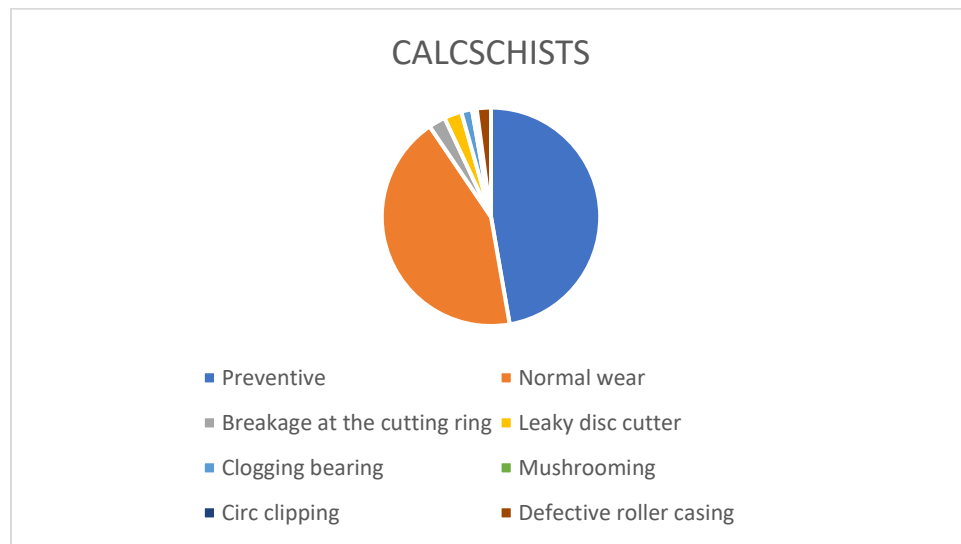
Figure 81 – Disc replacement causes during the tunnelling in the Calcschists

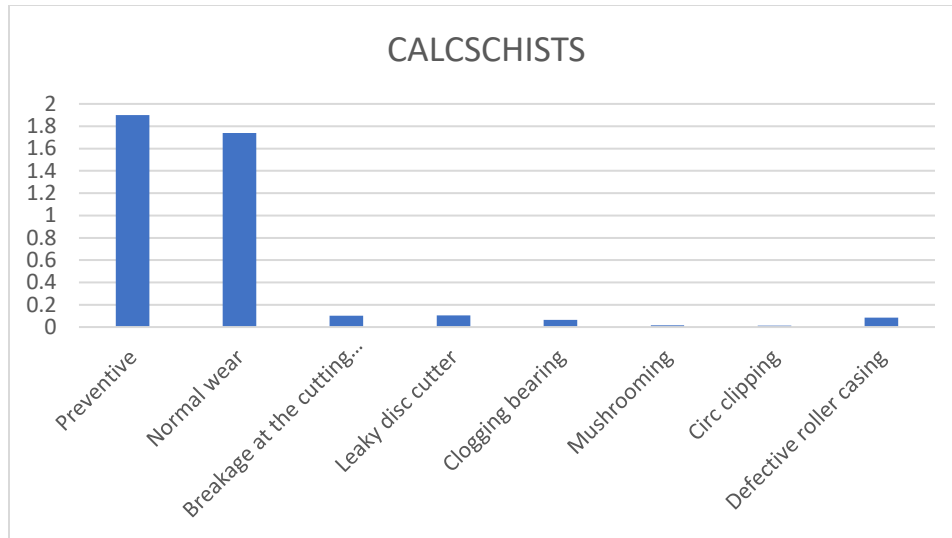
Figure 82 - Different frequencies of cutter tools substitution related to the excavation in Calcschists

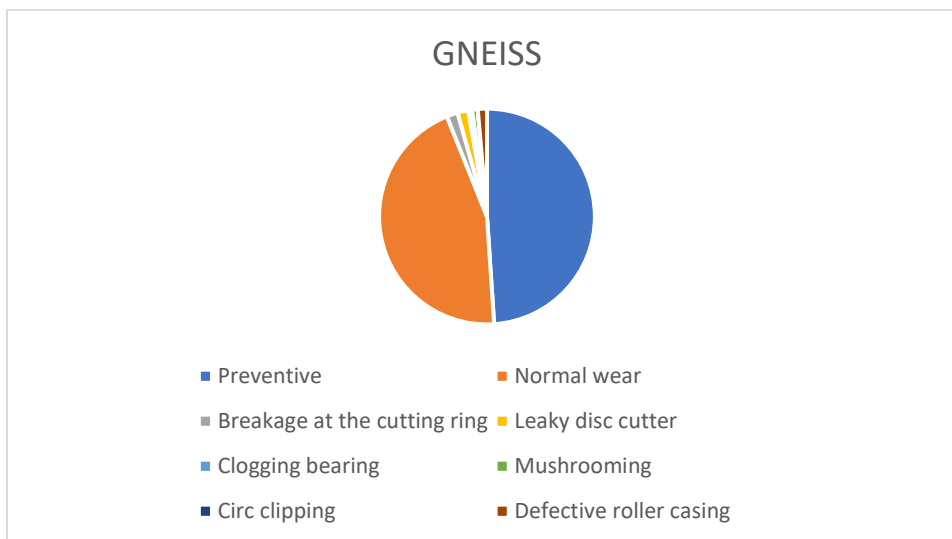
Figure 83 – Disc replacement causes during the tunnelling in the Gneiss

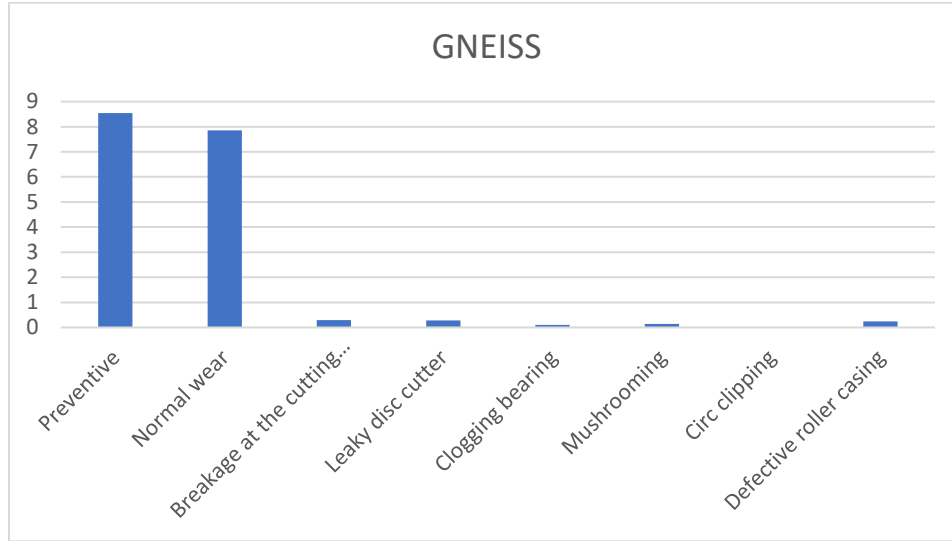
Figure 84 - Different frequencies of cutter tools substitution related to the excavation in Gneiss

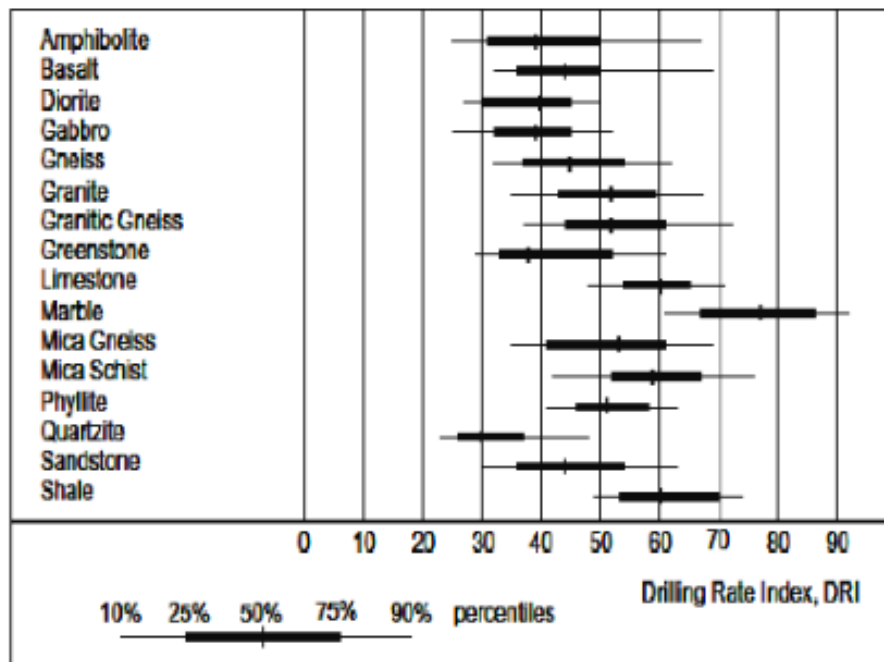
Figure 85 - Recorded Drilling Rate Index (DRI) for some rock types (Bruland, 1998)

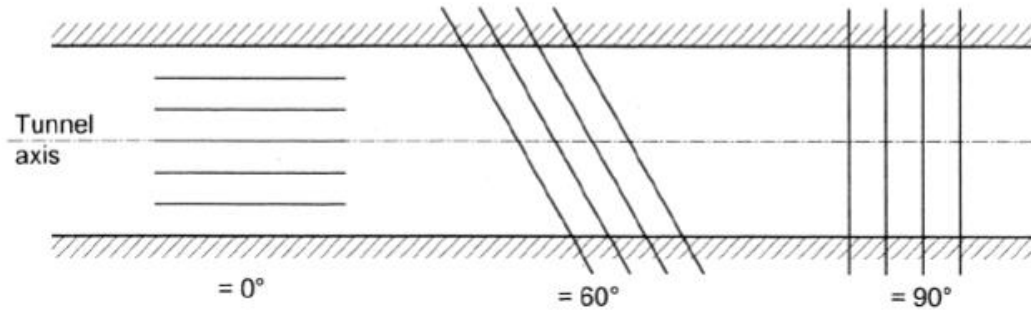
Figure 87 - examples of inclination of weakness planes

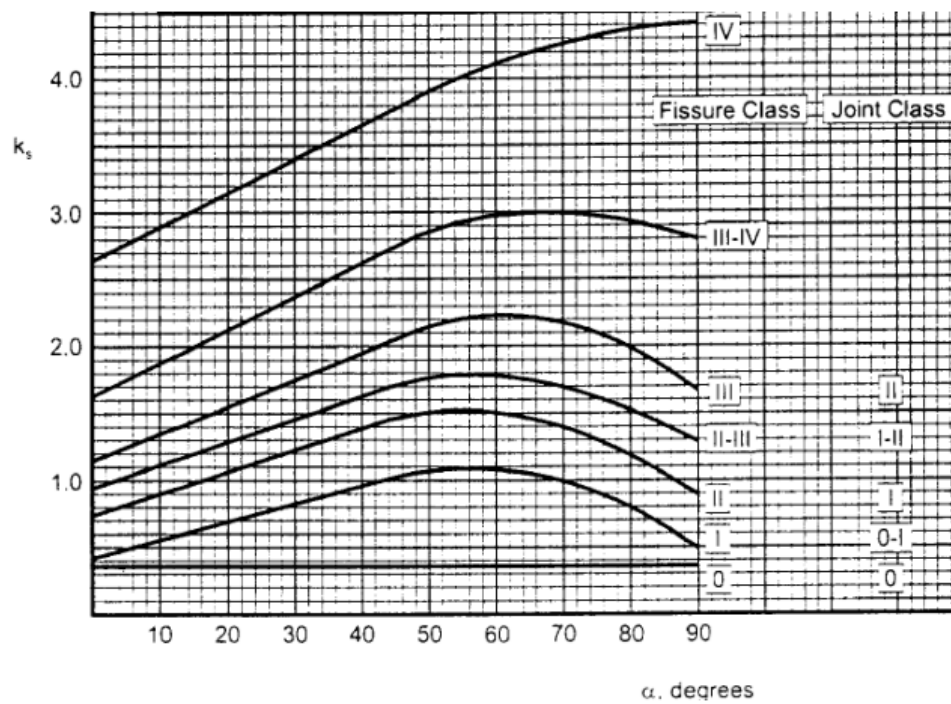
Figure 88 – Chart for the determination of K_s parameter

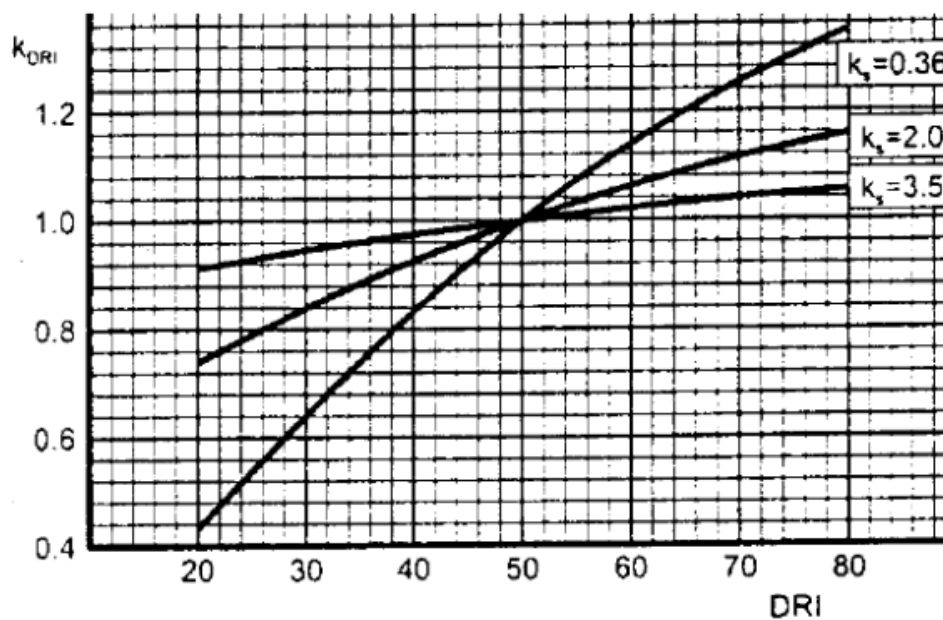
Figure 89 - Determination of the K_{DRI} value

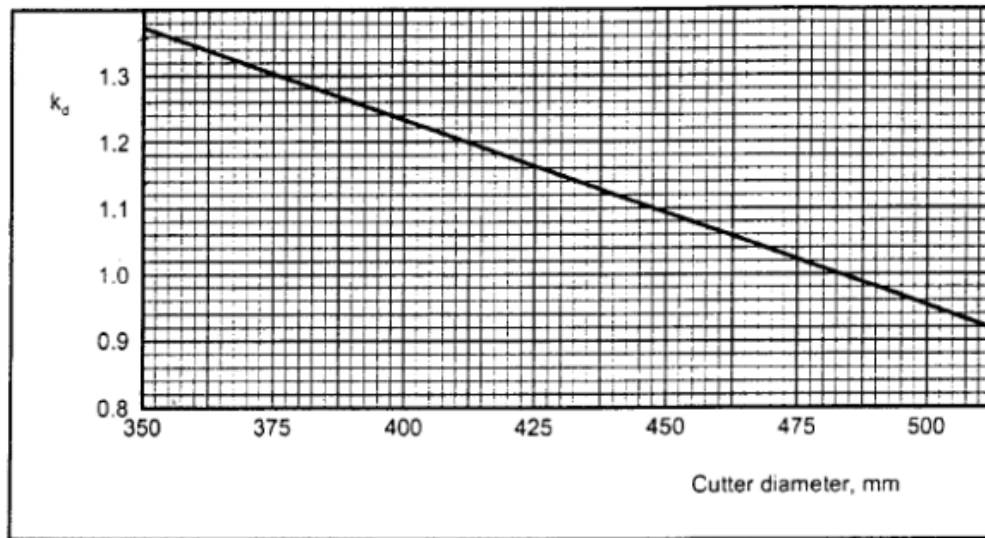
Figure 90 - Determination of K_d coefficient

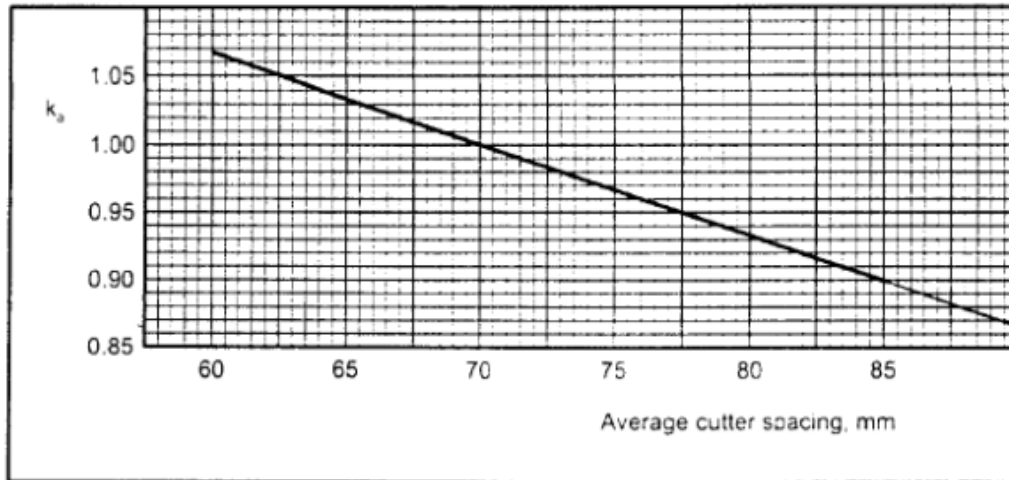
Figure 91 - Determination of cutter spacing coefficient (K_a)

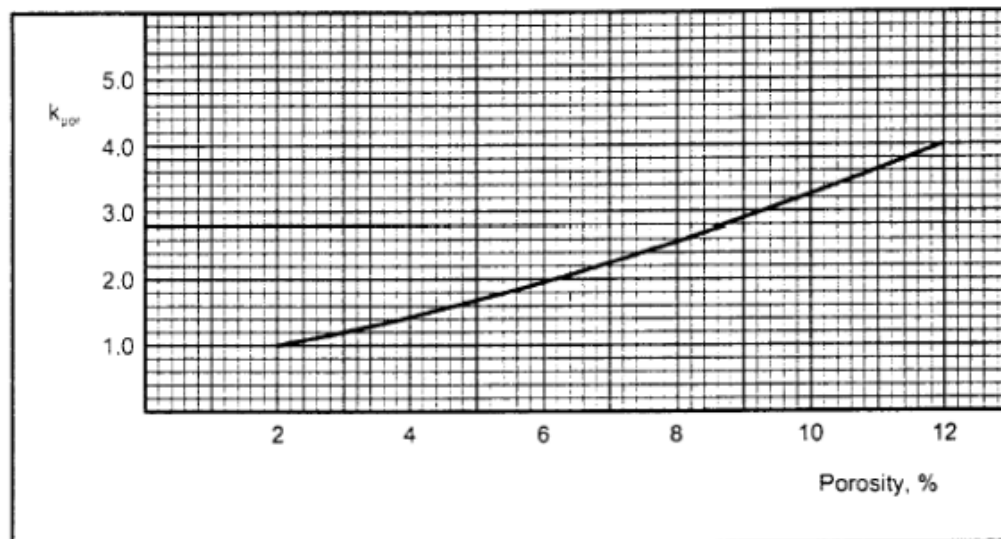
Figure 92 - Determination of the porosity coefficient (K_{por})

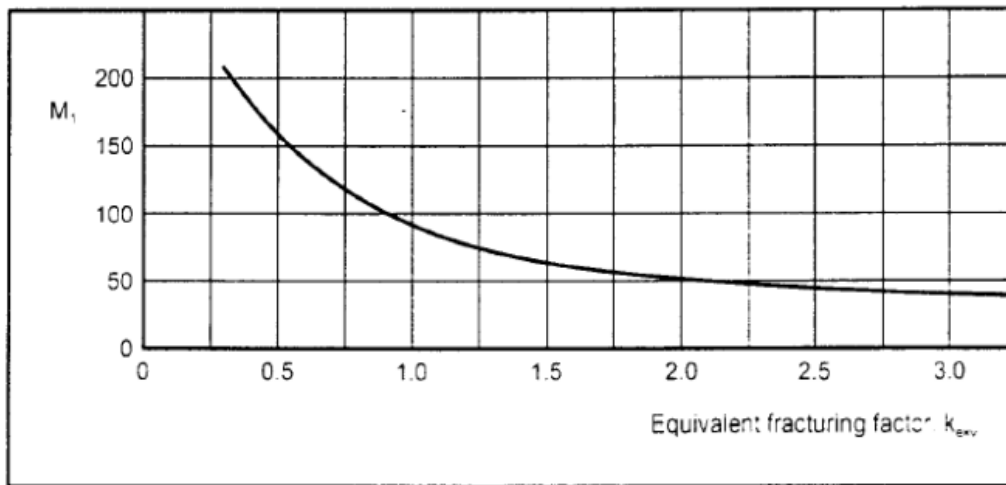
Figure 93 - Determination of the critical thrust M_1

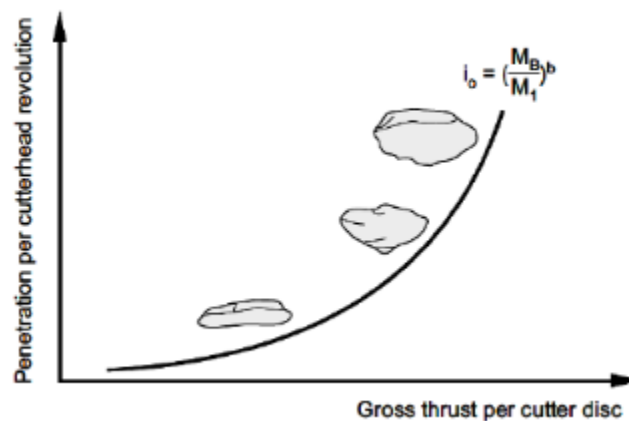
Figure 94 - General progress of a penetration curve (Bruland , 1998)

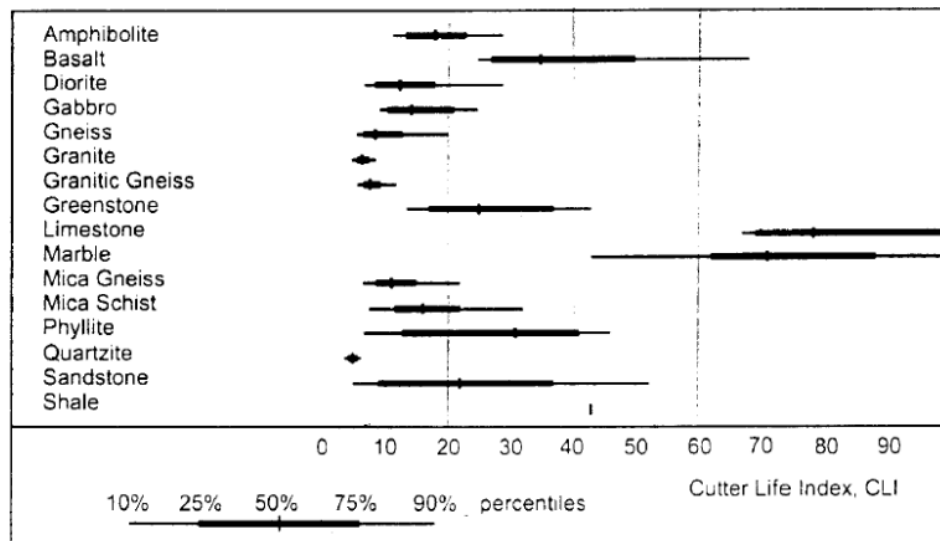
Figure 95 - Correlation between CLI (Cutter Life Index) and geology

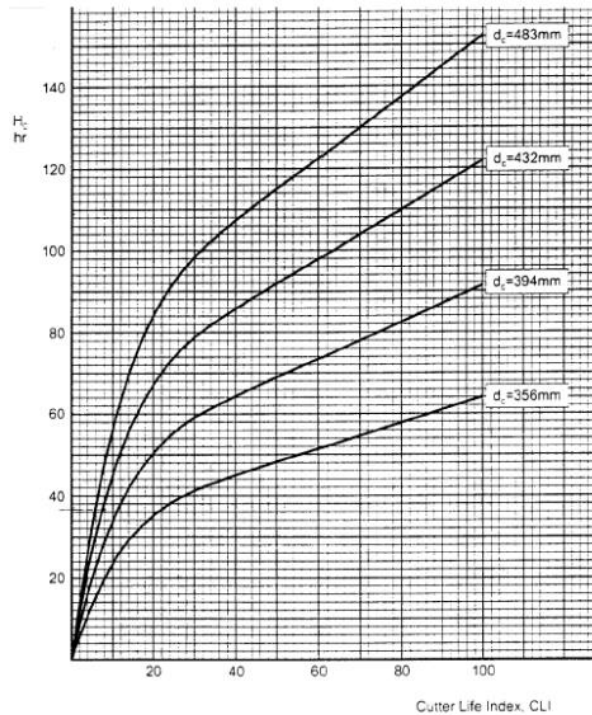
Figure 96 - Determination of the Base cutter life (H_c)

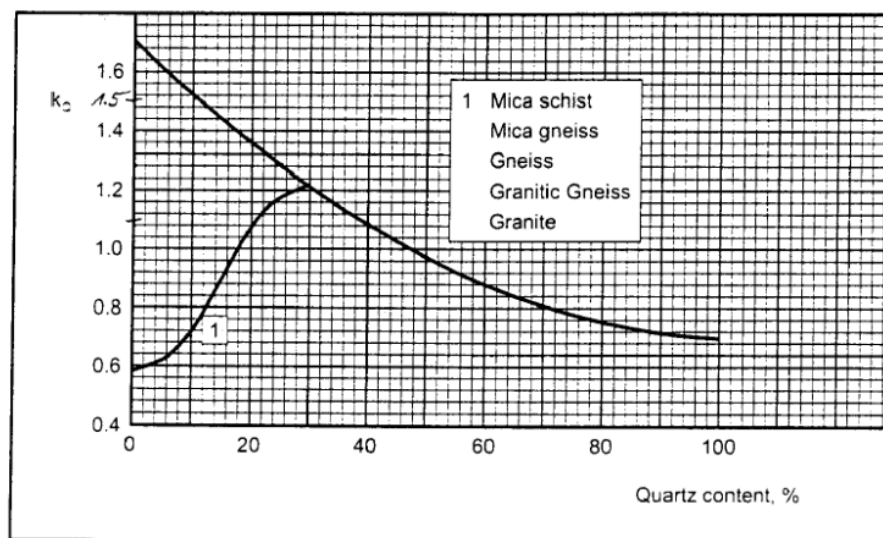
Figure 97 - Correction due to the quartz content

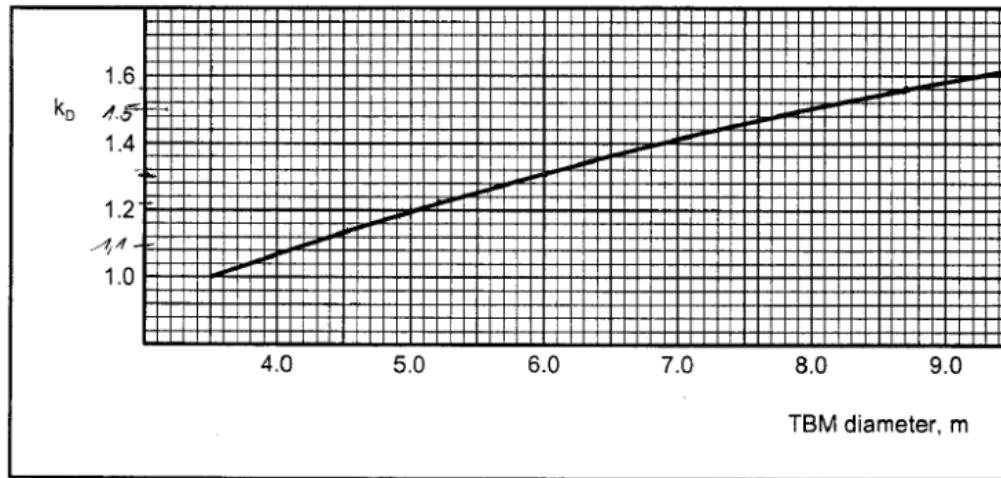
Figure 98 - Correction for cutterhead diameter (K_d)

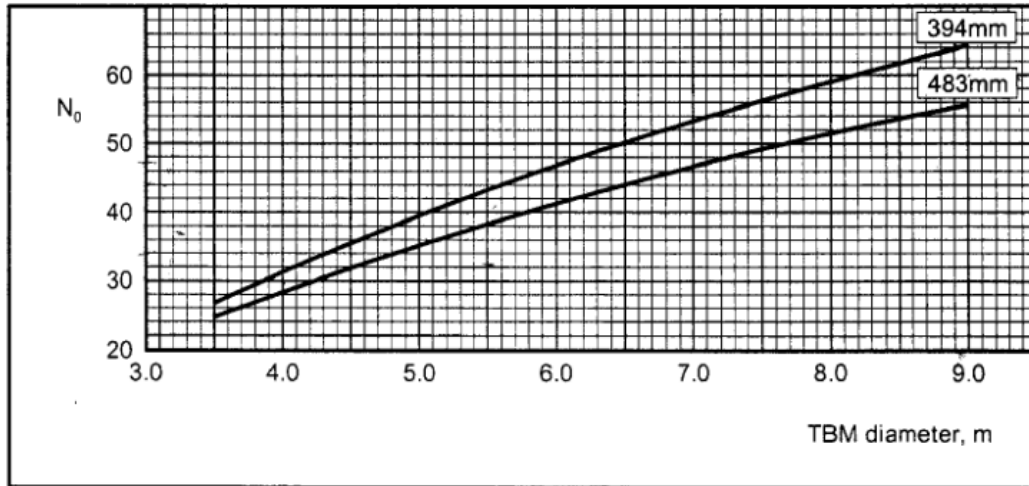
Figure 99 - Determination of the parameter N_0
