POLITECNICO DI TORINO

Master's degree in Civil Engineering

Thesis of Master of Science

Calculation of residual prestress levels on beam bridge elements using a non- destructive and a destructive method.

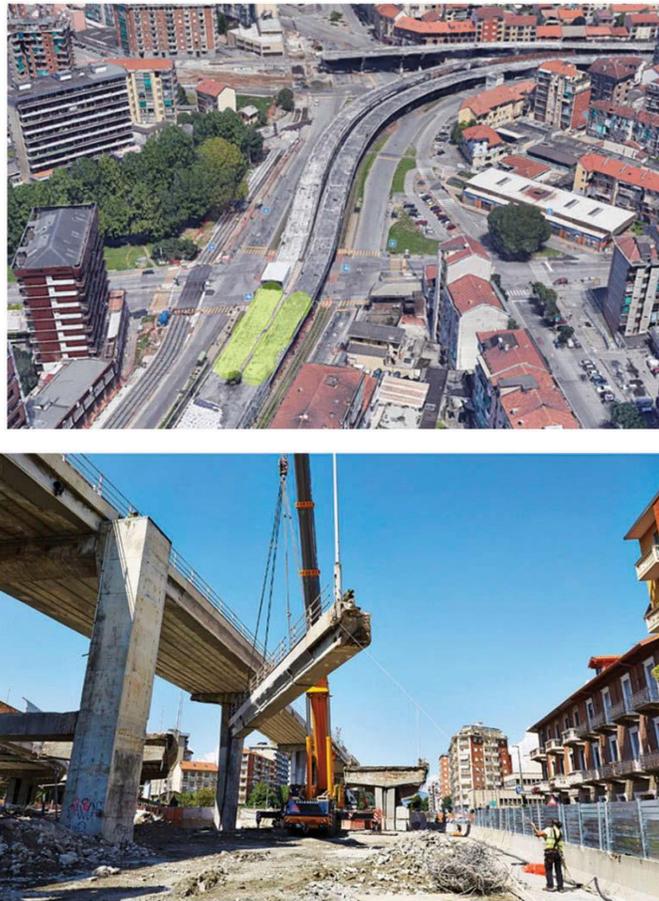
Figure 1. (a) Corso Grosseto viaduct (Turin). (b) Bridge deconstruction process (Anghileri, Biondini, et al., 2021).

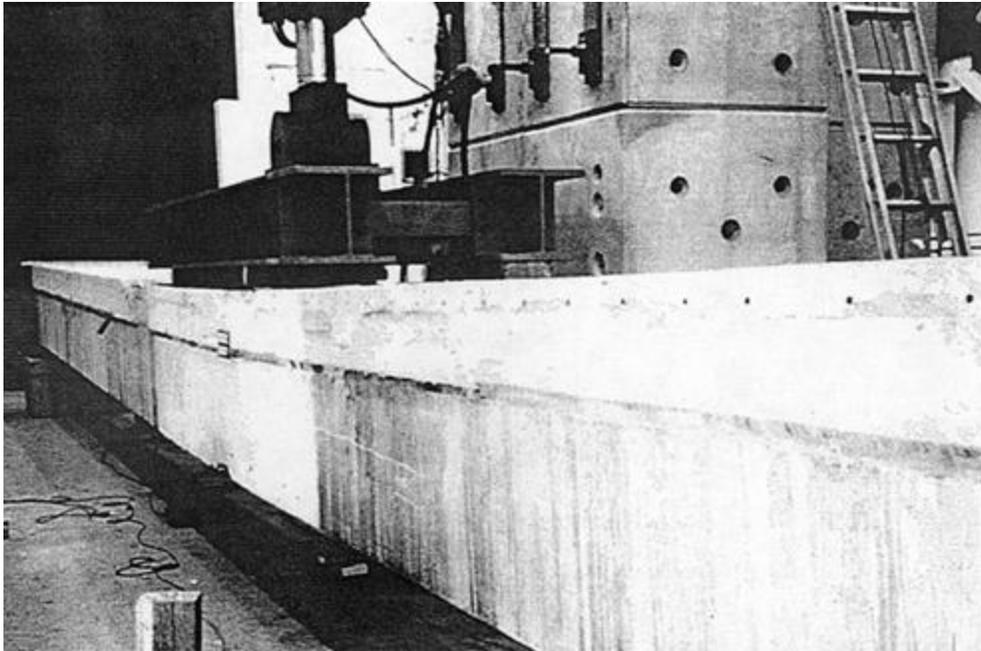
Figure 2. The general test set up for the experiments conducted by (Labia et al., 1997).

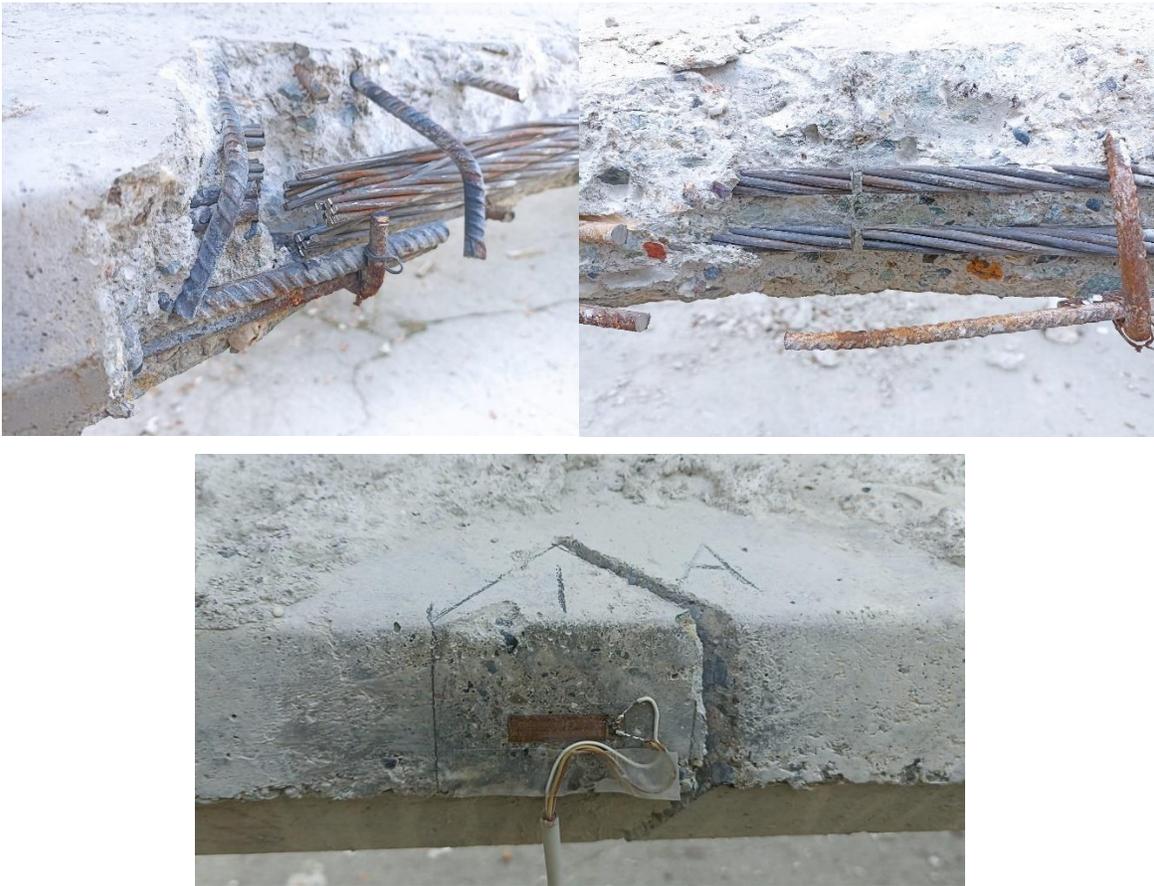
Figure 3. (a & b) Strand cuts. (c) Concrete relax (saw-cuts) test.

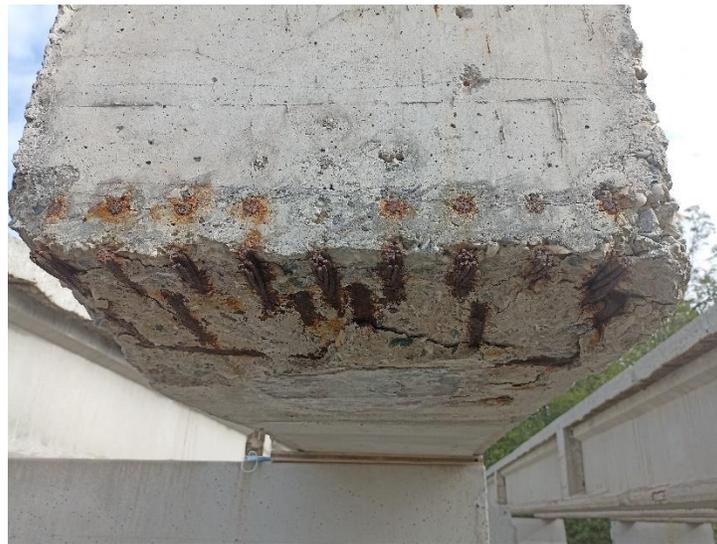
Figure 4. Prestressed corroded tendons at the end of a PC beam.

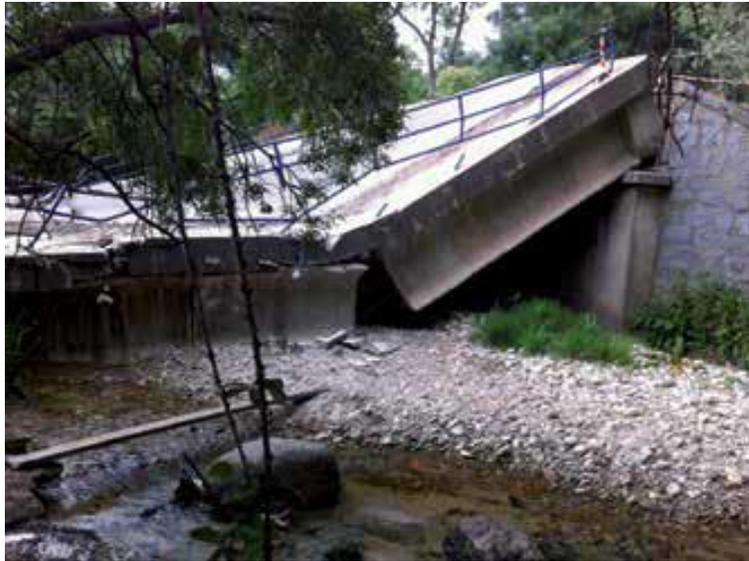
Figure 5. Collapsed M-527 bridge, Madrid community, Spain (Parrondo Rodriguez, 2017).

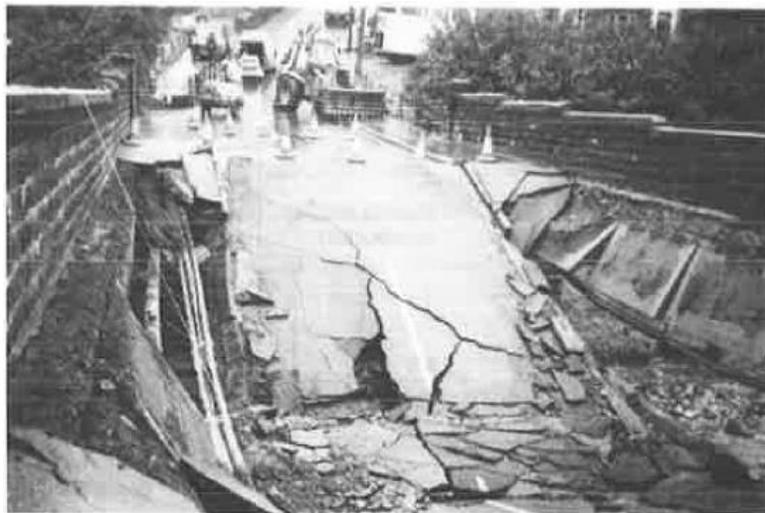
Figure 6. Ynys-y-Gwas bridge after collapse, West Glamorgan, UK (Woodward, 1989).

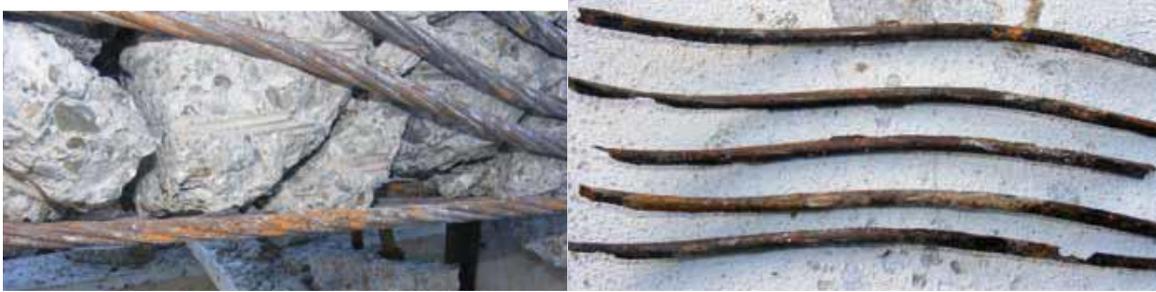
Figure 7. (a) Broken out strands with uniform corrosion; (b) Individual wires with pitting damage, from (Rogers et al., 2012).

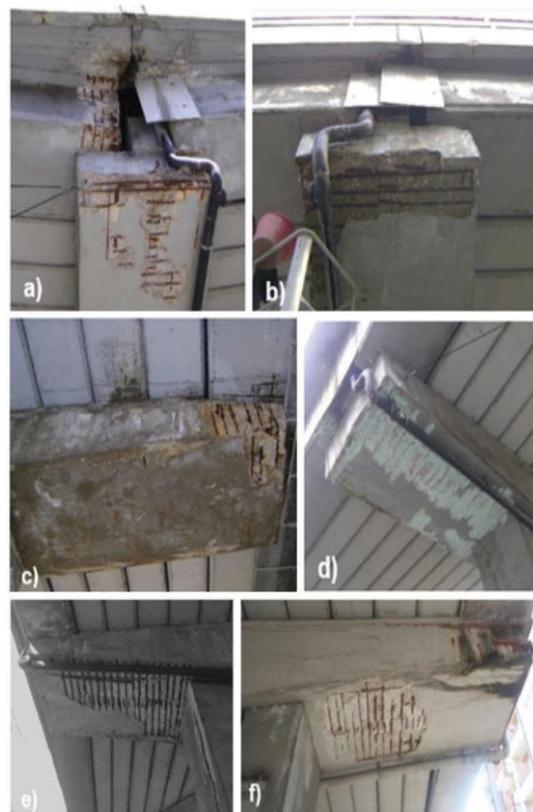
Figure 8. Degradation and corrosion at support zones in the Corso Grosseto viaduct at different years of inspection. a) 2011, b) 2012, c) 2013, d) 2014 maintenance interventions, e) 2015 and f) 2016. (Savino et al., 2021)

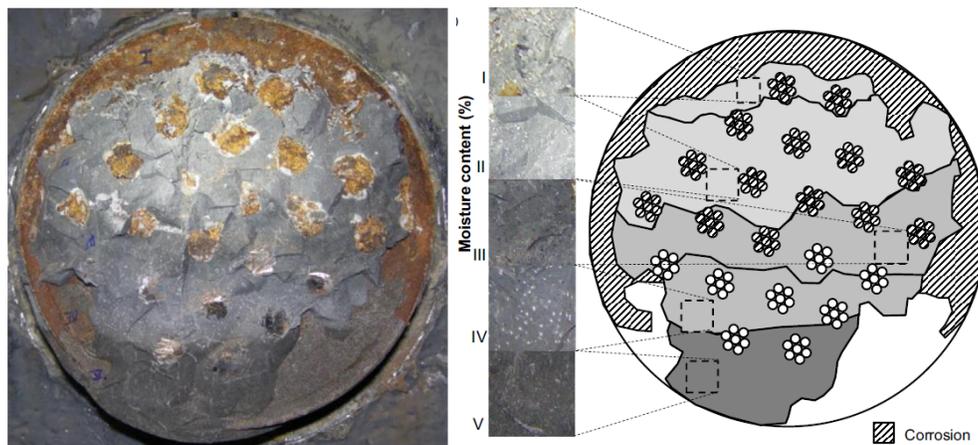
Figure 9. Deficient grout and corrosion at an anchor cap (Lau & Lasa, 2016).

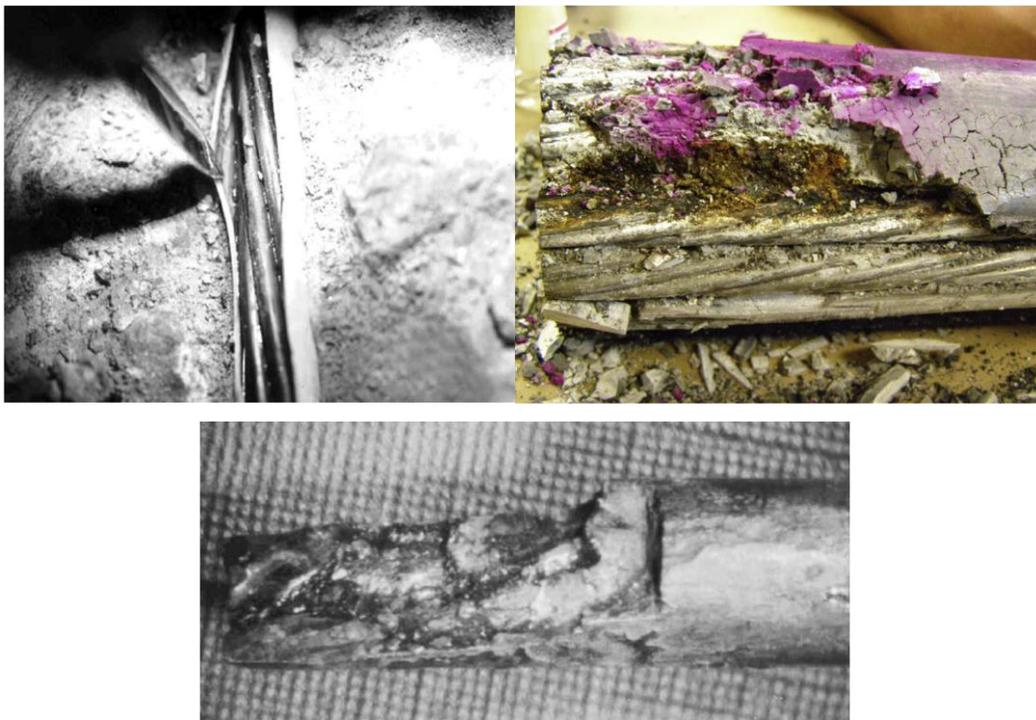
Figure 10. (a) In-place examination of an unbonded tendon, (b) corrosion of a strand embedded on deficient grout, (c) Brittle wire fracture. (Hamilton et al., 2005; Lau & Lasa, 2016).

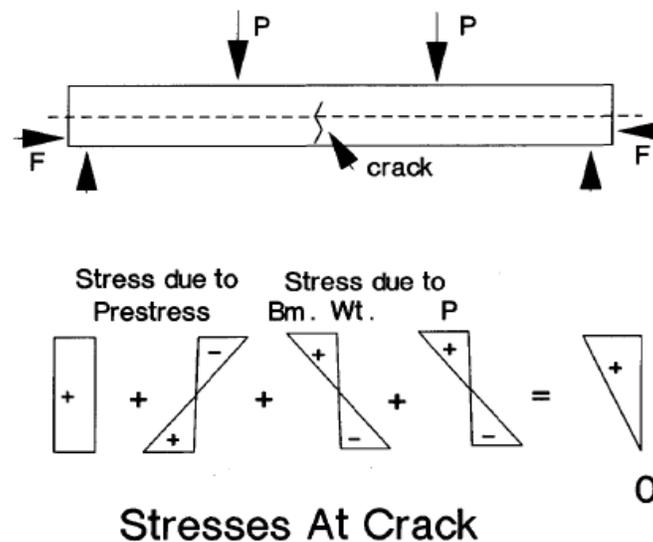
In 1991 Shenoy & Frantz determined experimentally the prestress force in two 27-year-old prestressed concrete box beams considering a cracked moment-based method. Once determined the crack opening load corresponds to the instant of the first crack opening, the prestress force can be calculated by statics. The bending moment due to dead load and applied load should be taken into account.

Figure 11. Static scheme determination for prestressed force (Shenoy & Frantz, 1991).

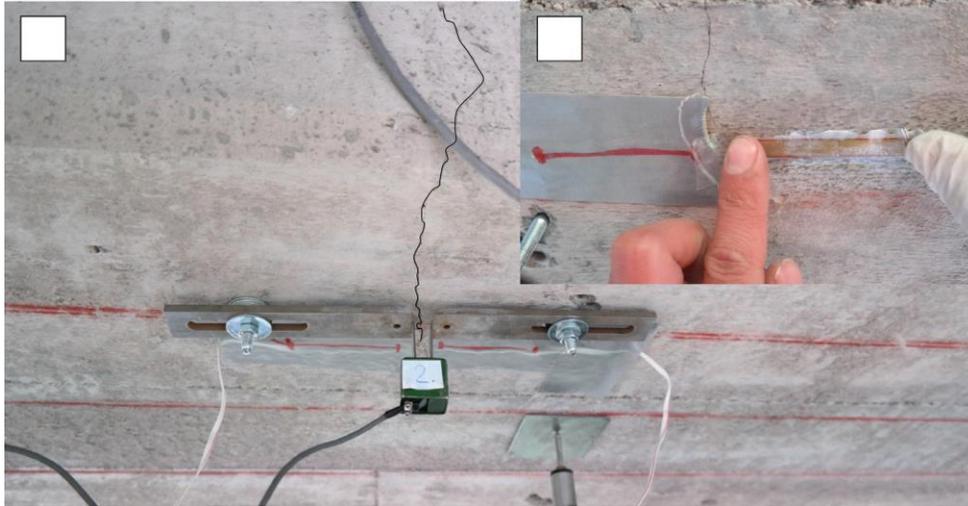
it showcases a linear variation in relation to the load up to the so-called decompression load; beyond this level, the crack reopens, and a dramatic change in stiffness occurs (Bagge et al., 2017).

Figure 12. Crack decompression monitoring (Bagge et al., 2017).

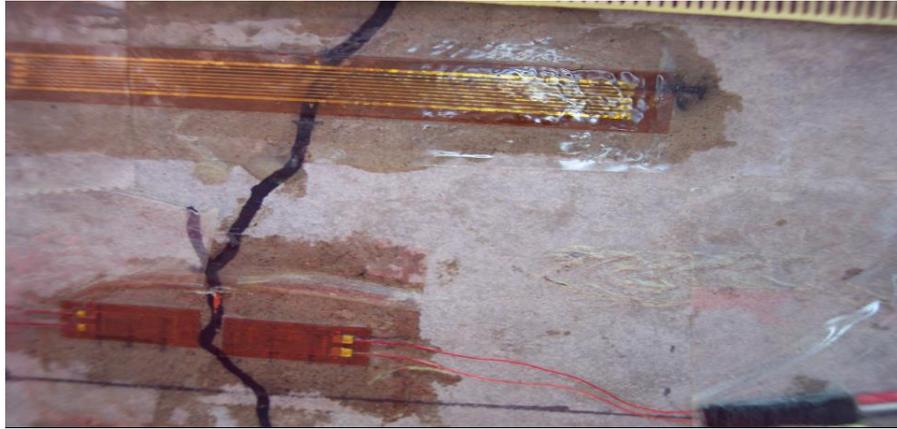
Figure 13. Strain gauges to identify crack reopening (B. M. Kukay, 2008).

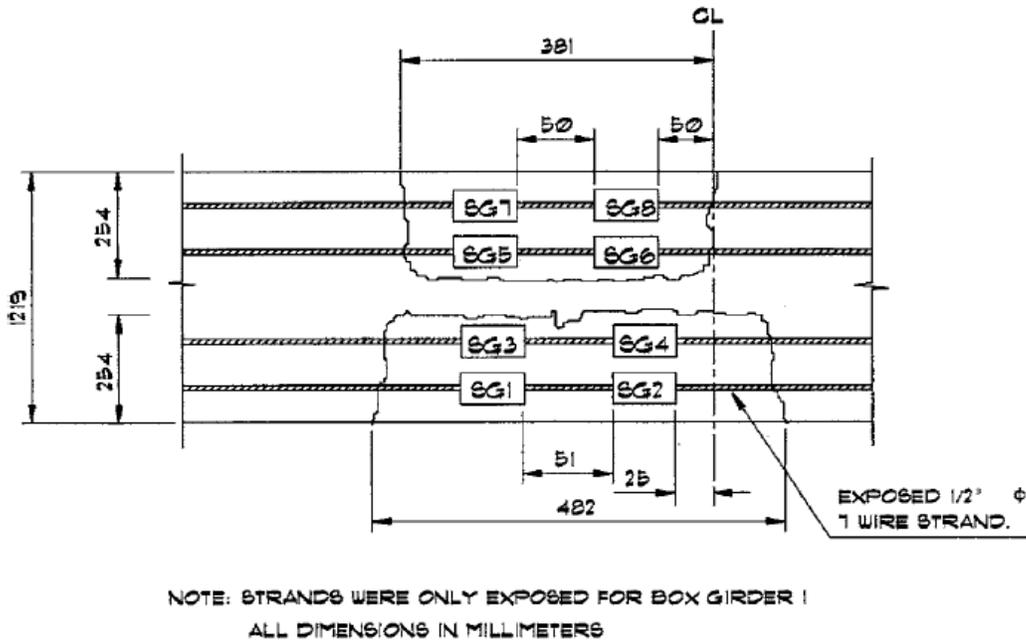
approximately 508 mm of two strands on each of the beams, they instrumented with strand gauges three wires on each strand, and flame-cut them; they conclude that this method is one of the most “effective ways of determining prestress losses in prestressed concrete beams” along with using vibrating wire gauges embedded in the concrete. It was also applied by (Labia et al., 1997) on box girders, where nine strain gauges were mounted on three strands.

Figure 14. Strand cutting scheme on (Labia et al., 1997).

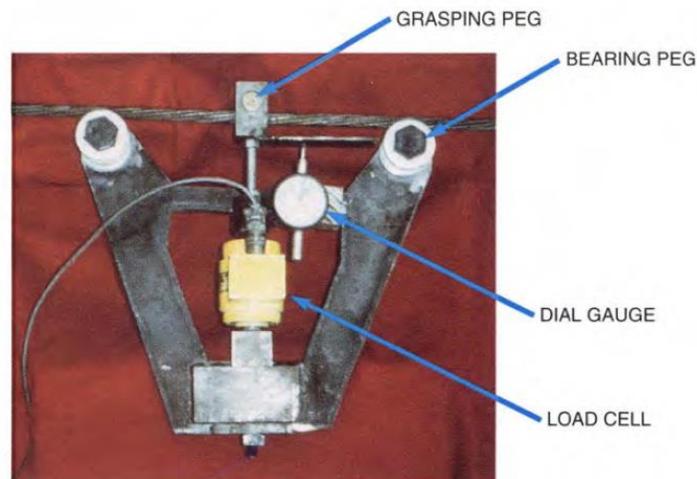
The device developed by (Civjan et al., 1998) consists of a frame containing roller-bearing pegs that rest against the strand. Load is applied through a high-strength grasping peg aligned with a load cell. A nut is tightened along a threaded rod for the load application, and a dial gauge attached to the frame record the measured displacements. The final prototype requires only an external voltage source and a voltmeter, being well suited to be used in the field for existing bridge girders. The authors also looked for the instrument to have minimized dimensions to ensure its placing between strands in case of closely spaced multiple-strand arrangements typical in prestressed concrete I-shaped girders.

Figure 15. (Civjan et al., 1998) *Prototype plan view.*

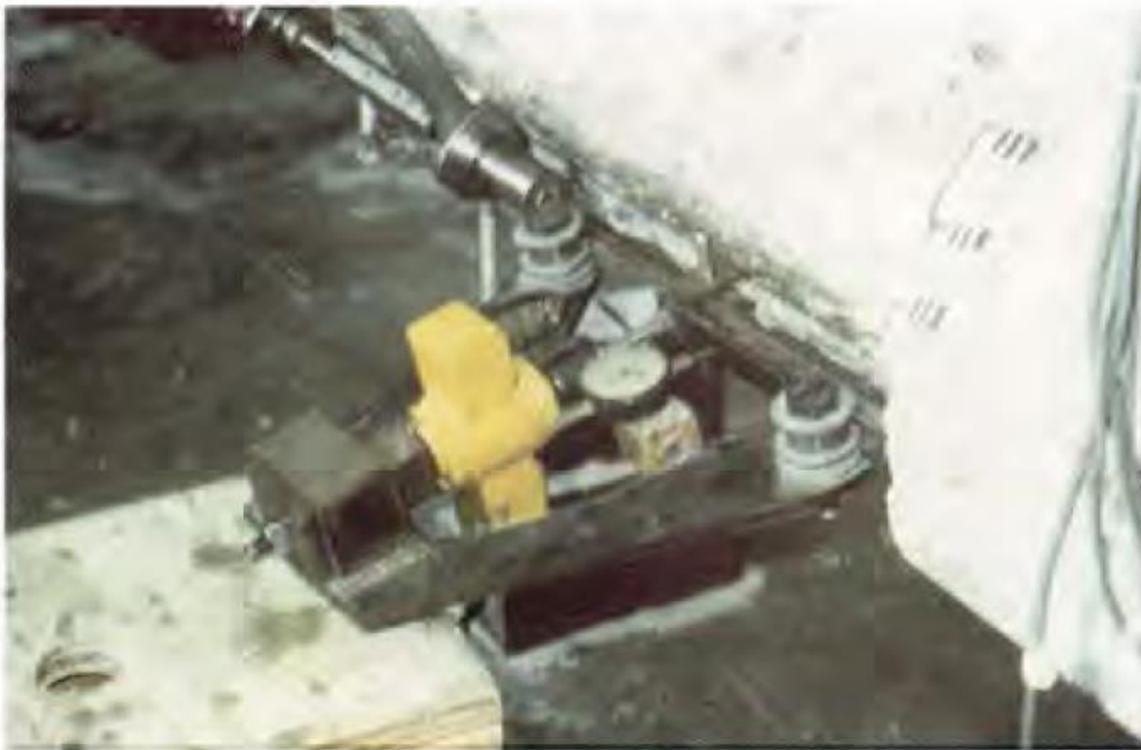
Figure 16. (Civjan et al., 1998) Prototype during splice test.

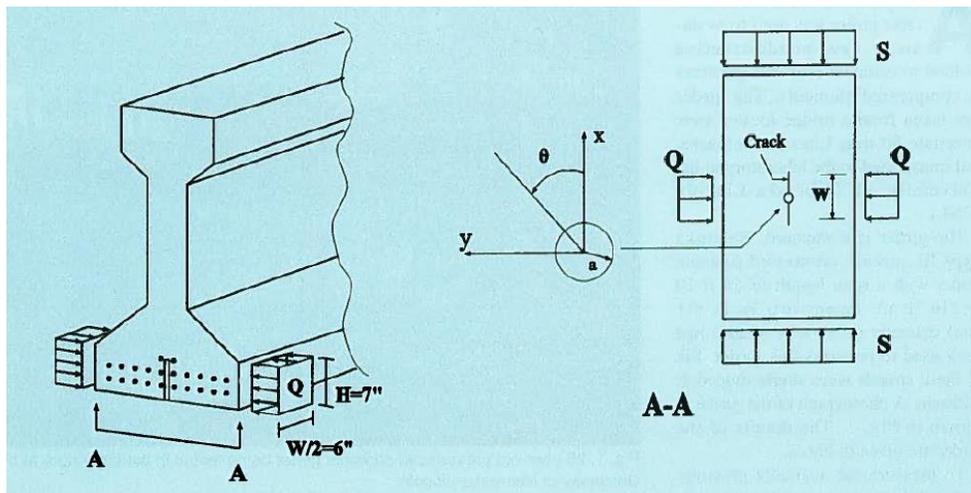
(Azizinamini et al., 1996) Describes this method as an investigation “of the state of stress around a hole in a prestressed concrete member.” The procedure is as follows, on the bottom flange of a prestressed girder, a cylindrical hole is drilled (the bottom flange is assumed to be under compression, the following descriptive figure is to be found in the same article

Figure 17. Sectional view of a drilled hole test (Azizinamini et al., 1996).

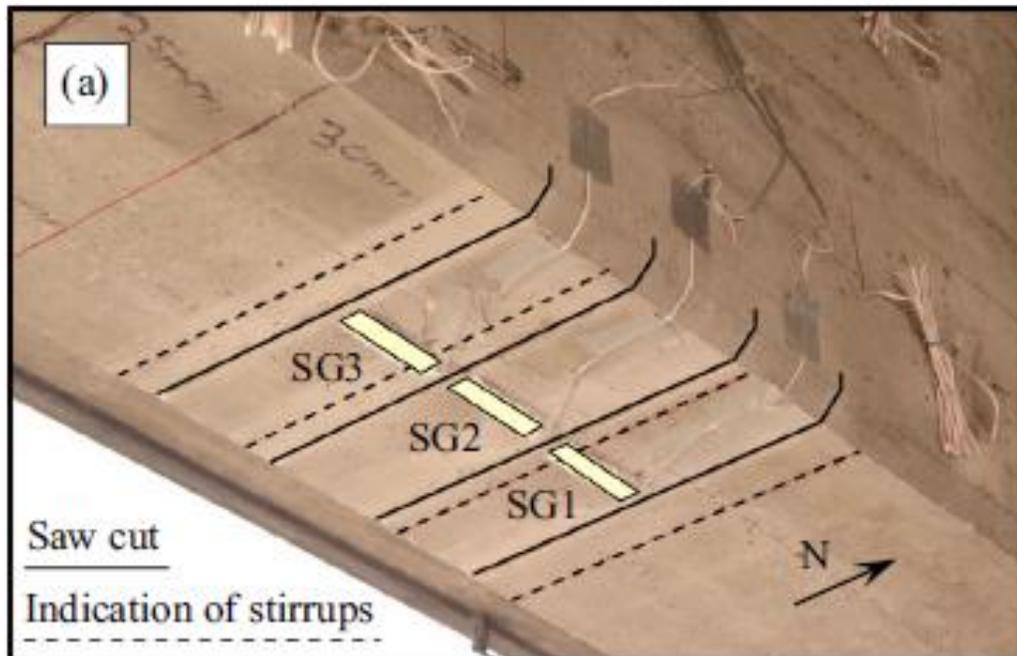
In 2010 (Kukay et al.) introduced a new method as an alternative to the traditionally used techniques. This new method consists of saw-cutting small sections on the bottom of the bridge where a strain gauge was placed previously. The objective of the saw-cuts is to isolate the small section of concrete from any stress induced by external loads or prestress. Then the strain change produced from the isolation after the cutting can be correlated to the residual prestress force in the girder's tendons (Bagge et al., 2017; B. Kukay et al., 2010). As in the drilled-hole method, the saw-cuts method has only been applied to relatively simple members in controlled environments (Bagge et al., 2017).

Figure 18. Cuts at the bottom flange of a beam and strain gauges (Bagge et al., 2017).

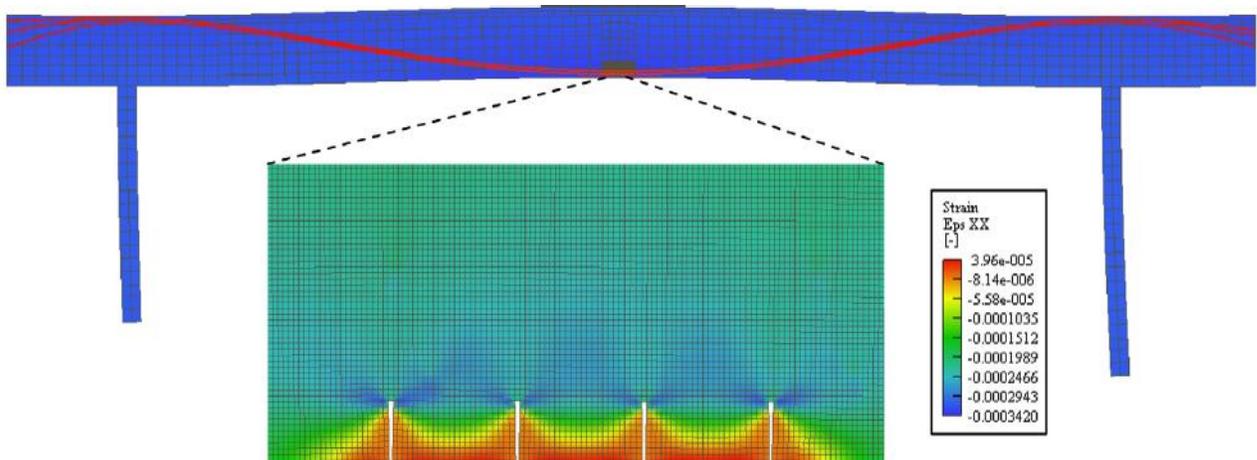
The saw-cuts non-destructive method is only suitable to be applied in situations where the possibility of completely isolating a concrete block from the prestress forces exists. In existing structures, this is not always possible because, in some cases, it is possible to damage non-prestressed reinforcement as it may be located too close to the concrete surface to make sufficiently deep saw-cuts. For those situations (Bagge et al., 2017) suggest that complementing the saw-cuts method with a FE analysis may provide valuable complementary information.

Figure 19. FE model for non-destructive evaluation used by (Bagge et al., 2017).

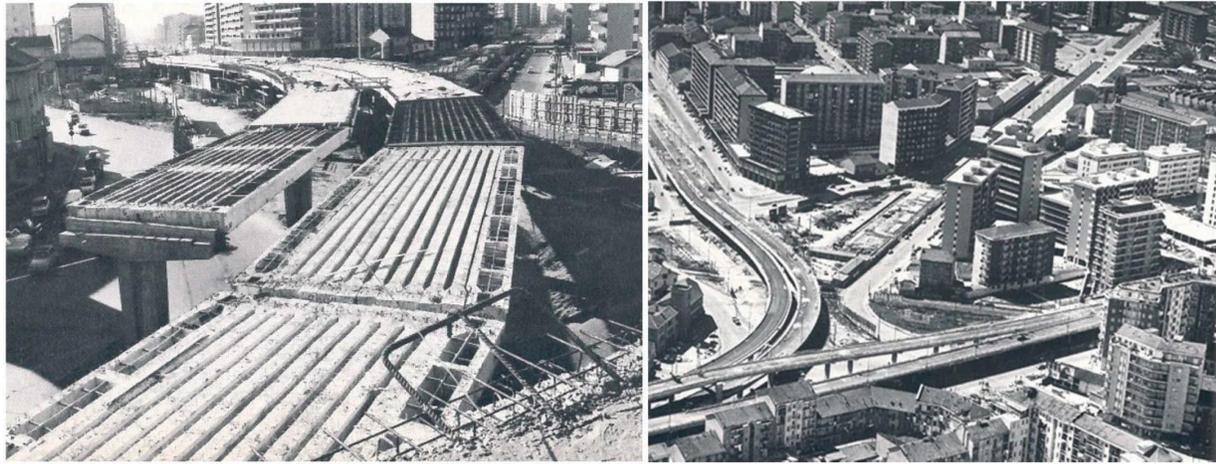
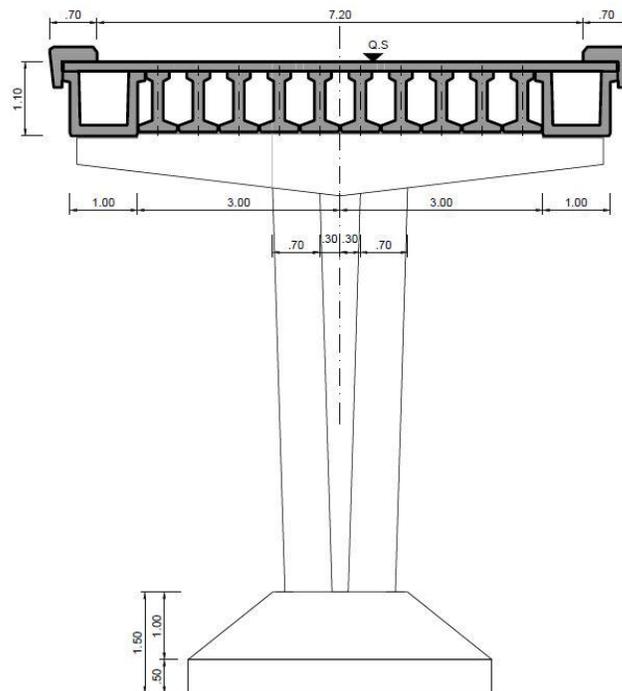
Figure 20. (a) Detail of the viaduct during the construction phases. (b) Corso Grosseto Viaduct, Torino (Italy), year 1970 (Impresa Pessina 1976) (Savino et al., 2021). (c) Bridge deck cross-section (Biondini, Tondolo, et al., 2021)

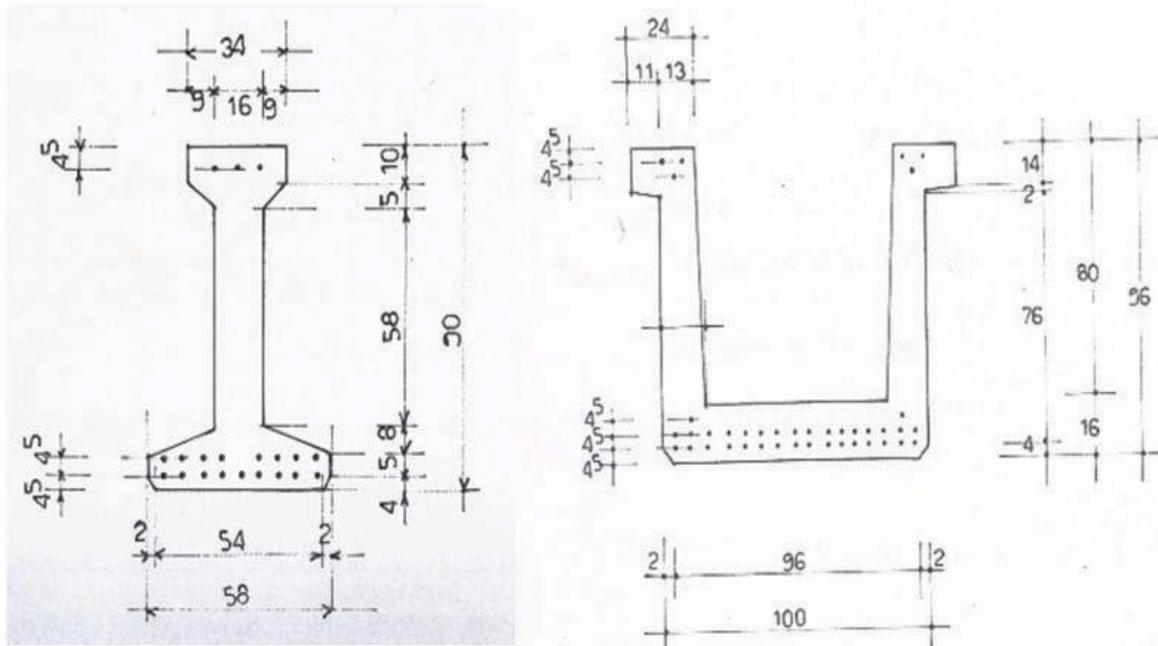
they were unbonded on the end sections and bonded in the transition area. Four strands were unbonded for the I-beams, and 11 strands were unbonded for the box beams. The prestressing action was extensively used to speed up the construction process. Figure 9 shows the beam typologies.

Figure 21. Double T-beam and U-beam cross section typologies (Savino et al., 2021)

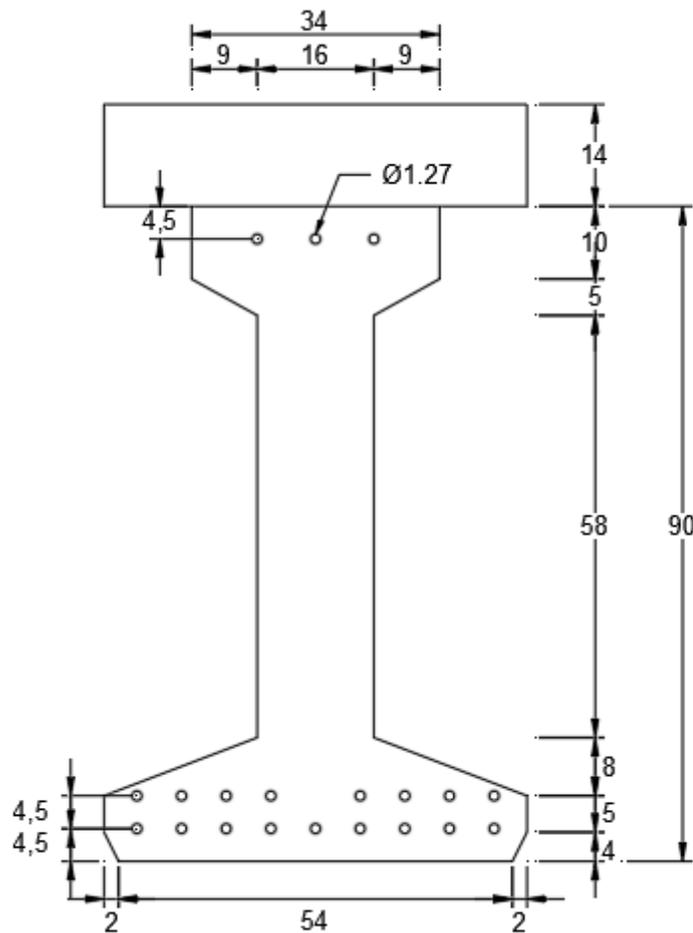
The tests described in this work are performed in double-T-type beams, which are presented in detail in the following figure.

Figure 22. Detailed geometry of double-T beams.

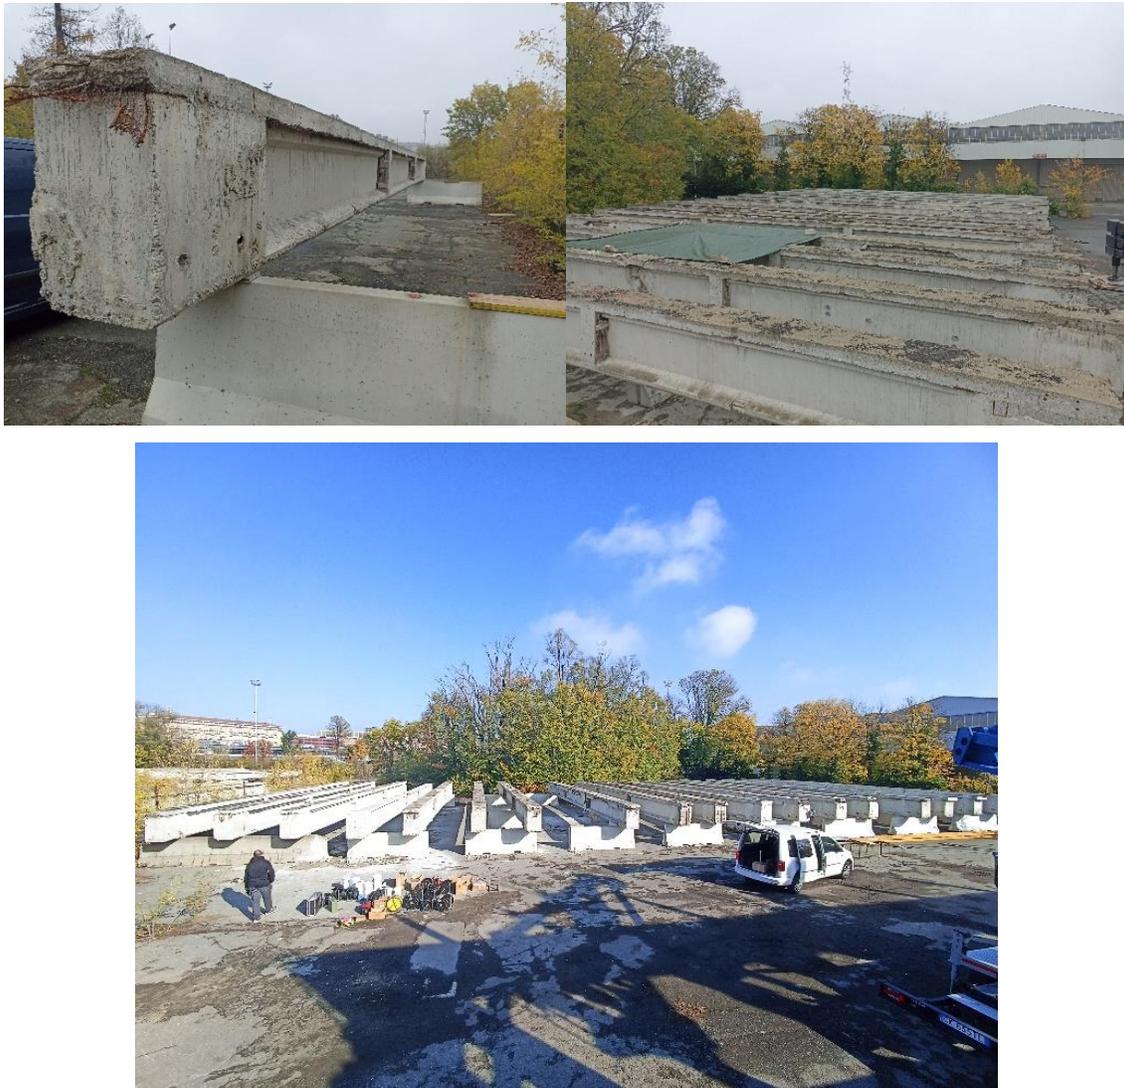
Figure 23. PC beams at the working site.

The beams are stored in an open space at the Politecnico di Torino campus at Mirafiori, south of Torino. In the place are stored 29 prestressed concrete (PC) deck beams, of which 25 are I-shaped beams, 4 are box beams, and 2 pier caps.

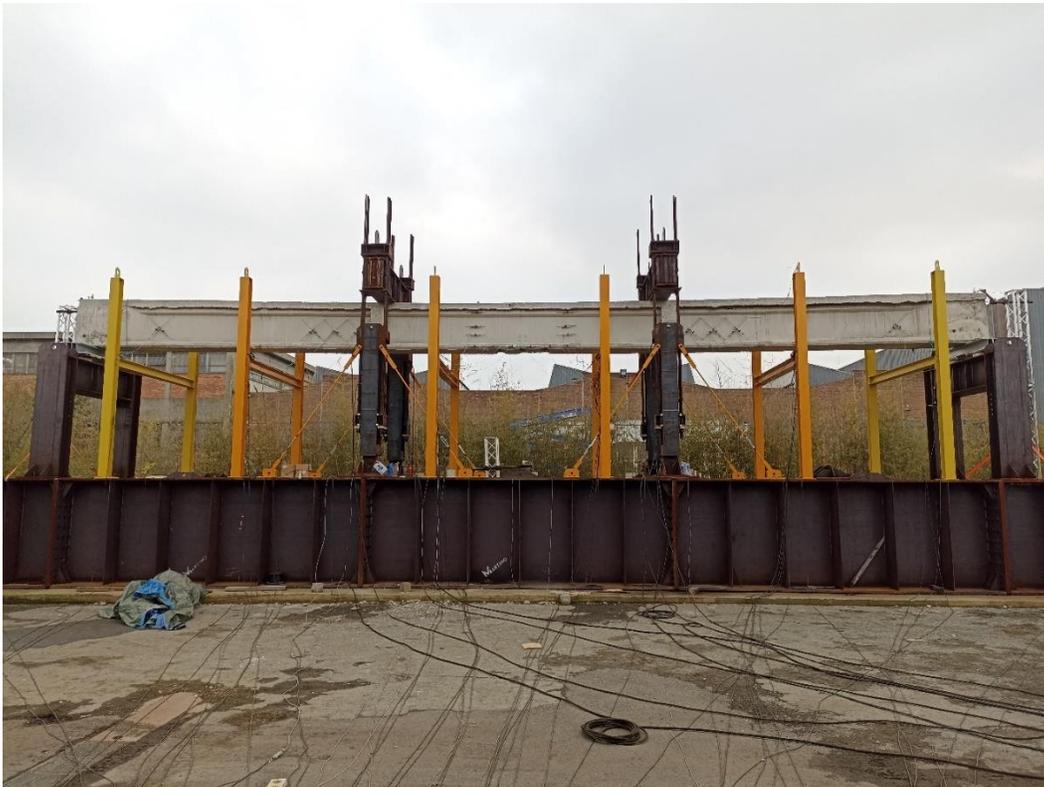
point bending test. Some beams are loaded in a specific way looking for pure flexural failure, and some are loaded looking to see the interaction between flexural and shear failure; the beams have a specific code in order to identify them, and the order of the loading tests is previously determined. The special loading frame is presented in figure 24.

Figure 24. PC beam on loading frame.

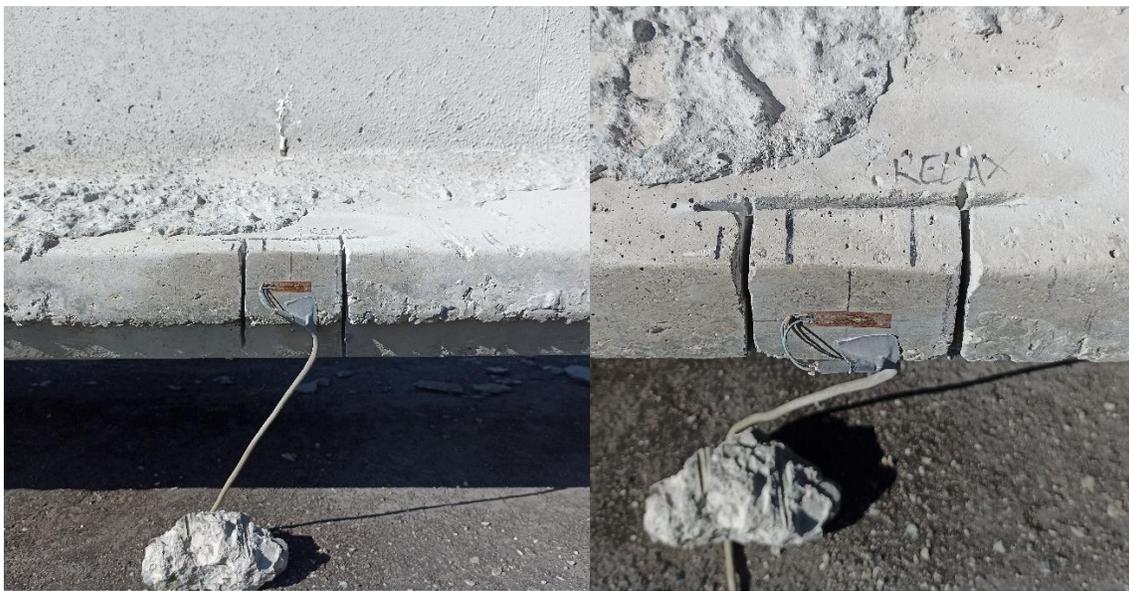
The used strain gauges are 20 mm long, and the cuts are performed 15 mm from each end of the gauge to avoid affecting the cable connections attached to one of the gauge's ends. An electric rotatory saw is used to perform the cutting. Initially, the cuts were meant to be perpendicular to the beam's longitudinal axis, as shown in the following image.

Figure 25. Concrete relax test on beam 1, point A (left), and point B (right).

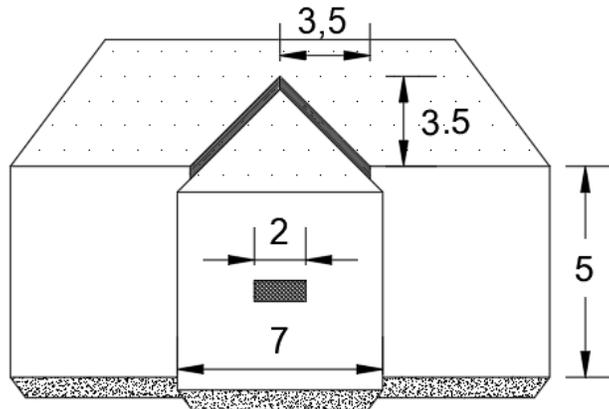
However, this methodology of cutting involved four cuts to completely detach the small block: two lateral cuts, one on top, and one at the bottom; which made it too complicated to reproduce and prone to errors; At the same time, the bottom cut involved an elevated risk for the operator of the saw which should place himself in an uncomfortable position to perform it. It was then decided to perform two cuts, starting at the same position, 7 cm from each other, but inclined 45° with respect to the vertical plane of the beam's longitudinal axis, meeting at the prolongation of the center of the strain gauges a generating a prism with an isosceles triangle on the to face.

Figure 26. Concrete relax test geometry in cm.

The figure shows the geometrical scheme for the test. Figures present the progression in the test cuts.

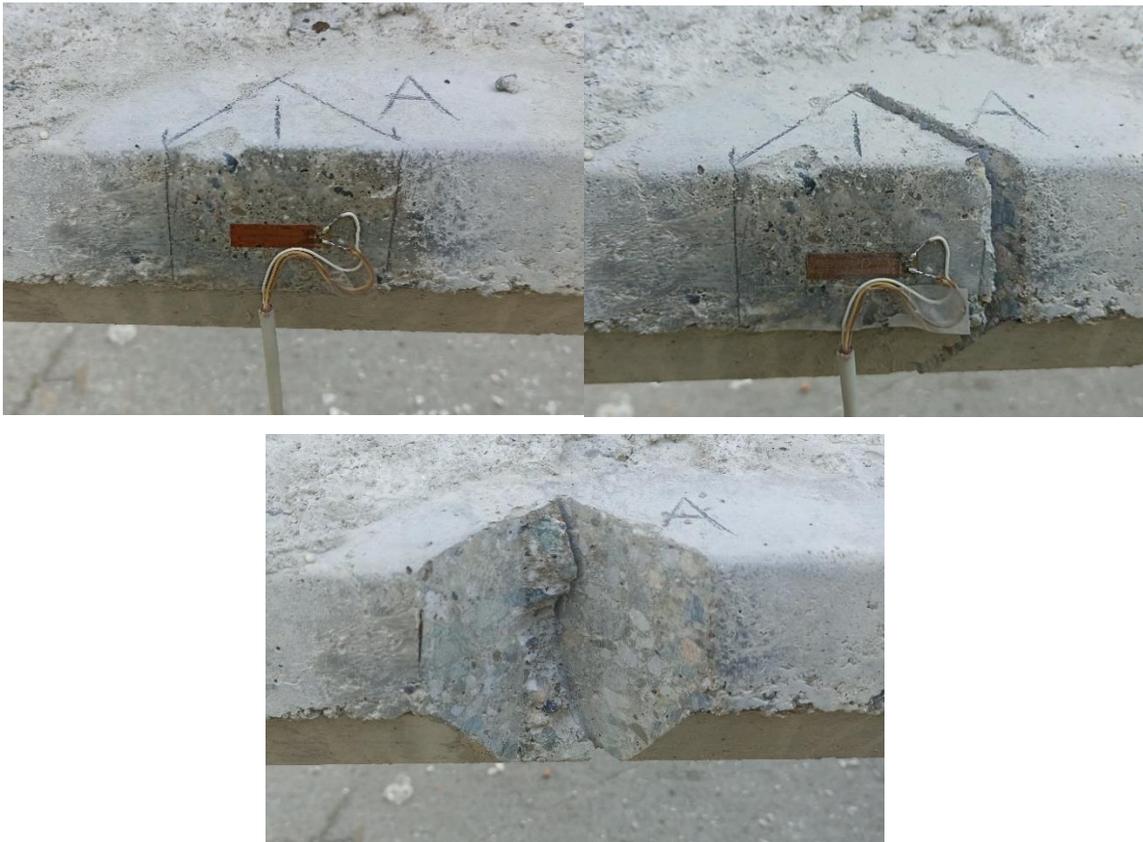
Figure 27. Concrete relax test. Before (a), mid (b) & after (c).

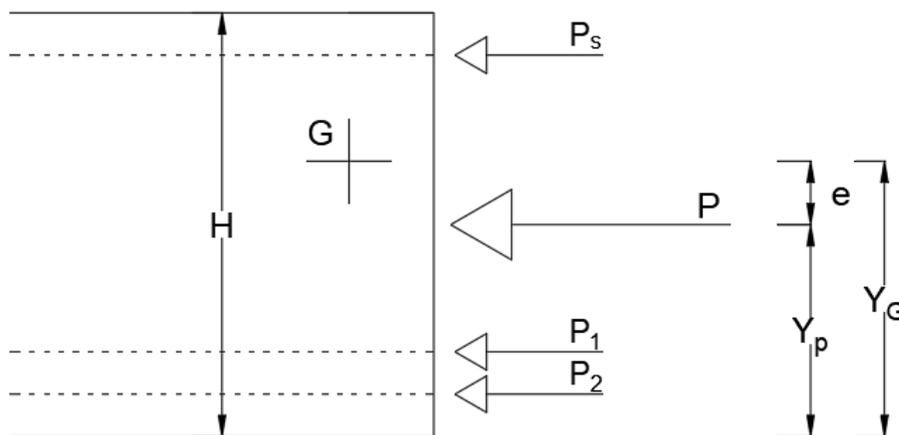
Figure 28. Force scheme of the section.

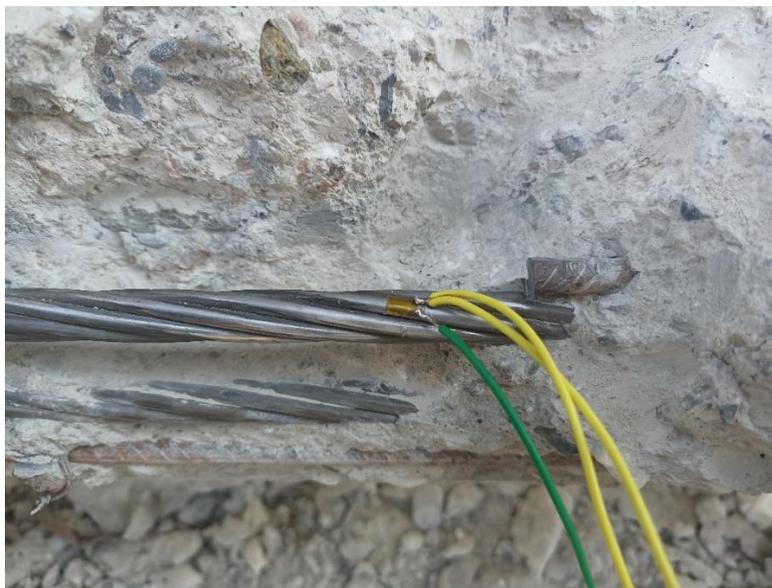
In the first attempts, only a section of the strand was exposed, and the cut was performed just some cm away from the stuck strain gauge. At the moment of each prestressed strand fiber complete cut, it suffered a strong recoil, causing the small welding in the strain gage cables to unstick, so for the first beam's attempts, the measurements were unsatisfactory.

Figure 29. Strain gauge on the steel strand.

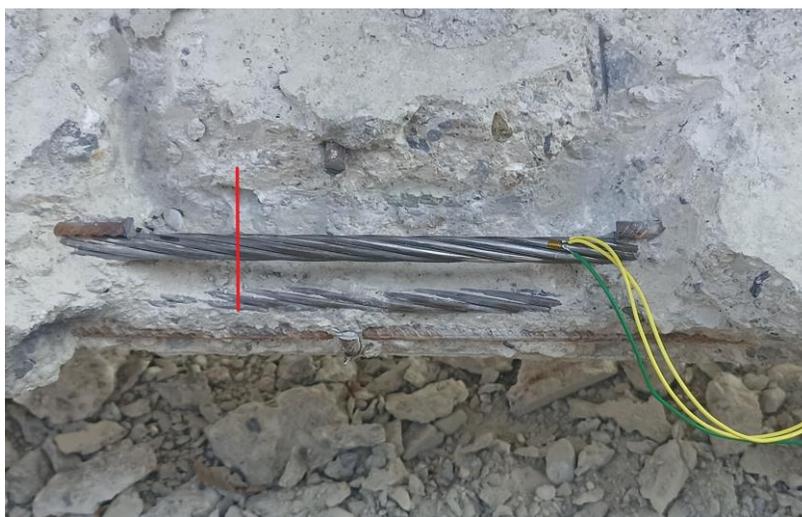
Figure 30. First test scheme (cut in red).

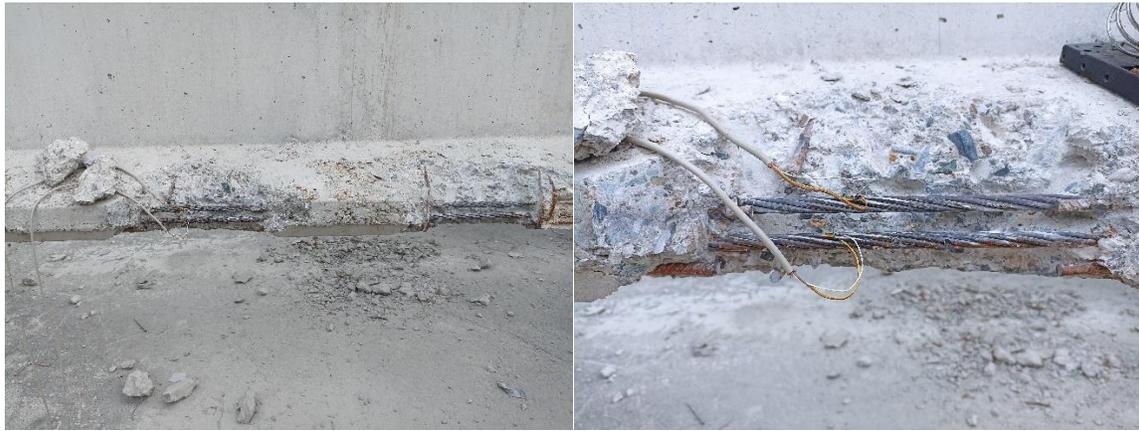
As a solution to the problem, two different segments of prestressed strands are exposed; a first segment where the strain gauge is placed and a second segment where the steel is cut. A concrete portion is left covering the strands between the exposed sections, acting as shock absorbers for the recoil impact. When the strand is cut, the left concrete portion is demolished, and with it, the strand portion is entirely free, allowing the strain measurement without the strain gauge being damaged. Figures 28 illustrates the test.

Figure 31. Configuration before strand cutting.

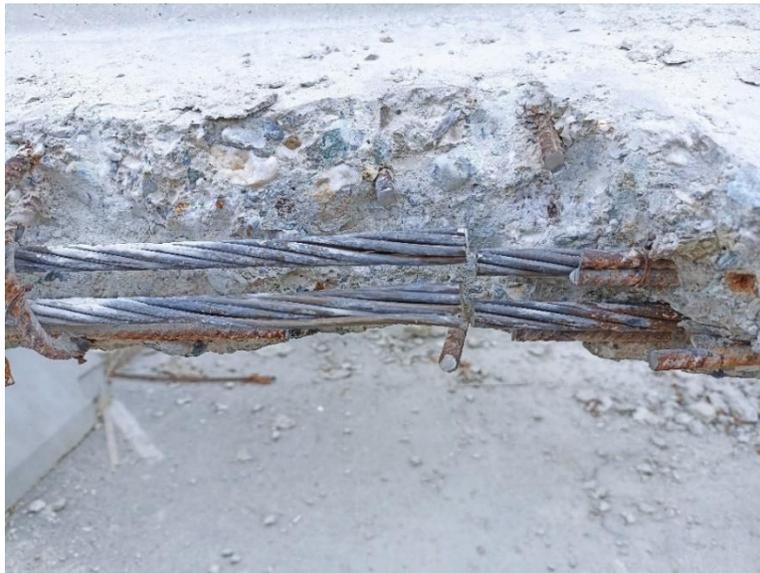
Figure 32. Completely cut strands.

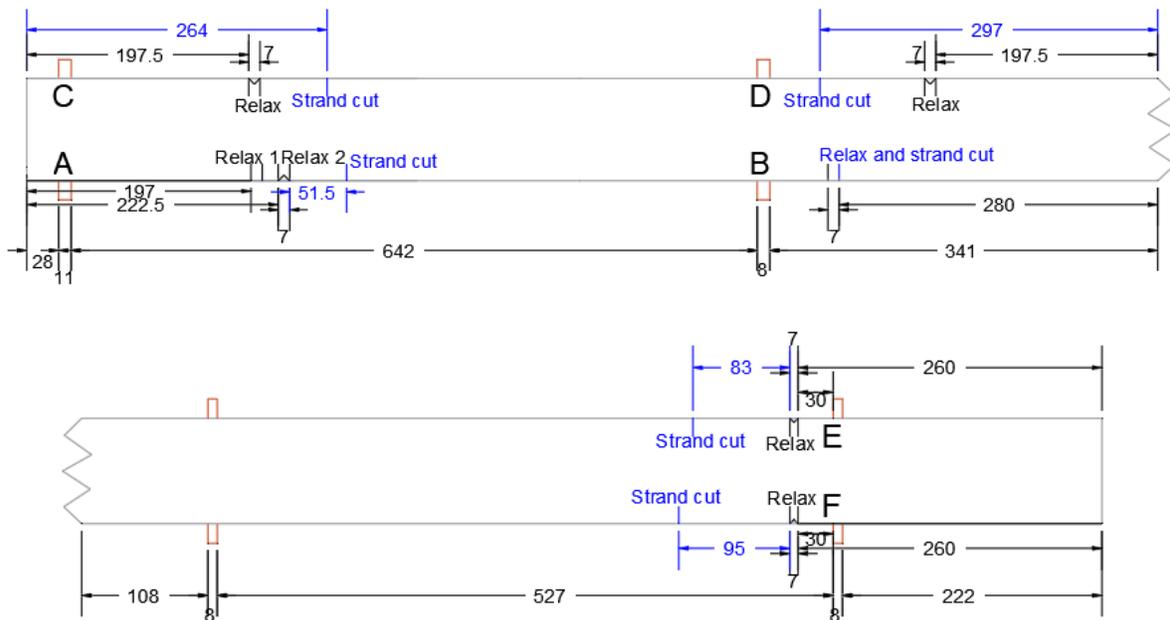
The tested beam number 1 showed a clear failure zone that divided the beam into two bodies, each of the two bodies stands in two simple supports. The first body has a total length of 10.3 meters and the failure zone is located at 3.49 m from its last support generating a cantilever. The second body is 8.73 meters long with a cantilever of 1.12 m from the failure zone to its nearest support. The total height of the element is 104 cm, 90 cm from the beam, and 14 cm from the top slab. The medium characteristic strength for the concrete (R_{ck}) is 43.8 MPa; all concrete strength values presented here are obtained from preliminary sclerometer (or rebound hammer) tests, more accurate values will be obtained later after compressive tests.

Figure 33. Beam number 1 measures and performed tests location.
