POLITECNICO DI TORINO

Master's degree in Civil Engineering

Thesis of Master of Science

Calculation of residual prestress levels on beam bridge elements using a non- destructive and a destructive method.

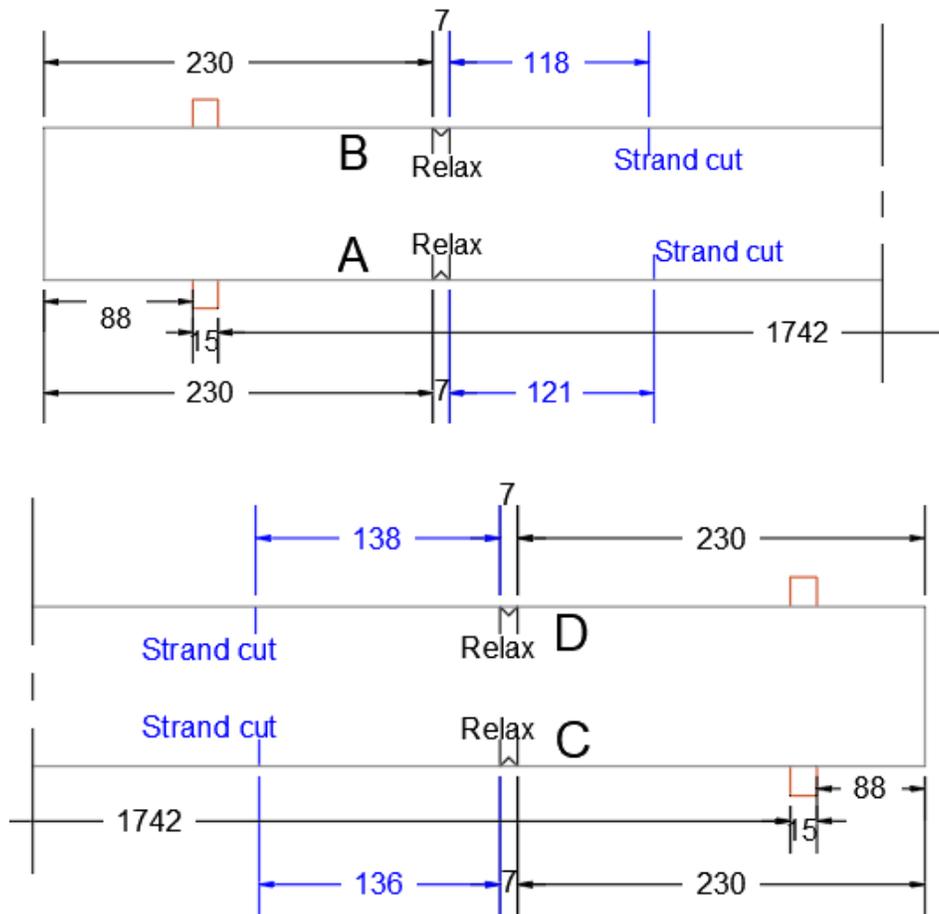
The second tested beam did not show a violent rupture as Beam 1 and its whole body is simply supported with a distance between supports of 17.42 m and a full length of 19.48 m. Each support is located at 0.88 m from the beam ends. The total height of the element is 104 cm, 90 cm from the beam, and 14 cm from the top slab. The medium characteristic strength for the concrete (R_{ck}) is 45.6 MPa.

Figure 34. Beam number 2 measures and performed tests location.

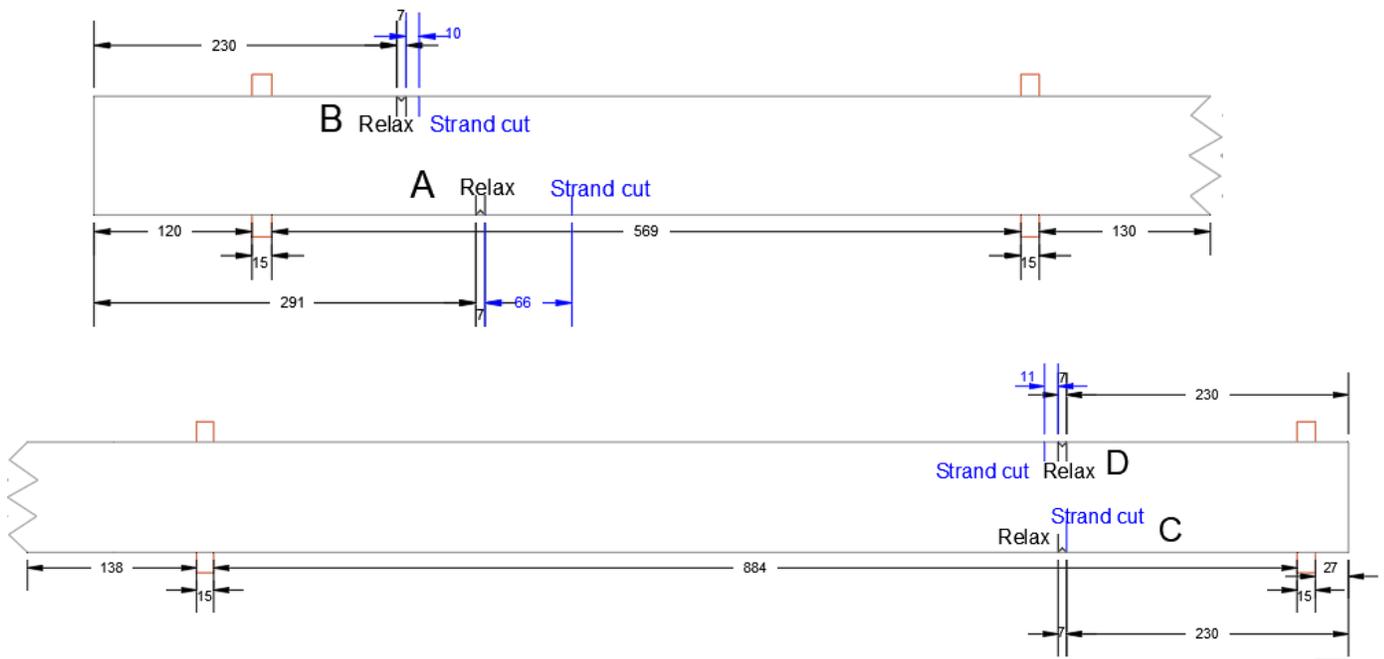
For beam # 3 once again the element presents a violent rupture and is divided into two bodies, each with a simply supported scheme. The first body has a total length of 8.49 m with a 1.30 m cantilever on the failure part; while the second body is 10.79 m with a 1.38 m cantilever on the failure side. The total height of the element is 104 cm, 90 cm from the beam, and 14 cm from the top slab. The medium characteristic strength for the concrete (R_{ck}) is 39.2 MPa.

Figure 35. Beam number 3 measures and performed tests location

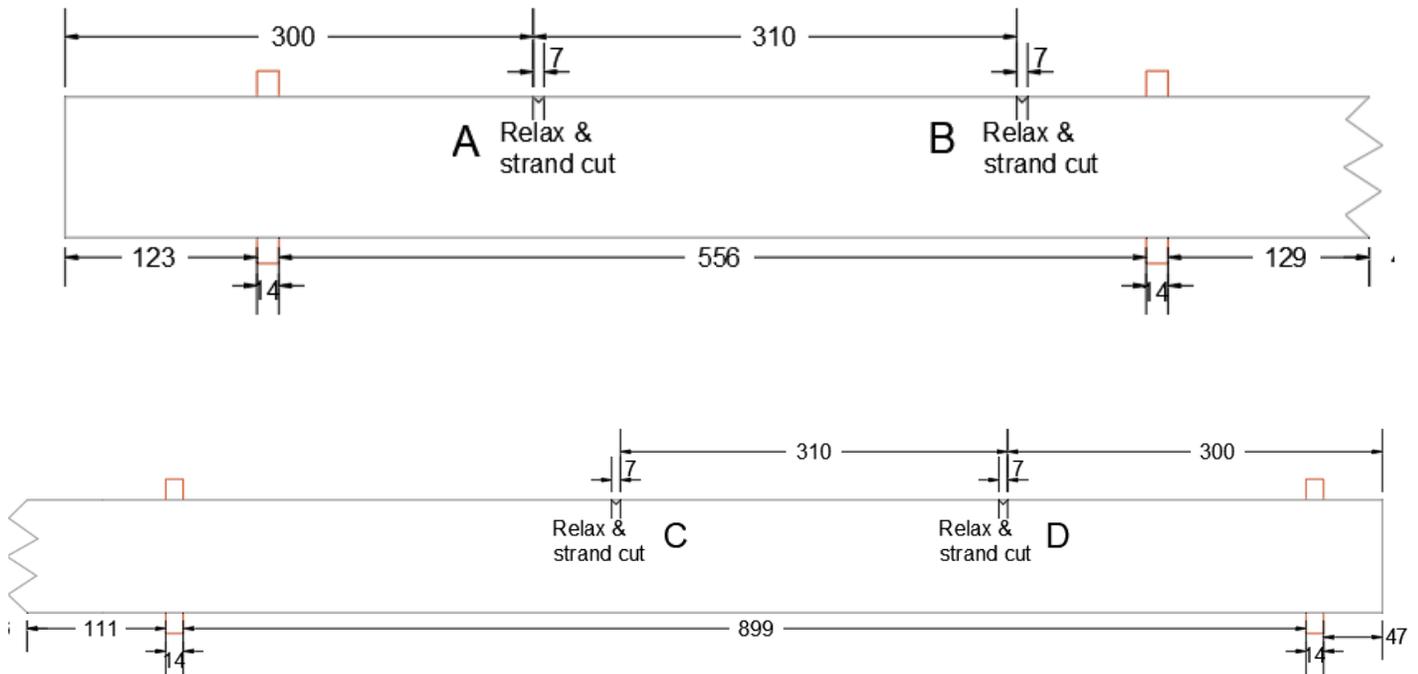
Beam #4 shows once again a complete rupture, divided into two bodies simply supported. The first body is 8.36 m long and has a 1.29 m cantilever close to the failure zone; the second body is 10.85 m long and has a 1.11 m cantilever at the failure end. The total height of the element is 90 cm, in this beam there is no slab at the top. The medium characteristic strength for the concrete (R_{ck}) is 43 MPa.

Figure 36. Beam number 4 measures and performed tests location.

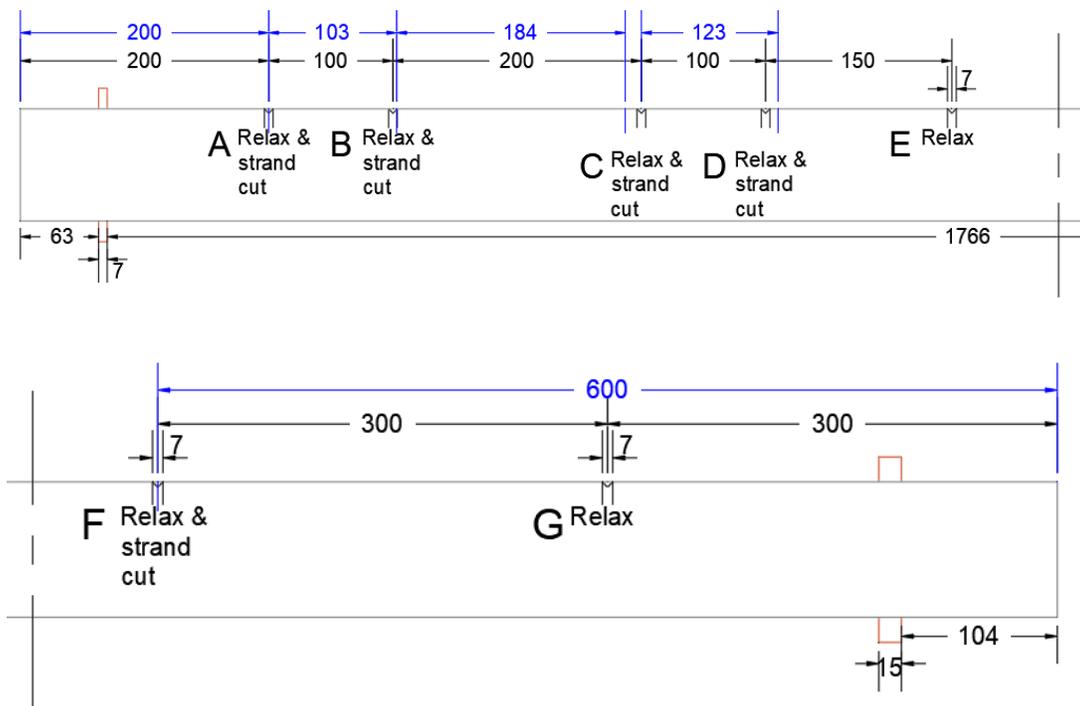
Tested beam #5 failed by compression on the top flange and does not present a full failure zone as beams #3 and #4, the beam is a whole supported body with a total length of 19.55 m, it is simply supported with a central span of 17.66 m. The total height of the element is 104 cm, 90 cm from the beam, and 14 cm from the top slab. The medium characteristic strength for the concrete (R_{ck}) is 50.2 MPa.

Figure 37. Beam number 5 measures and performed tests location.

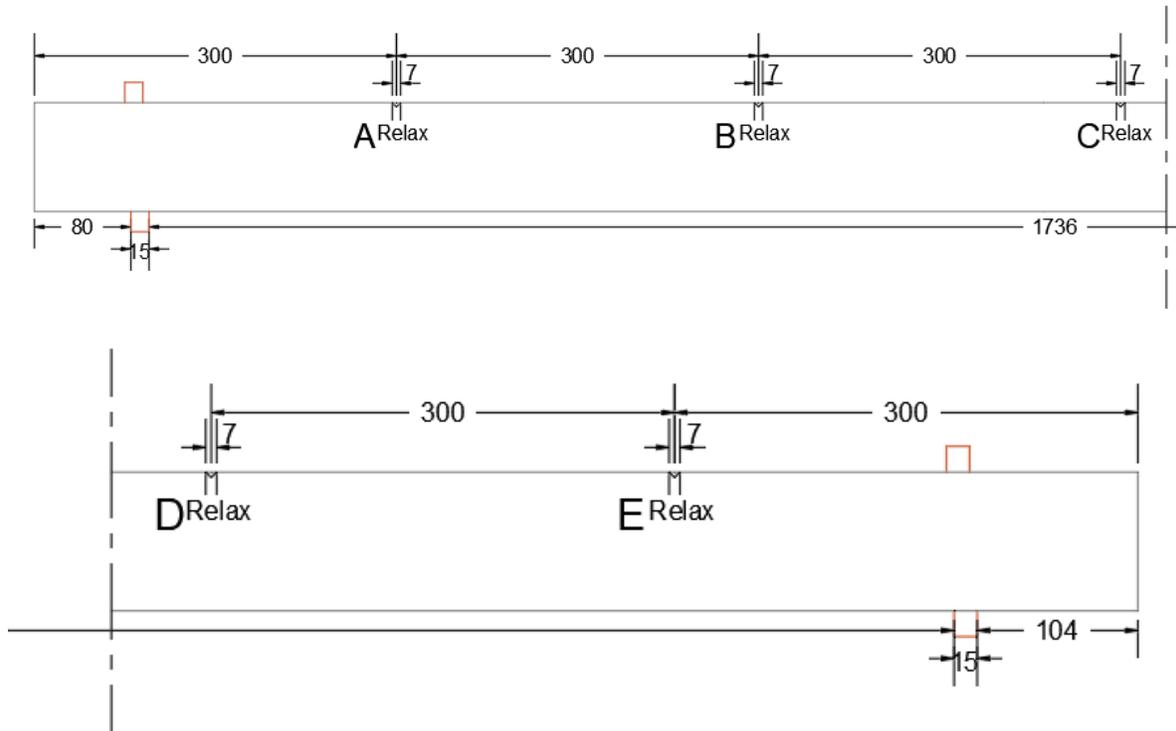
Figure 38. Beam number 6 measures and performed tests location.

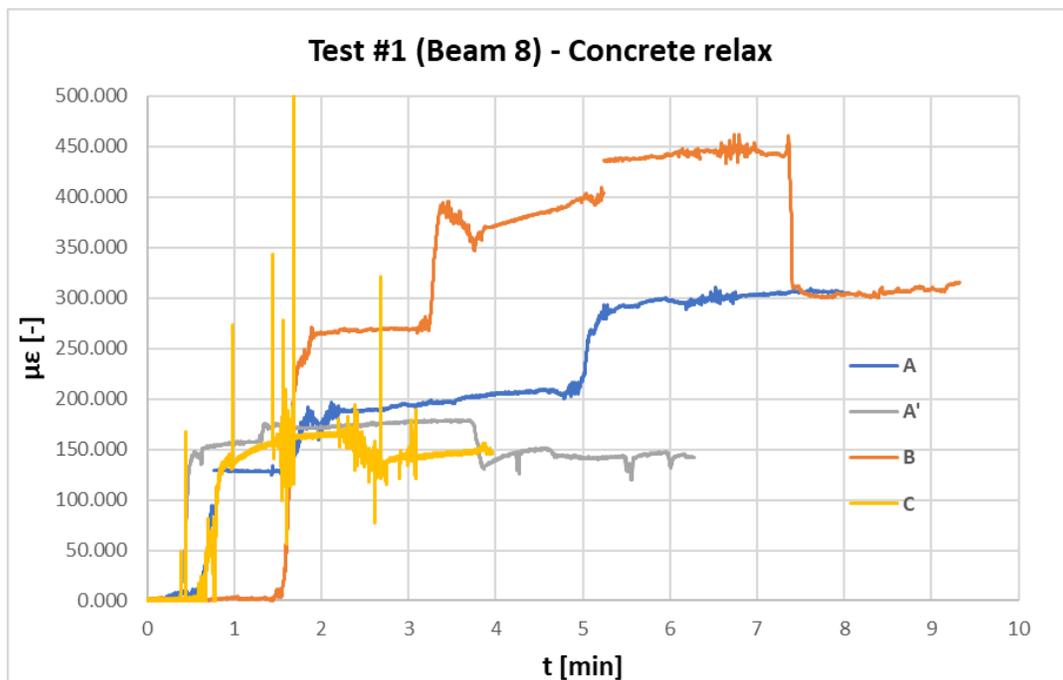
Figure 39. Concrete relax test measured strains on tested beam #1, points A, A', B, and C.

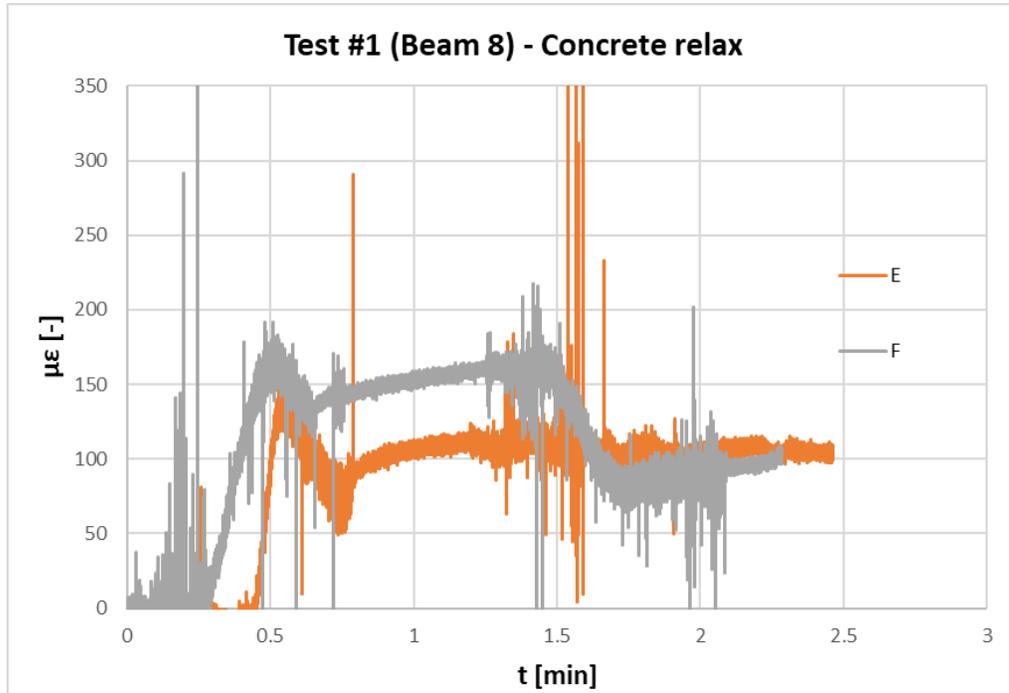
Figure 40. Concrete relax test measured strains on tested beam #1, points E and F.

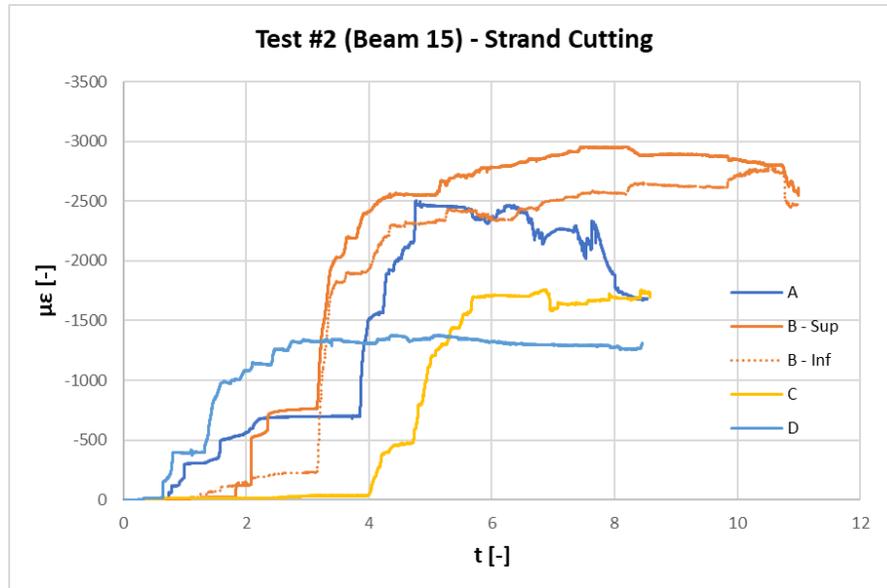
On beam #2, data obtained on the concrete relax test was not trustworthy so is not presented. Results for the strand-cutting test on beam #2 are presented below.

Figure 41. Strand cutting test measured strain on tested beam #2.

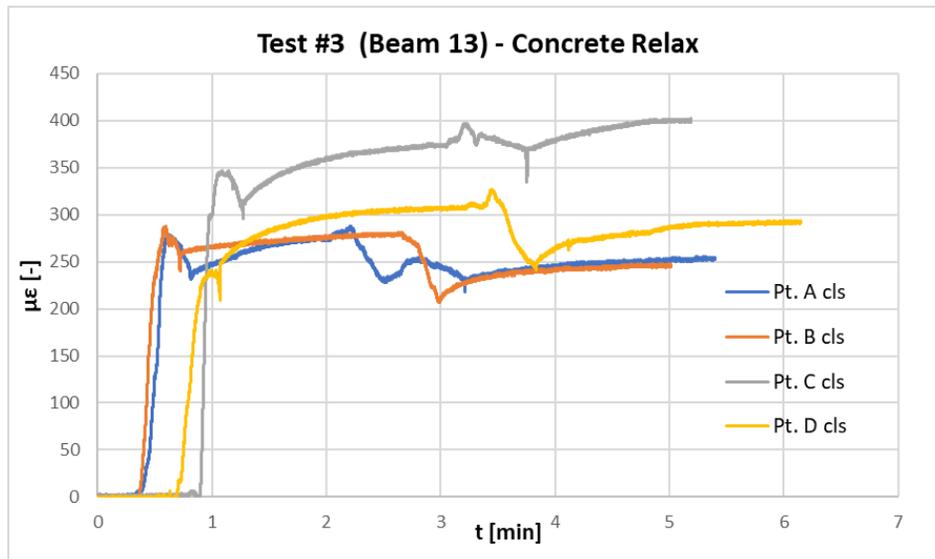
Figure 42. Concrete relax test measured strains on tested beam #3.

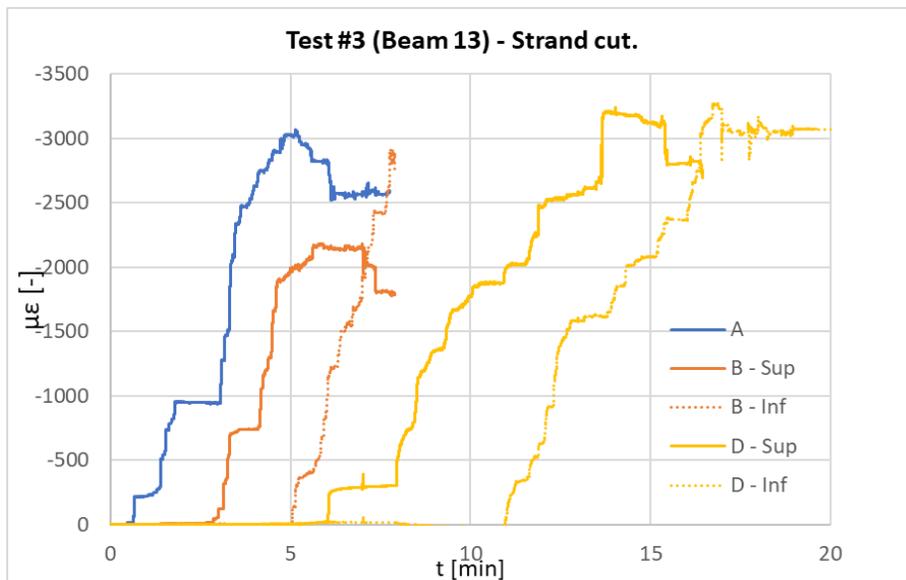
Figure 43. Strand cutting test measured strains on tested beam #3.

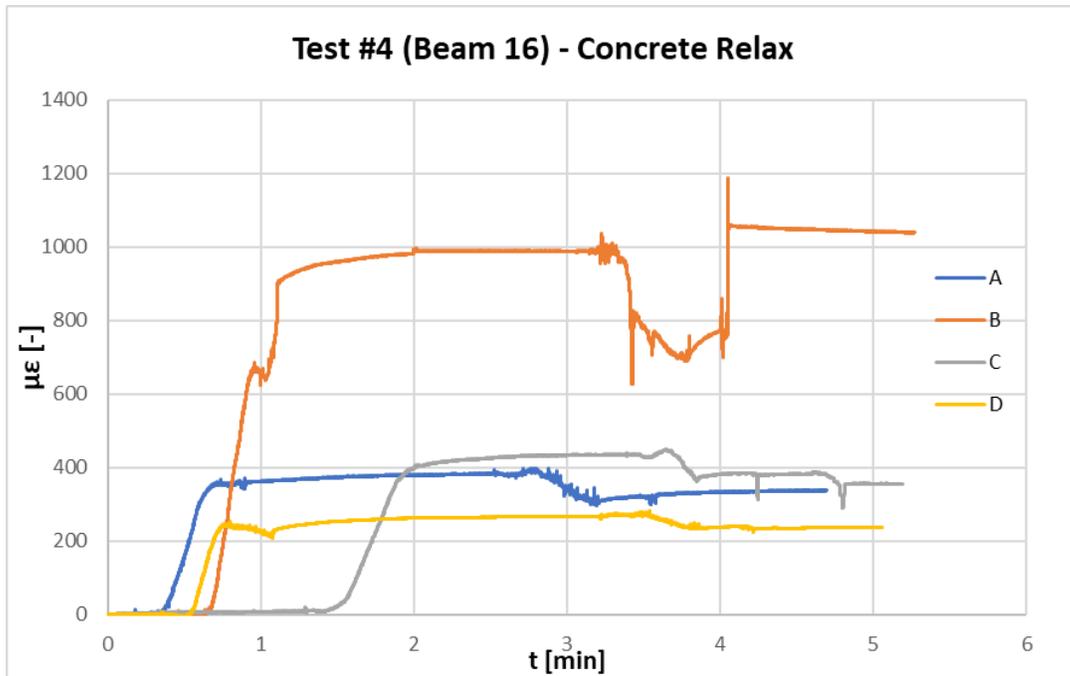
Figure 44. Concrete relax test measured strains on tested beam #4.

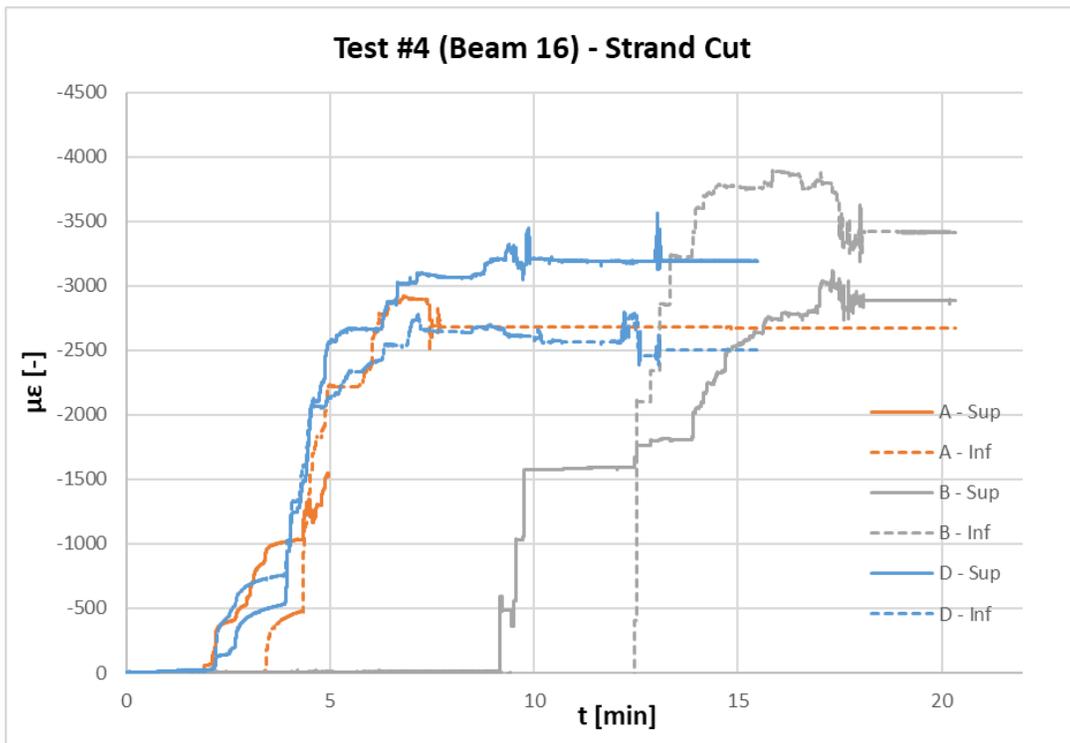
Figure 45. Strand cutting test measured strains on tested beam #4.

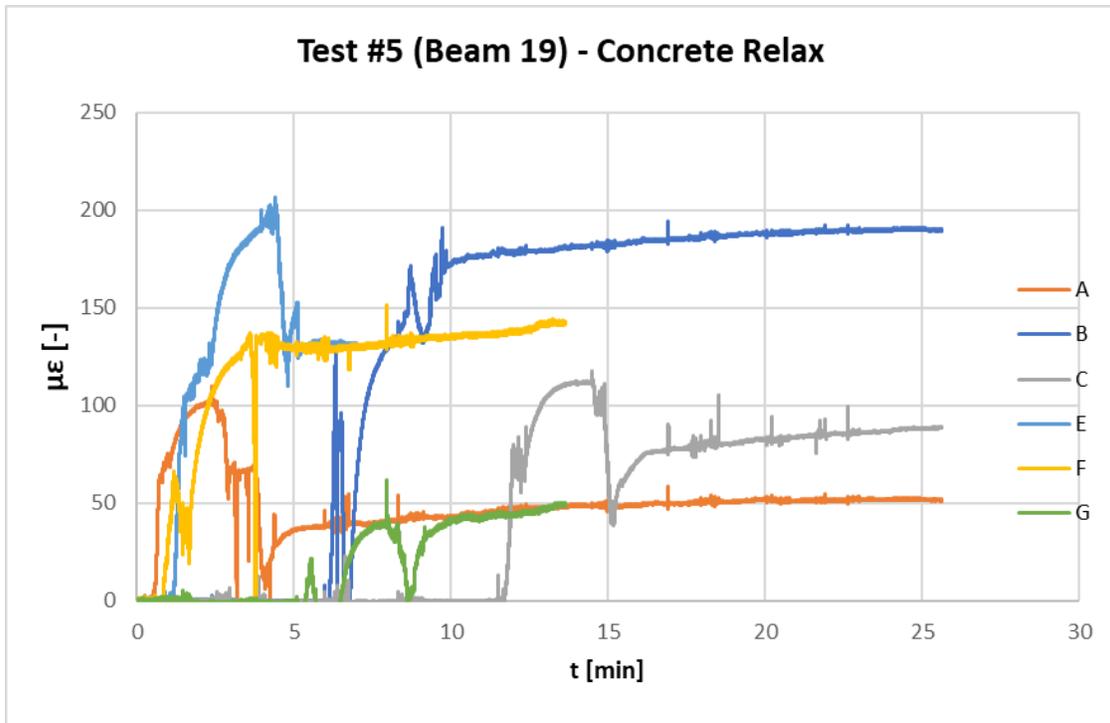
Figure 46. Concrete relax test measured strains on tested beam #5.

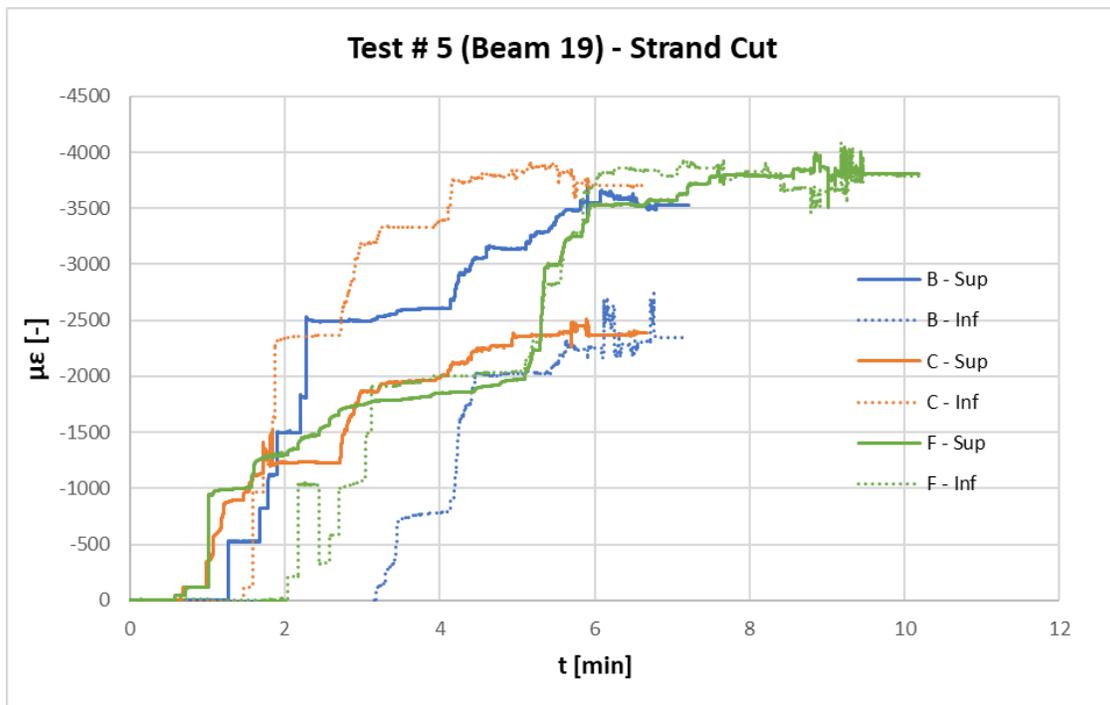
Figure 47. Strand cutting test measured strains on tested beam #5.

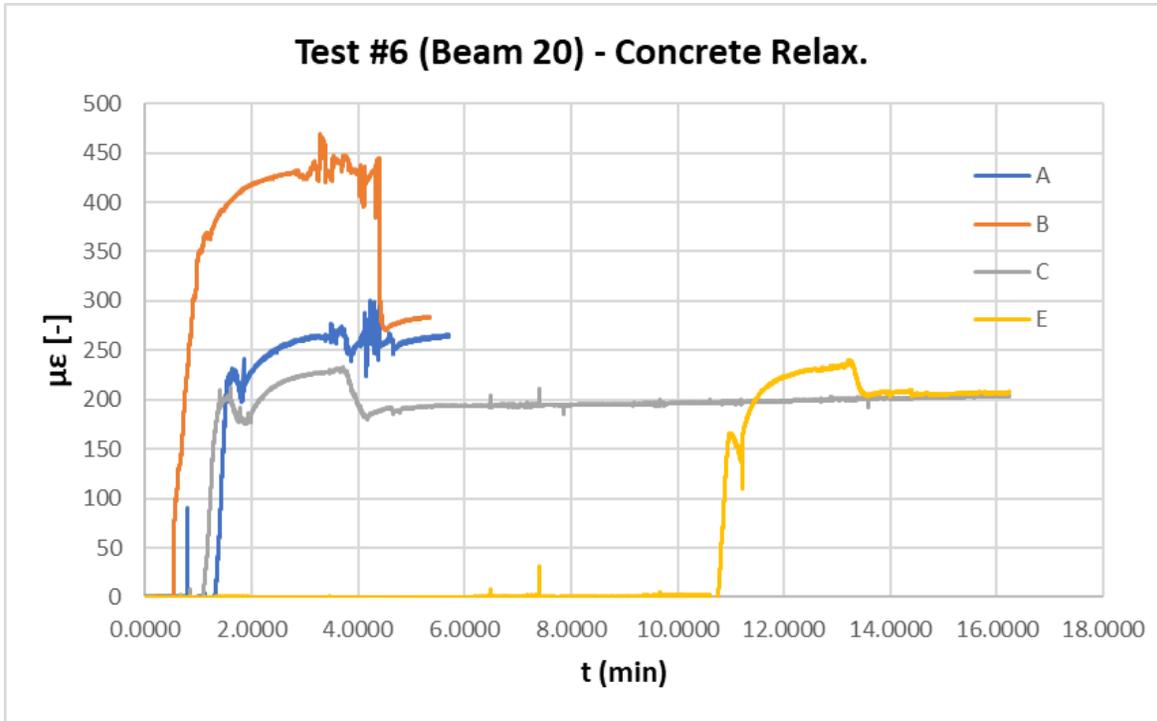
Figure 48. Concrete relax test measured strains, tested beam #6.
