THE HOUSE OF ZARUMA

KNOWING A CONSTRUCTION SYSTEM IN ITS 'GOLDEN' AGE

POLITECNICO DI TORINO
Master's degree program in
ARCHITECTURE HERITAGE PRESERVATION AND ENHANCEMENT

2023

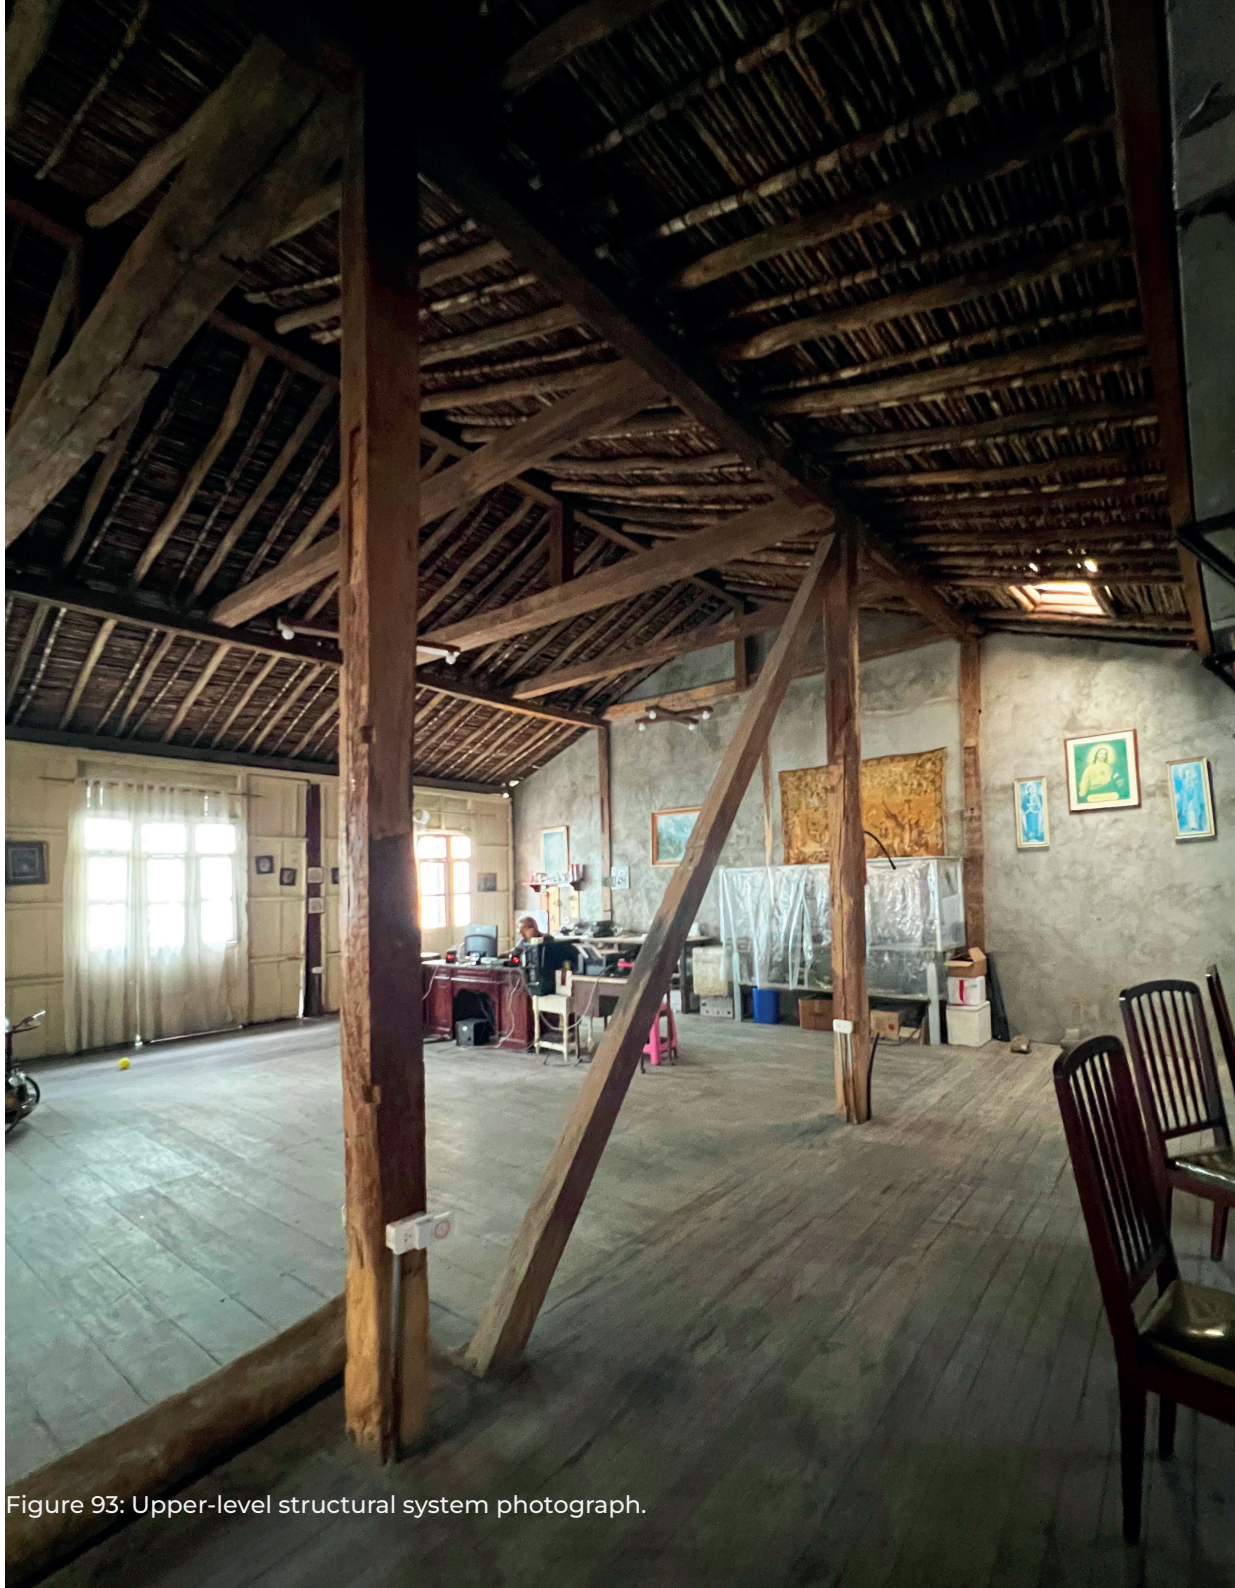
Figure 93: Upper-level structural system photograph.

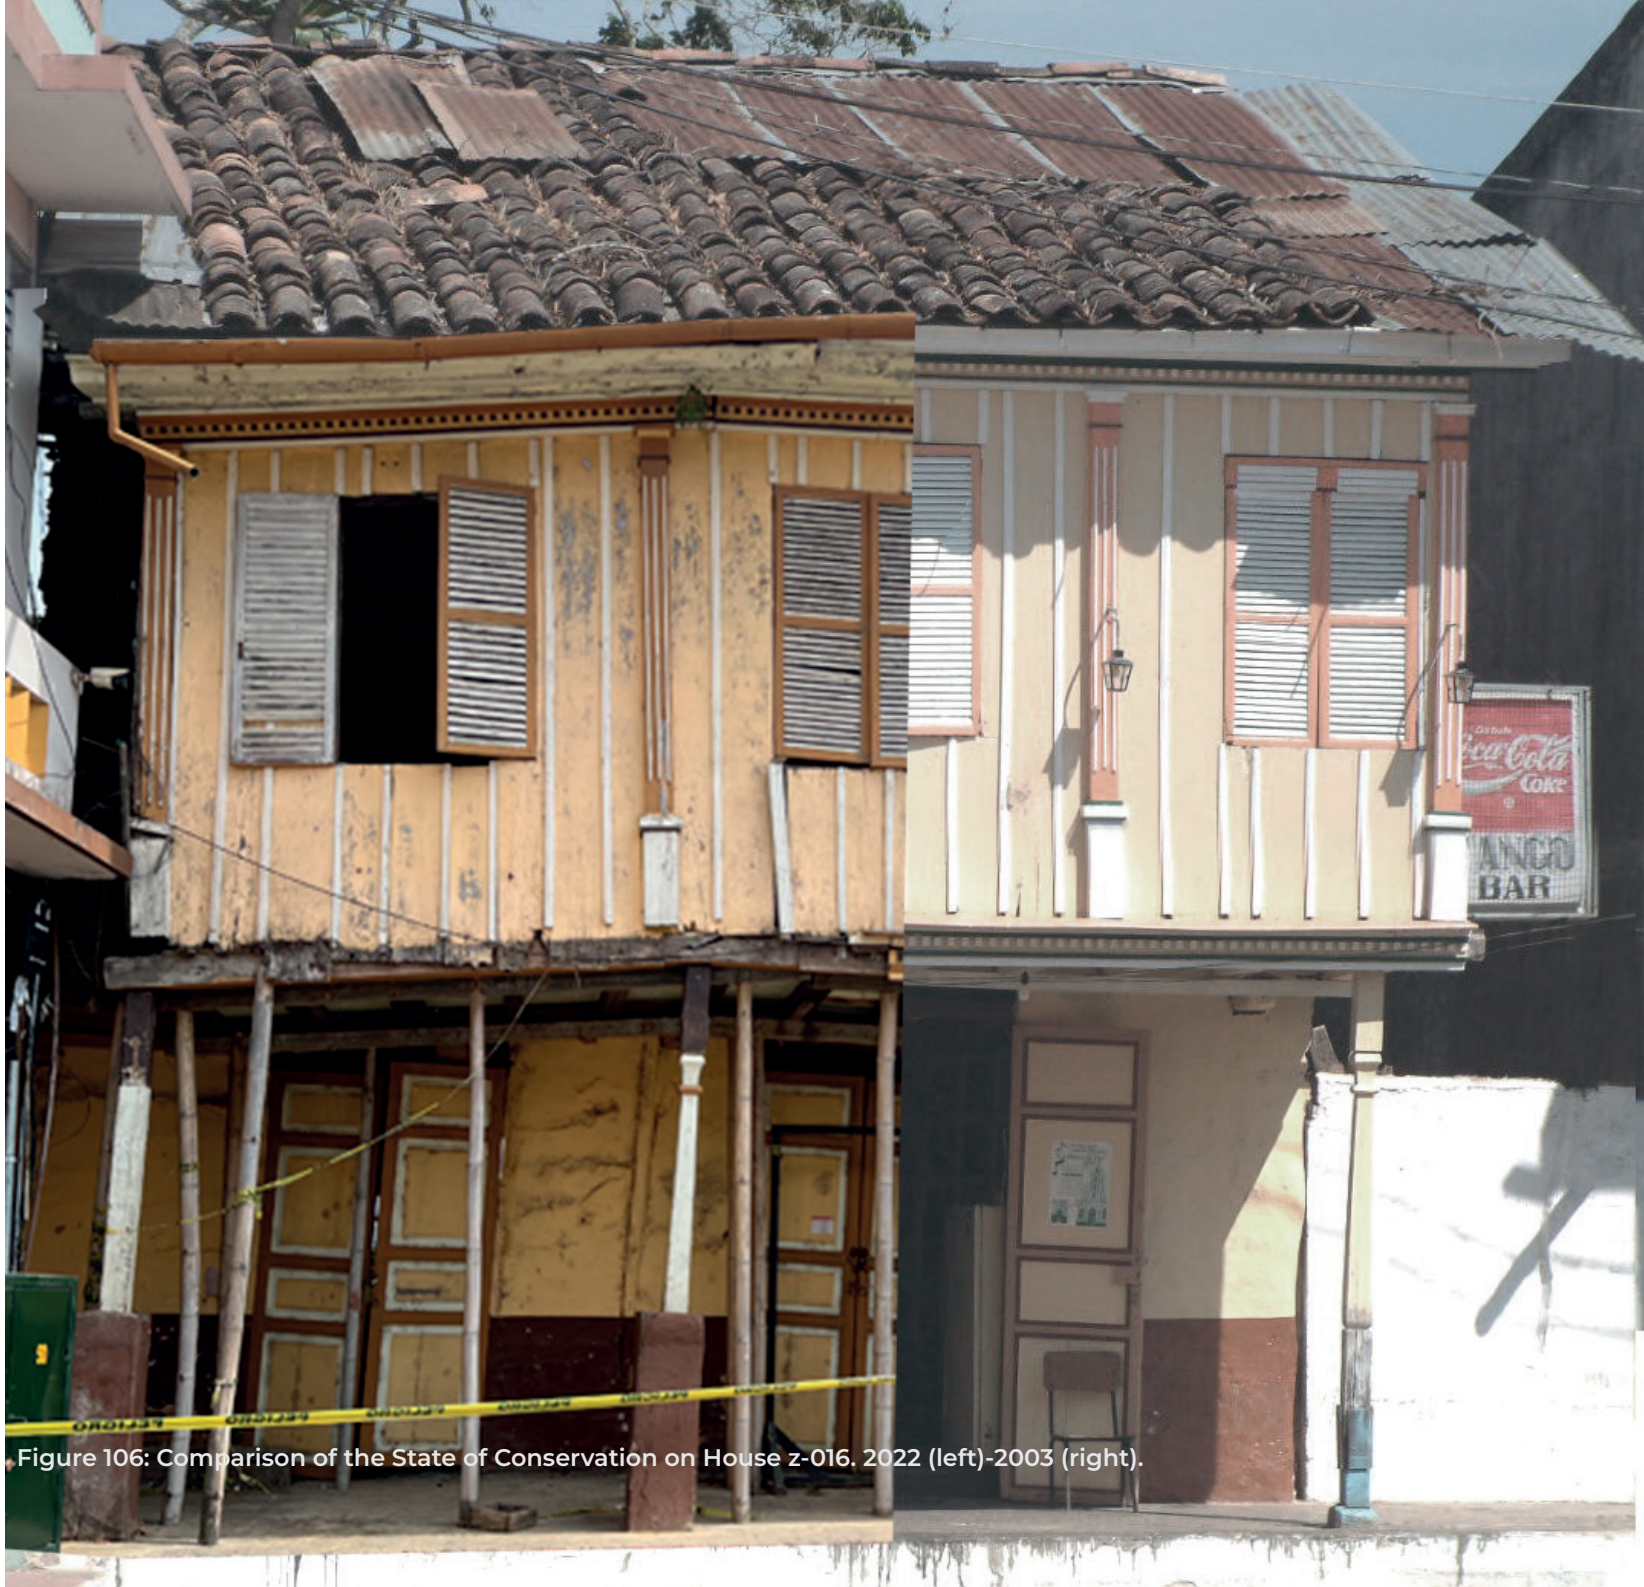
Figure 106: Comparison of the State of Conservation on House z-016. 2022 (left)-2003 (right).

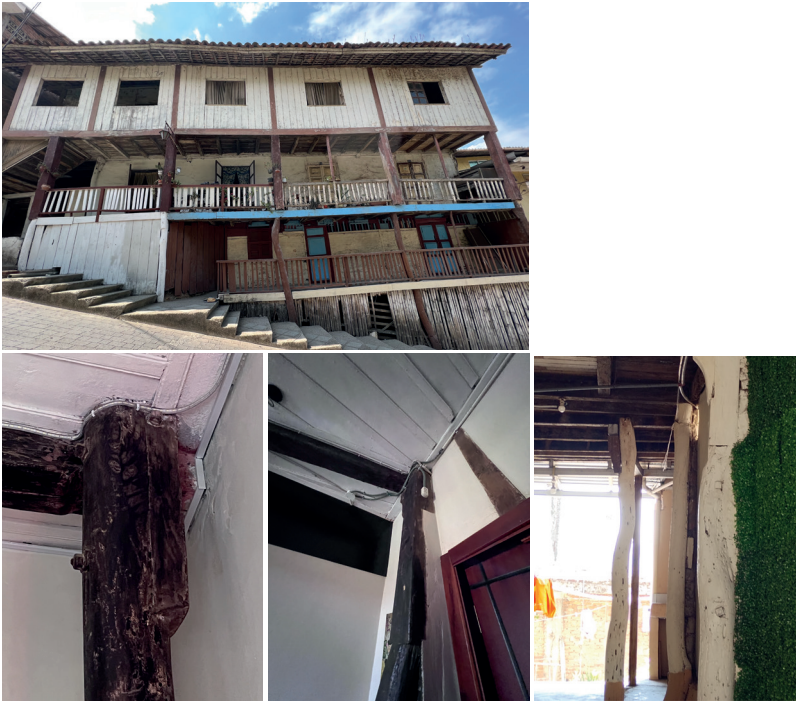
Figure 115: Structural Layout Decay- Warping of vertical elements.

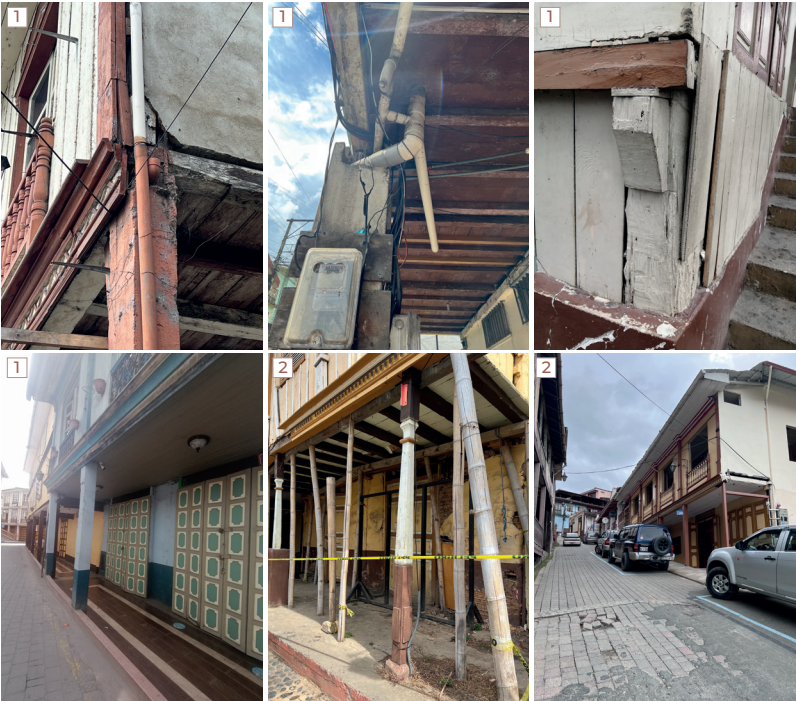
Figure 116: Structural Layout Decay-Replacement of original technique.

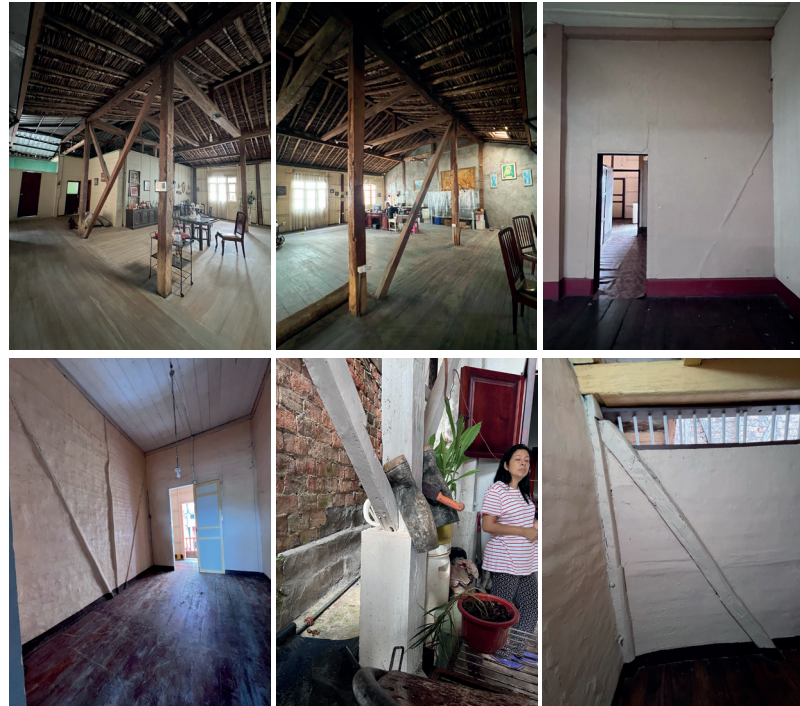
③ DISTRIBUTION OF DIAGONALS

Irregular distribution of the diagonal braces.

Figure 117: Structural Layout Decay- Distribution of Diagonals.

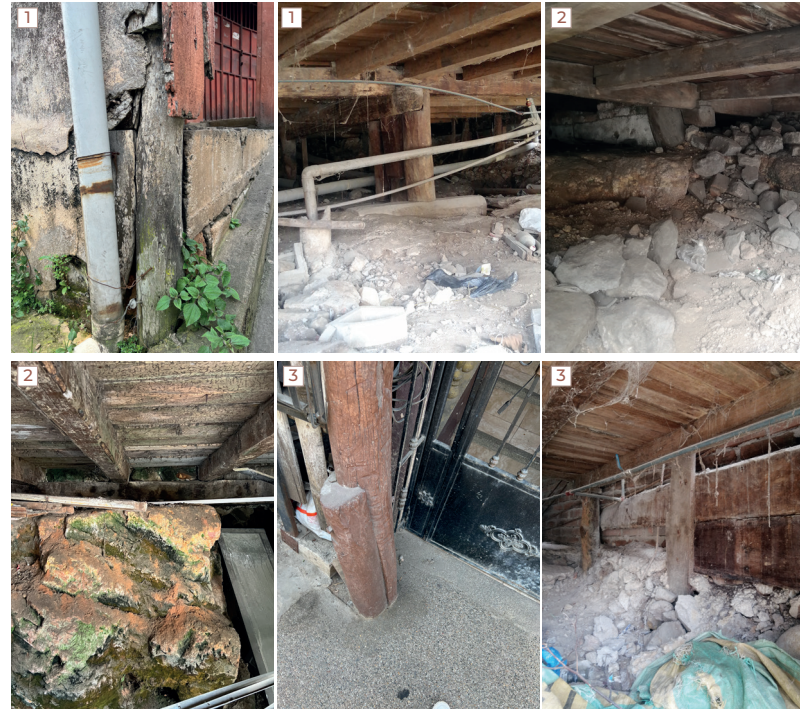
Figure 118: Structural Layout Decay- Foundations Defects.

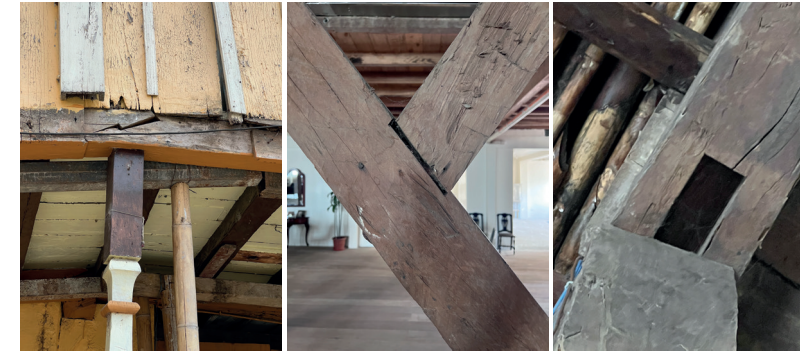
Figure 119: Connections & Elements Decay- Assembly Defects.

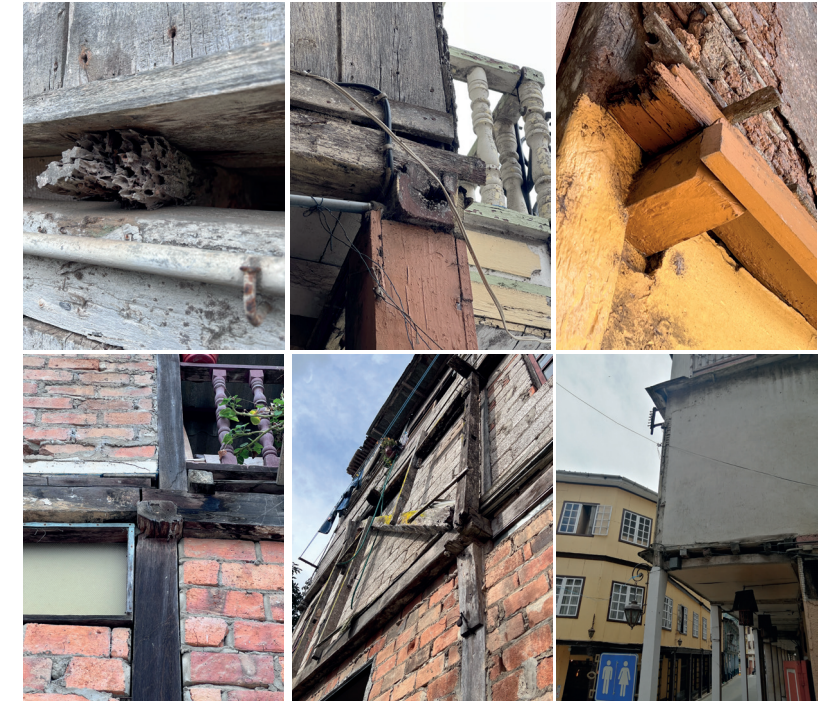
Figure 120: Connections & Elements Decay- Exposed Elements.

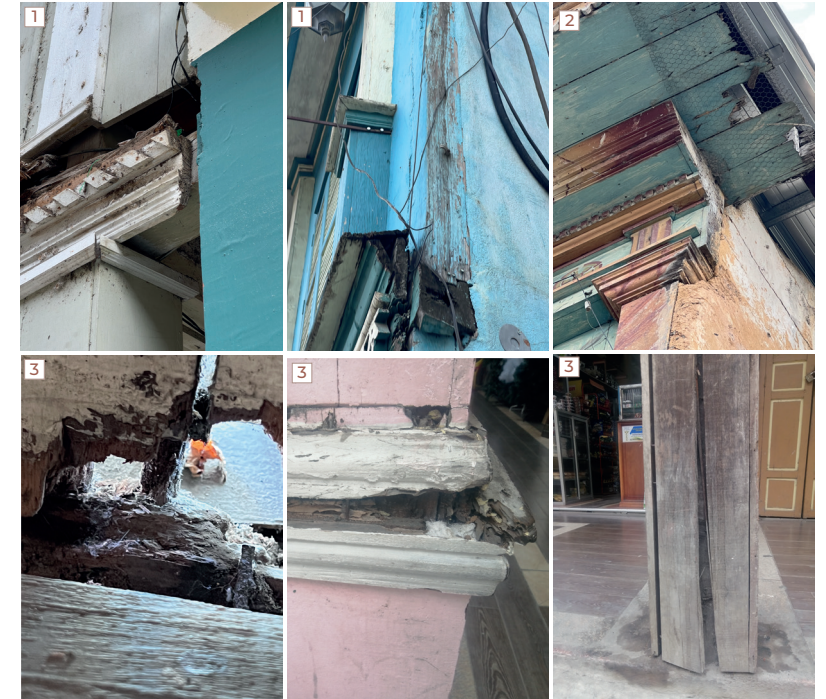
Figure 121: Connections & Elements Decay- Material Crumbling.

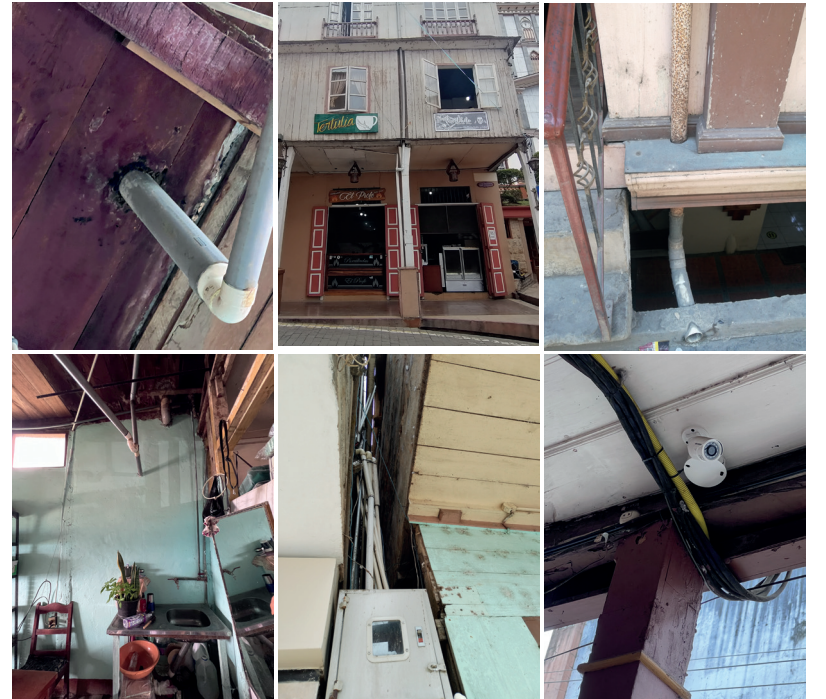
Figure 122: Connections & Elements Decay- Wall Elements and Decorations.

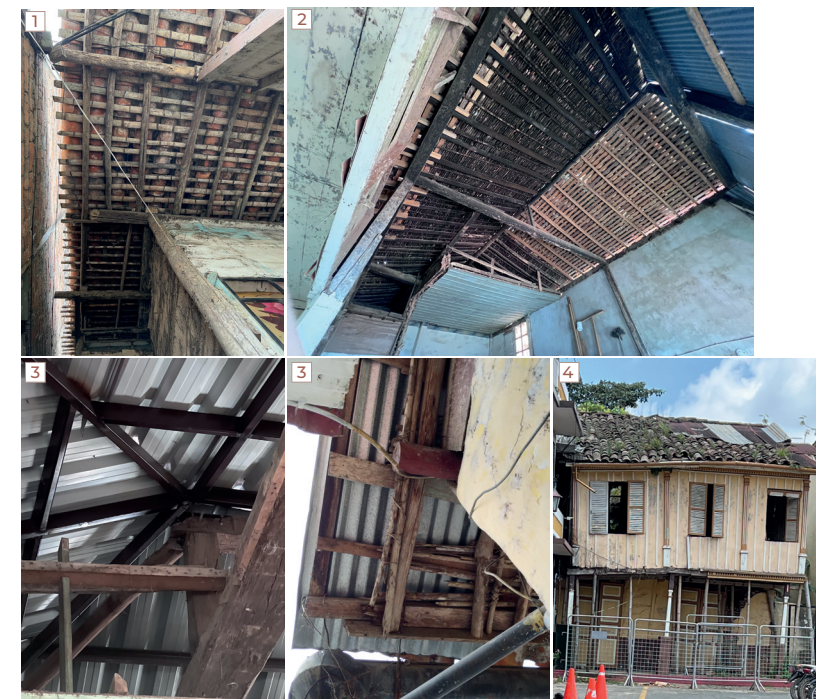
Figure 123: Connections & Elements Decay- Roof Elements.

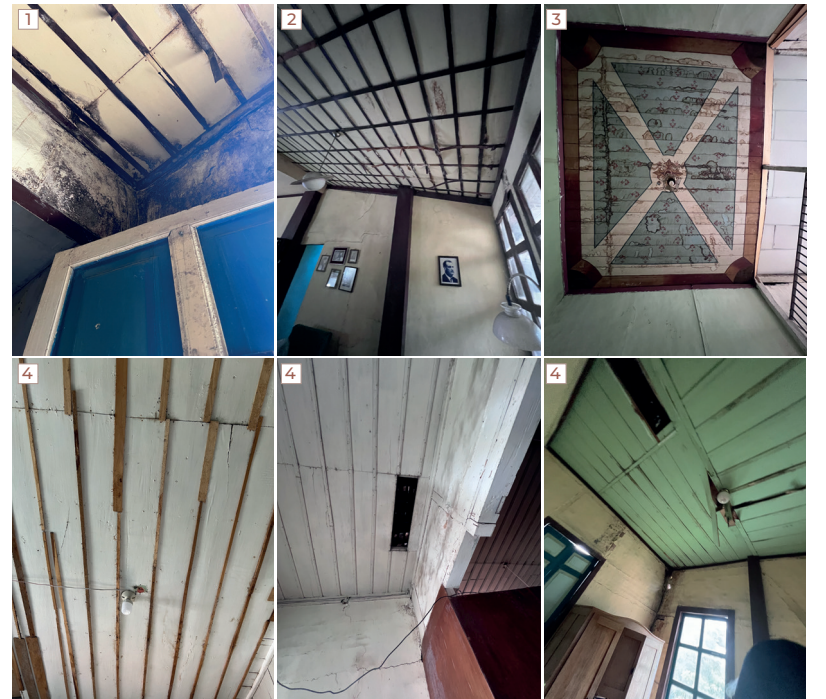
Figure 124: Connections & Elements Decay- Ceilings.

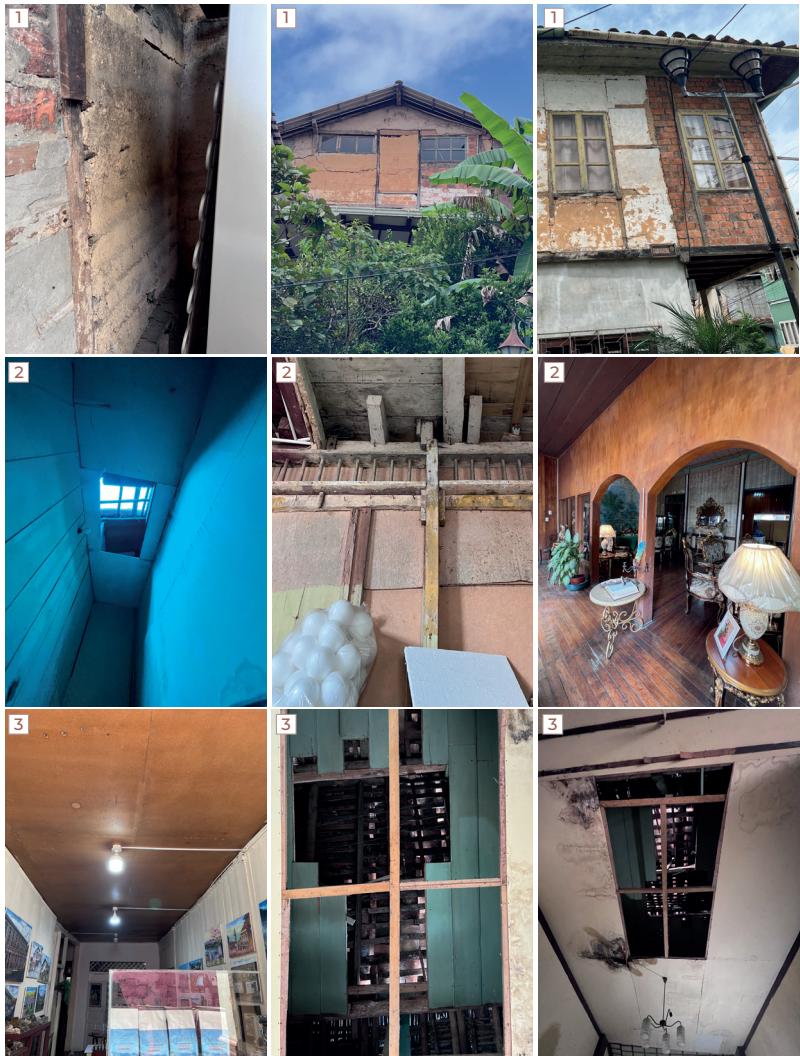
Figure 125: Connections & Elements Decay- Alteration of Original Material.

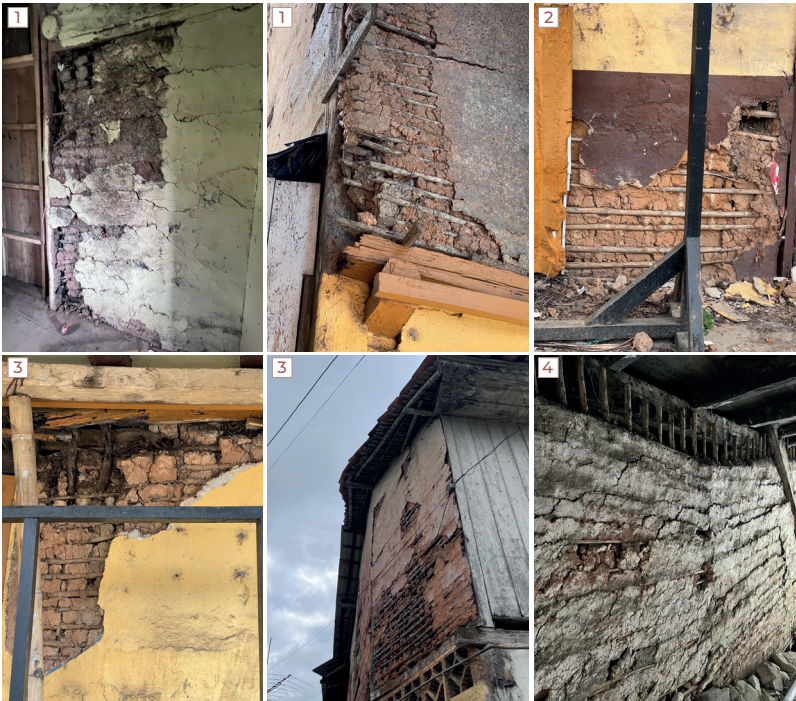
Figure 126: Connections & Elements Decay- Bahareque.

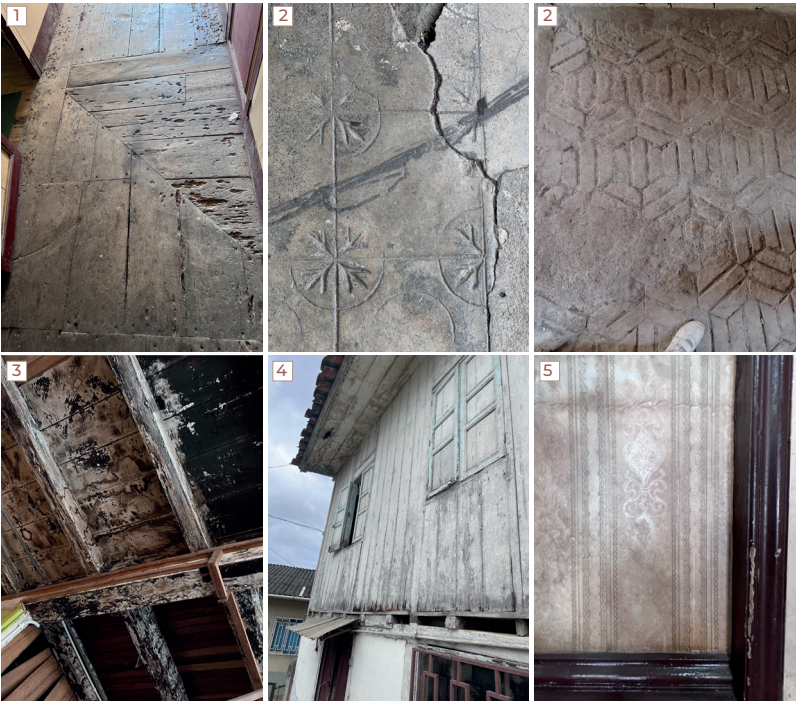
Figure 127: Connections & Elements Decay- Walls and Floors.

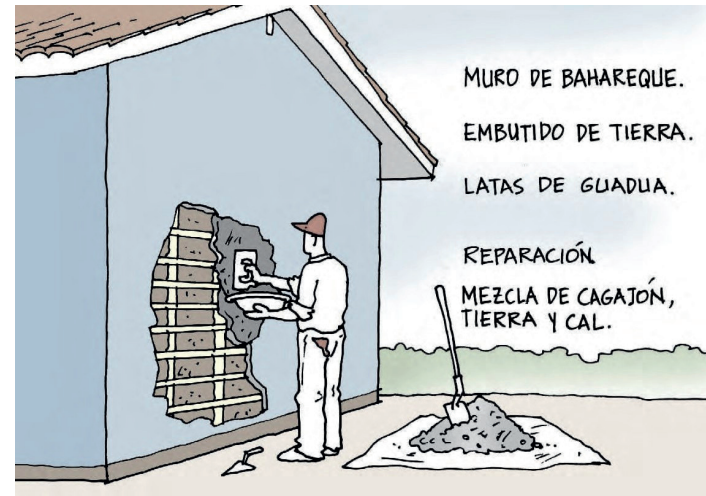
Figure 135: Repair of revoque (plaster) and empañetado (finish coat) (Asociación Colombiana de Ingeniería Sísmica, 2002)

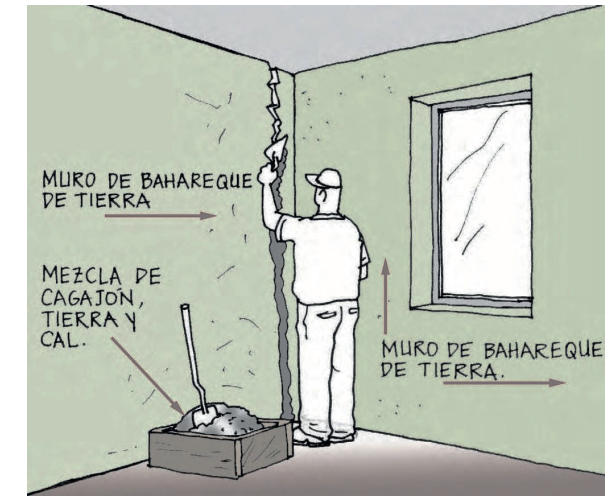
Figure 136: Repair of detachment between walls (Asociación Colombiana de Ingeniería Sísmica, 2002)

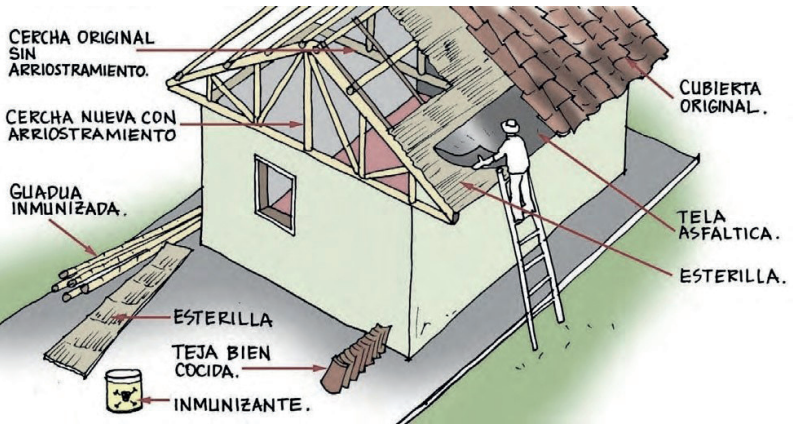
Figure 139: Improvement of partial collapse of the roof. (Asociación Colombiana de Ingeniería Sísmica, 2002)
