Integrating Hurricane Resilient Technologies into Creole Traditional Architecture. A Case Study in the Archipelago of San Andres, Providencia & Santa Catalina, Colombia.

POLITECNICO DI TORINO

MSc. degree program in Architecture for Sustainability

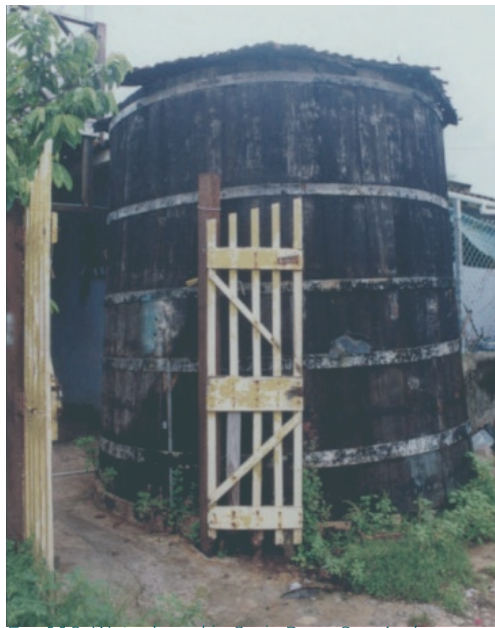
- Wooden barrel used as a water reservoir that was later replaced by the cement cistern for rainwater storage (Sánchez, 2022).

Fig. 113. Water barrel in Sarie Bay - San Andres.
Source: Sánchez, C., (2004).

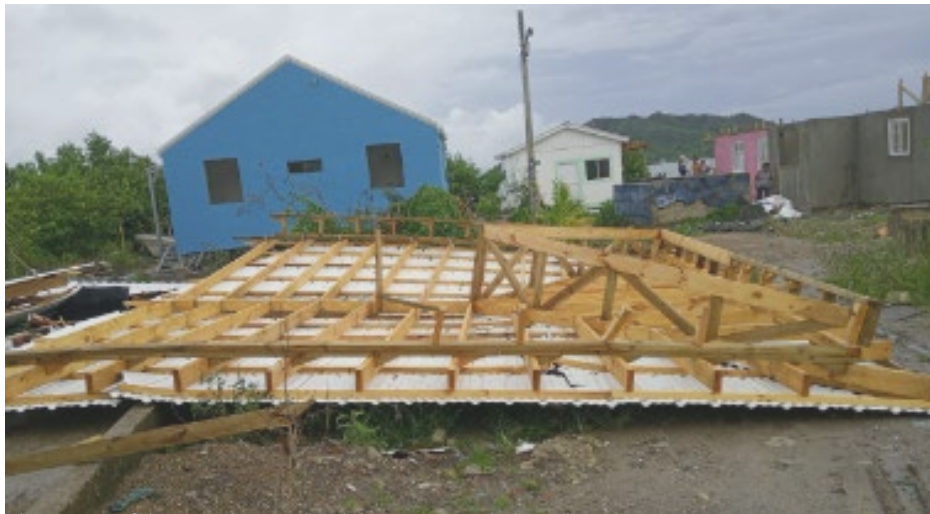
Fig. 168. Roof damage due to a hurricane. Source: Findeter, (2022).
