**POLITECNICO DI TORINO**

*Master's degree in Environmental and Land Engineering  
Geo-Engineering*

**Securing and monitoring of tourist routes**  
The case of Chianocco Gorge

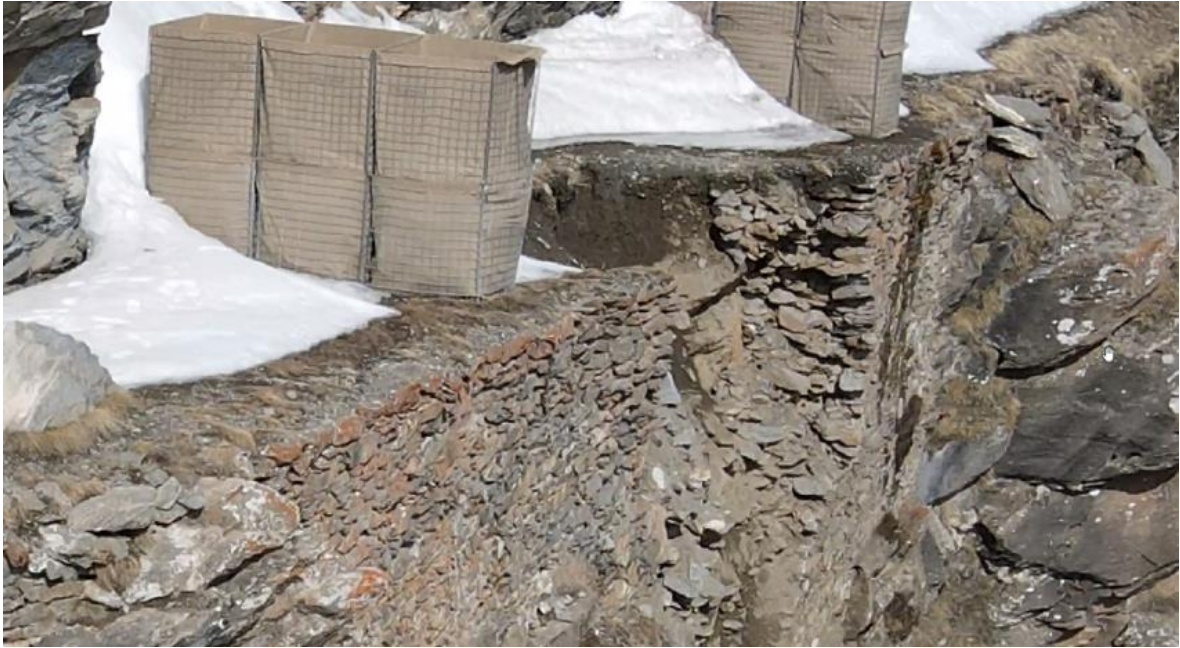
*Figure 17 - Detail of big bags. In this image, the collapsed section of the wall is clearly visible (courtesy of Casale M.).*

The subsequent figures present various details of the site. *Figures 14, 15, 16, 17* highlight the presence of different big bags strategically placed to deter cyclists from progressing into areas where the route poses heightened risks. In *figure 16*, a bird's-eye view of the trail during winter is depicted. *Figure 17* illustrates a detail of the void created by the collapsed section of the wall.

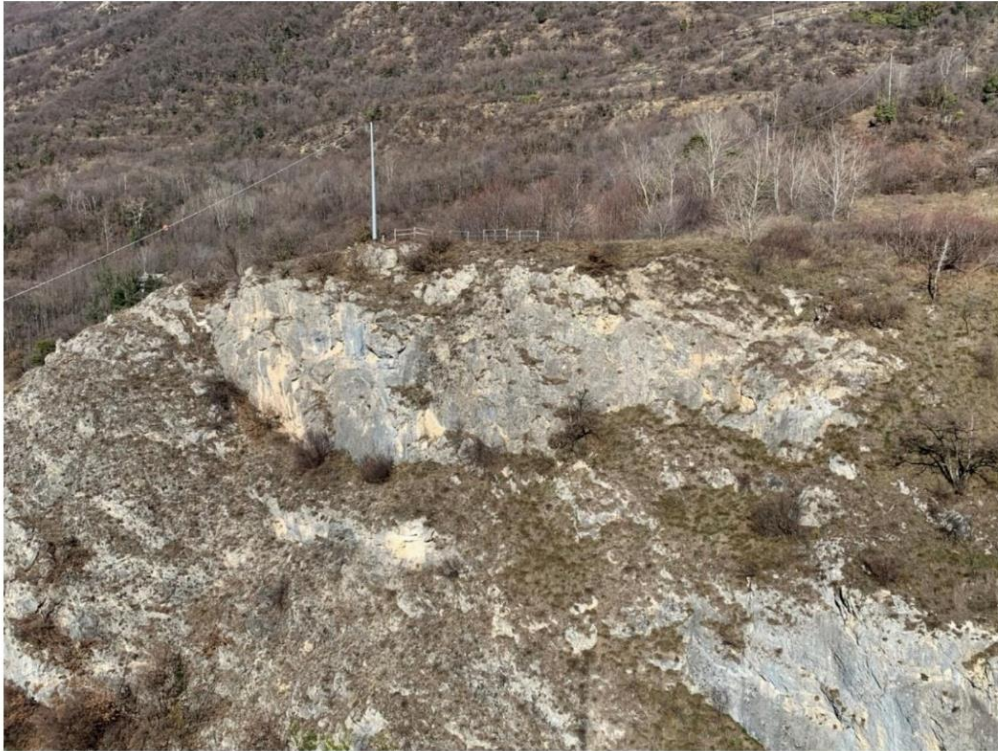
*Figure 24 - Overall recovery of the wall in the hydrographic right (blocks L, M, U, V).*

Specifically, on the wall to the hydrographic right are blocks marked **L**, **M**, **U** and **V**. An overall view of these blocks is in *figure 24* and, in *figure 25*, with a closer view.

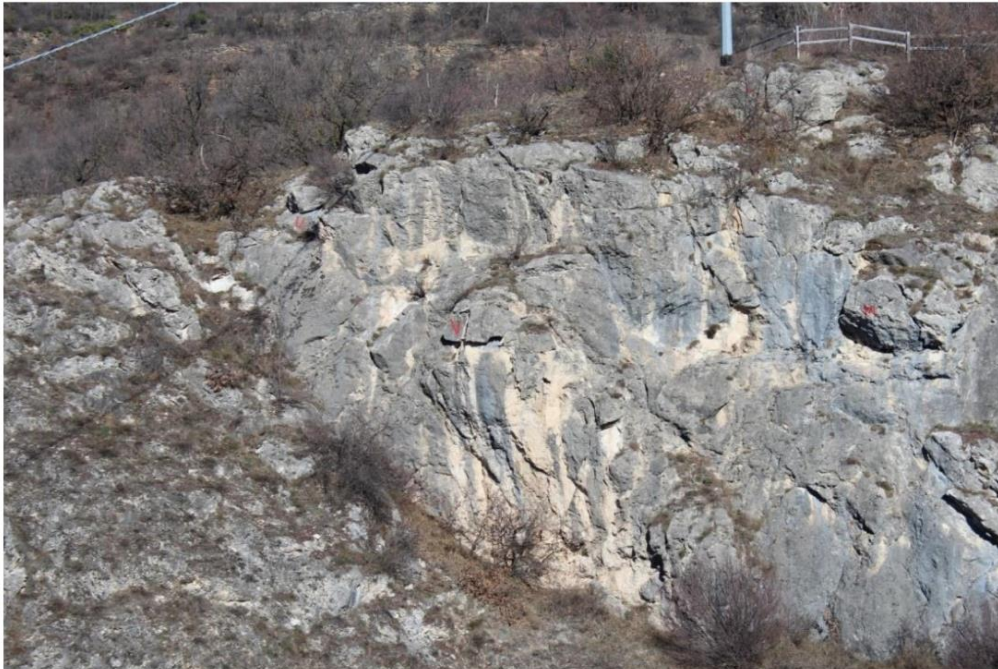
*Figure 25 - Detail of the wall in the hydrographic right (blocks L, M, U, V).*

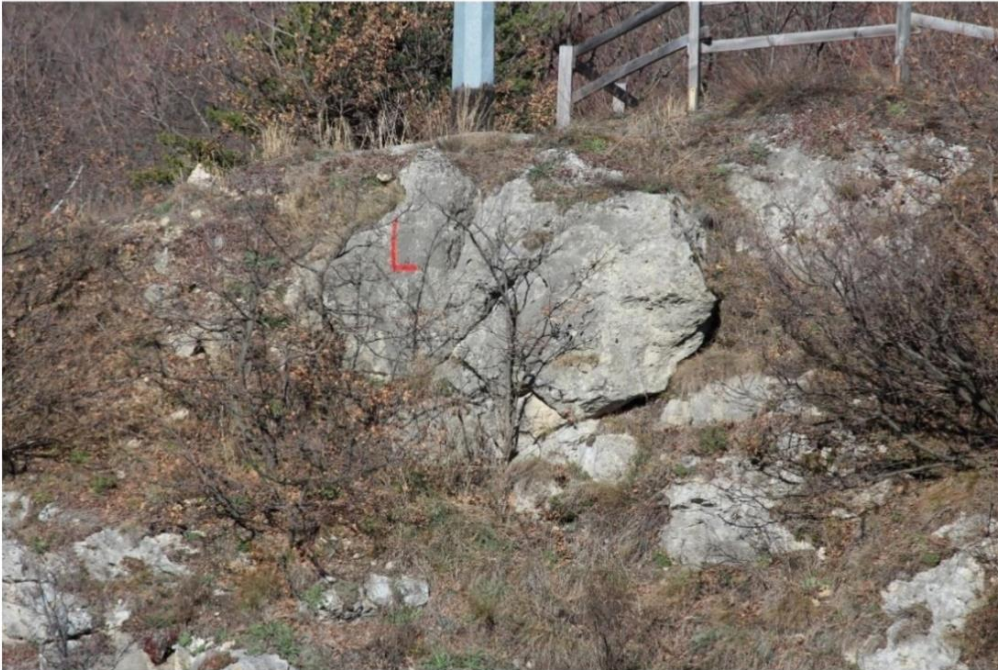
*Figure 26 - Detail of block L.*

In the following photographic shots, individual unstable blocks along this wall are shown in greater detail (*figures 26, 27, 28, 29*).

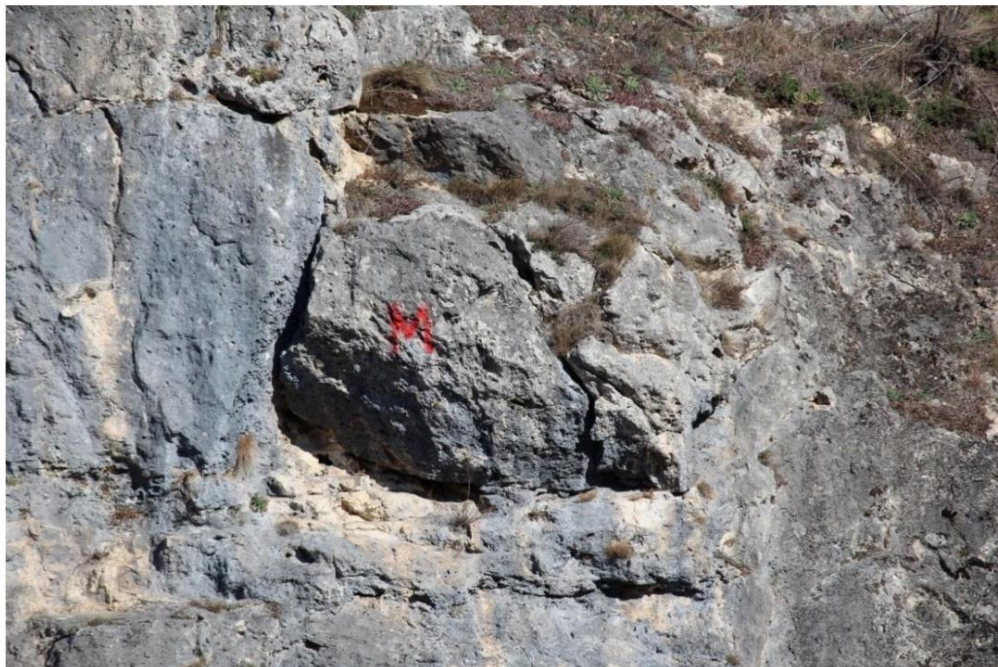
*Figure 27 - Detail of block M.*

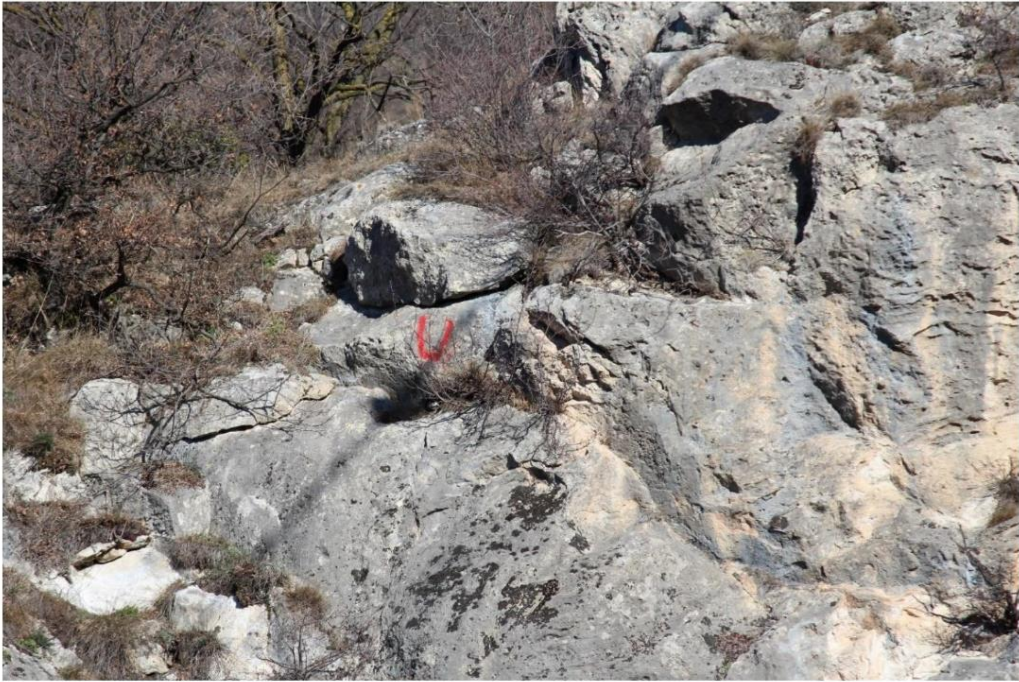
*Figure 28 - Detail of block U.*

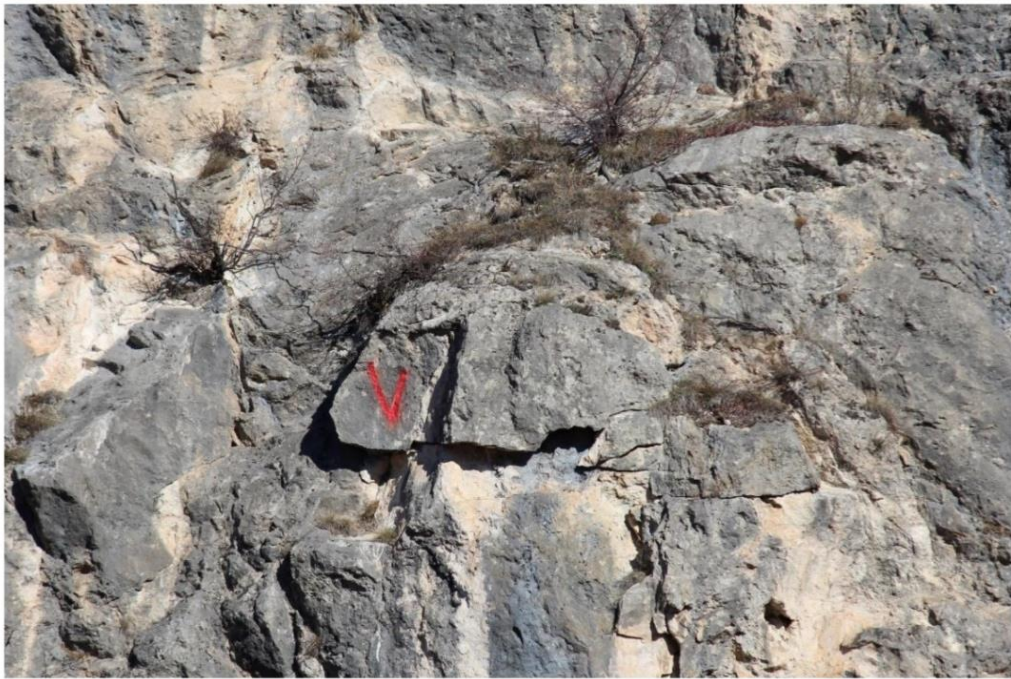
*Figure 29 - Detail of block V.*

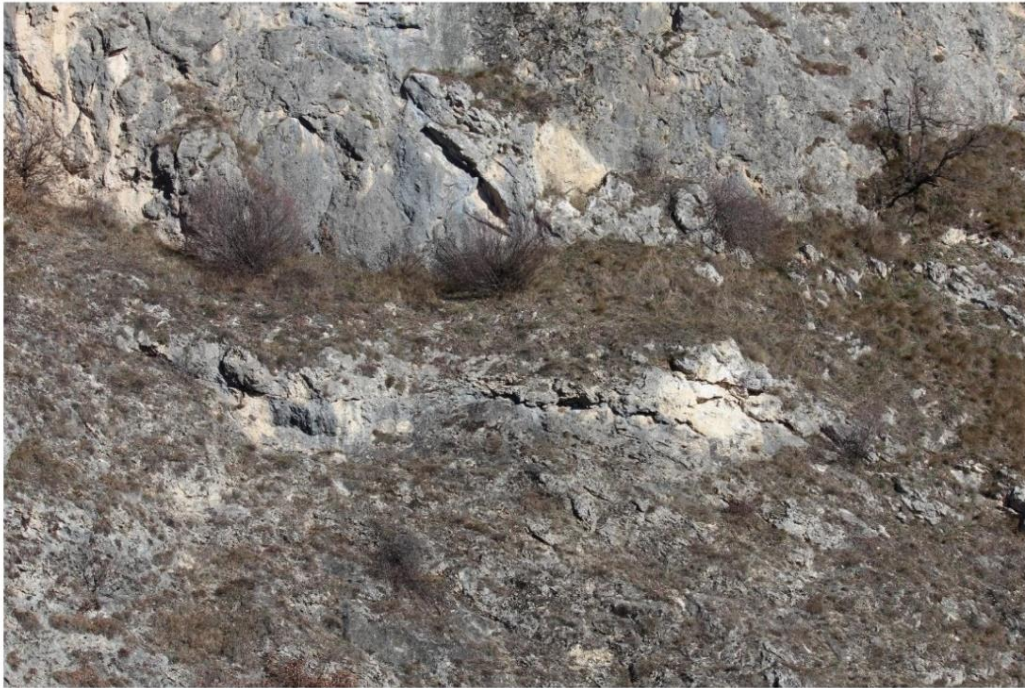
*Figure 30 - Wall in the hydrographic right where the detachment niches of some previously monitored blocks are visible (N, O, P, Q).*

Also, on the same wall, downstream of the gorge, detachment niches can still be recognized, which are related to some previously monitored blocks, named with the letters **N**, **O**, **P** and **Q** (*figure 30*). These detachment niches indicate how the area is prone to rockfall and how preventive action is therefore fundamental to avoid damage. It is no coincidence that, when evaluating the risk of a landslide, conducting a thorough study of previous perilous occurrences at the same site is very important.

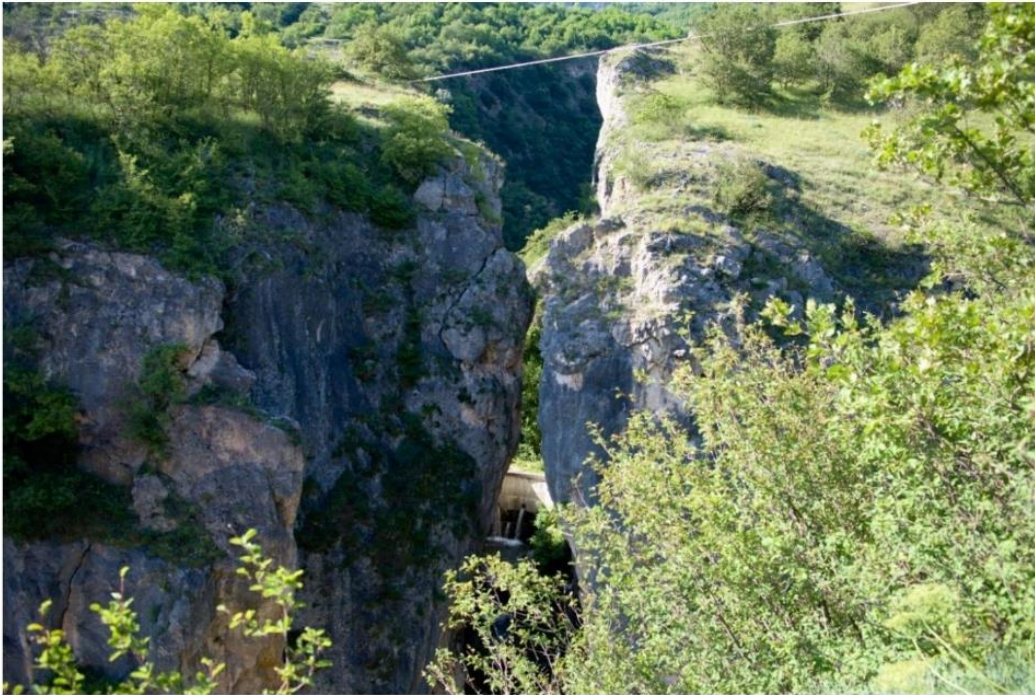
*Figure 32 - More detailed view of the top of the "Pillar" and "Hat".*

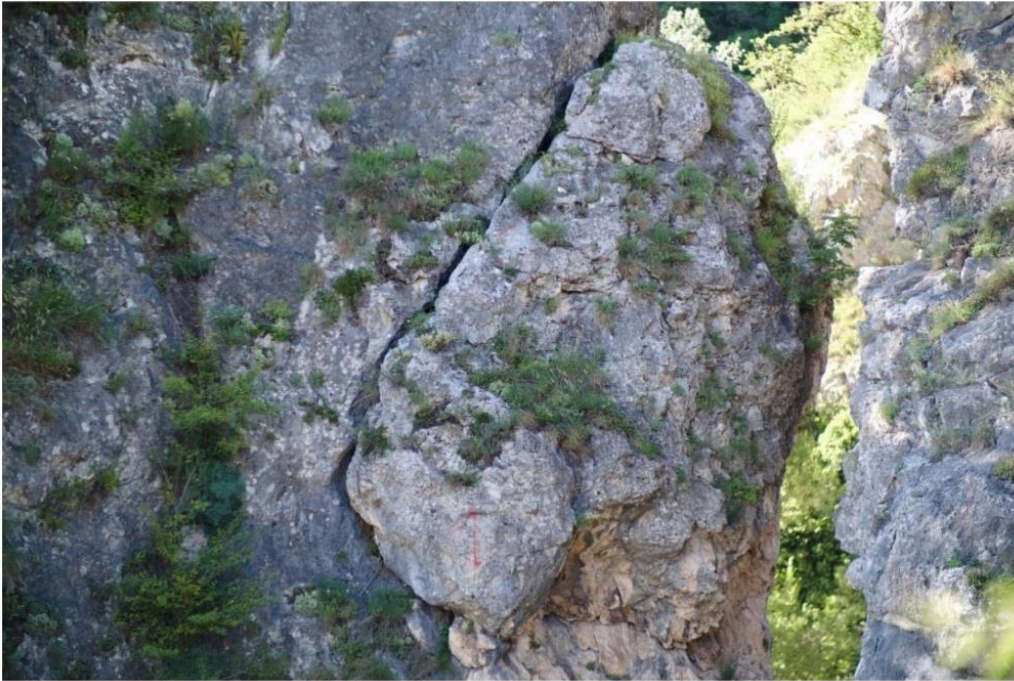
*Figure 34 - Close-up of the "Hat".*

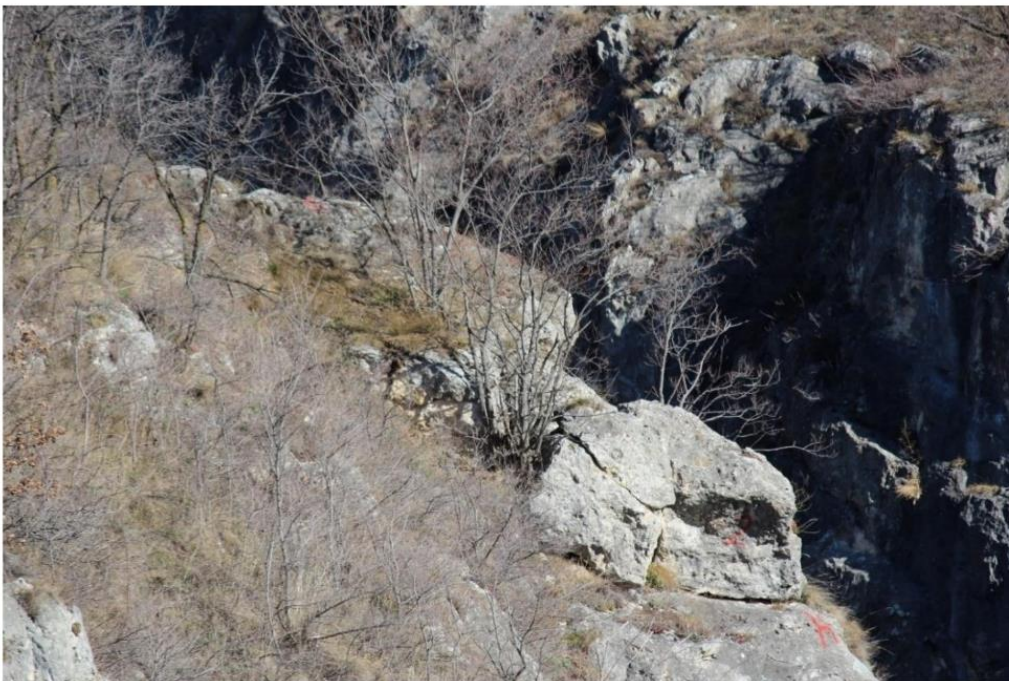
*Figure 41 - Detail of blocks H and 2.*

Going down to the details of the “pillar” and “cap” sector, blocks marked **H, 2** (figures 41, 42, 43) and **E** (figure 44) were identified.

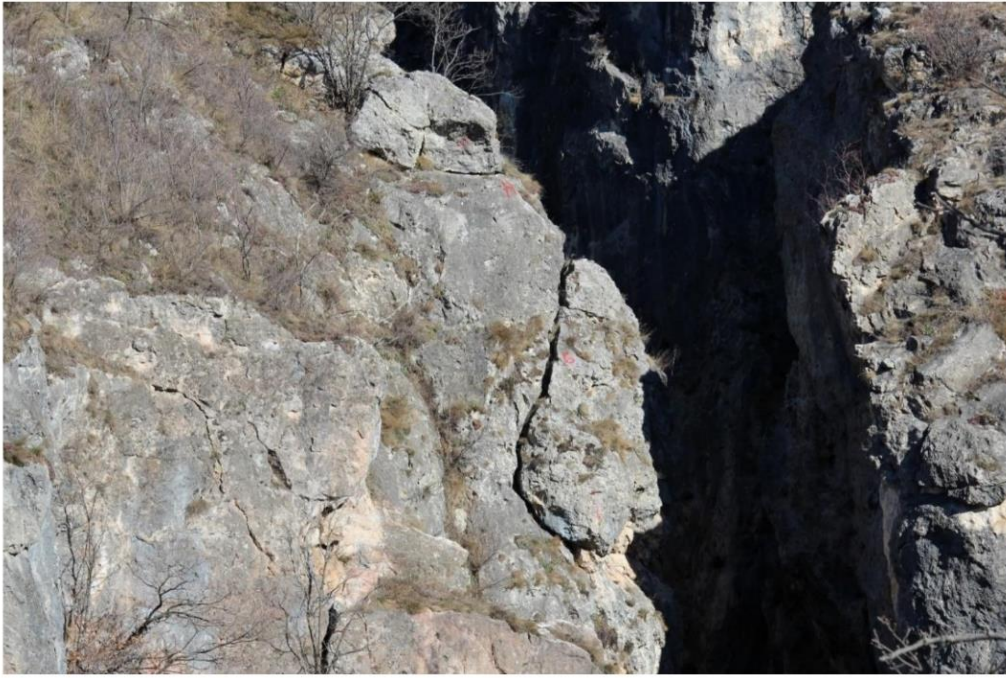
*Figure 42 – “Hat” detail and blocks H and 2.*

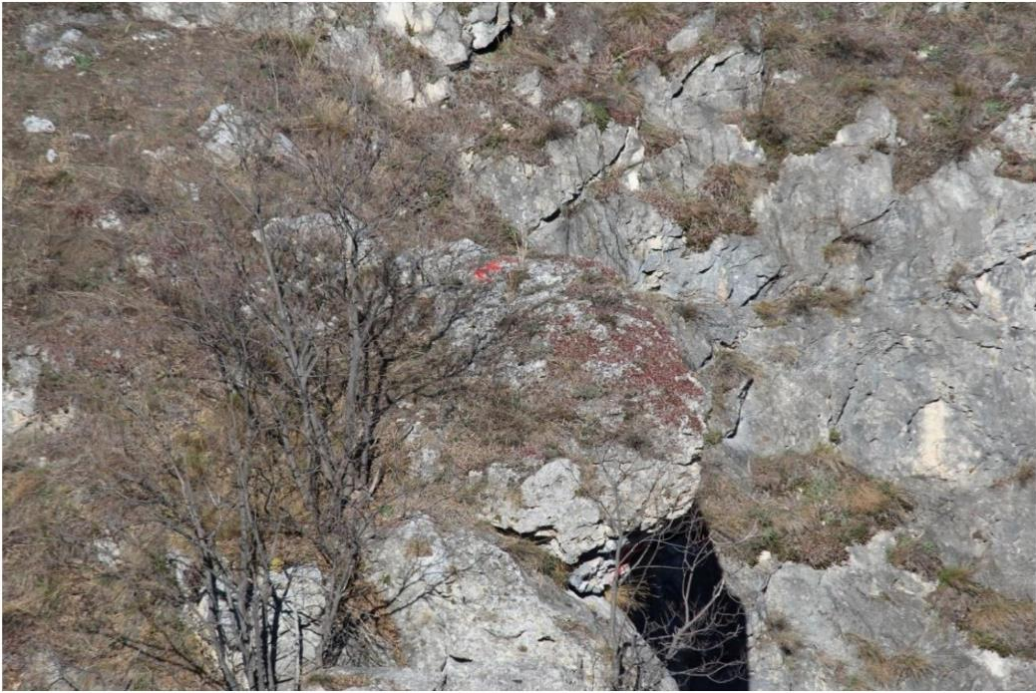
*Figure 44 - Block E.*

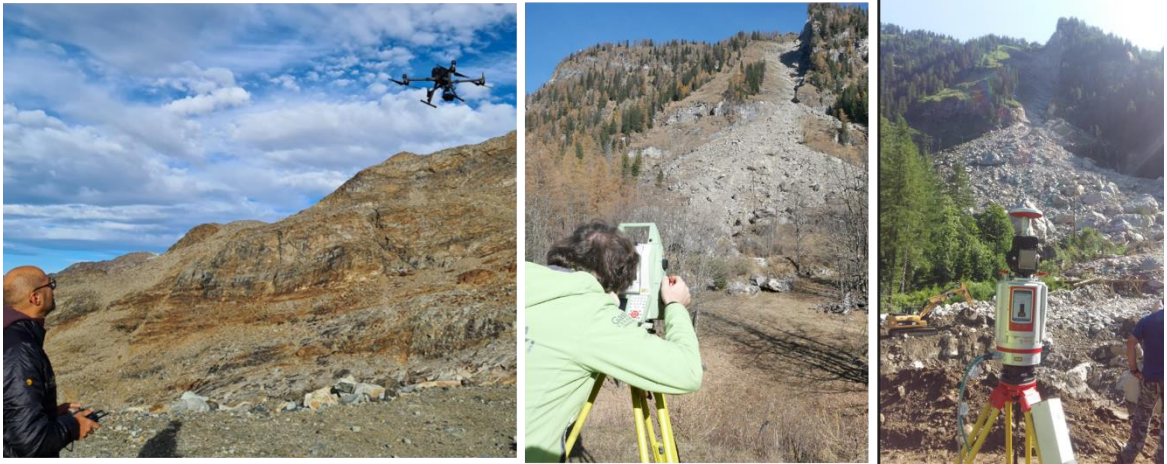
Figure 45 - a) Drone photogrammetry; b) total station; c) LiDAR (courtesy of Maschio P. and Cina A.).

coordinates of both artificial and natural features by emitting light pulses toward the ground and recording the reflected radiation. The result is a three-dimensional point cloud representing the specified area.

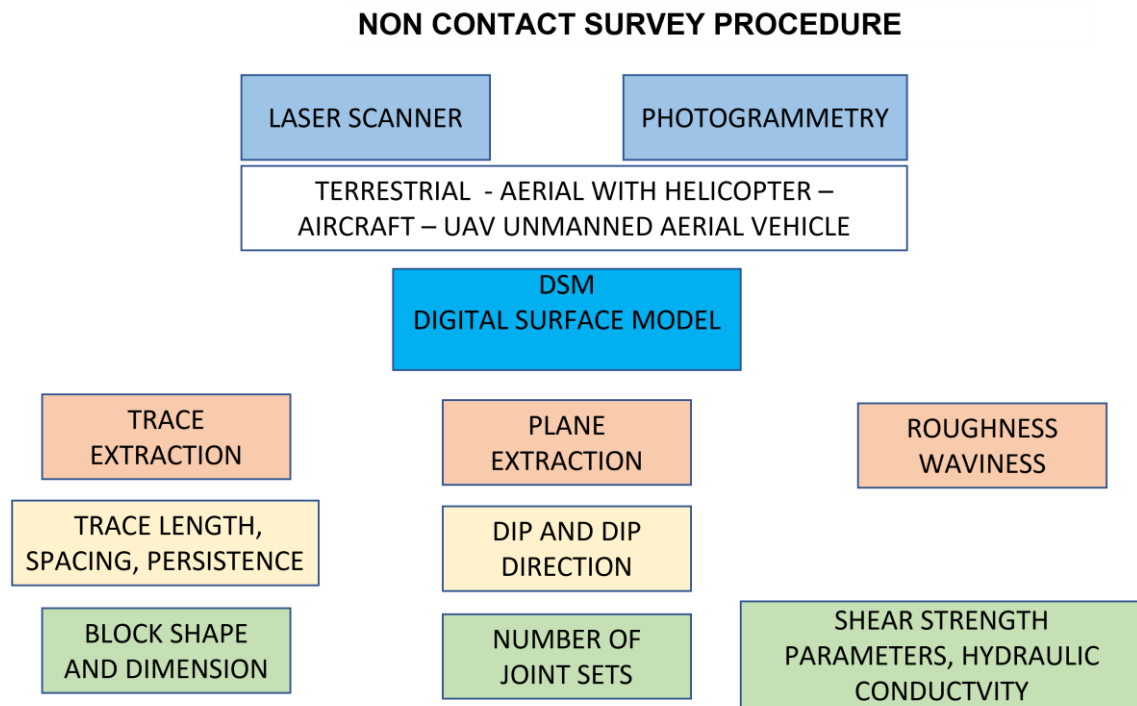
Figure 47 - Overview on non-contact survey procedure.

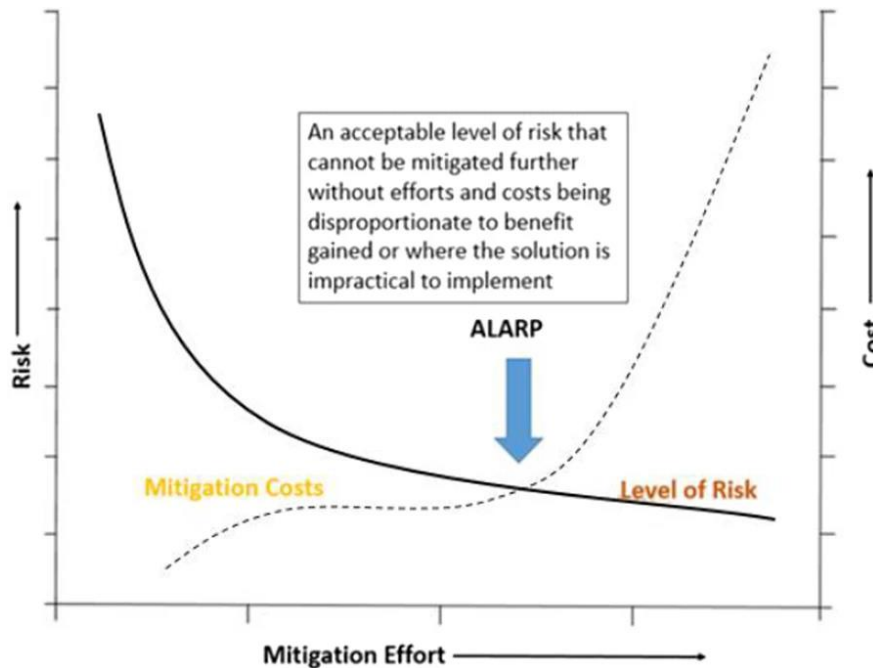
Figure 58 - Graph of ALARP principle for risk evaluation (Campbell et al., 2016; quoted by Sim et al., 2022).

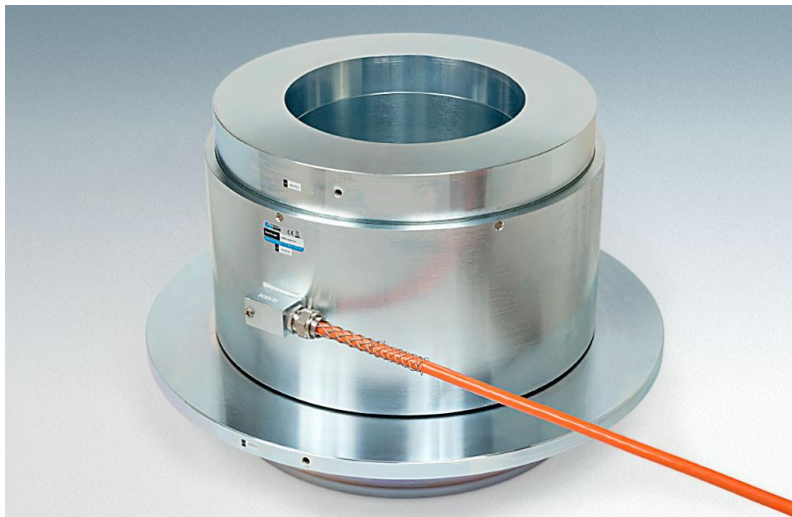
*Figure 65 - An example of 1500 Ton Load Cells (VW) (from GEOKON).*

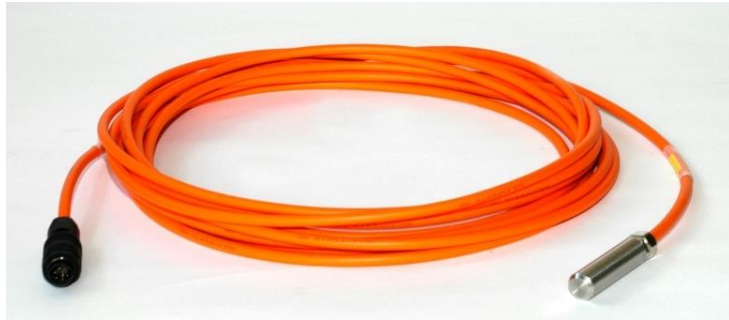
*Figure 66 – Example of pressurized water-tight encapsulated sensors employed for measuring temperature in the ground, rock, or on the structure (from SOLEXPERTS).*

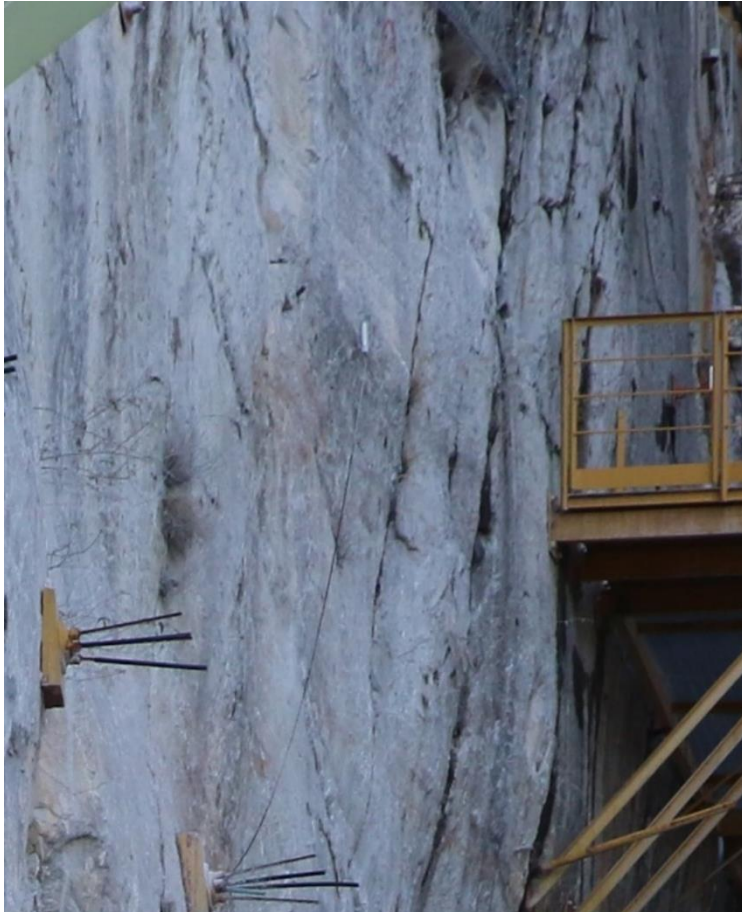
*Figure 67 - Tiltmeter in vertical wall in underground marble quarry (Oggeri).*

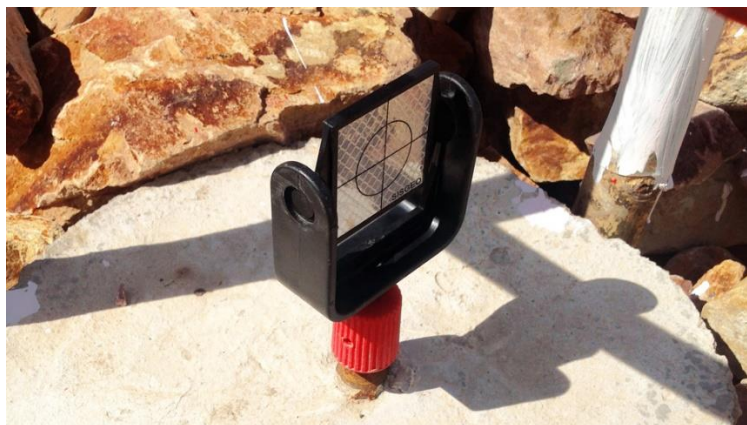
*Figure 68 - A topographic target mounted on a rock mass (from SISGEO).*

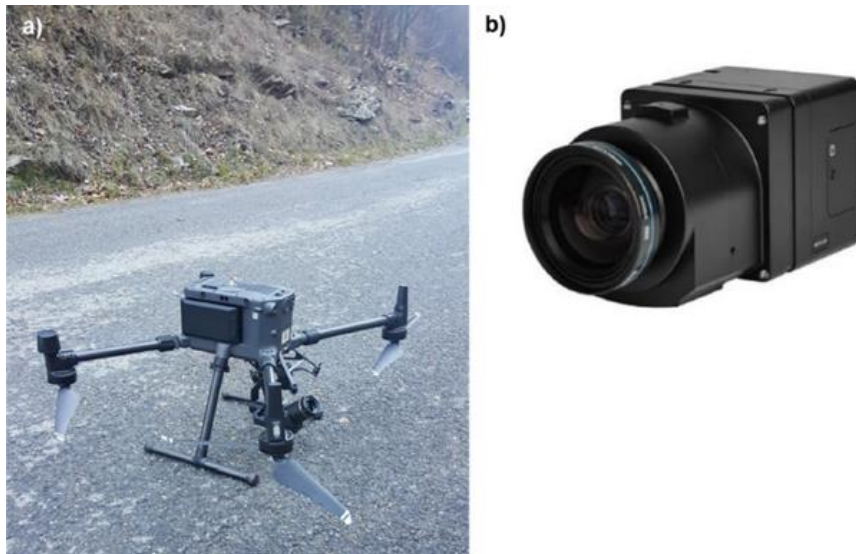
*Figure 71 - Drone and camera utilized for aerial photogrammetry survey (courtesy of Maschio P.).*
