Analysis of the structural and architectural damages and hypothesis of reinforcement of the church S.Bernardino in Saluzzo, Italy

by Gianaria Chiara

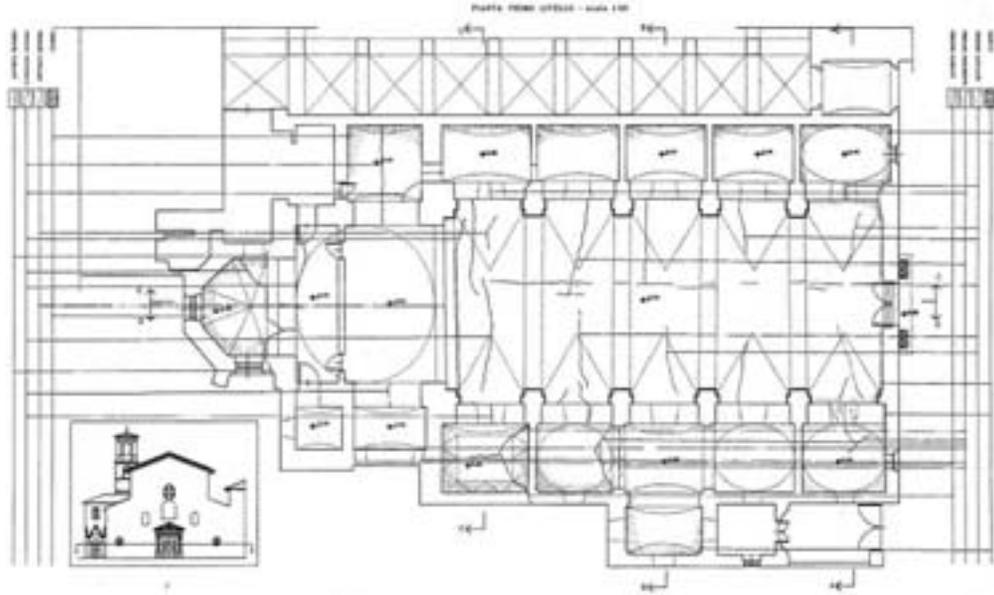
THE EXACT MEASUREMENTS OF THE ARCHITECTONICAL AND STRUCTURAL DAMAGES

The barrel vaults of the five spans which make up the central nave and particularly the last two spans against the presbitero, have some advanced cracks in key, perpendicular to their directrix, whereas some capillary cracks are found parallel to the same directrix still corresponding to the keystone

The walls present advanced and capillary cracks having mostly vertical and 45° direction on both sides of the central nave.

The first two side chapels ,both on northern and on southern sides, present only some capillary cracks of small sizes; the third chapel on the northern side, besides having a wide humidity situation, presents advanced cracks, particularly corresponding to the key and the directrix of the arch which divides this chapel from the next one.

The presbitero chapels present advanced cracks corresponding to the keystone parallel to the directrix of the same.

The apse is damaged by passing-through and advanced cracks, which follow the direction of the ribs of the (umbrella) vault in the contacting side between the transept and the apse self.

- the repair of the passing-through cracks by means of reinforced concrete
- the reinforcement of the foundations by means of microsupports (micropoles), which overpassing the clayey strata on which the foundations selves are placed, may reach a depth suitable to secure the bulding stability.
