POLITECNICO DI TORINO
SECOND SCHOOL OF ARCHITECTURE
Master of Science in Architecture (Rehabilitation and Revaluation)
Honors theses

The yard for restauration and structural rehabilitation of the “Cappella della SS. Sindone” in Turin. Contribution for the restauration project of the external surfaces of the Guarini’s Chapel

by Monica Marelo

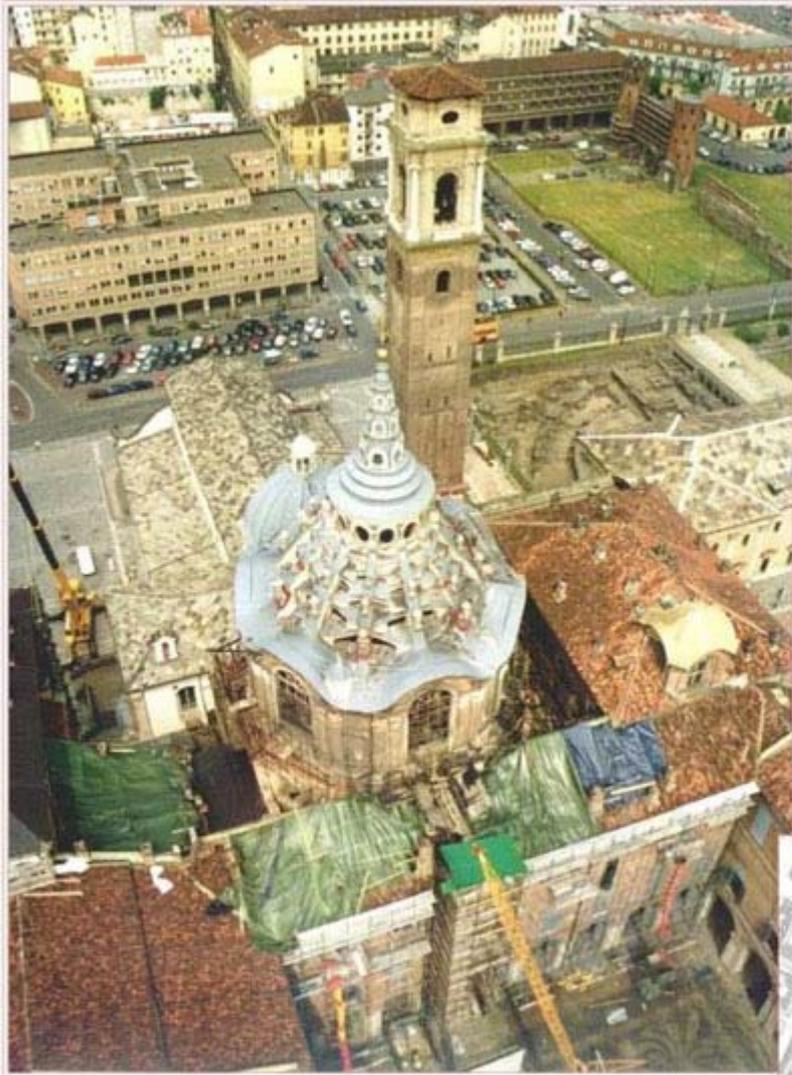
Figura 29.1

Cappella della SS. Sindone Dopo incendio, Archivio fotografico della Soprintendenza per i Beni Ambientali e Architettonici del Piemonte, Raccolitore n 16. foto n. 019a. 05/ **1997** Torino.
