2. Action on **the Egg**

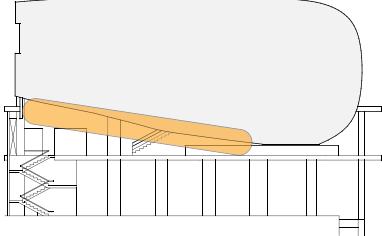
Localizaion of the decay	First Floor, on the slope above
Localizaion of the decay in plan

Decays	Discoloration
Hatch

Decay description	Color variation from what is expected or planned. Originally, the ceilings and the walls were white.
Visible effects at sight	The zones are not thick. Brownish areas seem to be shallow.
Possible causes	Sunlight, severe weather, and high temperatures, along with low quality paint, absence of water repellent layer.
Decay mechanism	The plaster is in poor condition; the surface is marked by a shift in color to dark brownish, which is the result of the building's neglect for more than thirty five years after it was partly destroyed by conflict.
Suggested intervention	Check the degree of discoloration to see whether the decay is only aesthetic or profound in order to avoid additional risky decays.

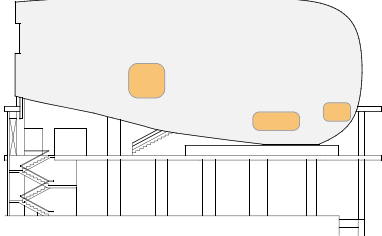
Localizaion of the decay	Second floor, EAST elevation
Localizaion of the decay in plan

Decays	Spalling
Hatch

Decay description	A detachment of the coating from the base along its plane.
Visible effects at sight	Surface discontinuity: plaster Large portions of the plaster layer have come unstuck. The finishing layer is rough and 2 cm elevated from the concrete.
Possible causes	Thermal loops. Climate Impact, weathering.
Decay mechanism	The lack of adhesion between the concrete and the plaster caused the coating to separate from the substrate.
Suggested intervention	In order to avoid more harmful decays, check the degree of separation to see whether it is only superficial or severe. The investigation may be carried out on-site using macroscopic observation.

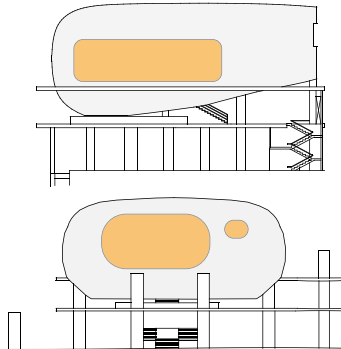
Localizaion of the decay	Second floor, NORTH & WEST elevation
Localizaion of the decay in plan

Decays	Human Action
Hatch

Decay description	Mechanical damage caused by human action
Visible effects at sight	Cavities
Possible causes	The structure was subjected to the impact of bullets during the conflict. Impact of a firearm; projectiles
Decay mechanism	Isolated impact of combat bullets, resulting in the loss of plaster and a piece of the concrete underneath. The degradation is concentrated in the building.
Suggested intervention	Check the detachment status to determine if the decay is problematic. If not, the decay may be kept to keep the memory of past events.
Notes & remarks	This decay is apparent on the structure's four façades as well as internally.

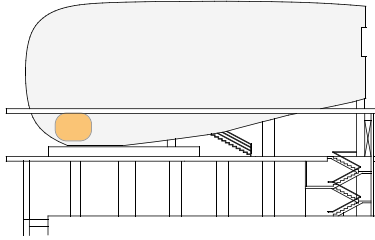
Localizaion of the decay	Second floor, WEST elevation
Localizaion of the decay in plan

Decays	Diagonal Cracks
Hatch

Decay description	<p>A crack: is the total or partial separation of concrete into two or more portions caused by breaking or fracturing.</p> <p>Diagonal Crack: An angled crack that is generally 45 degrees to the dimension axis of 0.1mm.</p>
Visible effects at sight	<p>The surface discontinuity highlited in the photo (Long Diagonal crack).</p> <p>Small fractures around the large fissure.</p>
Possible causes	<p>The result of a spall, most likely generated by an impact.</p> <p>The material's characteristics (Dosage).</p>
Decay mechanism	<p>An angled fissure formed by shear stress in a flexural part, generally approximately 45° to the horizontal axis; or a fissure in a slab that is not parallel to either the lateral or longitudinal axes.</p>
Suggested intervention	<p>Determine if the decay is only superficial or significant in order to avoid future risk. The investigation may be carried out on-site using macroscopic observation & sonic and thermographic tests.</p>

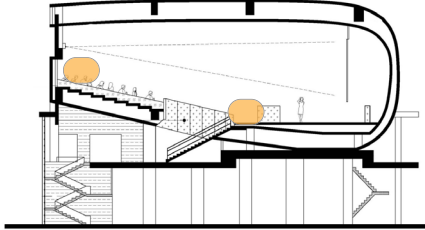
Localizaion of the decay	Second floor, Interior
Localizaion of the decay in plan

Decays	Thin Pattern Cracks
Hatch

Decay description	Pattern Cracks: fine cracks in concrete in the shape of a pattern with dimensions more between $0.5\text{mm} < 1\text{mm}$
Visible effects at sight	Numerous polygonal fractures with varying dimensions on the surface. The decay has spread onto the surface. Some zones have darker tints than others.
Possible causes	Thermal distinction between the several layers Mechanical processes. Concrete density variability. Material characteristics. Mode of operation: executive. Weather action.
Decay mechanism	It occurs due to a reduction in the volume of the substance near the surface.
Suggested intervention	Determine if the decay is only superficial or significant in order to avoid future risk. The investigation may be carried out on-site using macroscopic observation & sonic and thermographic tests. In the lab: Chemical analysis: alkali aggregates reaction to provide qualitative information on interior detachments and potential fracture expansion. (The phrase "alkali-aggregate reaction" refers to a reaction that happens in concrete over time between extremely alkaline cement paste and non-crystalline silicon dioxide, which is present in many common aggregates. This reaction may cause the changed aggregate to expand, resulting in spalling and a loss of concrete strength.)

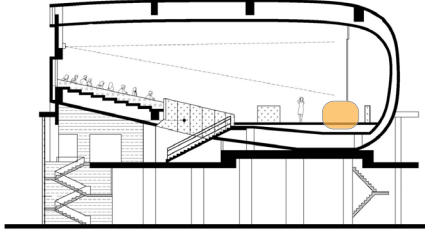
Localizaion of the decay	Second floor, Interior
Localizaion of the decay in plan

Decays	Hair line crack
Hatch

Decay description	Hairline cracks are cracks on an exposed concrete surface that are so light that they are hardly detectable (0.1mm).
Visible effects at sight	A thin fracture that breaks the surface's consistency without affecting the lower layers.
Possible causes	Moisture. Mortar shrinkage upon drying.
Decay mechanism	Hair cracks form on the surface owing to a variety of factors, including atmospheric pollutants, unequal shrinkage, and moisture. They do not entirely penetrate the plaster layer.
Suggested intervention	Take a sample to see whether the decay is only aesthetic or harmful in order to avoid risky decays. On-site: Examination of the nearby structure and details to determine if the hair fractures are caused by a lack of wall stability.

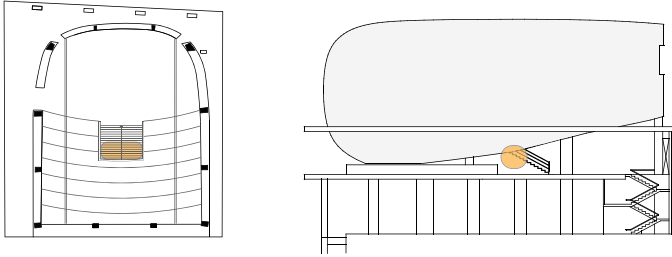
Localizaion of the decay	First floor, Stair case
Localizaion of the decay in plan

Decays	Serious Cracks
Hatch

Decay description	A full or partial separation of bars along a line caused by reinforcing corrosion.
Visible effects at sight	Surface discontinuity all the way along the ceiling and the stair step. Material loss because the fracture is substantial (>5mm).
Possible causes	Concrete carbonation. The reinforcing of the frame has corroded. Sedimentation of water.
Decay mechanism	Steel corrosion generally results in bolt rupture, resulting in a fracture.
Suggested intervention	Locate the reinforcing steel beams and chemically examine it to determine their degree of corrosion and the possibility of further deterioration. Consolidate the crack to prevent future movement between the 2 components; use substance that is compatible with the previous ones in terms of chemic elements, texture, and pigment. Development of alternative technical ways to prevent fracture growth.

Maintenance	Check twice a year if any further cracks appears to take action again.

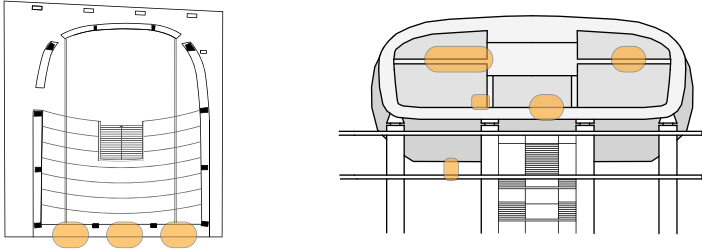
Localizaion of the decay	SOUTH elevation, First and second floor
Localizaion of the decay in plan

Decays	Biological Growth
Hatch

<p>https://blogbaledi.com/awesome-shots-from-the-egg-beirut/</p>
Decay description	<p>Surface organic growth (moos and grass) Moos are vegetative organisms that make little, soft, green cushions a few centimetres in size. They resemble thick micro-leaves (a few millimetres in size) that are firmly packed together. Mosses typically grow on stone surfaces, open spaces, cracks, and also medium lenght wild plants up to 10-15 cm.</p>
Visible effects at sight	<p>Moos: A thin, soft coating made of of thick, green and brown leaves with little adherence to the substrate. Grass is a form of vegetation that consists of small plants with long, thin leaves.</p>
Possible causes	Long exposure to outdoor areas, with the presence of moisture.
Decay mechanism	<p>The moisture present aided in the growth of micro-vegetation. The moss is localized in certain areas of the structure, particularly the outside, and is therefore visibly caused by precipitation.</p>
