**Gardella's Lost Legacy:
The Church of Alessandria.**
Study, 3D documentation and
Analysis

Board No. 11

EAST FACADE

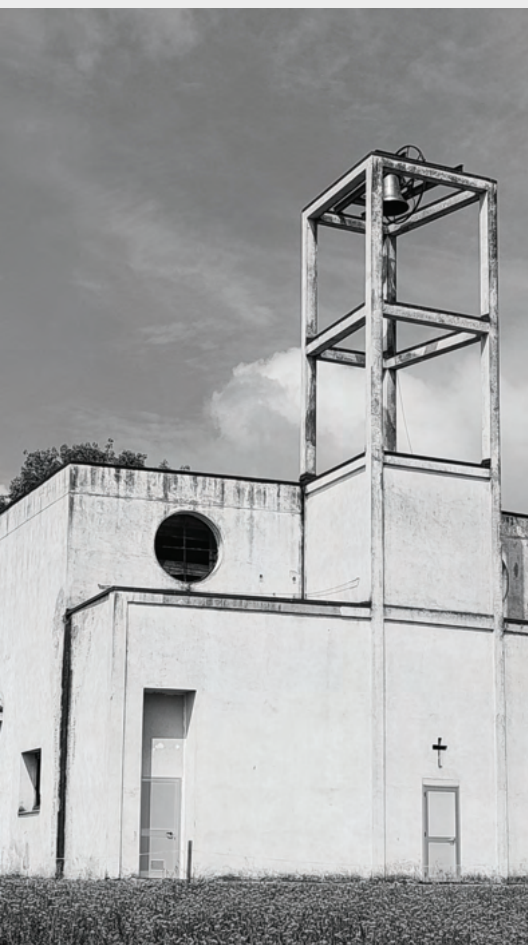
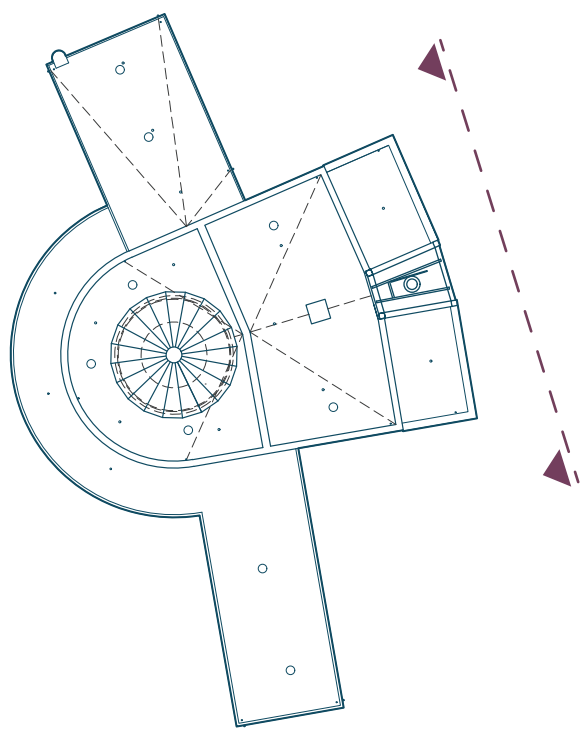
Degradation Analysis			
Pattern / Symbols	Photo	Degradation and Description	Causes
East Facade Windows	W1*	Missing Elements in Windows These windows of size 80 x 150 cm of the south wing are covered with wooden planks. The planks were installed during 2020-2023 restoration probably as a temporary measure to prevent further damage or intrusion while awaiting permanent restoration or replacement of the original frames and glass. The window is a circular opening (90 cm diameter) with remnants of an original metal grid and wooden planks installed inside, likely for temporary closure. The metal grid is intact but exhibits potential <i>corrosion, visible as dark discoloration and possibly rust</i> . The boards show signs of weathering, with uneven coloration and potential warping or deterioration due to exposure to moisture. The edges of the circular opening display <i>staining, moss/algae growth, and surface erosion</i> , particularly along the bottom edge.	The windows were likely left open for an extended period due to vandalism, structural decay, or deferred maintenance, leaving the church vulnerable to weather and environmental damage. The <i>absence of glass and frames</i> over time allowed water and moisture to penetrate the interior and exterior surfaces, leading to, peeling plaster, and biological colonization (<i>visible staining below the windows</i>).

W7*	The windows are missing the glass and lack of protective coating on the metal grid causing exposure to environmental moisture leading to rust and corrosion, which is evident from the discoloration. The accumulation of rainwater at the base of the circular frame (<i>visible from the dark, damp area and moss growth</i>) has caused moisture-related damage to the concrete and surrounding materials.	
	W1-x*	W1-X windows of size 80 x 150 cm are most likely similar to W1 (original design). The frames are deteriorated, with visible cracking, uneven surfaces, and discoloration likely caused by weathering and lack of maintenance. Some panes appear intact but dirty, while others seem <i>broken or missing</i> . The sill, likely made of stone or concrete, show dark discoloration and <i>moss/algae growth</i> , indicating prolonged moisture exposure.	The missing or broken glass is likely due to either <i>vandalism, structural movement, or environmental impact</i> (e.g., <i>strong winds or falling debris</i>). The discoloration and moss growth on the sills suggest pooling or absorption of water, causing moss and algae growth and leading to plaster degradation

Material Incompatibility		Plaster change demarcation line This part of the facade shows two types of plaster applications. The upper part of the mortar appears smoother and more uniform in texture (likely a cement based mixture). There are visible patches of plaster detachment but overall holds better integrity. The lower part exhibits more pronounced degradation and moisture related damage (likely a lime-based or weaker cement lime mixture). There is also discoloration or possible erosion of plaster in lower part and worse material cohesion.	The two mortars reflect two different times of application, with material quality or composition varying due to factors such as local availability or cost. The lower line of mortar may indicate a repair or restoration phase, where a different, potentially less durable or more porous mortar was used, possibly to address earlier degradation due to rising damp issues.

Structural Degradation	×	Wall Perforations The holes appear small and localized, with dark discoloration or staining around them. The staining suggests potential water ingress, or material seepage from within the wall. They are relatively uniform in spacing and alignment, suggesting an <i>intentional or structural purpose</i> . The discoloration below the holes hints at potential water seepage, mold, or biological growth , indicating moisture-related issues	These holes may have been created to anchor structural elements (e.g., scaffolding, signage, or bracing) during construction or previous repair work that began in 2020. Over time, the absence of proper sealing allowed moisture ingress, leading to staining and potential internal degradation.
		Scratches/abrasions on paint The black marks are irregular and vertical to slightly diagonal. Some are thin and linear, while others are broader or smudged. They appear scattered across the wall surface, with a higher density in certain areas, suggesting external forces or contact with objects. The wall has an uneven finish, and the scratches are superficial, likely not penetrating deeply into the plaster or render.	The marks could result from physical contact with sharp or abrasive objects, such as scaffolding, ladders, or tools scraping against the wall during construction, maintenance, or repair activities. The irregularity and variety in depth/width of the scratches suggest accidental or unintentional abrasion.

~	Crack - Medium Intensity The crack appears as a horizontal fissure that extends below the parapet-wall junction but does not exhibit significant displacement or crumbling. The formation of these cracks can be linear or rectilinear and their proper intensity can be tested through a series of structural analysis performed by experts.	Major causes can be Thermal expansion and contraction - Daily and seasonal temperature fluctuations can cause materials to expand and contract at different rates. This cyclic movement creates tensile stresses at rigid connections, such as the parapet-wall junction. Water Ingress and Freeze-Thaw Cycles can be another reason. Since there is an obvious rising damp from the ground, this can be due to Settlement or Structural Movement of the foundations as they cause horizontal cracking.
	~	Fissures - Severe Intensity Diagonal Cracks: Typically caused by differential settlement or structural movement, Horizontal Crack: Likely due to thermal stress or weakened structural elements, especially near load concentrations. The cracks show advanced propagation and connect multiple points, indicating compromised structural integrity. Some areas show detachment of plaster, which exposes the underlying masonry to environmental damage.	Foundation movements leading to differential settlement may have caused tensile stresses in the upper masonry layers, leading to diagonal cracks. The alignment of diagonal cracks suggests stress redistribution due to an unstable load-bearing element. It can also be due to the inadequate structural reinforcement in areas like window lintels or slab-wall junctions leading to shear or tensile failures. Other reasons are same as above aggravated to a worse condition

Solutions / Interventions	
<ul style="list-style-type: none">- In these windows, apparently, the whole frame of the windows are missing, hence they need to be replaced with new ones, keeping in mind their thermal properties. The design of the frames and window aesthetics must match the original design. Careful procedure must be taken in order to remove temporary closure with planks and structural durability of the lintel of openings must be tested and fixed before intervention of new windows. A permanent solution for window sills must be planned to avoid water accumulation.	
<ul style="list-style-type: none">- Removing debris and dirt from the metal frame and plaster in the opening using soft brushes and a low-pressure water spray.- Cleaning the metal bars with a wire brush or rust-removal tools to eliminate surface corrosion. Then treating the metal bars to stabilize corrosion and applying corrosion resistant primer to protect from future rusting.- Finally, the desired size of glass can be added to the frame based on the required thermal properties.

<ul style="list-style-type: none">- First, wood must be inspected for rot and insect intensification and areas of high moisture content must be identified. The frame's structural integrity must also be tested to detect any weak spots.- After removing dust and debris, wood must be repaired for any damages identified (for example, applying wood consolidation agent) and parts of frames beyond repair must be replaced.- The old paint must be removed with help of chemical paint stripper and a suitable primer must be applied to the surface to protect against UV damage. In addition, existing hardware of the windows must also be examined.- Broken or damages glass to be removed, and new glass (ensuring thickness of the frame) must be added.	
<ul style="list-style-type: none">- Conducting laboratory tests to confirm the composition of both plasters and performing moisture mapping to identify areas of trapped water or capillary rise in lower section.- Cement based plasters are not compatible with lime based materials and are less permeable, hence in case it is used in the upper section, it is necessary to remove it carefully without damaging the masonry.- After cleaning the surface, a lime based plaster can be used for both upper and lower section for better compatibility and for enhanced durability, aggregates and pozzolanic additives can be added.

<ul style="list-style-type: none">- Cleaning the stained surface using Biocidal cleaner to remove Biological growth and discoloration around the perforations.- For rust and other salty deposits, a neutral pH rust remover or poultice with clay and distilled water can be used. There is no apparent efflorescence around the holes, but it is still a good solution to extract salts, just in case.- Holes can then be filled with a suitable lime based mortar, with fine aggregates for structural voids. For smaller perforations, lime putty filler can be used for a finer finish.- final steps are using suitable lime based surface plaster and final paint finish as per aesthetic requirement.	
<ul style="list-style-type: none">- Cleaning of the surface using low pressure water washing and soft natural-bristle brush to remove surface dirt and loose particles without damaging plaster. For persistent grime in scratches areas, mild, non-ionic detergent can be used by diluting in water.- For filling and repair, lime-based filler mortar can be used which is compatible with the original plaster. For example, Hydraulic lime mixed with fine sand. The areas of scratches must be filled with small trowel or palette knife, ensuring smooth texture. To fill shallow abrasions, lime slurry can be filled in abraded areas.- Final surface finishing as per original aesthetics.
