Analysis of the instability, institutions of provisional support and intervention of reinforcement in the San Giuseppe church of Fossano

by Tommaso D'Amico

This study concerns the provisional safety procedure for the San Giuseppe Church of Fossano, Cuneo, Italy carried out by means of an adequate temporary protective framework to tackle the static shortcomings of the structure.

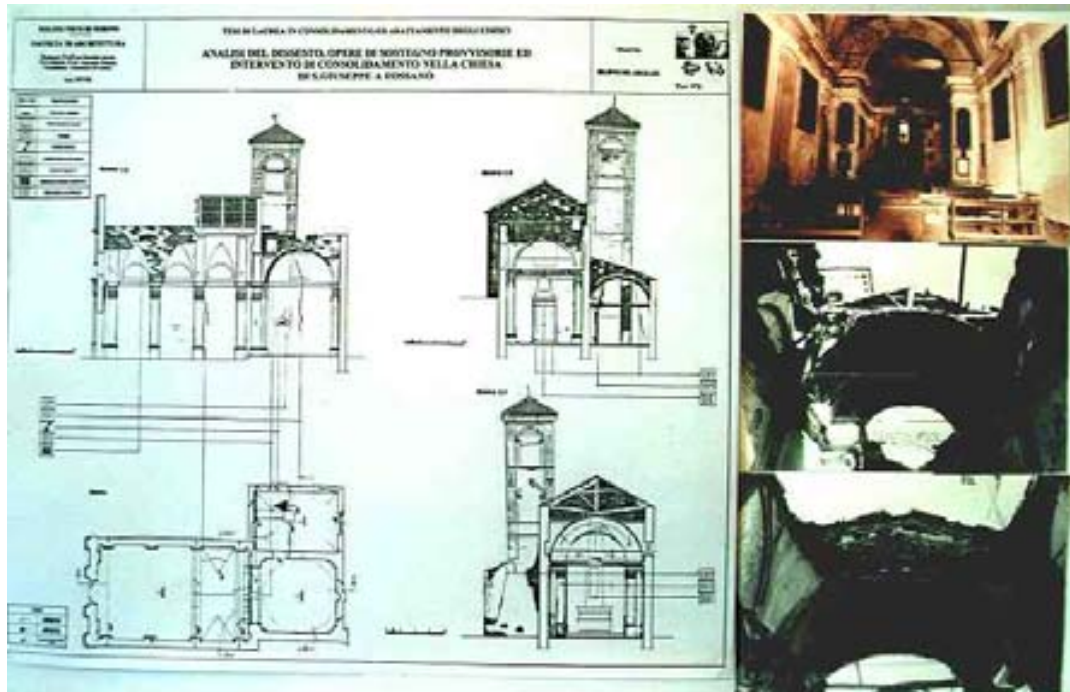
These modifications can have different causes, vary with time and influence each other.

Thanks to a critical analysis it is possible to formulate a hypothesis about the perturbing causes and therefore about the most appropriate static measures to be taken.
