W I N D O W S C H E D U L E

D O O R S C H E D U L E

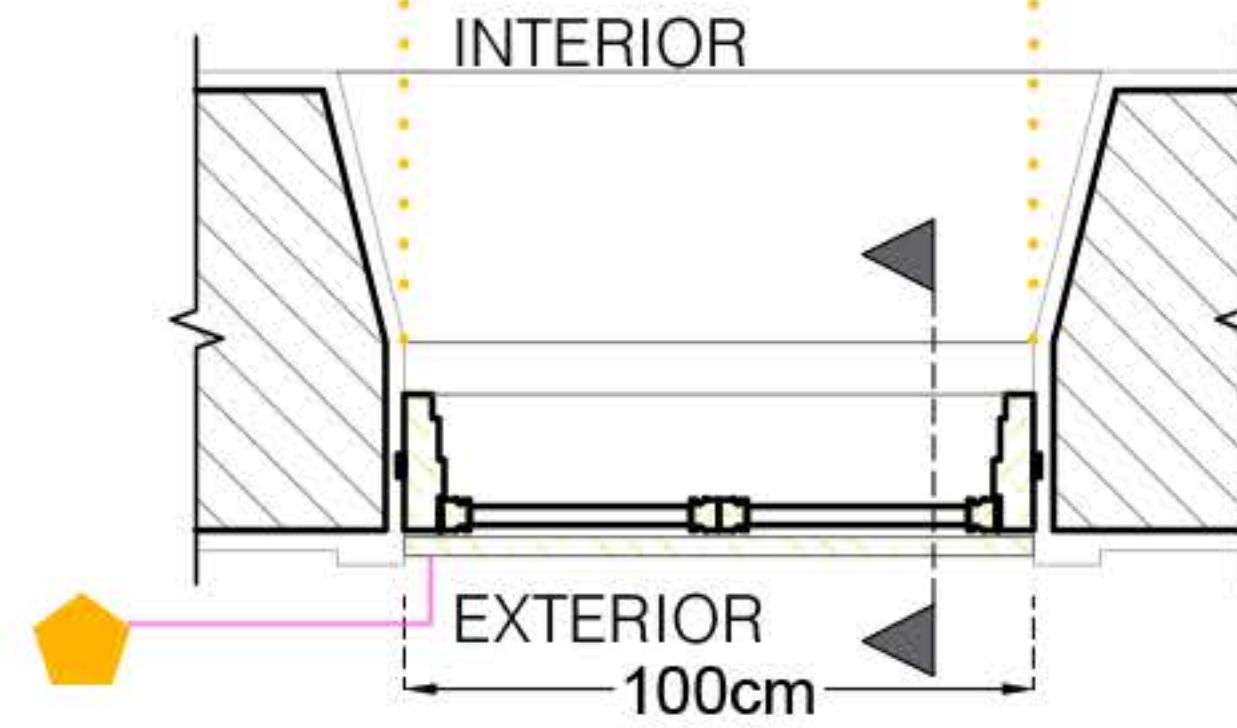
NO. - W1 LOCATION - ROOM 2

BEFORE

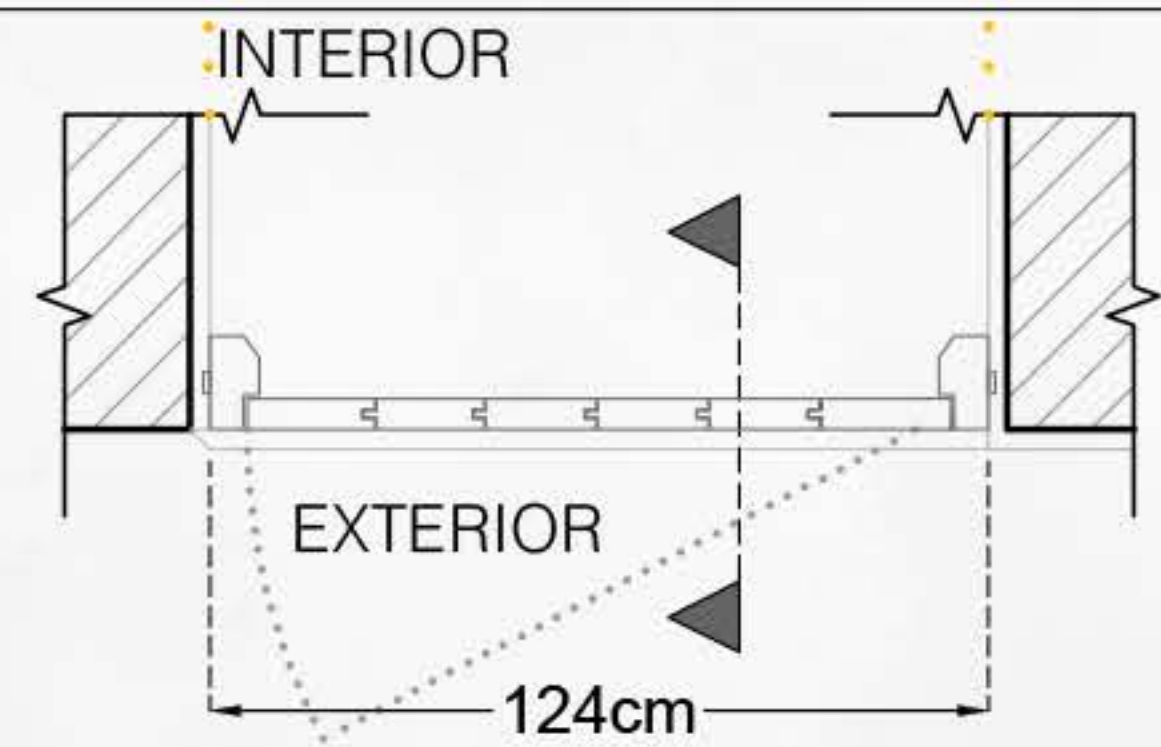
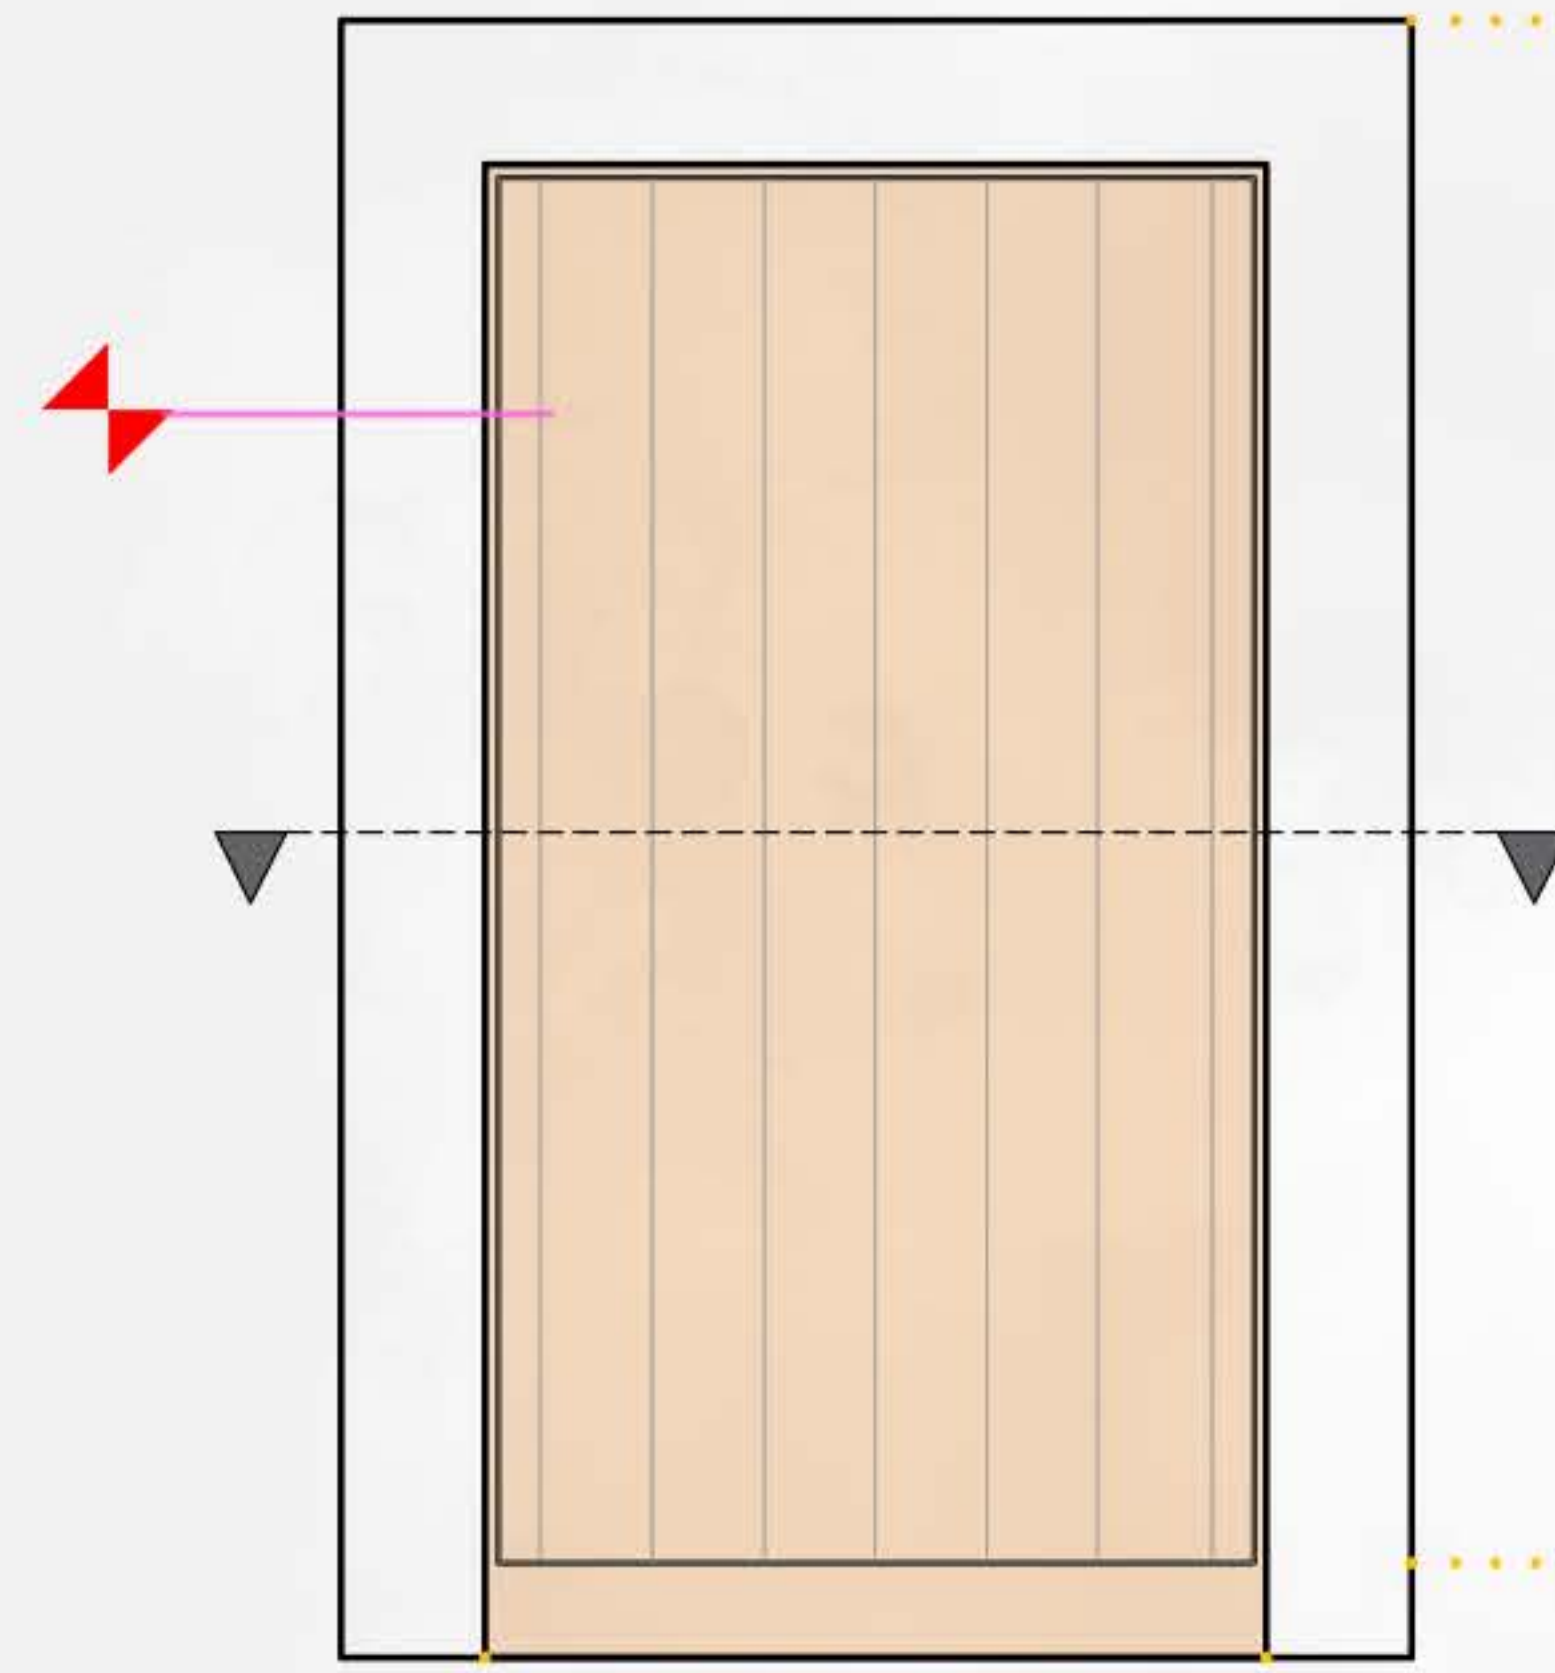
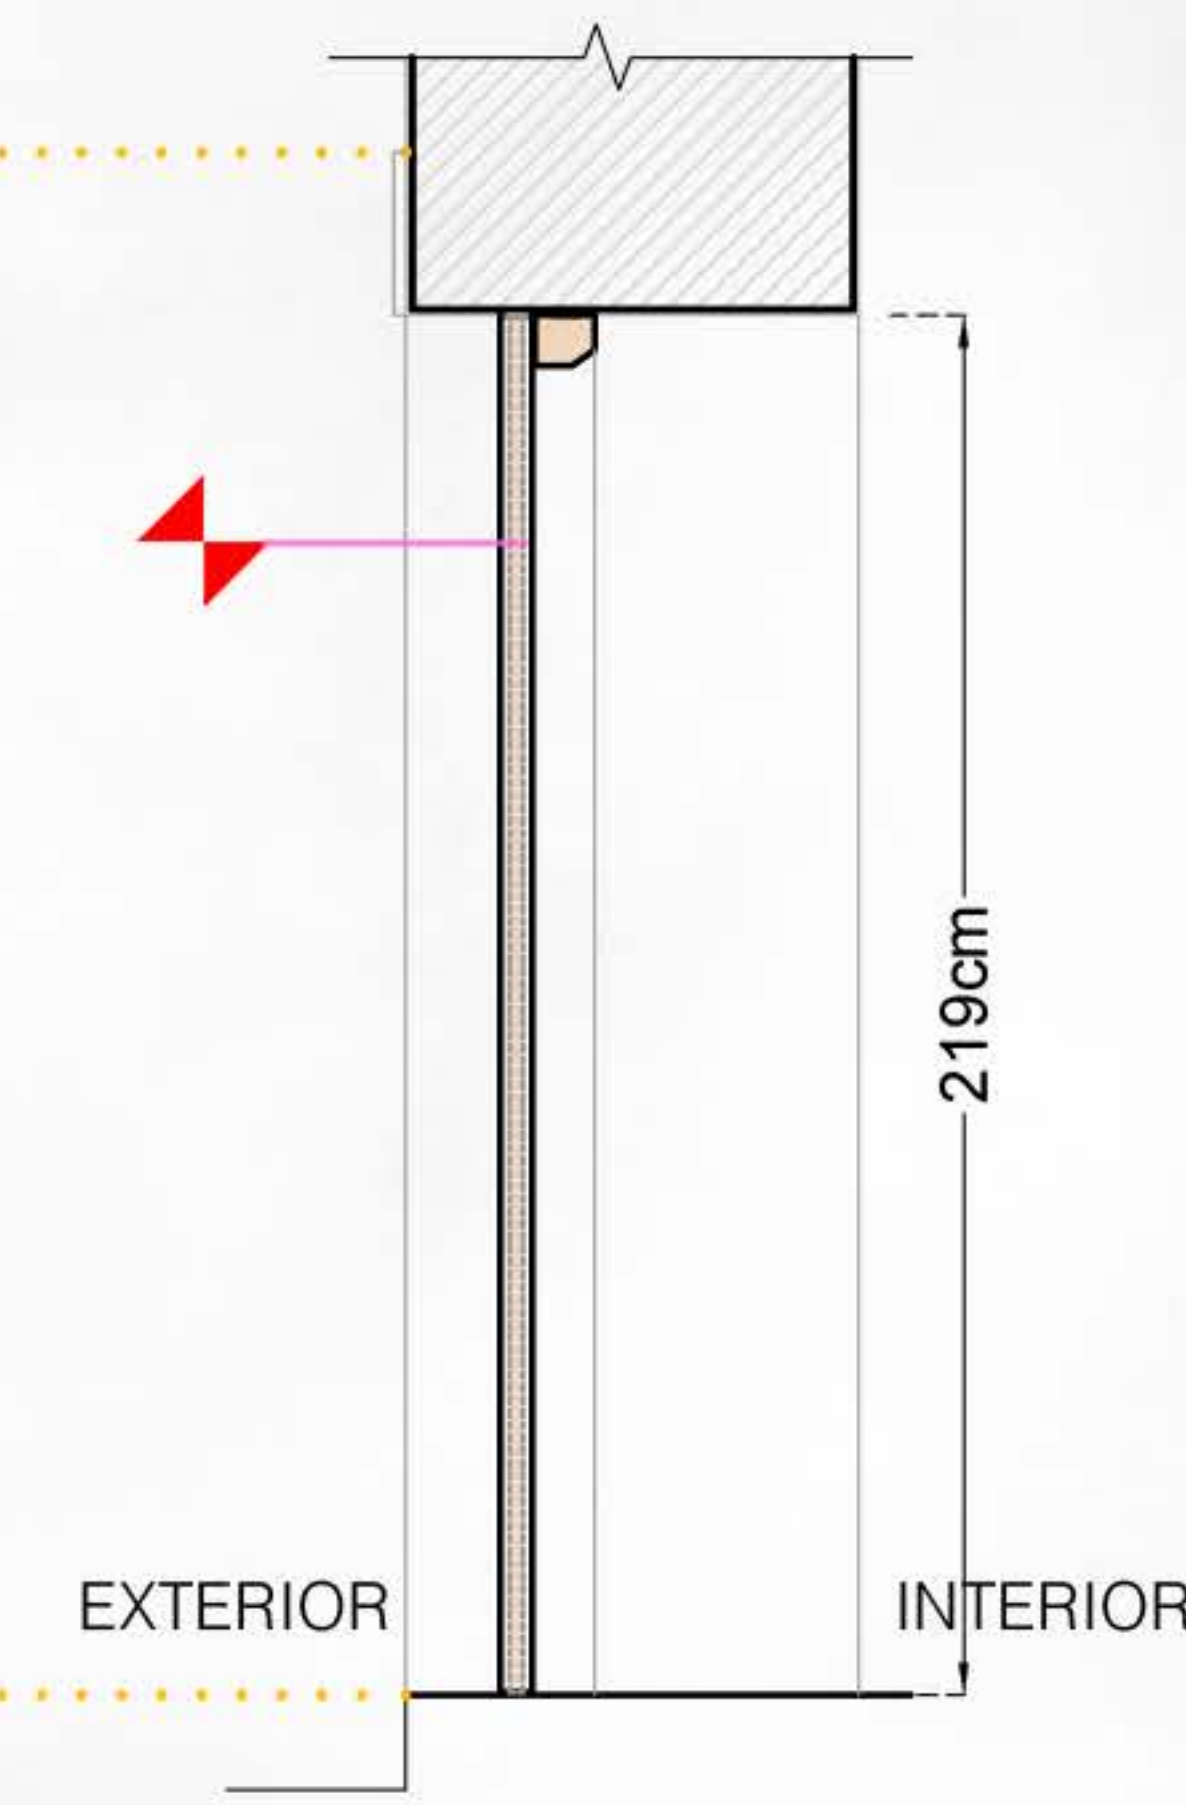
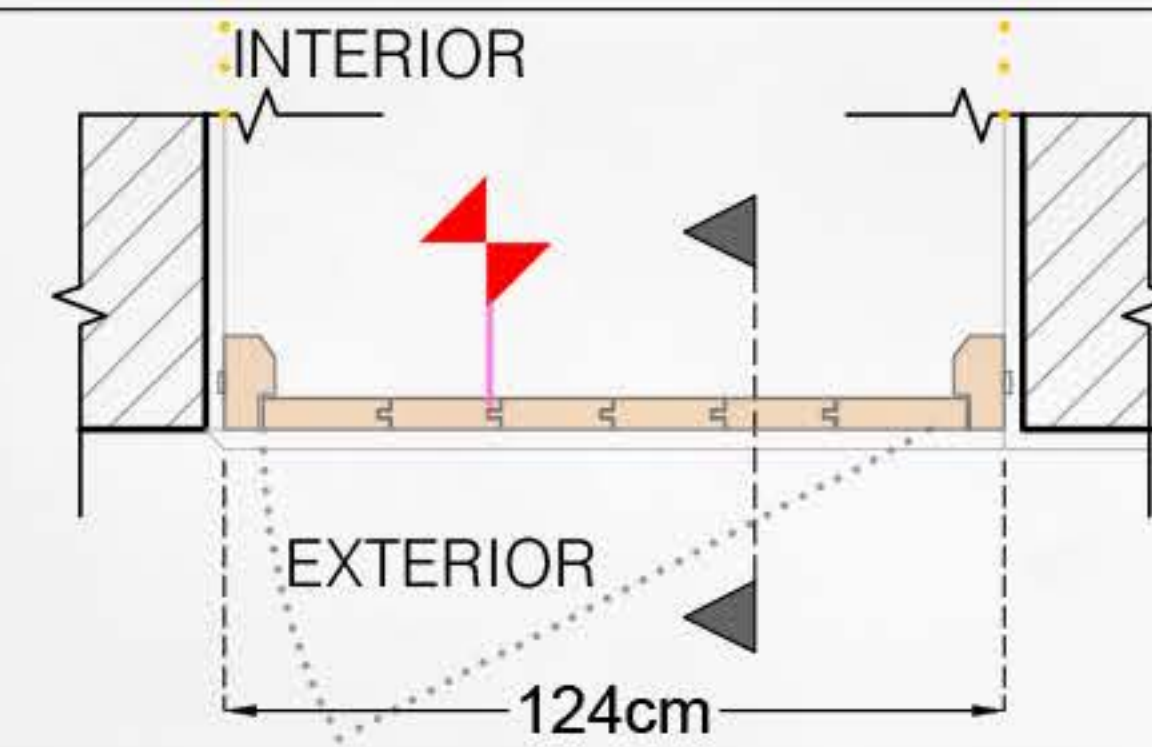
NO. - D3 LOCATION - ROOM 7

- CUT STONE MASONRY
- CUT PLASTER LINE
- STONE MASONRY
- STONE BLOCK
- WINDOW OPENING
- PLAN/SECTION LINE
- PROMINENT CRACKS
- RUSTED METAL
- WOODEN ELEMENT
- PROJECTION LINE
- LOWER VEGETATION

- Restoration of existing wooden frames with process of painting and integration of small elements
- Scraping to remove black crust & pigmentation
- Plastering of wall
- Paint finish
- Removing vegetation

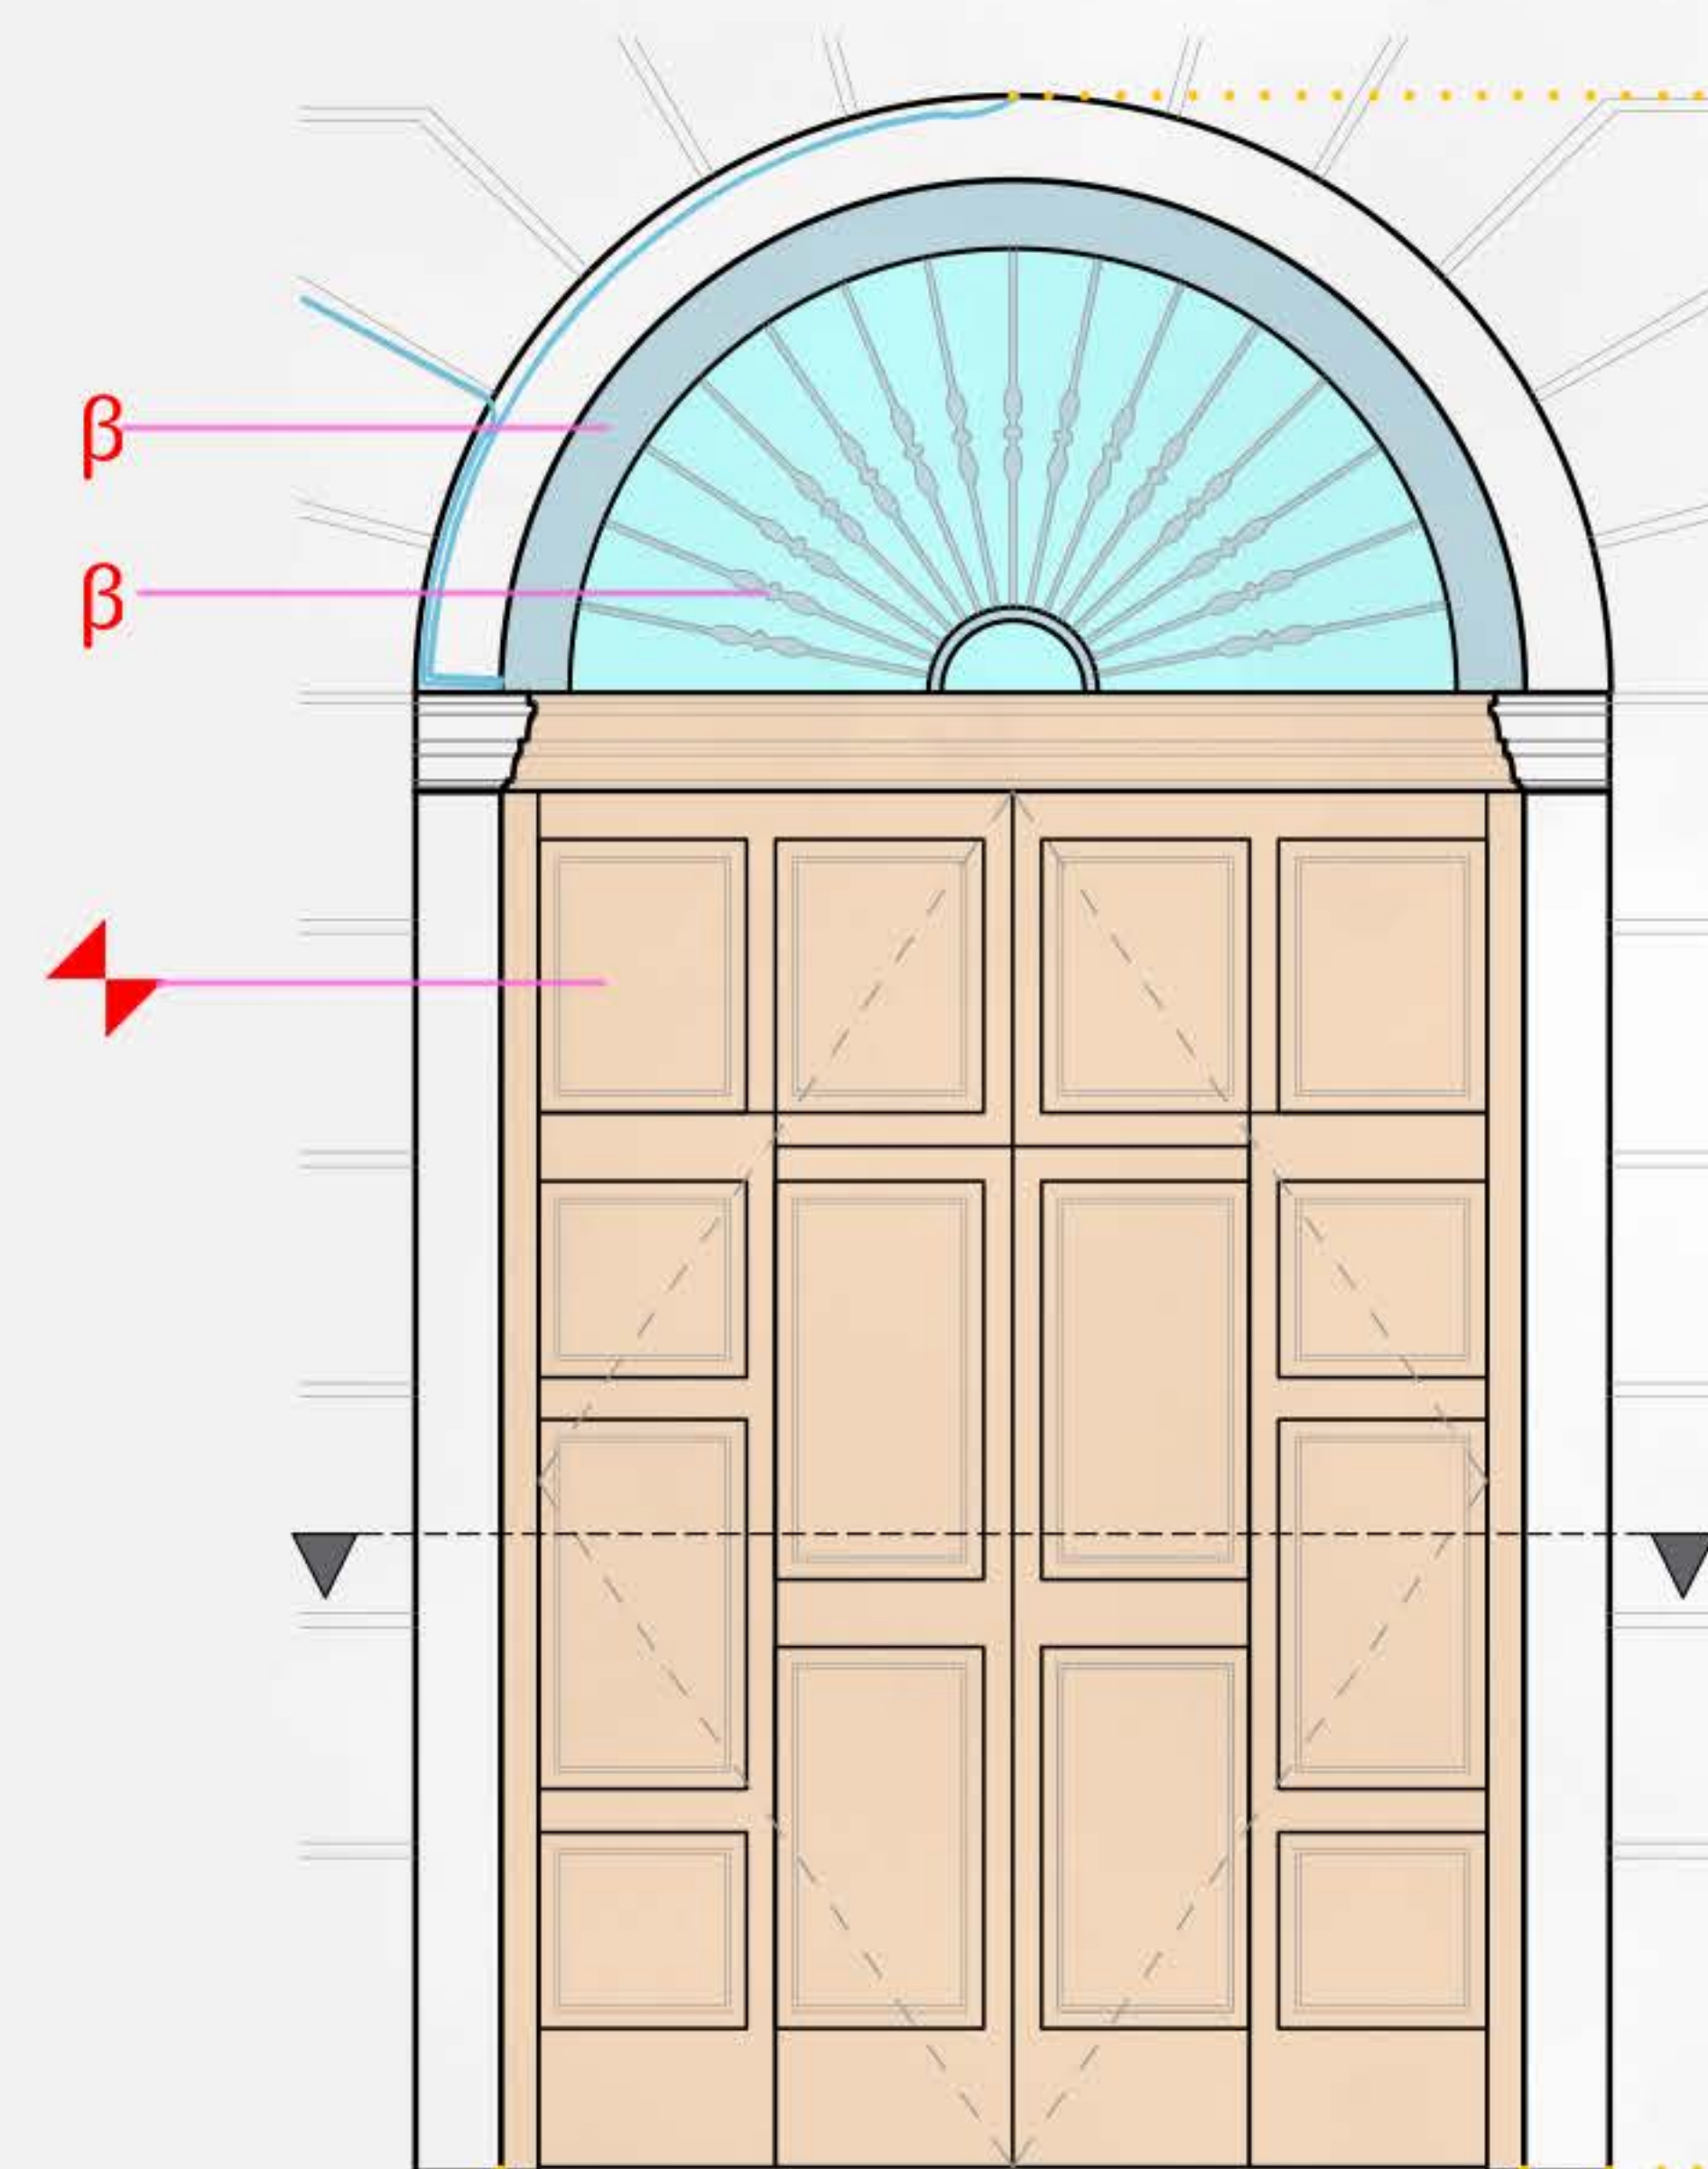
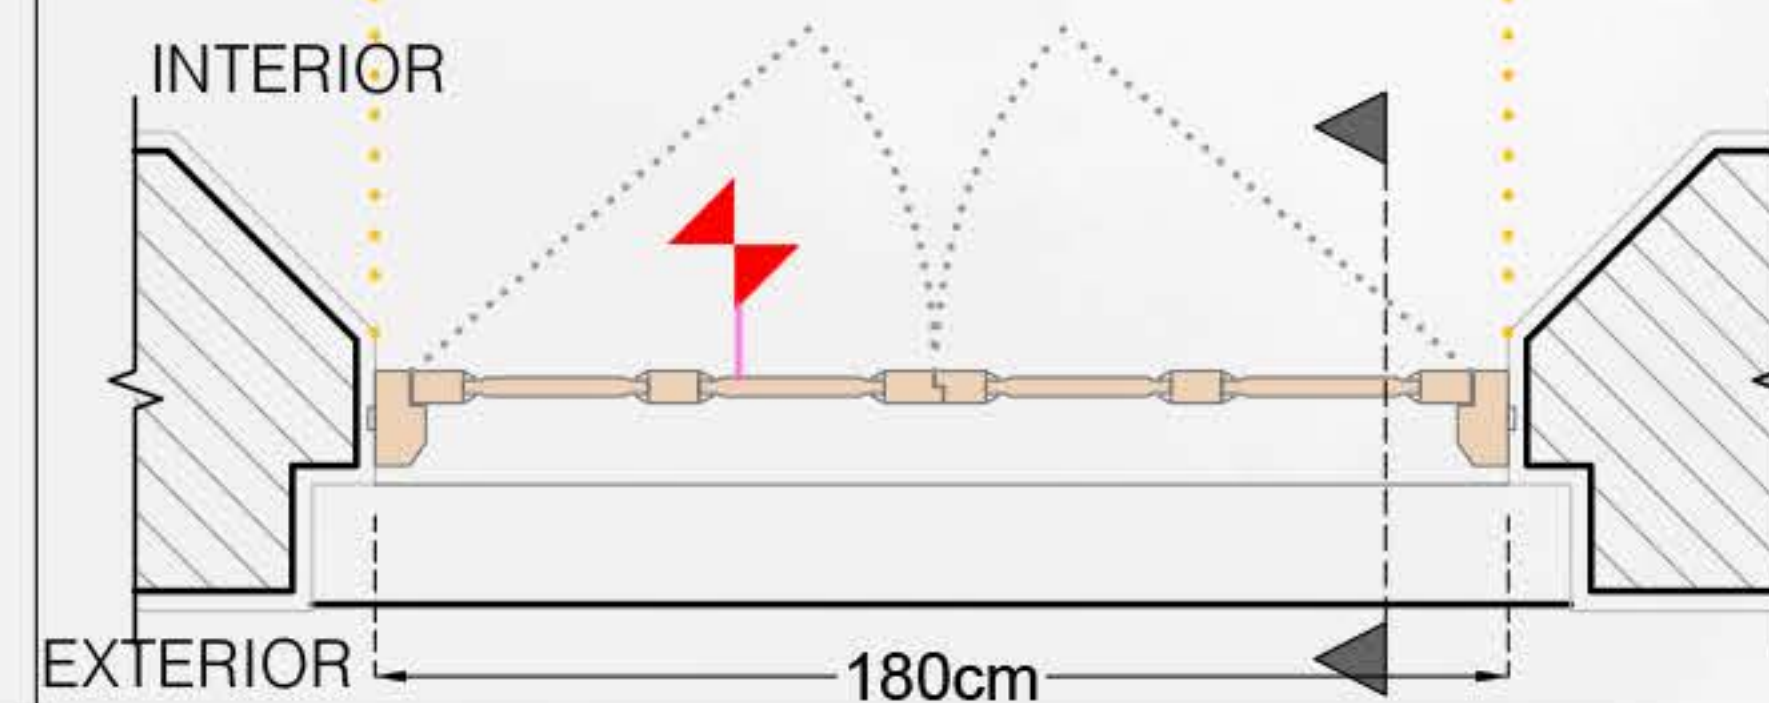
NO. - D1 LOCATION - ROOM 1

- CUT STONE MASONRY
- CUT PLASTER LINE
- STONE MASONRY
- WINDOW OPENING
- PLAN/SECTION LINE
- PROMINENT CRACKS
- BROKEN WINDOW
- BROKEN GLASS
- WOODEN ELEMENT
- METAL ELEMENT
- DOUBLE GLAZED PANEL
- PROJECTION LINE
- RUSTED METAL
- LOWER VEGETATION

- Restoration of existing wooden frames with process of painting and integration of small elements
- Cleaning & removal of rust
- Removing vegetation

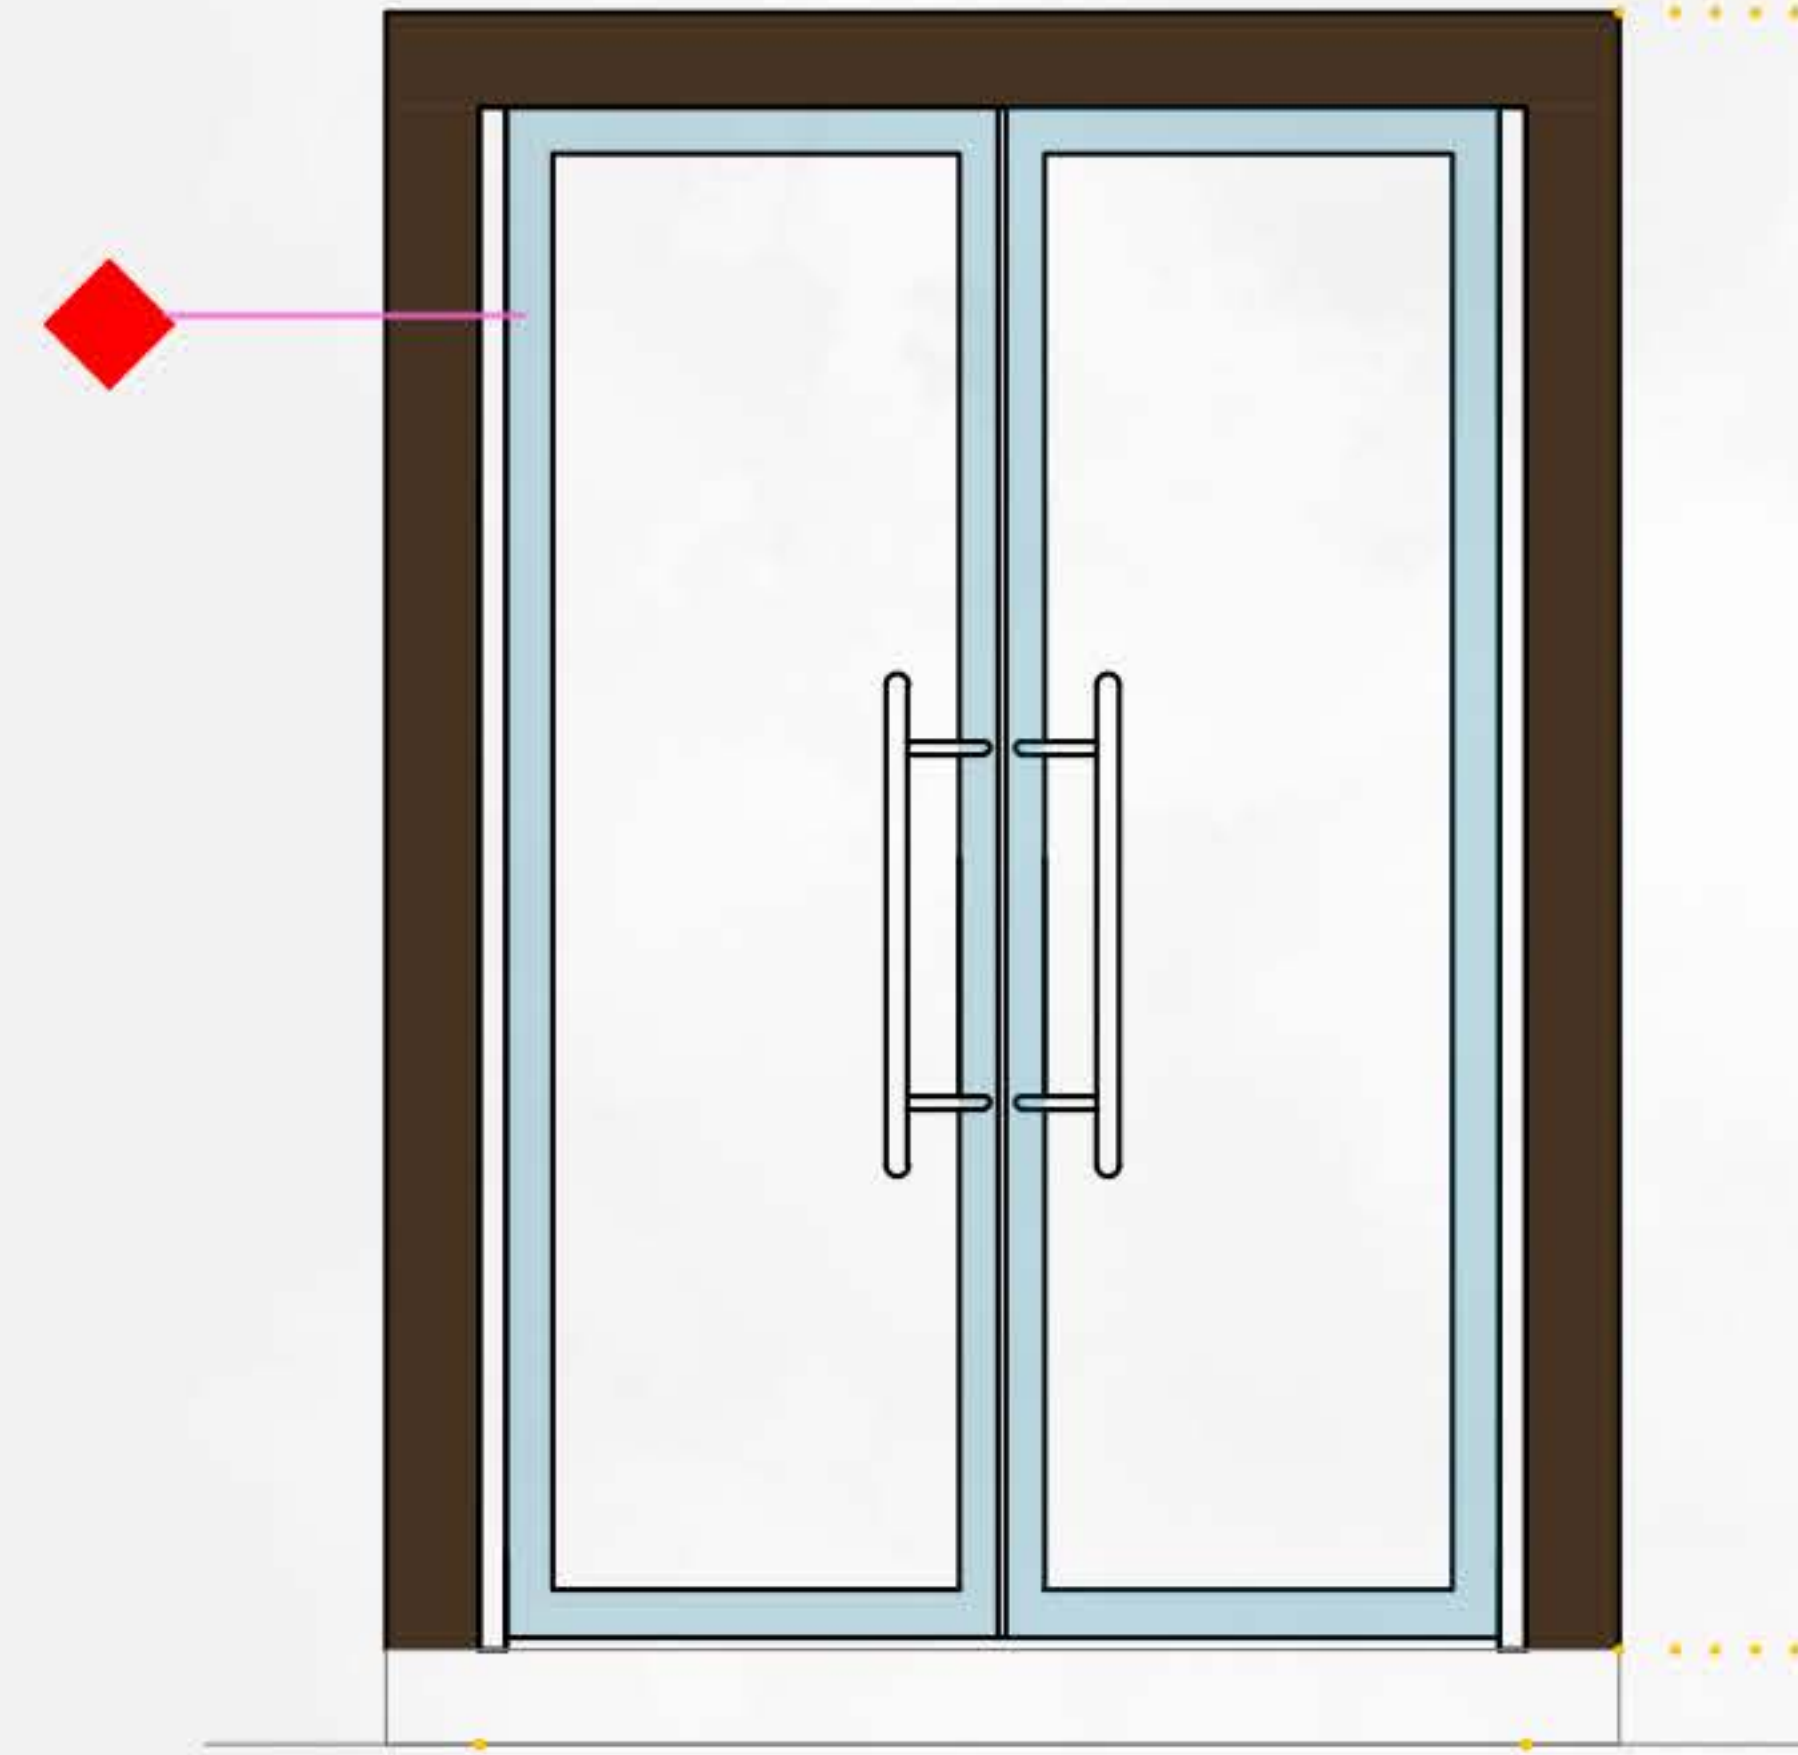
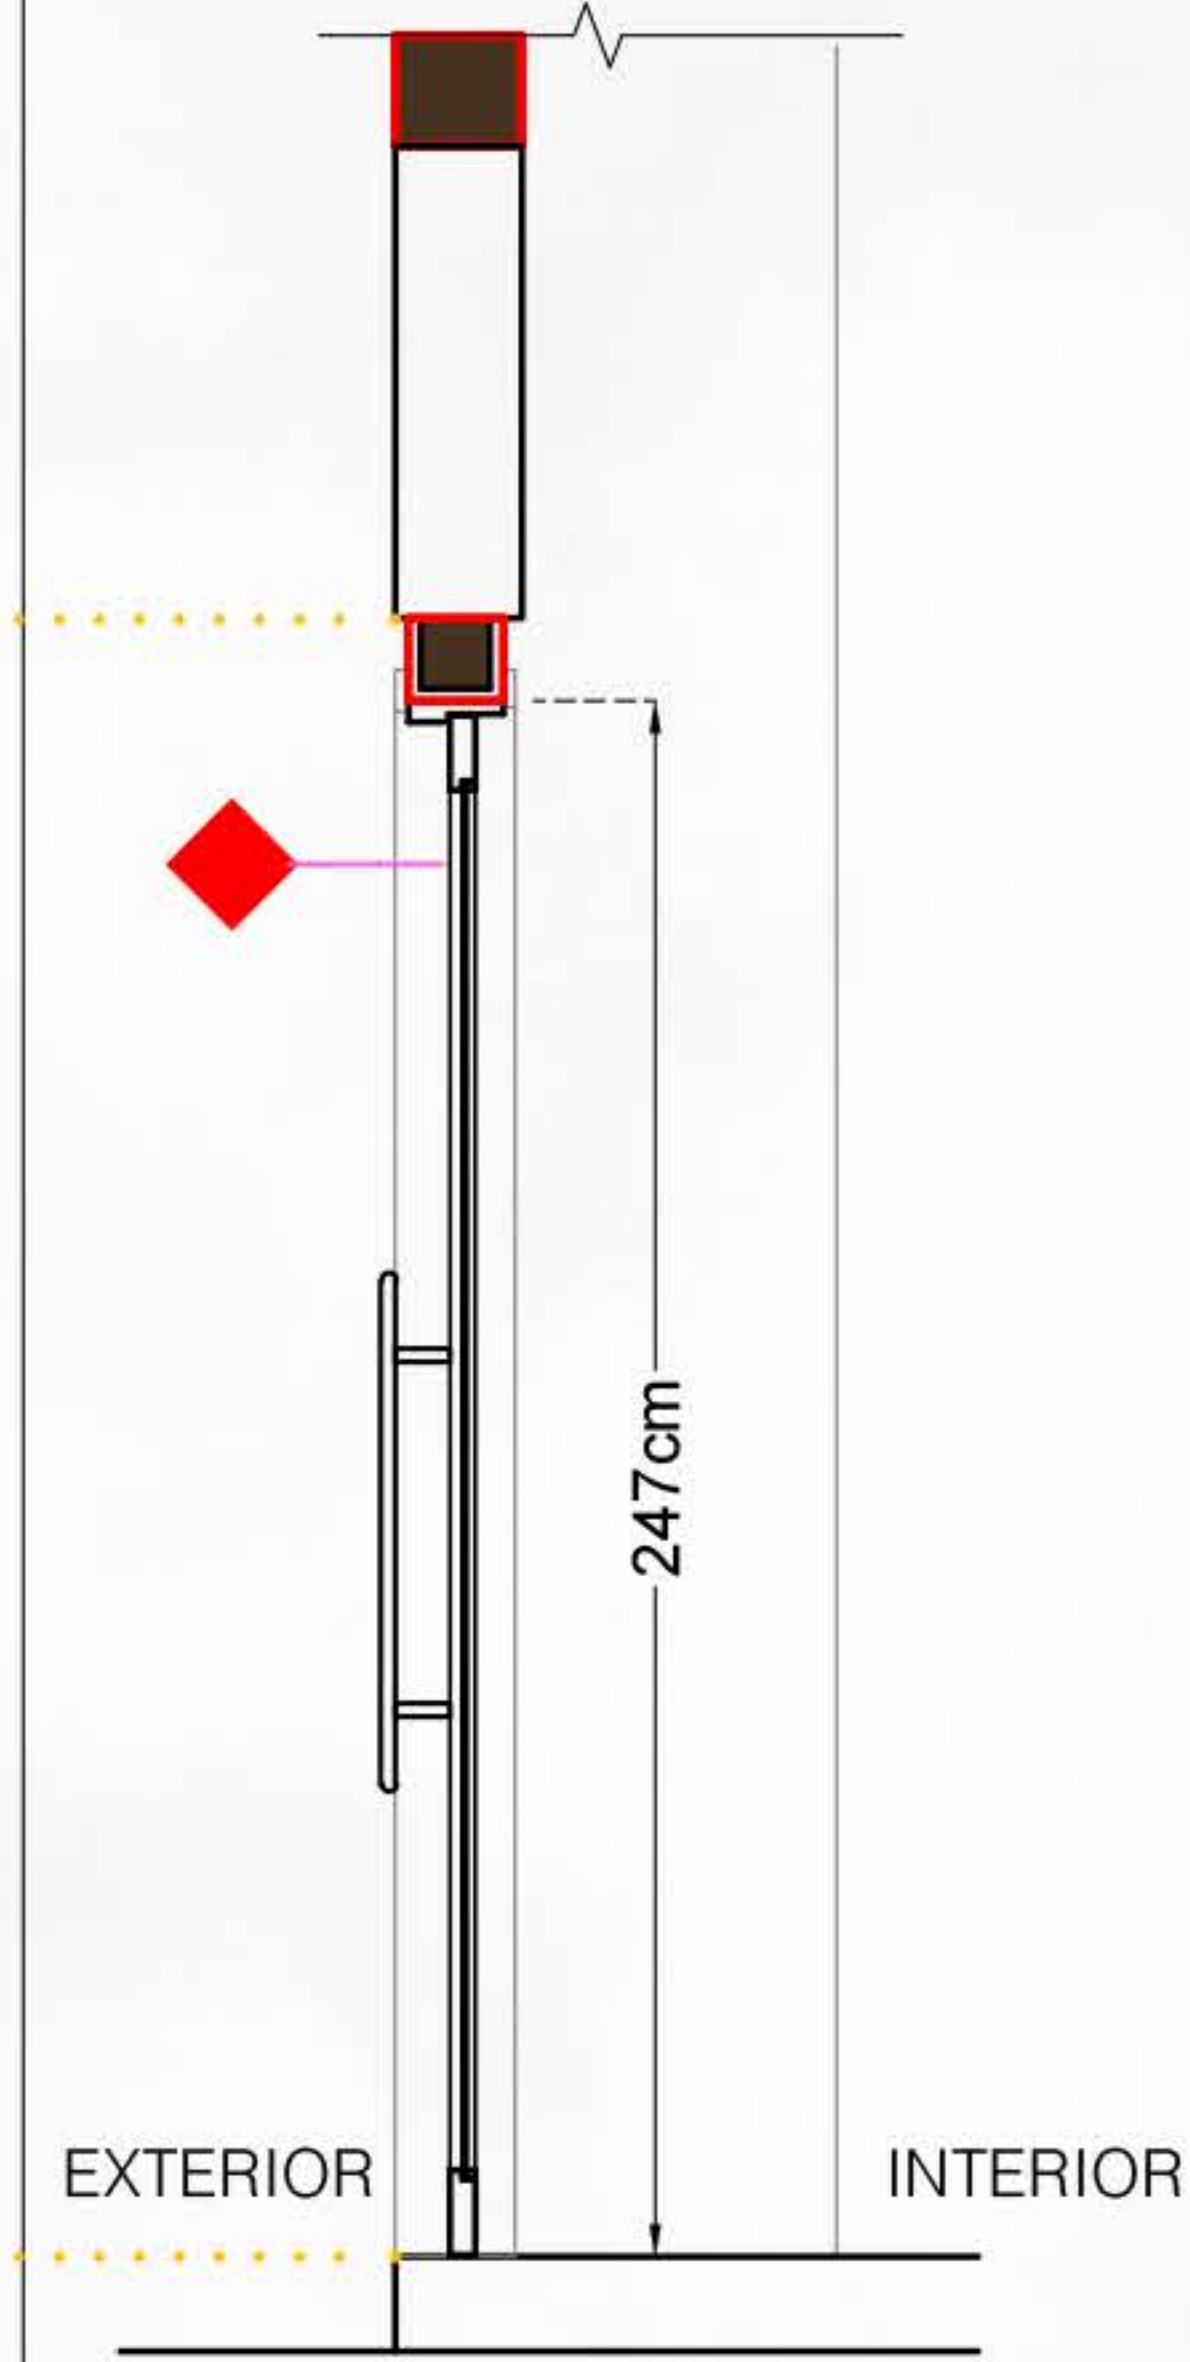
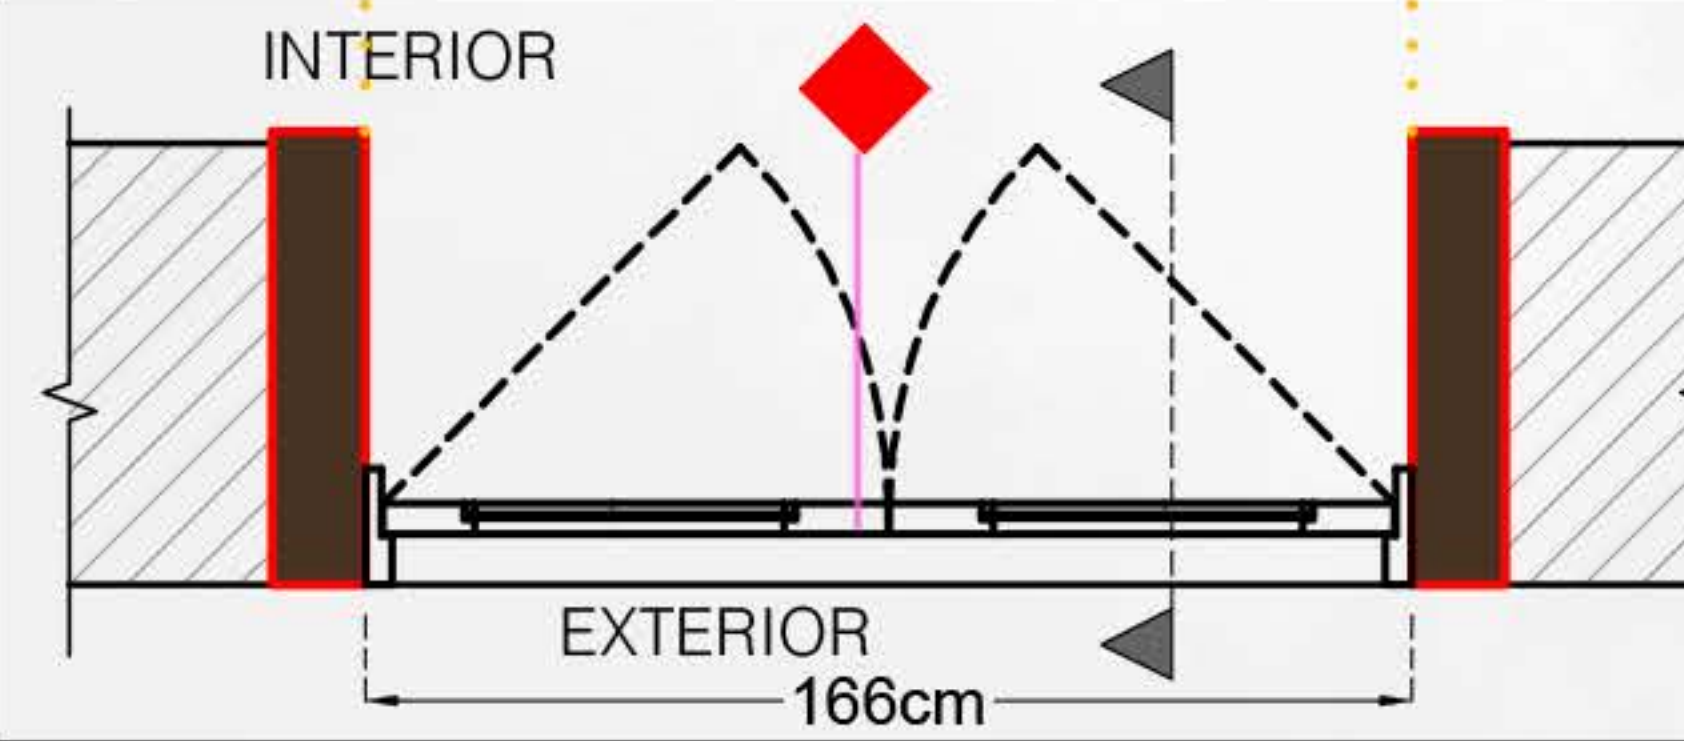
NO. - D4 LOCATION - ROOM 3

- CUT STONE MASONRY
- CUT PLASTER LINE
- STONE MASONRY
- STONE BLOCK
- WINDOW OPENING
- PLAN/SECTION LINE
- PROMINENT CRACKS
- RUSTED METAL
- STRUCTURAL FAILURE
- WOODEN ELEMENT
- METAL ELEMENT
- PROJECTION LINE
- BIOLOGICAL PATINA
- STEEL MEMBER

- New Frames insertion for door along with glass panel
- Structural stabilization
