# VERNACULAR RESIDENTIAL ARCHITECTURE FROM THE GOLDEN CYCLE IN THE BRAZILIAN MIDWEST

BEST PRACTICES FOR THE RESTORATION

POLITECNICO DI TORINO  
DEPARTMENT OF ARCHITECTURE AND DESIGN  
MASTER THESIS IN ARCHITECTURE FOR HERITAGE

Débora Carneiro Ávila  
*Student*

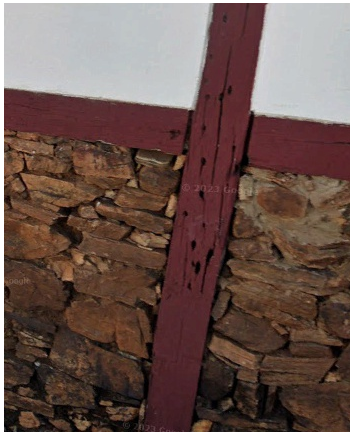
*Decay: Wood splitting  
Possible Causes: Nail penetration causing localized stress and splitting along the wood grain.  
Location: Pillar*

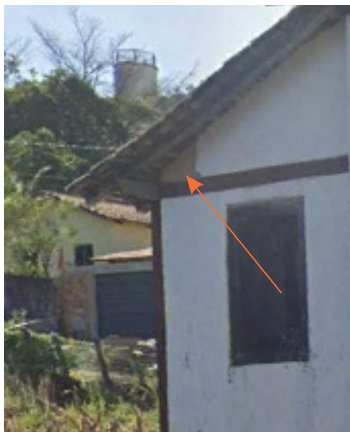
*Decay: Delamination  
Possible Causes: Excess moisture; Incompatible materials; Rapid drying; Poor adhesion between the wall plaster layers; Structural movement; Incorrect mix composition  
Location: plaster applied under the roof*

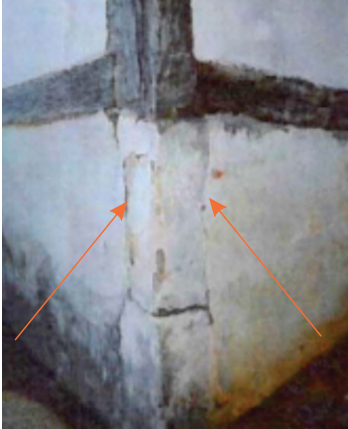
*Decay: Crack in mortar*

*Possible Causes: Differential movement between materials; Shrinkage of the earthen material during drying; Lack of proper bonding connection at the joint; Moisture variation affecting one material more than the other; Wood swelling or shrinking due to humidity changes; Foundation settlement or structural movement; Thermal expansion and contraction cycles; Improper construction detailing or lack of flexibility at the junction*

*Location: exterior wall painting*

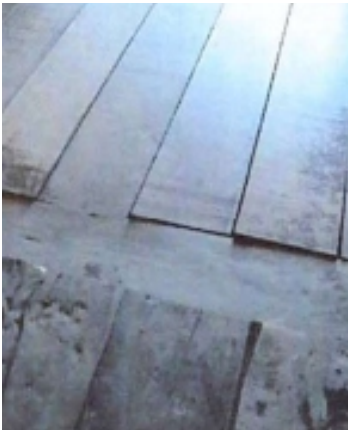
*Decay: Wood bending*

*Possible Causes: Excessive moisture absorption (from below or above the floor); Improper acclimatization of the wood before installation; Uneven subfloor or structural movement; Use of green or insufficiently dried wood; Thermal expansion due to temperature changes; Improper fastening or installation techniques; Incompatible adhesives or finishes trapping moisture*

*Location: Barrote floor*

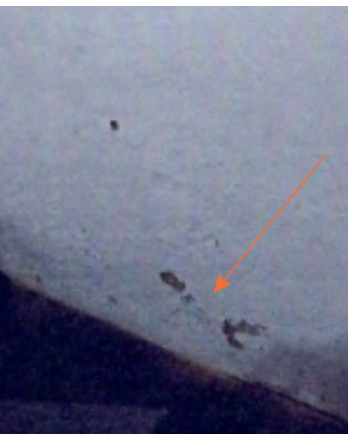
*Decay: Blistering*

*Possible Causes: Trapped moisture beneath the surface layer; Application of plaster over a wet or non-cured substrate; Use of non-breathable finishes (acrylic or cement-based coatings); Poor adhesion between layers; Condensation behind the wall due to lack of insulation or ventilation*

*Location: internal wall painting*

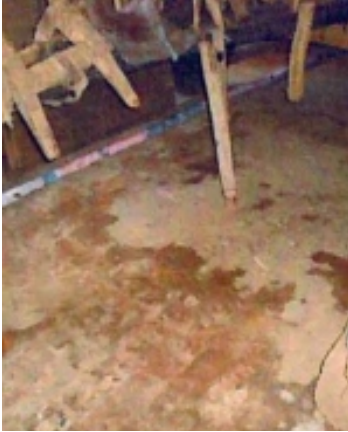
*Decay: Abrasion*

*Possible Causes: Frequent foot traffic or friction from furniture;  
Use of a weak or overly sandy earthen mix*

*Moisture fluctuations weakening the surface; No regular maintenance  
or reapplication of protective layers; Vibration or structural movement*

*Location: Kitchen Mezalena floor*

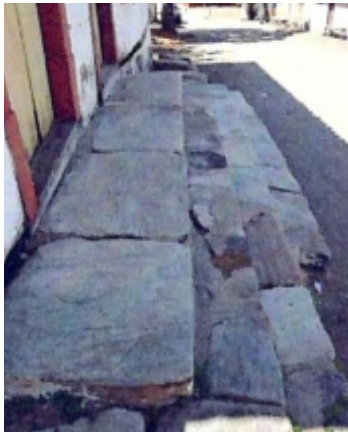
*Decay: Stone abrasion*

*Possible Causes: Frequent foot traffic; Moisture fluctuations  
weakening the surface; Vibration or structural movement*

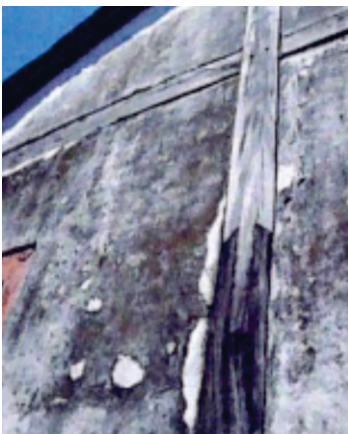
*Decay: Moisture darkening*

*Possible Causes: Water infiltration from rain or leaks;  
Rising damp from the ground; Lack of protective overhangs  
or drainage; Use of non-breathable surface coatings;  
Hair cracks allowing moisture ingress*

*Location: exterior wall painting*

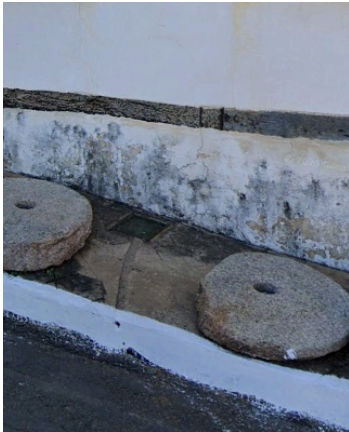
*Decay: Rising damp*  
*Possible Causes: Degraded or failed damp-proof barrier;*  
*Capillary action drawing moisture from the soil into the masonry;*  
*Soil in direct contact with stone walls without protection;*  
*Use of impermeable plasters or coatings trapping moisture inside;*  
*Water accumulation around the foundation due drainage failures*  
*Location: exterior wall*

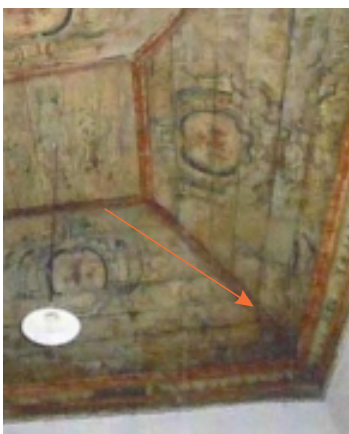
*Decay: Mold*  
*Possible Causes: High indoor humidity levels; Poor ventilation in the room;*  
*Roof leaks allowing moisture to reach the wood; Condensation forming on*  
*the wood surface; Lack of protective coating or sealant on the wood;*  
*Thermal bridges causing localized dampness; Organic dust accumulation*  
*acting as a food source for mold; Inadequate insulation leading to*  
*temperature differences and moisture buildup*  
*Location: gamela ceiling*

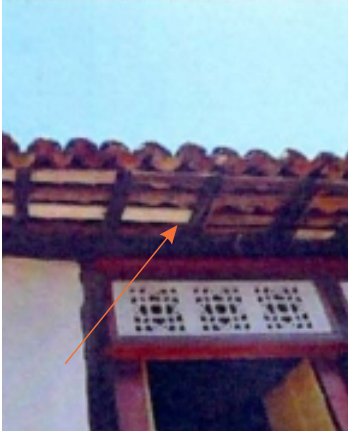
*Decay: Wood-decaying fungi*  
*Possible Causes: Persistent moisture infiltration;*  
*Water trapped between tiles and wood;*  
*Failure of protective coatings.*  
*Location: Roof eaves*

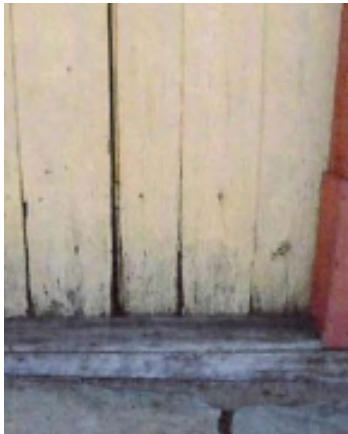
*Decay: Wood-decaying fungi*  
*Possible Causes: Persistent moisture infiltration;*  
*Water trapped between paint layers and wood; High wood*  
*moisture content; Failure of protective coatings.*  
*Location: Door*

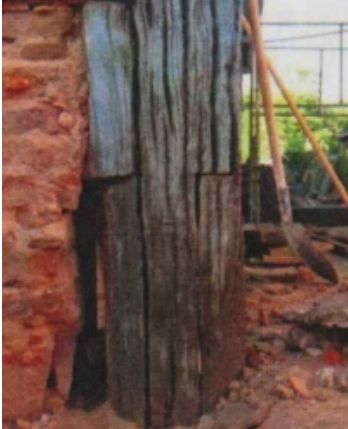
*Decay: Wood-cracks  
Possible Causes: Loss of moisture causing contraction;  
Rapid or uneven drying; Internal stresses in the wood grain;  
Natural wood defects; Expansion and contraction cycles;  
Use of green wood; Mechanical stress or overloading;  
Aging and long-term weathering  
Location: Pillar*

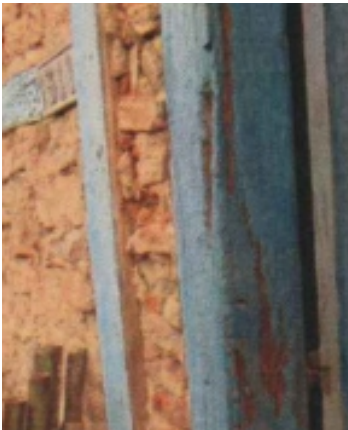
*Decay: Wood-cracks  
Possible Causes: Loss of moisture causing contraction;  
Rapid or uneven drying; Internal stresses in the wood grain;  
Natural wood defects; Expansion and contraction cycles;  
Use of green wood; Mechanical stress or overloading;  
Aging and long-term weathering  
Location: Jamb*

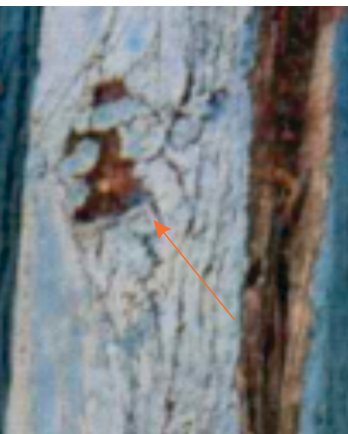
*Decay: Craquelé in Paint  
Possible Causes: Wood movement due to humidity changes ;  
Application of paint over an unstable or dirty surface; Incompatible  
paint layers; Aged or degraded wood under the paint; Painting over  
a surface with residual moisture; Excessive paint thickness or poor  
layering; Sun and weather exposure causing thermal stress;  
Use of low-quality or expired paint  
Location: Jamb*

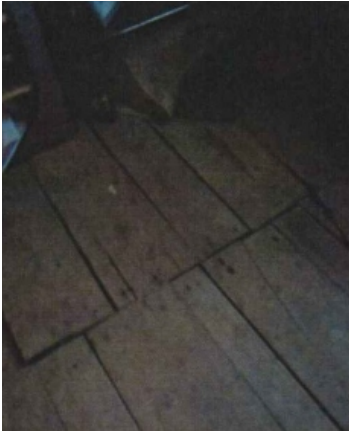
*Decay: Wood bending*

*Possible Causes: Excessive moisture absorption (from below or above the floor); Improper acclimatization of the wood before installation; Uneven subfloor or structural movement; Use of green or insufficiently dried wood; Thermal expansion due to temperature changes; Improper fastening or installation techniques; Incompatible adhesives or finishes trapping moisture*

*Location: Barrote floor*

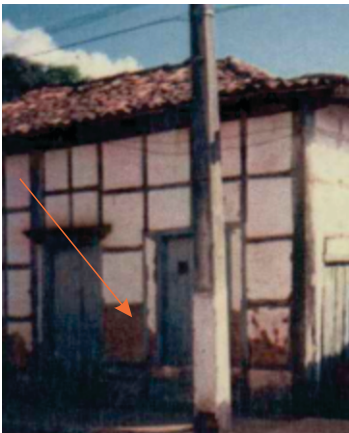
*Decay: Delamination*

*Possible Causes: Excess moisture; Incompatible materials; Rapid drying; Poor adhesion between layers; Structural movement; Incorrect mix composition*

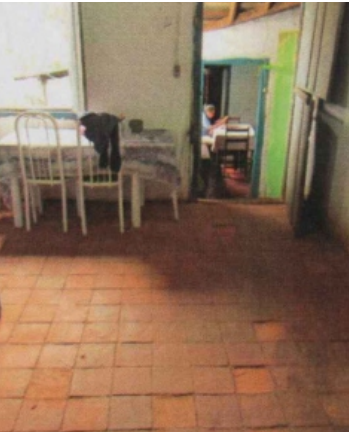
*Decay: Abrasion*

*Possible Causes: Frequent foot traffic or friction from furniture; Use of a weak or overly sandy earthen mix*

*Moisture fluctuations weakening the surface; No regular maintenance or reapplication of protective layers; Vibration or structural movement*

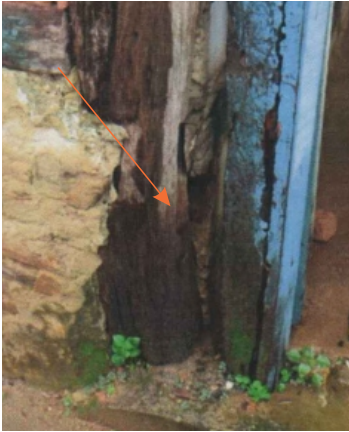
*Decay: Wood-decaying fungi*  
*Possible Causes: Persistent moisture infiltration;*  
*Water trapped between paint layers and wood;*  
*Failure of protective coatings.*  
*Location: Pillar*

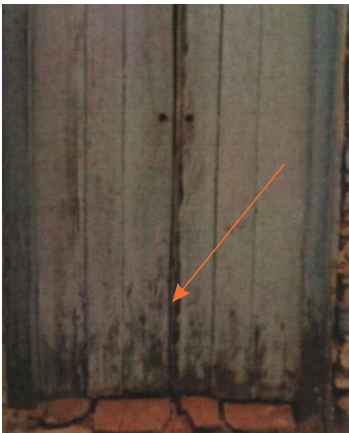
*Decay: Wood-decaying fungi*  
*Possible Causes: Persistent moisture infiltration;*  
*Water trapped between paint layers and wood;*  
*Failure of protective coatings.*  
*Location: Door*

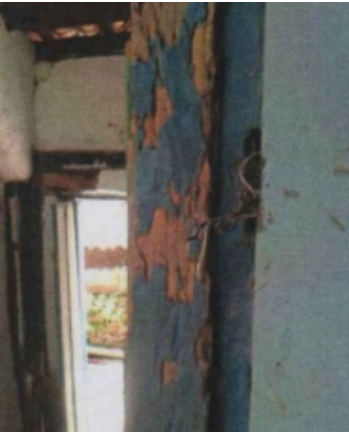
*Decay: Wood-boring insects*  
*Possible Causes: Use of untreated or unprotected wood;*  
*Lack of preventive chemical treatment; Wood in direct contact*  
*with soil or damp masonry; Cracks or openings allowing*  
*insect entry; Warm and humid environments favorable to insect activity*  
*Location: Jamb*

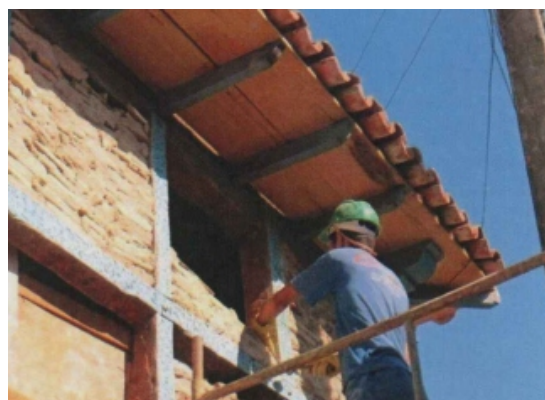
With the removal of the superficial plaster, it was found that the half-timbered facade walls were partially made of stone and adobe. Due to the observed damage, a total or partial reconstruction of the panels was chosen. The wooden structures of the wattle and daub were restored or replaced, respecting the traditional dimensions and joints. In the case of the wattle and daub panels, traditional techniques of wood locking and clay filling were

Total or partial reconstruction of the panels in the stone walls

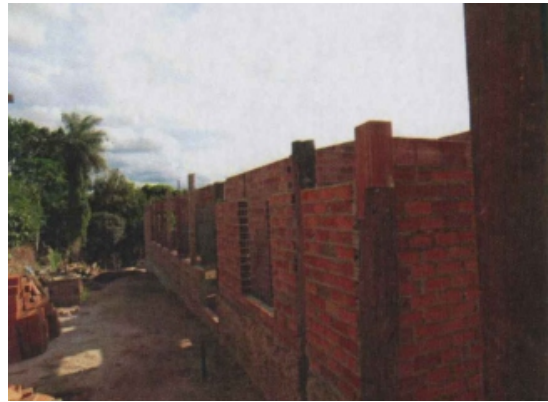
SC.EH. - Walls made of hollow bricks and cement

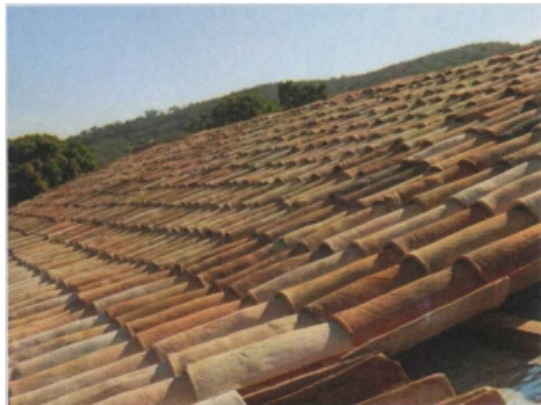
SC.EH. - Annex roof: simulating colonial tiles

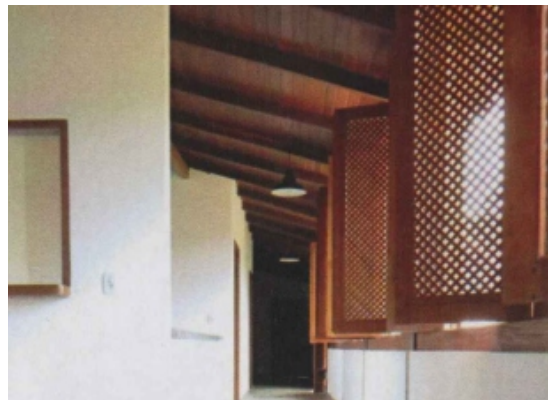
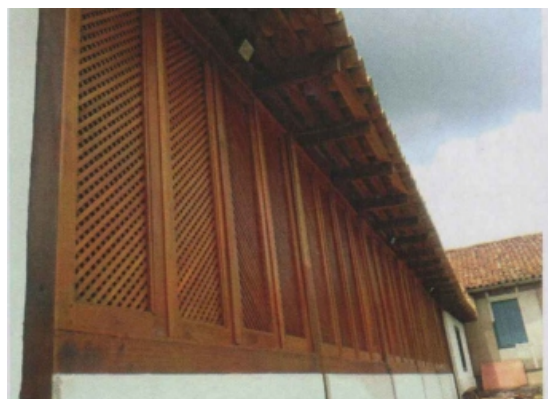
This means one must not to attempt to imitate or falsify the colonial style or use materials that artificially recreate the language of the period. The intervention should be legibles as contemporary, without competing volumetrically or formally with the existing building. This was not the case at the Enxaimel House (Figure 116), where elements like mashrabiya closely

SC.EH. - Annex mashrabiya
