RIALTO LIVING

Detailed Technological
Analysis of Buildings of the
Highest Environmental Quality

Detailed Technological Analysis of Buildings of the Highest Environmental Quality:

Analysis of Rialto Living, Palma de Mallorca

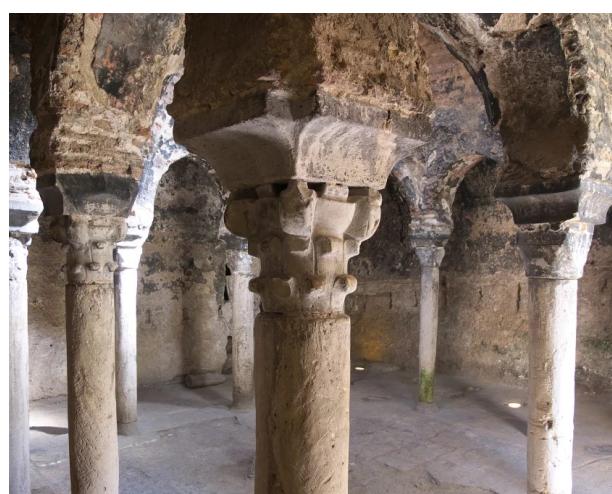
06 Columns of Banys Arabs
source: see-mallorca

Another interesting point is the Moorish structures, most famously Banys Arabs (**06**), and it is possible to spot the different columns used during construction. The assumption is that they were salvaged from the ruins of Roman buildings after capturing the island, showing us a very early example of material recycling. With this diverse collage of architecture existing, some key elements can be found in the historical center of Palma that is repetitive and intertwining, thus identifying what could be described as Palma's architectural characteristic. Next up, there is a close-up analysis of some architectural elements that are very typical.

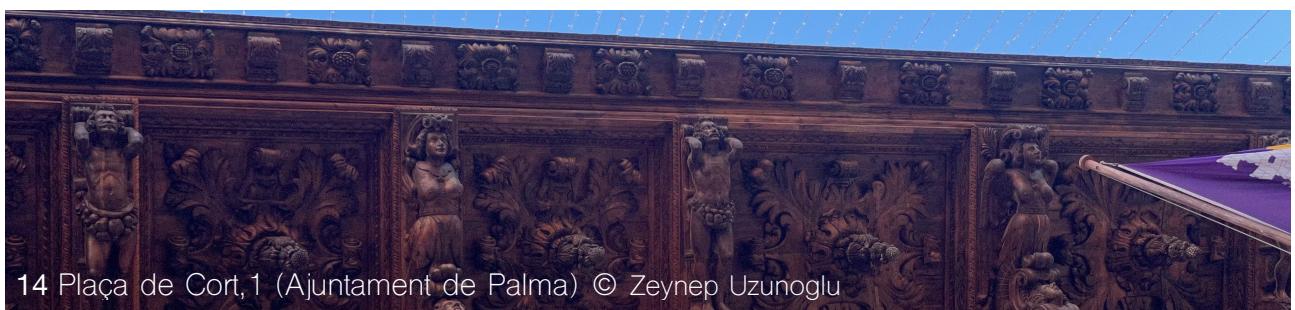
14 Plaça de Cort, 1 (Ajuntament de Palma) © Zeynep Uzunoglu

One of the most famous ones belonging to the Ajuntament de Palma (**14, E2**) protrudes 3 meters outwards and is considered a National Monument.

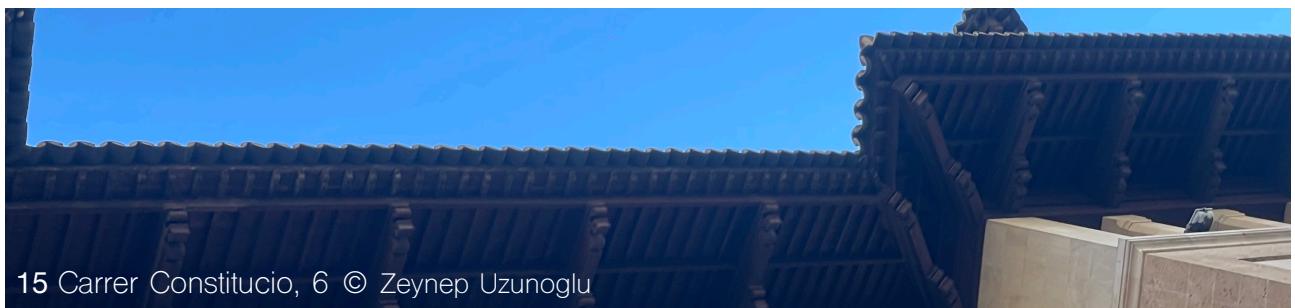
15 Carrer Constitucio, 6 © Zeynep Uzunoglu

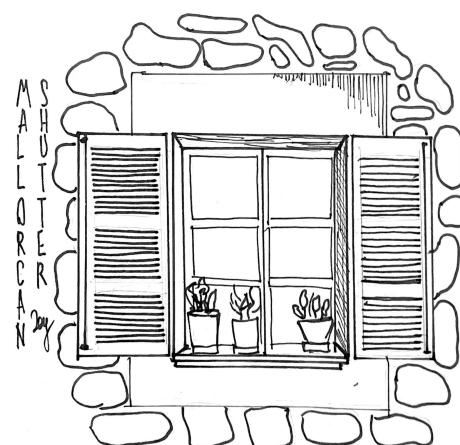
E3 Window with a Mallorcan Shutter

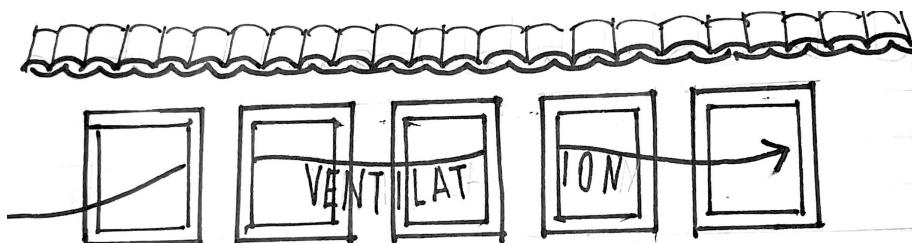
E4 Array Windows
of the Case Study
Buildings

Another thing that captures the attention of a passerby is the arrayed windows on the attic floors of the apartments.

Paris, back when these apartments were one complete residence belonging to the families of wealth, the attic floors were created solely for staff quarters or furniture storage. Furthermore, it creates good heat insulation and ventilation for the floors below where the family lived.

Currently, the attic floors are also a good accommodation space considering the high amount of daylight it is getting.

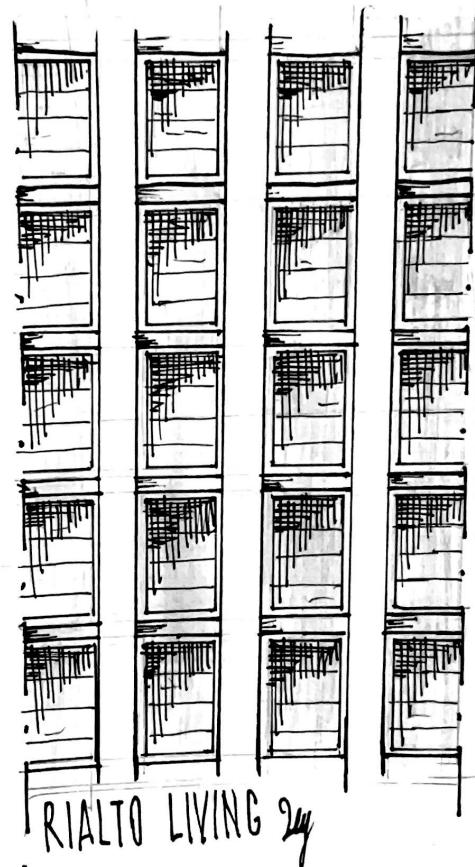
E5 Coffered Ceiling Pattern of Rialto Living

Coffered ceilings are a huge part of the hybrid architectural style of Palma, remaining from both the Moorish period and the Renaissance era. ‘Coffer,’ meaning a ‘sunken place in the ceiling,’ is used to hide imperfections and create an illusion of height in the room. As necessary as they are, exposed structural beams were considered unaesthetic in classical architecture, so other beams were built nearby to create visual symmetry and hide the structural beam.

‘Although hollows are sometimes used for structural weight distribution, coffers have always been used decoratively. Historically, a coffered ceiling can make a room look larger and more regal’ (J.Craven, 2018), and palaces being a symbol of social status for the upper-class families in Palma, it was a commonly used element.

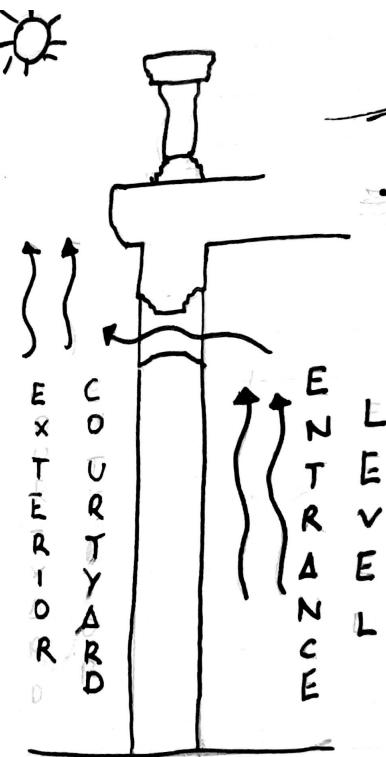
E6 How Air Travels from the Porthole

"Ojos de buey" is Spanish for "ox eyes," Ojos de buey are typically found in traditional Spanish architecture, particularly in houses and other buildings built in the Spanish colonial style.

In recent times, architects and designers have been reviving the use of ojos de buey in new construction, both for their functional and aesthetic benefits. They are increasingly being used in contemporary architecture as a way to bring a touch of traditional Spanish style to a building while also providing natural light and ventilation.

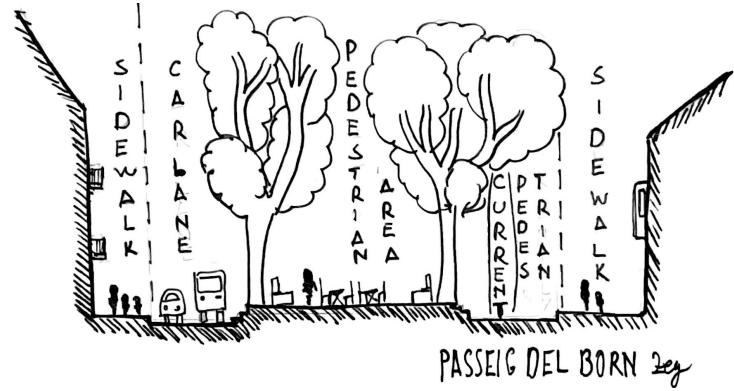
47 E7 Section Sketch of Passeig Del Born

Passeig del Born is a touristic boulevard with high-end fashion stores and cafes; it is arguably one of the most elegant avenues of Palma, which gave it the nickname 'Golden Mile.' It consists of a central pedestrian area with shading, trees, and benches; car lanes for each direction on its sides (currently, only one is active as a pedestrian passage) (**E7**); enclosed by buildings of typical Palma architecture. It goes perpendicular to the port of Palma and is 100 meters from two of the most popular landmarks, the Cathedral of Palma and the Medieval Palace of Almudania. The total length of the boulevard is roughly 300 meters, and it was built on the old riverbed Riera. (**M5**)

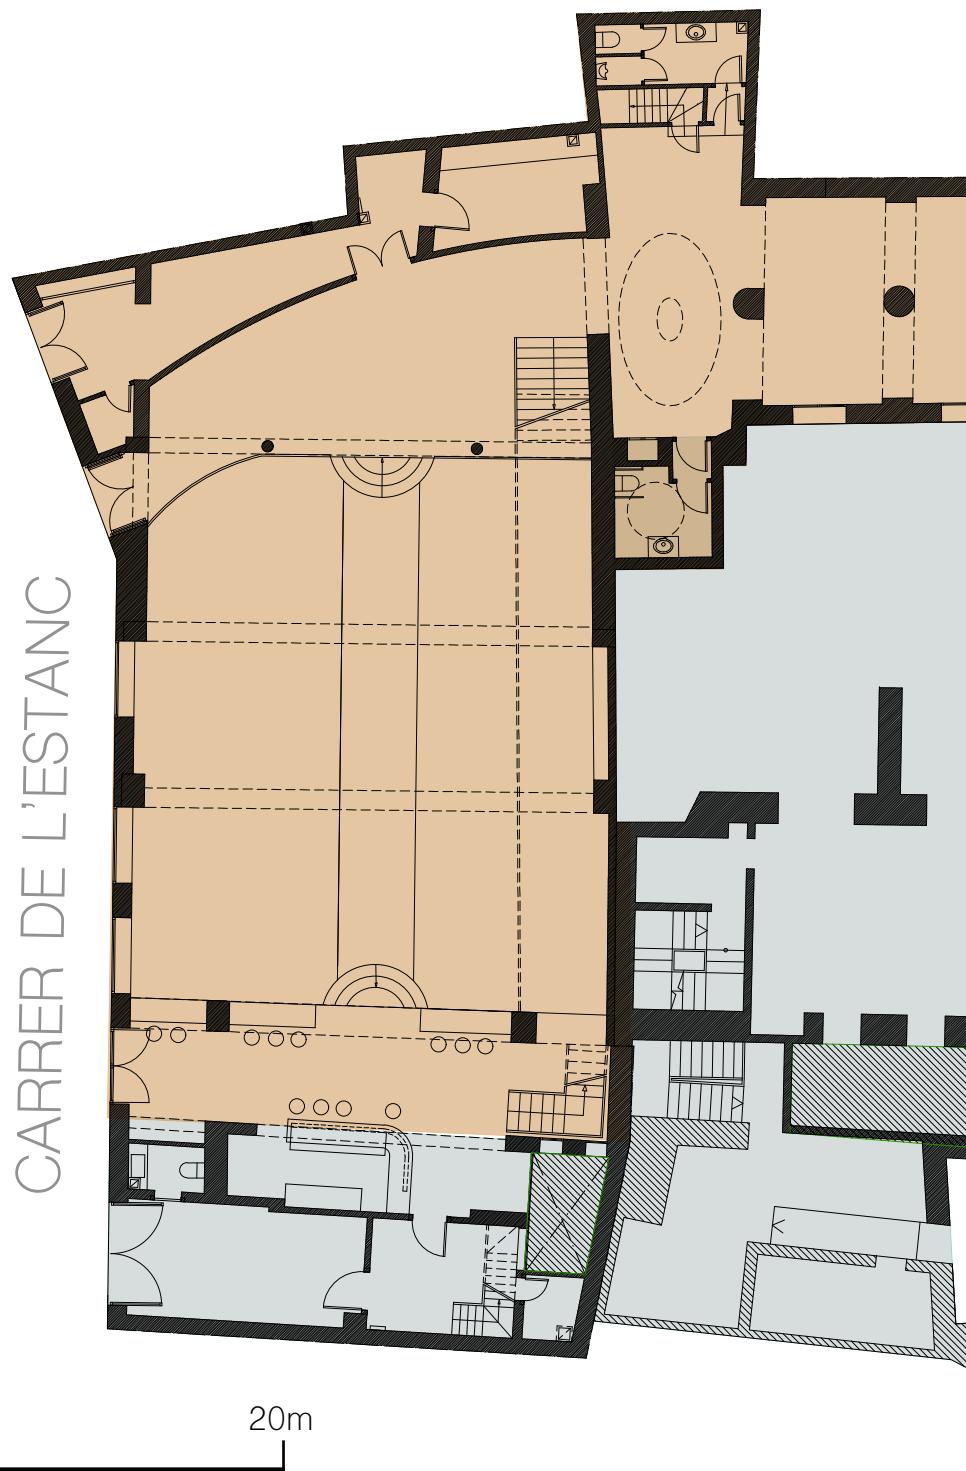
D1 Rialto Living Ground Floor Plan Acquisition Diagram
Scale: 1:200

Previously public junk yard, area
acquired for Rialto Living in 2011

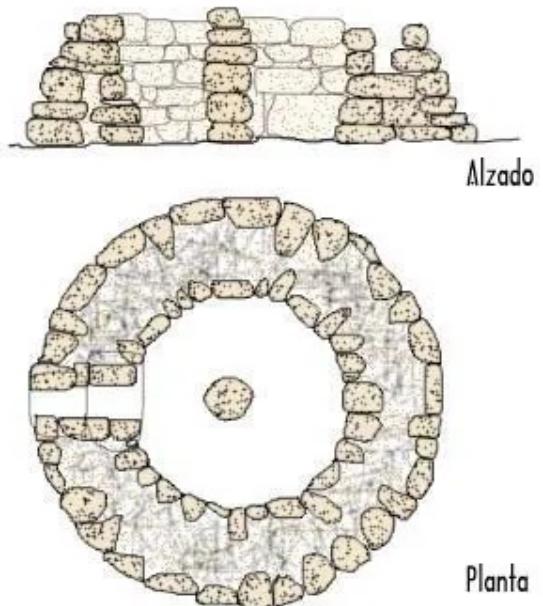
52 Plan & Section Illustration of Talaiots © esascosas.com

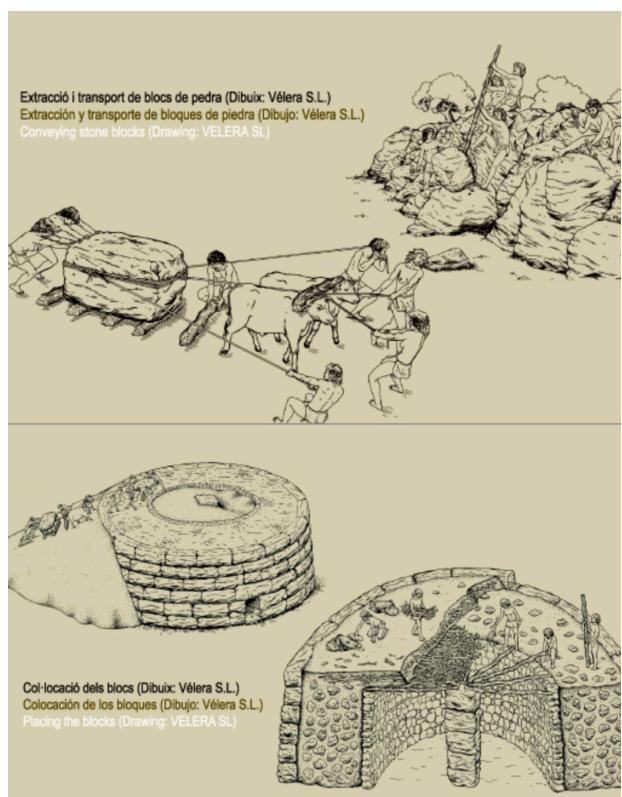
53 Illustration of Construction of Talaiots
© Valeria S. L.

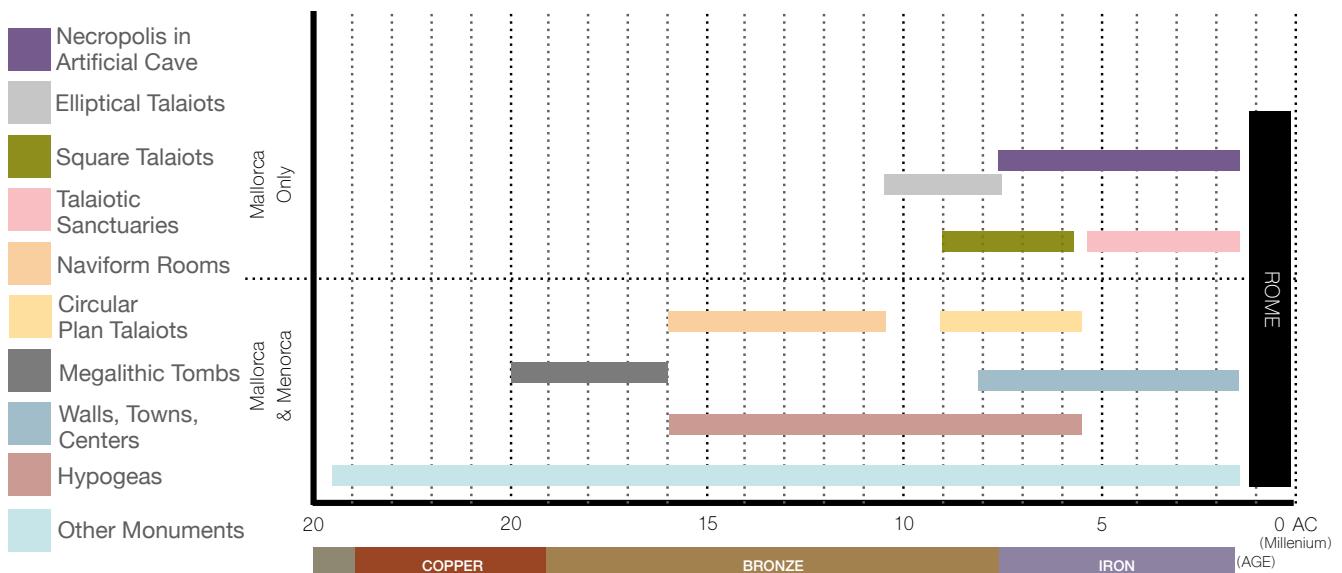
S5 Construction Types of Stone in Mallorca Timeline (Source: talaiots.es)

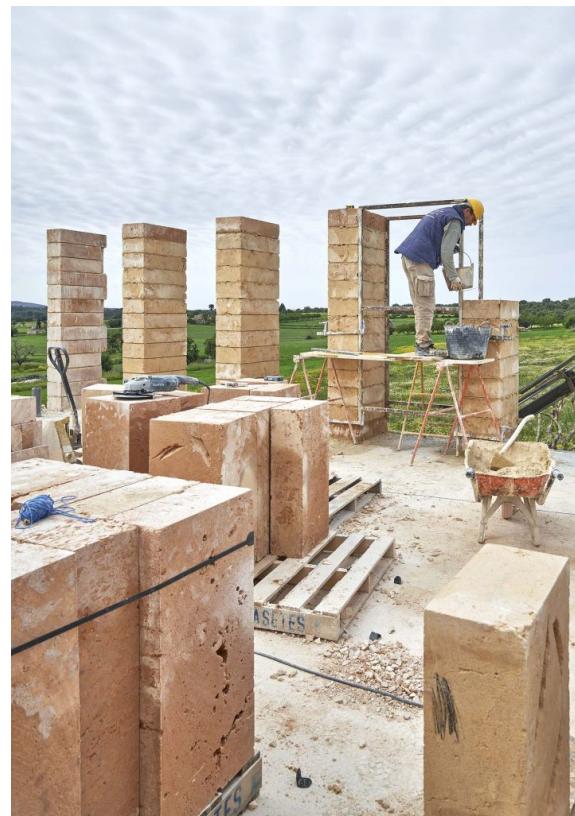
55 Marès Stone in Construction
© Wikipedia

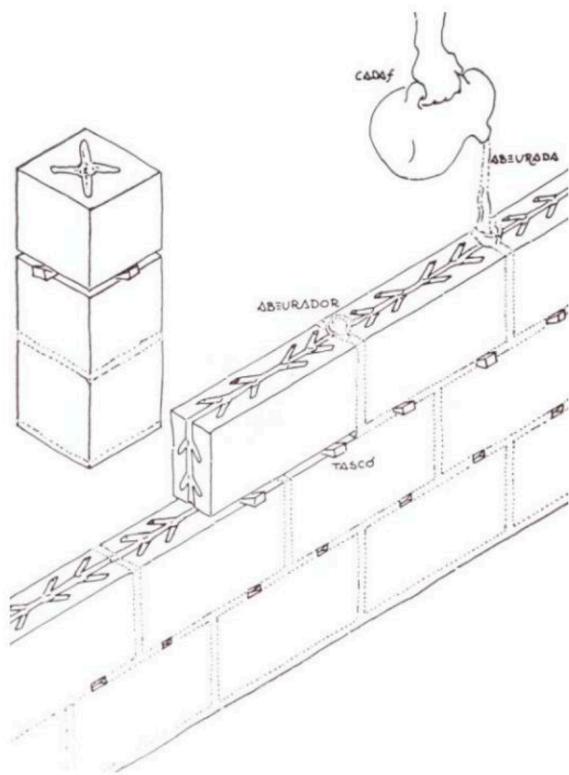
E8 Building a Marès Wall

Once the foundation of the building is finished, the first row of marès is laid, approximating around 20cm, and a continuous herringbone line is created on

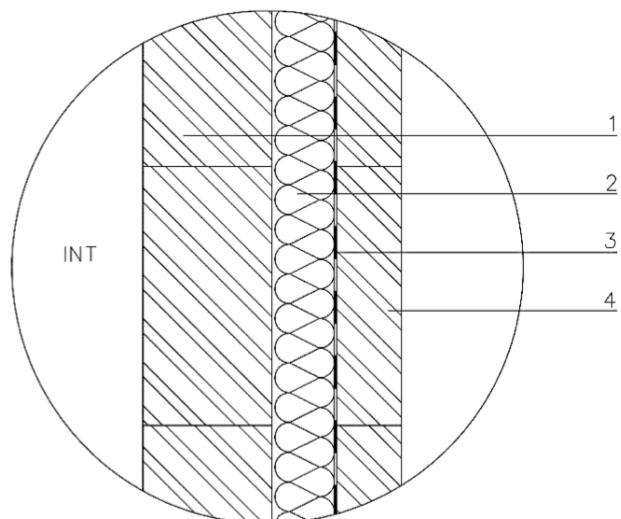
1. Marès Block (approx. 20cm)
2. Thermal Insulation (approx. 10cm)
3. Waterproofing Sheet
4. Marès (approx. 10cm)

E9 Typical Example of a Marès Wall

Finally, the 10 cm thick marès block must be placed the same way as the thicker first block of marès to create a partition for the rainwater. (**E9**)

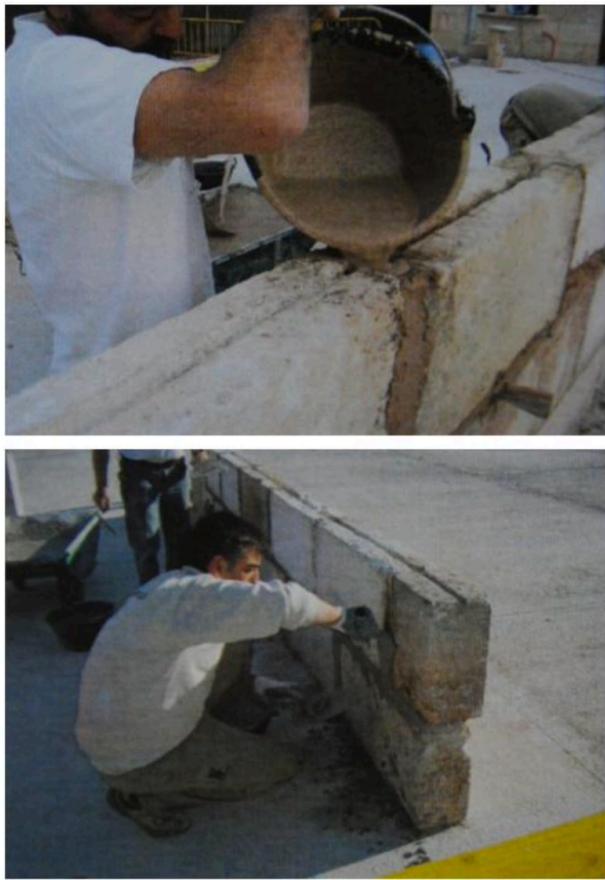
57 Building a Marès Wall
© Sanchez Cuenca (2010)

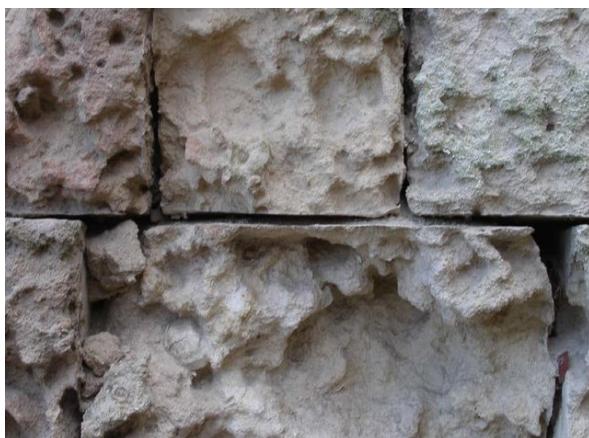
59 Alveolization of Calcarenite as an Example of the Phenomenon
© Ippolita Mecca (2016)

The action of the wind is not due to its erosive force but rather because it aggravates the crystallization phenomena by drying the surface. On the other hand, it drives these crystals into the holes in the stone, producing the so-called alveolization (59) (hollows or alveoli). (Ramis, 2003)

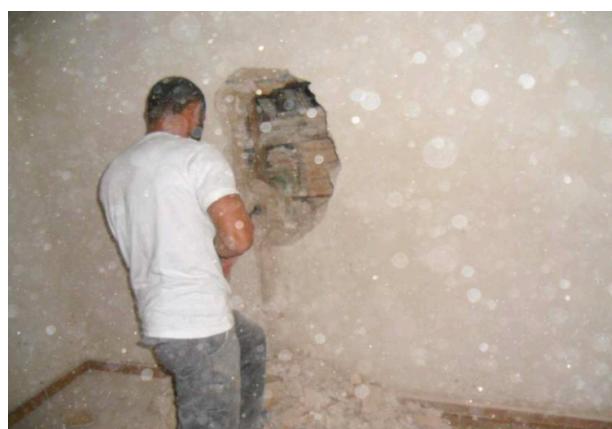
61 Drilling a Hole on the Wall of Rialto Living
© Bastidas Architecture

The initial action was to drill a hole in the wall at room 0.08 (**D8**) to verify the thickness of the existing volume, which did not correspond to the plans archived at the COAIB. (Collegi Oficial d’Arquitectes de Islas Baleares)

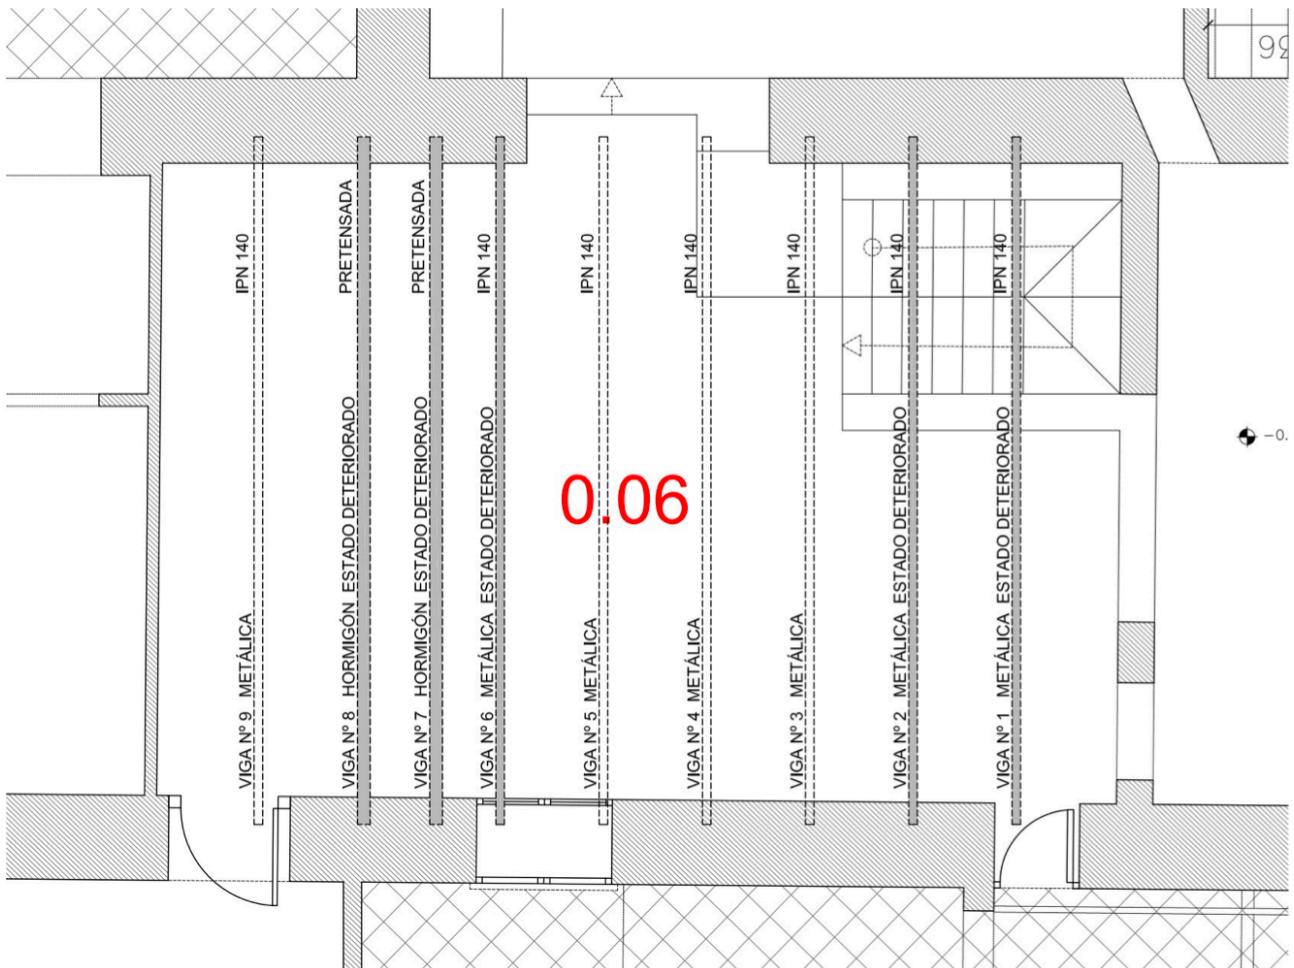
D2 Deteriorating Joists(Vigas) on Room 0.06 (Scale: Unscaled)

0.10 on the east wing of the building; all seven existing beams were described as deteriorating. The inspection of the beams proceeded, followed by the metal joists inspected around the building; the drawing of the kitchen, room numbered 0.06, can be seen as an example where 5 out of 9 of them were documented to be deteriorating. (**D2**)

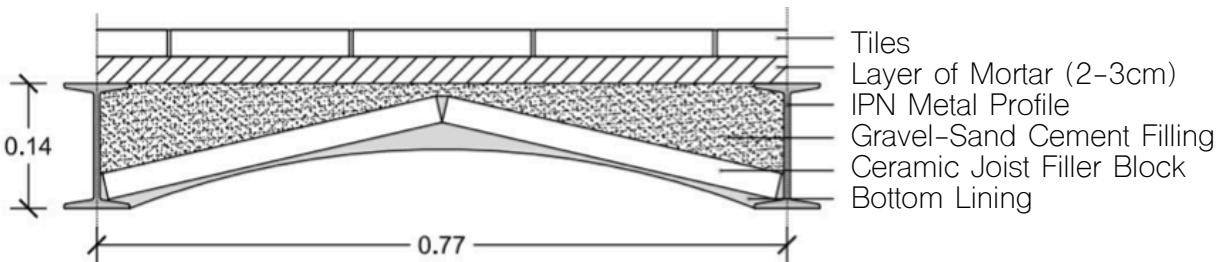
D3 Detail Lattice Section of Room 0.05 (Scale: Unscaled, Unit: m)

The condition of the metal and concrete joists on the garage ceiling, room number 0.05, is checked. Out of 18 metallic joists, 13 of them were reported to have deteriorated (**D4)(62**), and four stone corbels sized 20x18 cm were in a healthy state (**63**). Detail section of the lattice (**D3**) and a detail of the support of the joists on the stone corbel (**D5**) were added to understand the materials used in the original structure.

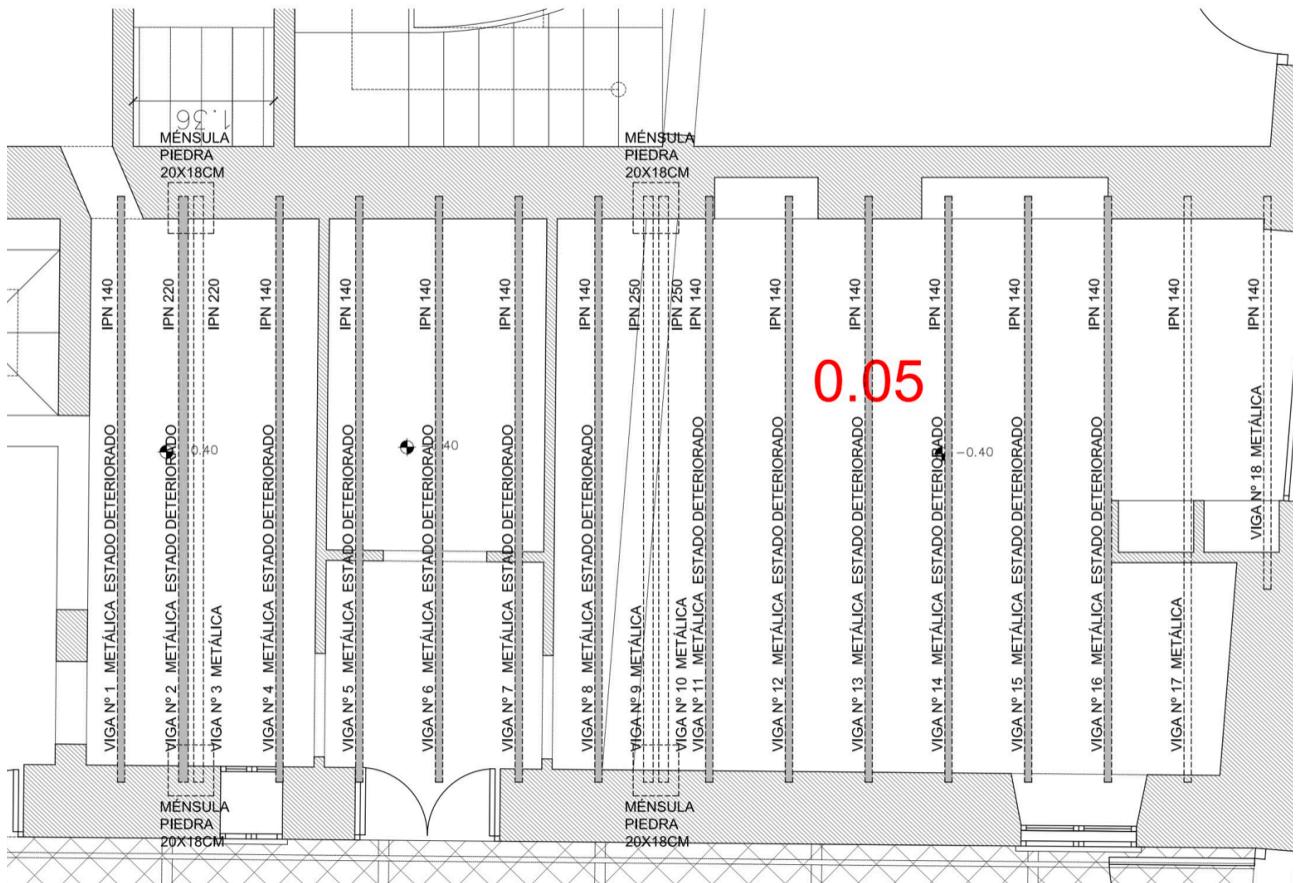
D4 Deteriorating Joists(Vigas) and inspected Stone Corbels (Mensula Piedra) on Room 0.05 (Scale: Unscaled) Source: Bastidas Architecture

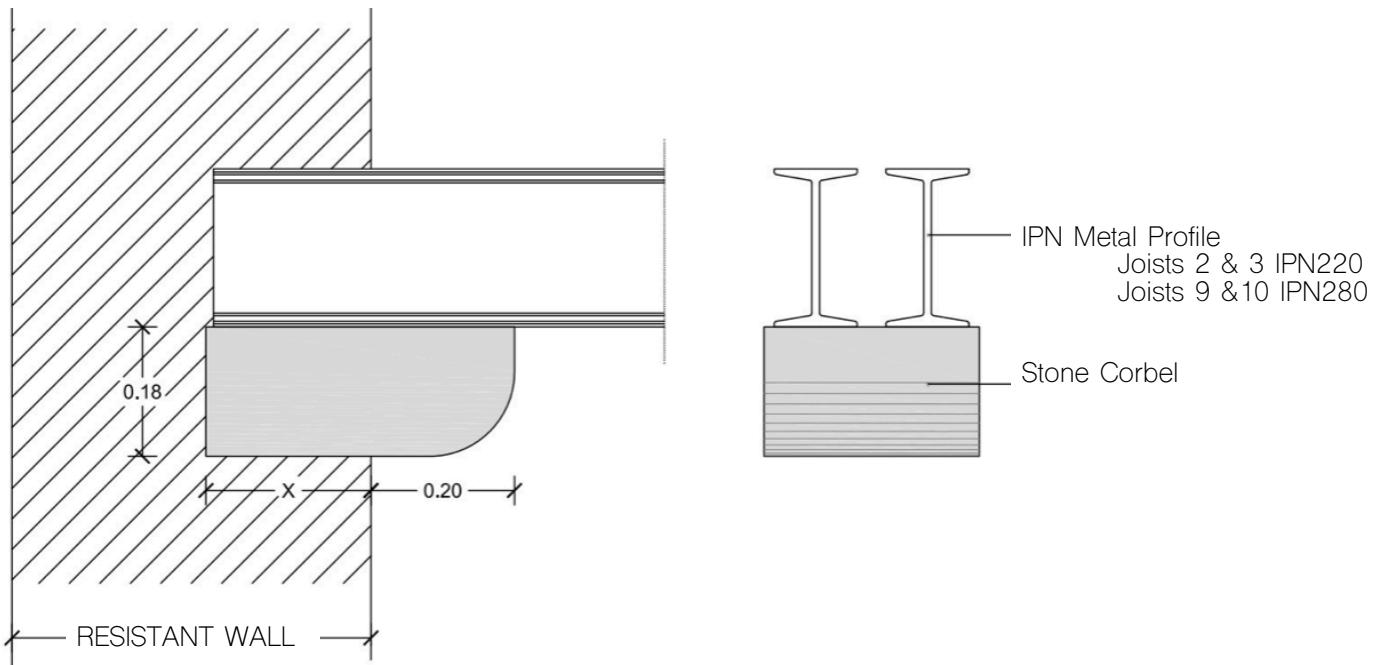
D5 Support of the Metal Joists on Stone Corbels (Mensula Piedra) of Room 0.05 (Scale: 1:10, Unit: m) Source: Bastidas Architecture

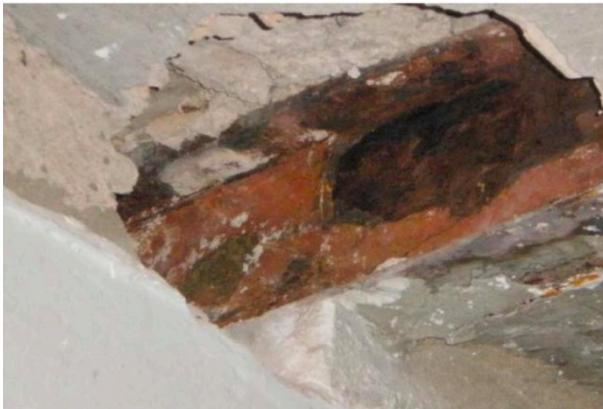
62 Deteriorating Metal Joists in Room 0.05
© Bastidas Architecture

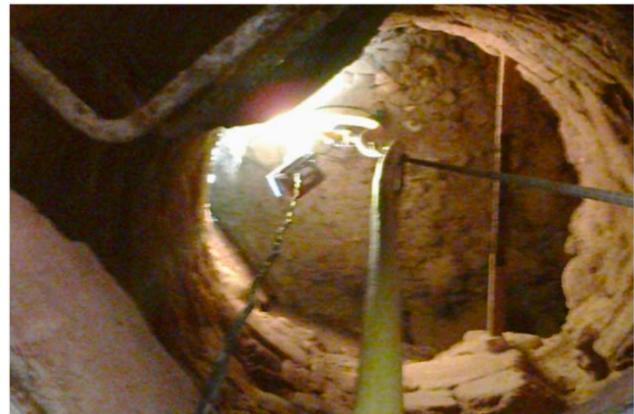
64 Well Found in Room 0.03
© Bastidas Architecture

Also, a gate was uncovered in the patio, numbered 0.03, and a cistern or well was observed. Due to the limits not being visible and the seeming existence of “lateral caves,” it was emptied, and the next day the water level recovered. The report concluded that there was a well. (64) Currently, this well is located in the basement storage of Rialto Living. Although the owners Bergman and Kall wanted to elevate the system to the ground floor for visitors to see it, it was

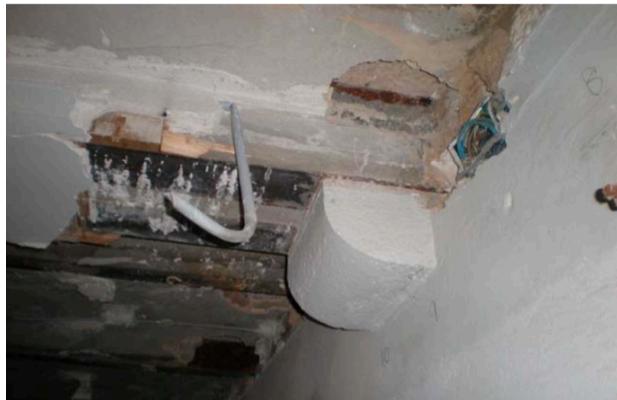
63 Stone Corbels in Room 0.05
© Bastidas Architecture

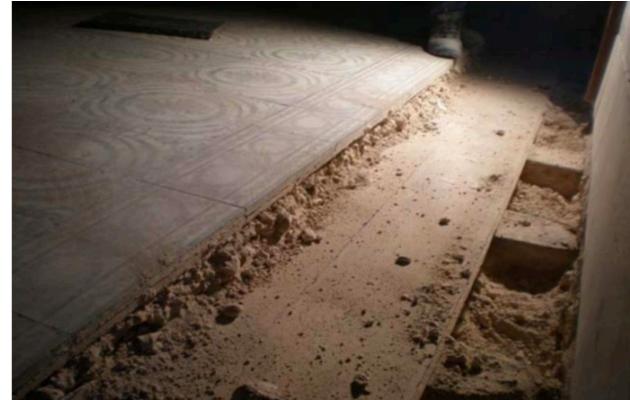
65 Meeting Between Coffered Ceiling with the Façade at Room 1.16
© Bastidas Architecture

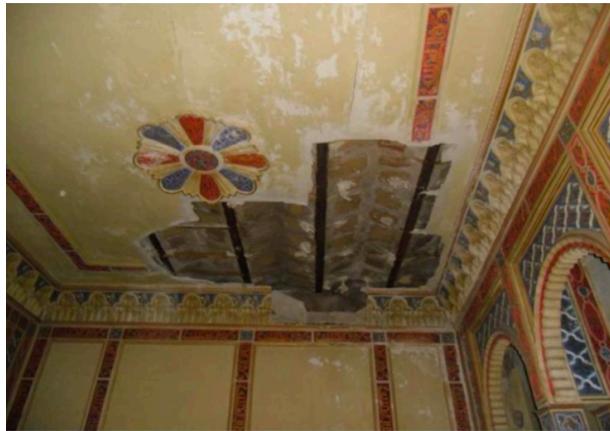
66 Partially Removed False Ceiling in Room 1.02 © Bastidas Architecture

False ceilings were removed to value each slab’s overall state of conservation of each slab, not just specific areas (66). In ceilings with unique decoration, a sample was left intact for later reproduction if so decided.

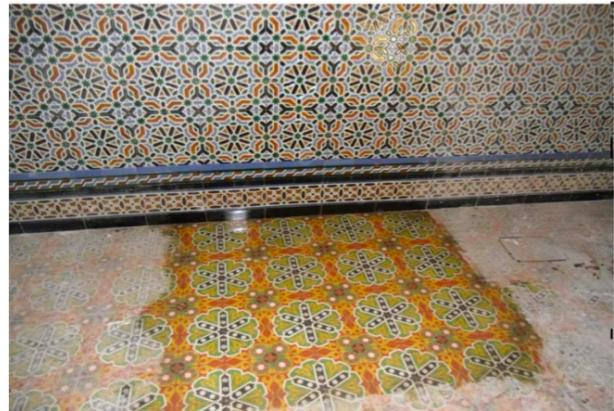
67 Cleaned Hydraulic Tiles in Room 1.02
© Bastidas Architecture

Since the project prioritized the reuse of the materials, 1m² of various hydraulic tiles was cleaned (67) to assess the possibility of reusing them and integrating

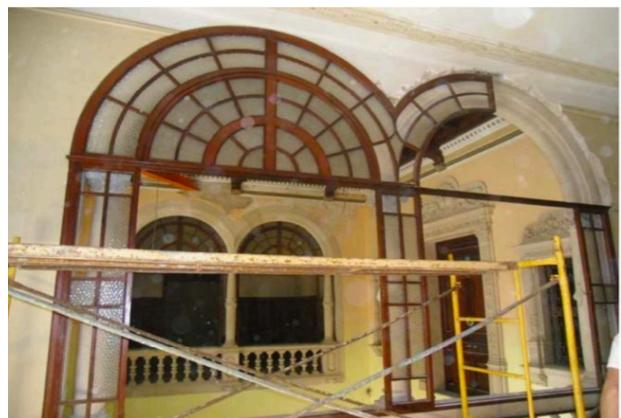
68 Removal of Carpentry in Room 1.12 © Bastidas Architecture

them into the design. The same procedure was applied for carpentry, especially the interior glass doors and windows (68); they were removed and stored for possible reuse.

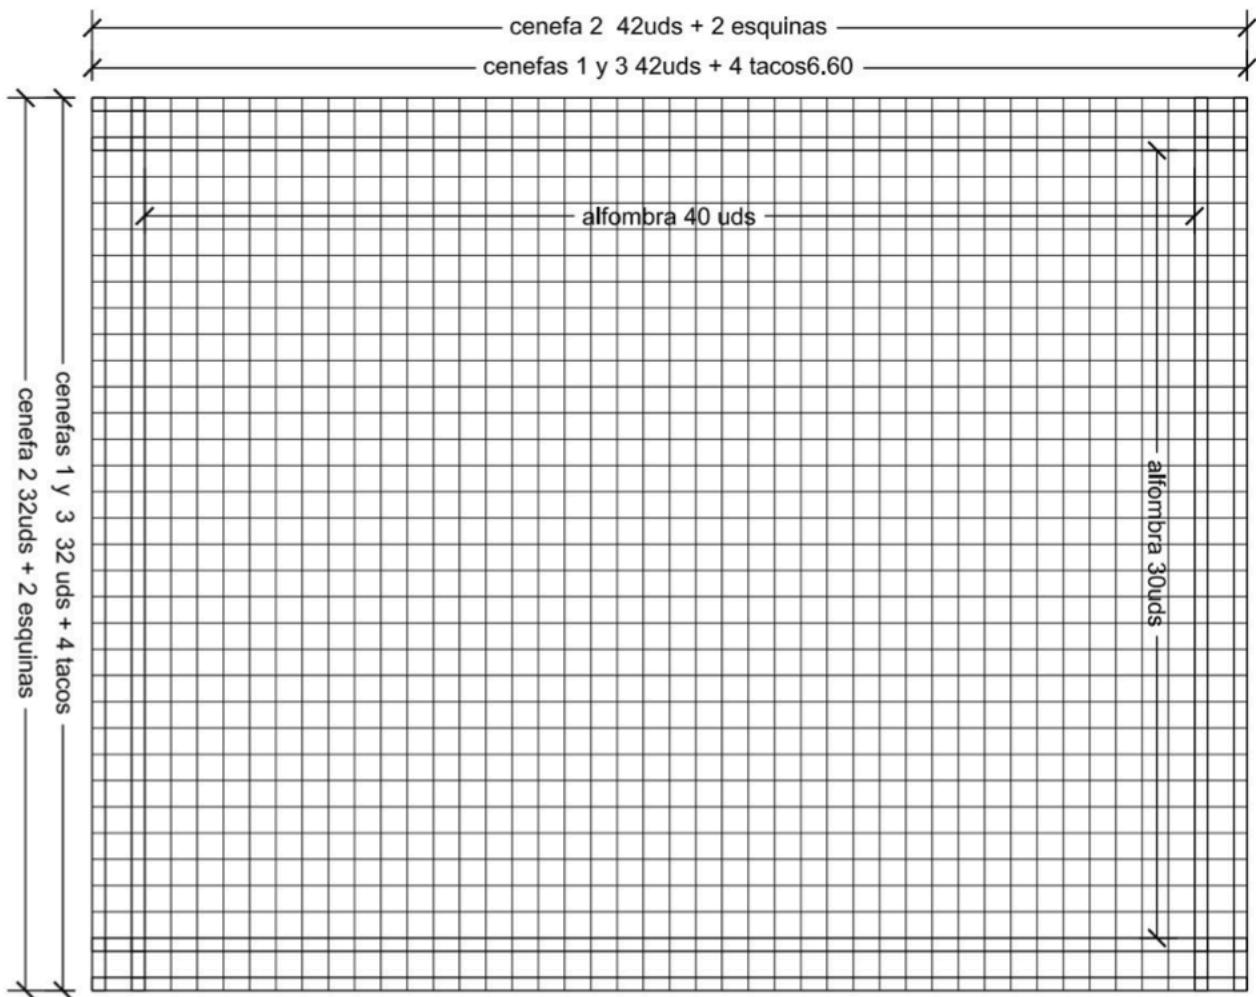
D18 Hydraulic Tile Pattern Identification of Room 1.15 (Alfombra:Tile Carpet, Cenefa: Borders, Tacos: Studs) © Bastidas Architecture

Scheme identification of the hydraulic tile patterns was documented for each room’s actual state; as seen in the example of room 1.15, the dimensions and linings were written (D18)(69)(E10).

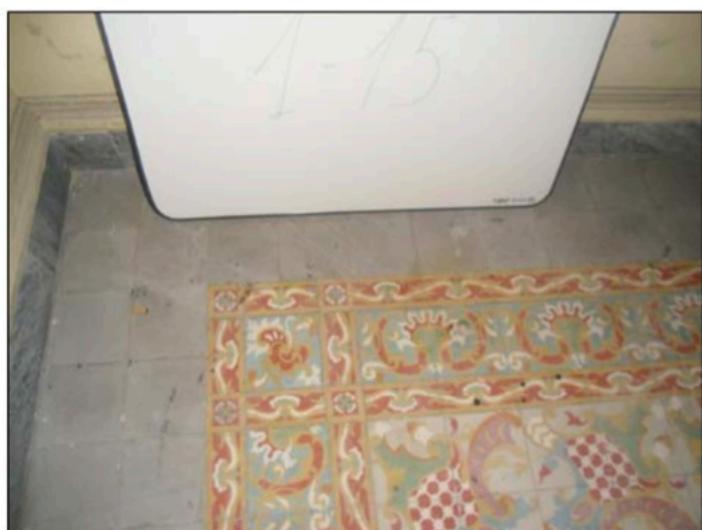
69 Borders and Studs of Hydraulic Tile Carpet of Room 1.15
© Bastidas Architecture

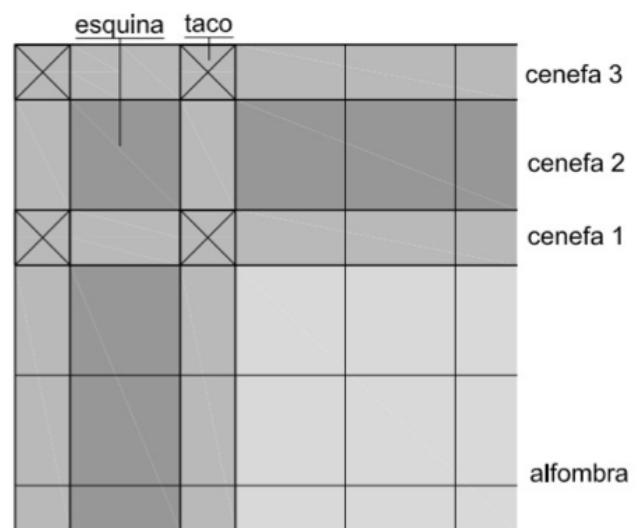
E10 Borders of the Tiling of Room 1.15
© Bastidas Architecture

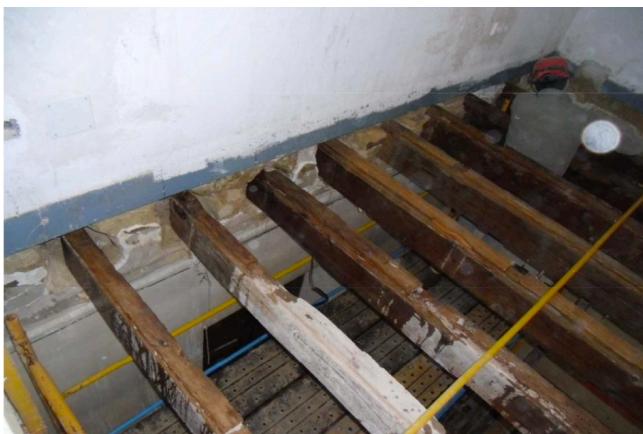
70 Beams at room 2A30

A significant fissure was observed in marés arches with particular affectation in the support area of the metal girder placed as a reinforcement for the wooden coffered ceiling. Preventive shoring of the zone was carried out. The healthy beam heads were discovered in room 2A30, the perimeter clearing was opened, and the beams were protected with an anti-woodworm product, plastic, plasterboard, and beam connectors were placed.

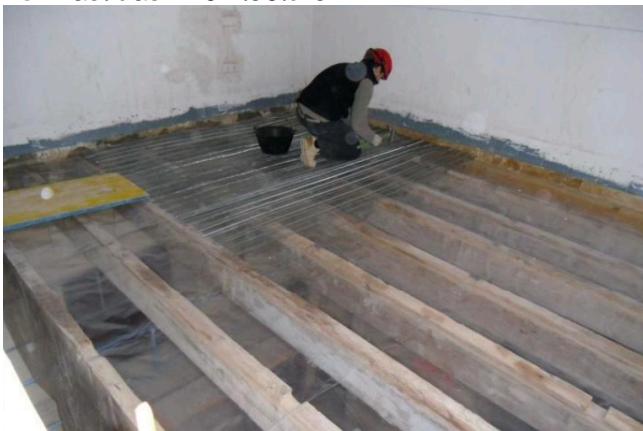
71 Rib Lath Placement on the Beams at Room 2A30

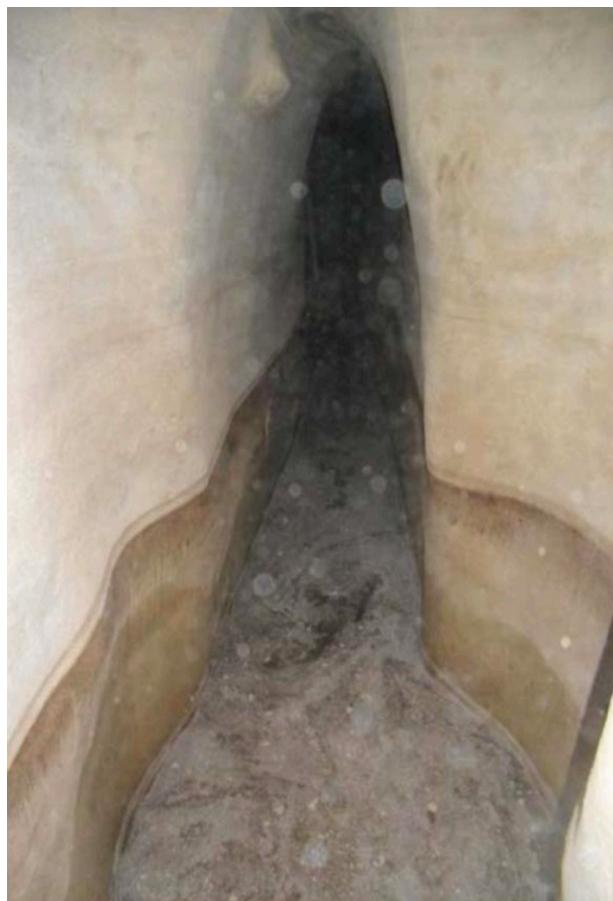
72 Extensions of the Cistern at the Basement

As a consequence of the emptying, demolition of partitions closing cisterns, and emptying of rubble from the interior, the existence of extensions of said cisterns in the subsoil was verified; the water passage can be seen in the image (72) with the scheme of cistern discovered on basement map. (D19) Internal rehabilitation was paused, and able to start the erection of external scaffolding on February 2013; also, the existing tower at the eastern wing of the building was started to get demolished.

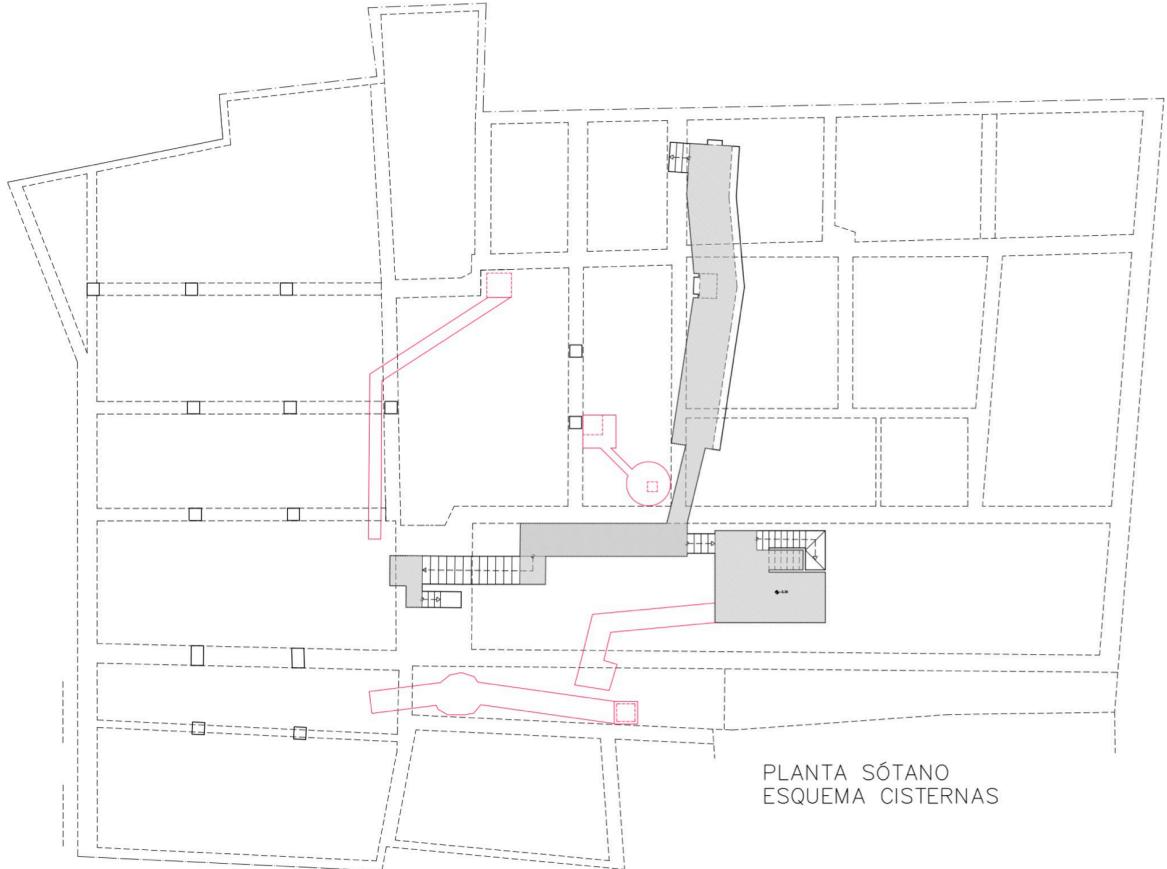
D19 Cistern Pathways Scheme on Basement Floor Plan, Pathways Market in Red (Unscaled) © Bastidas Architecture

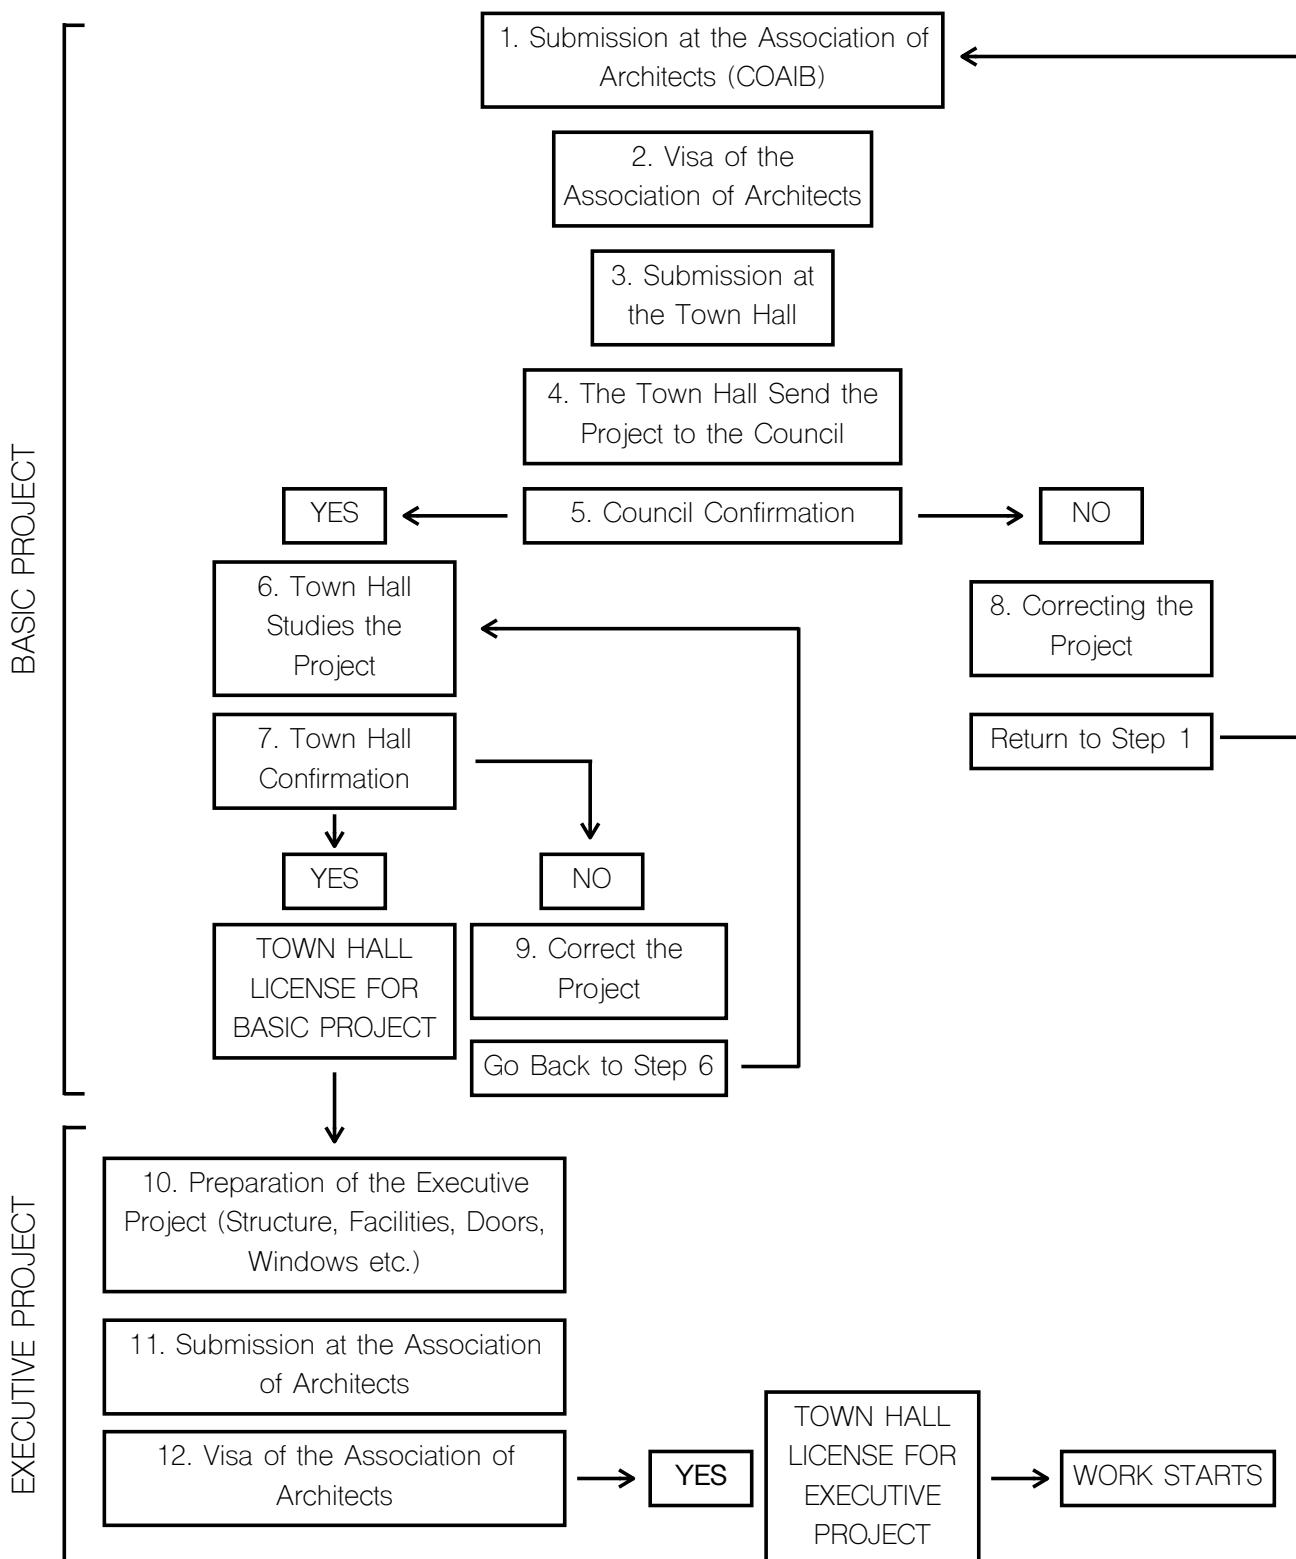
S6 Basic and Executive Project Approval Scheme to Start Construction in Palma de Mallorca
 Source: Bastidas Architecture

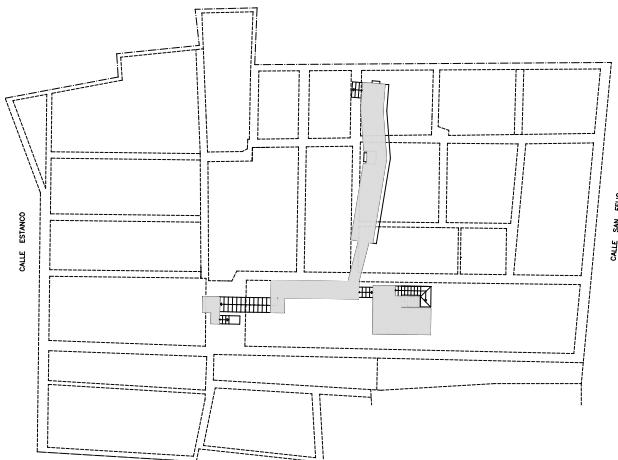
73 Basement Floor Existing State, D7
© Bastidas Architecture

Initially, eastern wing of the ground floor was planned to be used for the storage but considering the size of the building, it was concluded that the storage area wouldn't be enough, thus a storage room was constructed to the basement floor, paying attention to the report made by the archeologist to avoid intersecting the bunker and the cistern. (**D7 & D31**)

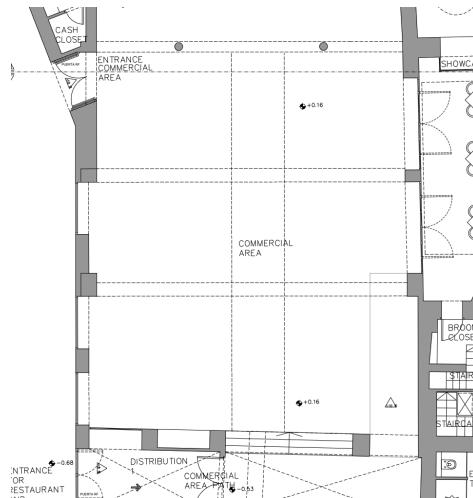
76 Ground Floor Basic Phase, D21
© Bastidas Architecture

Furthermore, the slope created previously for the movie theater was elevated and straightened during the Basic Phase, and some of the area was risen to match the height of the Rialto Cafe during the

Executive Phase, and slope was created to connect the lower and higher part for the disabled accessibility. (**D8, D21, D32**)
