RIALTO LIVING

Detailed Technological
Analysis of Buildings of the
Highest Environmental Quality

Detailed Technological Analysis of Buildings of the Highest Environmental Quality:

Analysis of Rialto Living, Palma de Mallorca

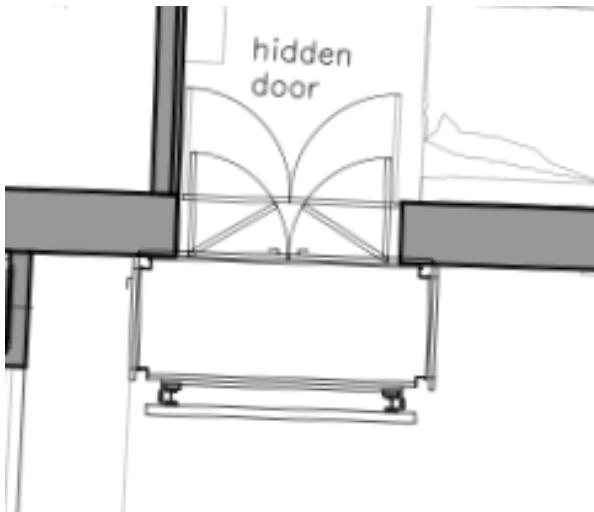
78 Service Elevator with Hidden Door, D34
© Bastidas Architecture

Total of 5 elevators were installed; two of them functioning only for ground and first floors and available for customers; one for the residents of the apartments functioning between the ground floor and

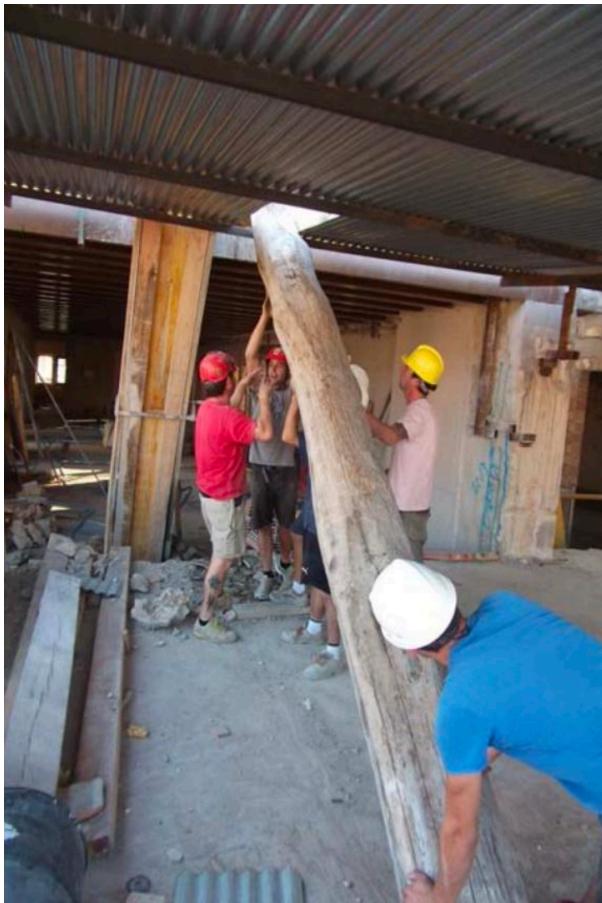
82 Removal of the Wooden Beams on Fourth Floor
© Bastidas Architecture

Considerably biggest extension to the building, the fourth floor was extended to be able to fit two apartments. The additional walls were built with brick and mortar. Wooden beams were removed from the roof (82), loaded, transported and ordered in the Can Ramis warehouse. Placement of new beams, wooden eaves, and a sandwich panel was put on the secondary apartment (83). Vapor barrier cloth, 5Kg/m² asphalt cloth, (with a layer of fiber mortar for protection), and traditional tile roof was placed (88). For the support additional HEB metal beams were used. The structural drawing can be seen at the next page. (D43)

The cantilevered Mallorcan roof was also restored and reinforced. (82) Zinc sheet was placed and tile eaves were formed. Closing is carried out with a brick wall, and eaves formed by means of recovered wooden joists and pending slopes of a conejero partition, as a tile covered base in the area where air conditioning machinery will be installed.

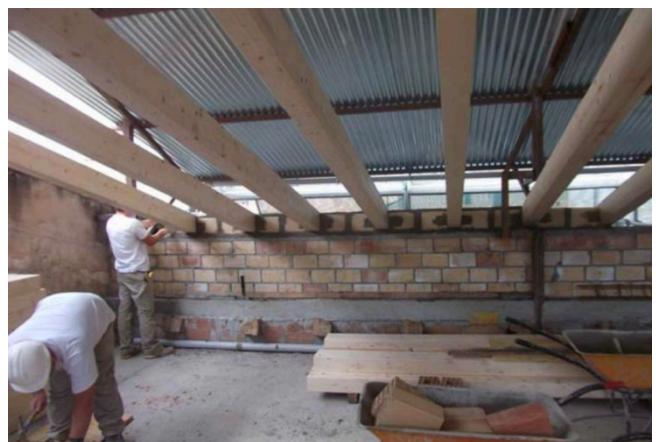
83 Installation of the Wood Joists on the Fourth Floor
© Bastidas Architecture

Laminated wood joists were placed on a metal structure in the bigger apartment. and terrace of fourth floor, including adjustment of beams by carpenter in connection with metal girder under hip. Work began with the placement of sandwich panel.

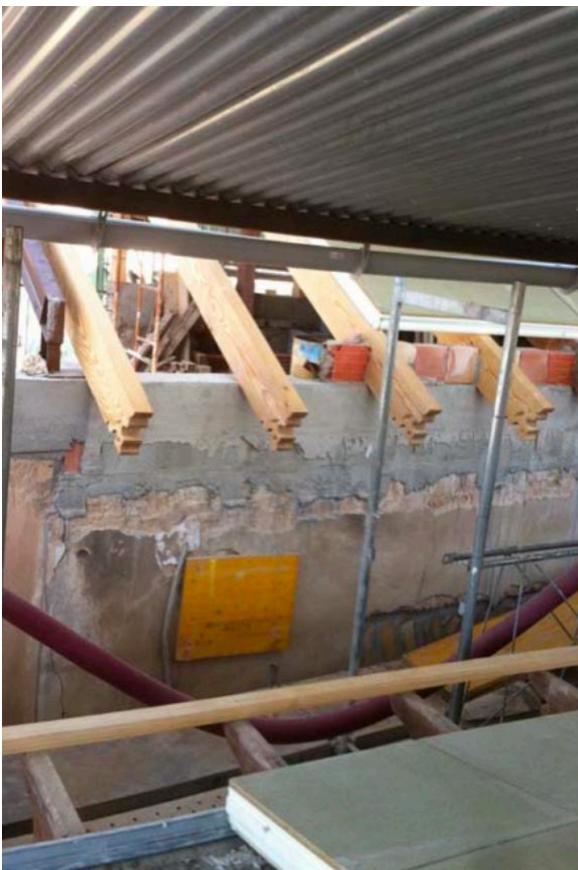
84 Cantilevered Roof Joists Installed After Restoration

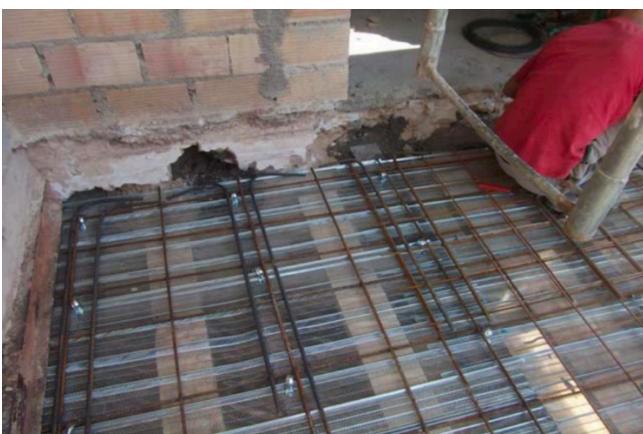
85 Formation of New Concrete Loading Bays in Area 3A26
© Bastidas Architecture

In area 3A26, demolition of the slab is carried out, formation of new concrete loading bays (85), placement of joists, reinforcements, and final concreting of the compression layer similar to the other zones to be reinforced after demolition of the existing floors is carried out.

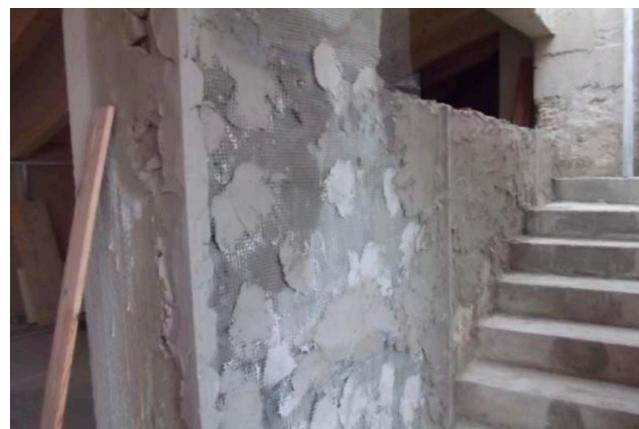
86 Existing Walls Before the KeraKoll

Biocalce Base Application

mortar was done with laying KeraKoll Biocalce Base. The choice of this material is due to the fact that the marès stone is highly reactive to the traditional cement mortar, the biological lime inside the KeraKoll mortar doesn't cause chemical

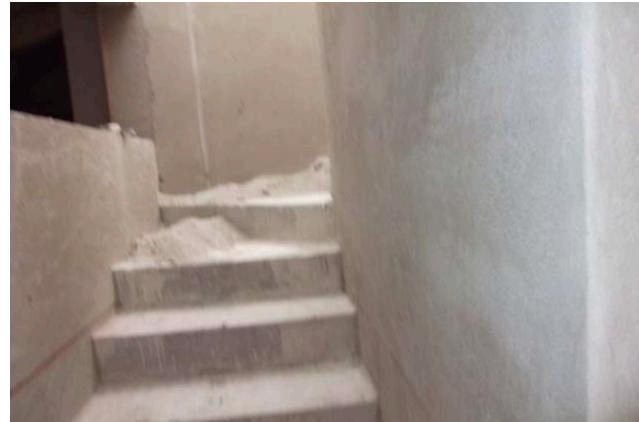
87 Existing Walls After the KeraKoll

Biocalce Base Application

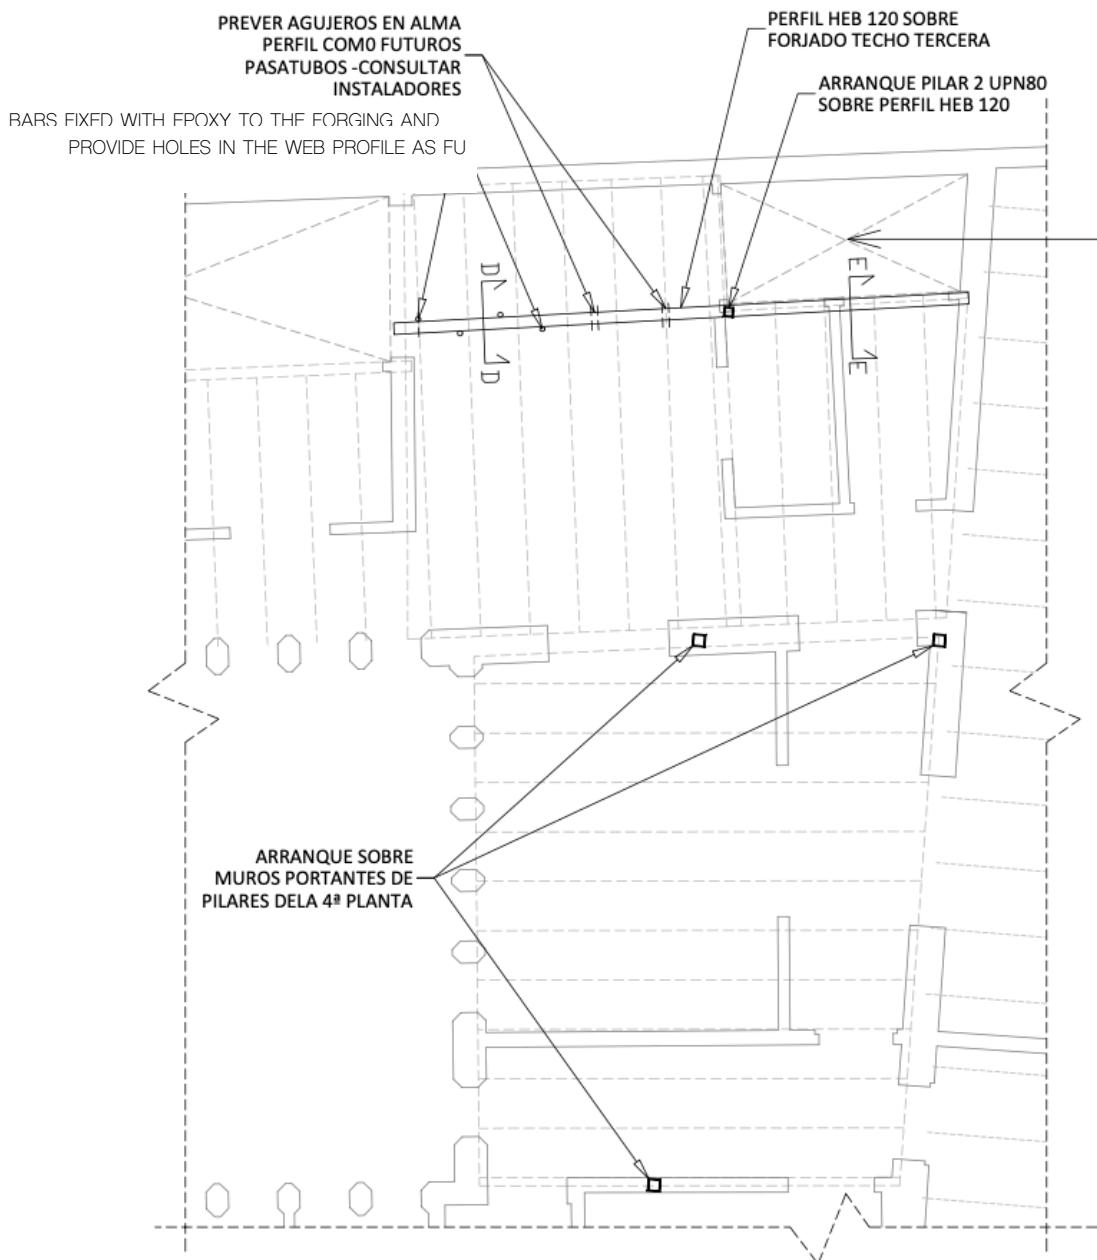
D43 Fourth Floor Roof Structural
Plan Scale: 1:100
Source: Bastidas Architecture

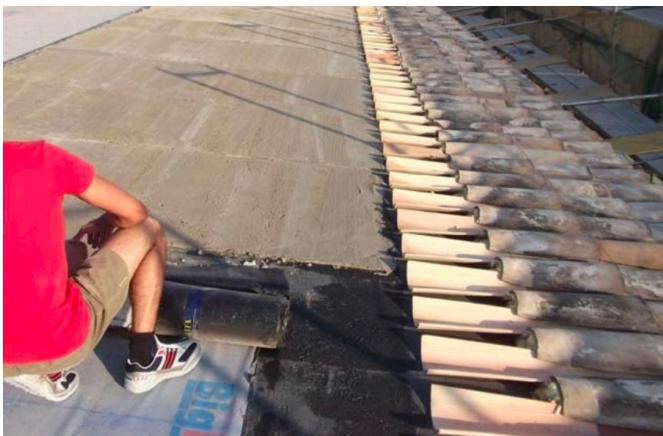
88 Application of Vapor Barrier on Roofs
© Bastidas Architecture

For the floors that will be finished with tiling, a vapor barrier and asphalt cloth was placed. Furthermore, rock wool mortar was put on the walls that required extra acoustic insulation.

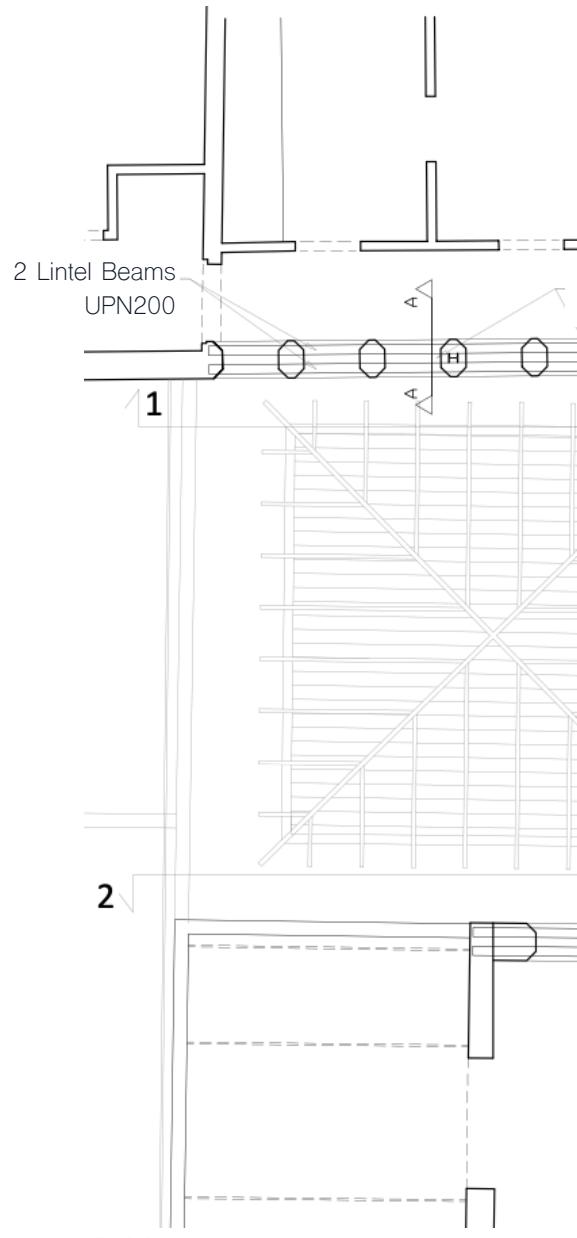
D44 Third Floor Array Windows F
(Unscaled)

Row of array windows were created on residential floors similar to the existent one on the north façade, for the structural stability two metal lintel beams and two metal HEB 100 dwarf pillars were installed; as the traditional Mallorcan array windows are made out solely out of stone, the dwarf pillars were also covered with Santanyi stone cladding.

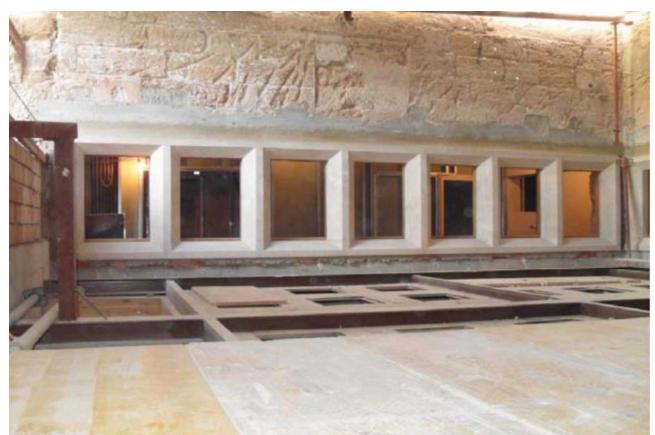
89 Santanyi Stone Cladding on Array Windows
© Bastidas Architecture

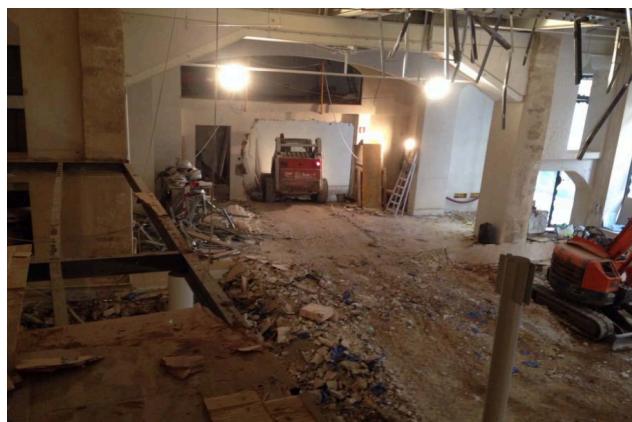
90 Initiation of Phase II on April 2015
© Bastidas Architecture

As mentioned by the owners of Rialto Living, the already purchased part of the ground floor remained untouched until rest of the building was complete. Thus, after rehabilitation of the newly purchased areas were done, a second phase was executed, specifically for the areas where the Cine Rialto was, the basement area below it, the designated restaurant terrace right above, and the remaining small scaled work to be done.

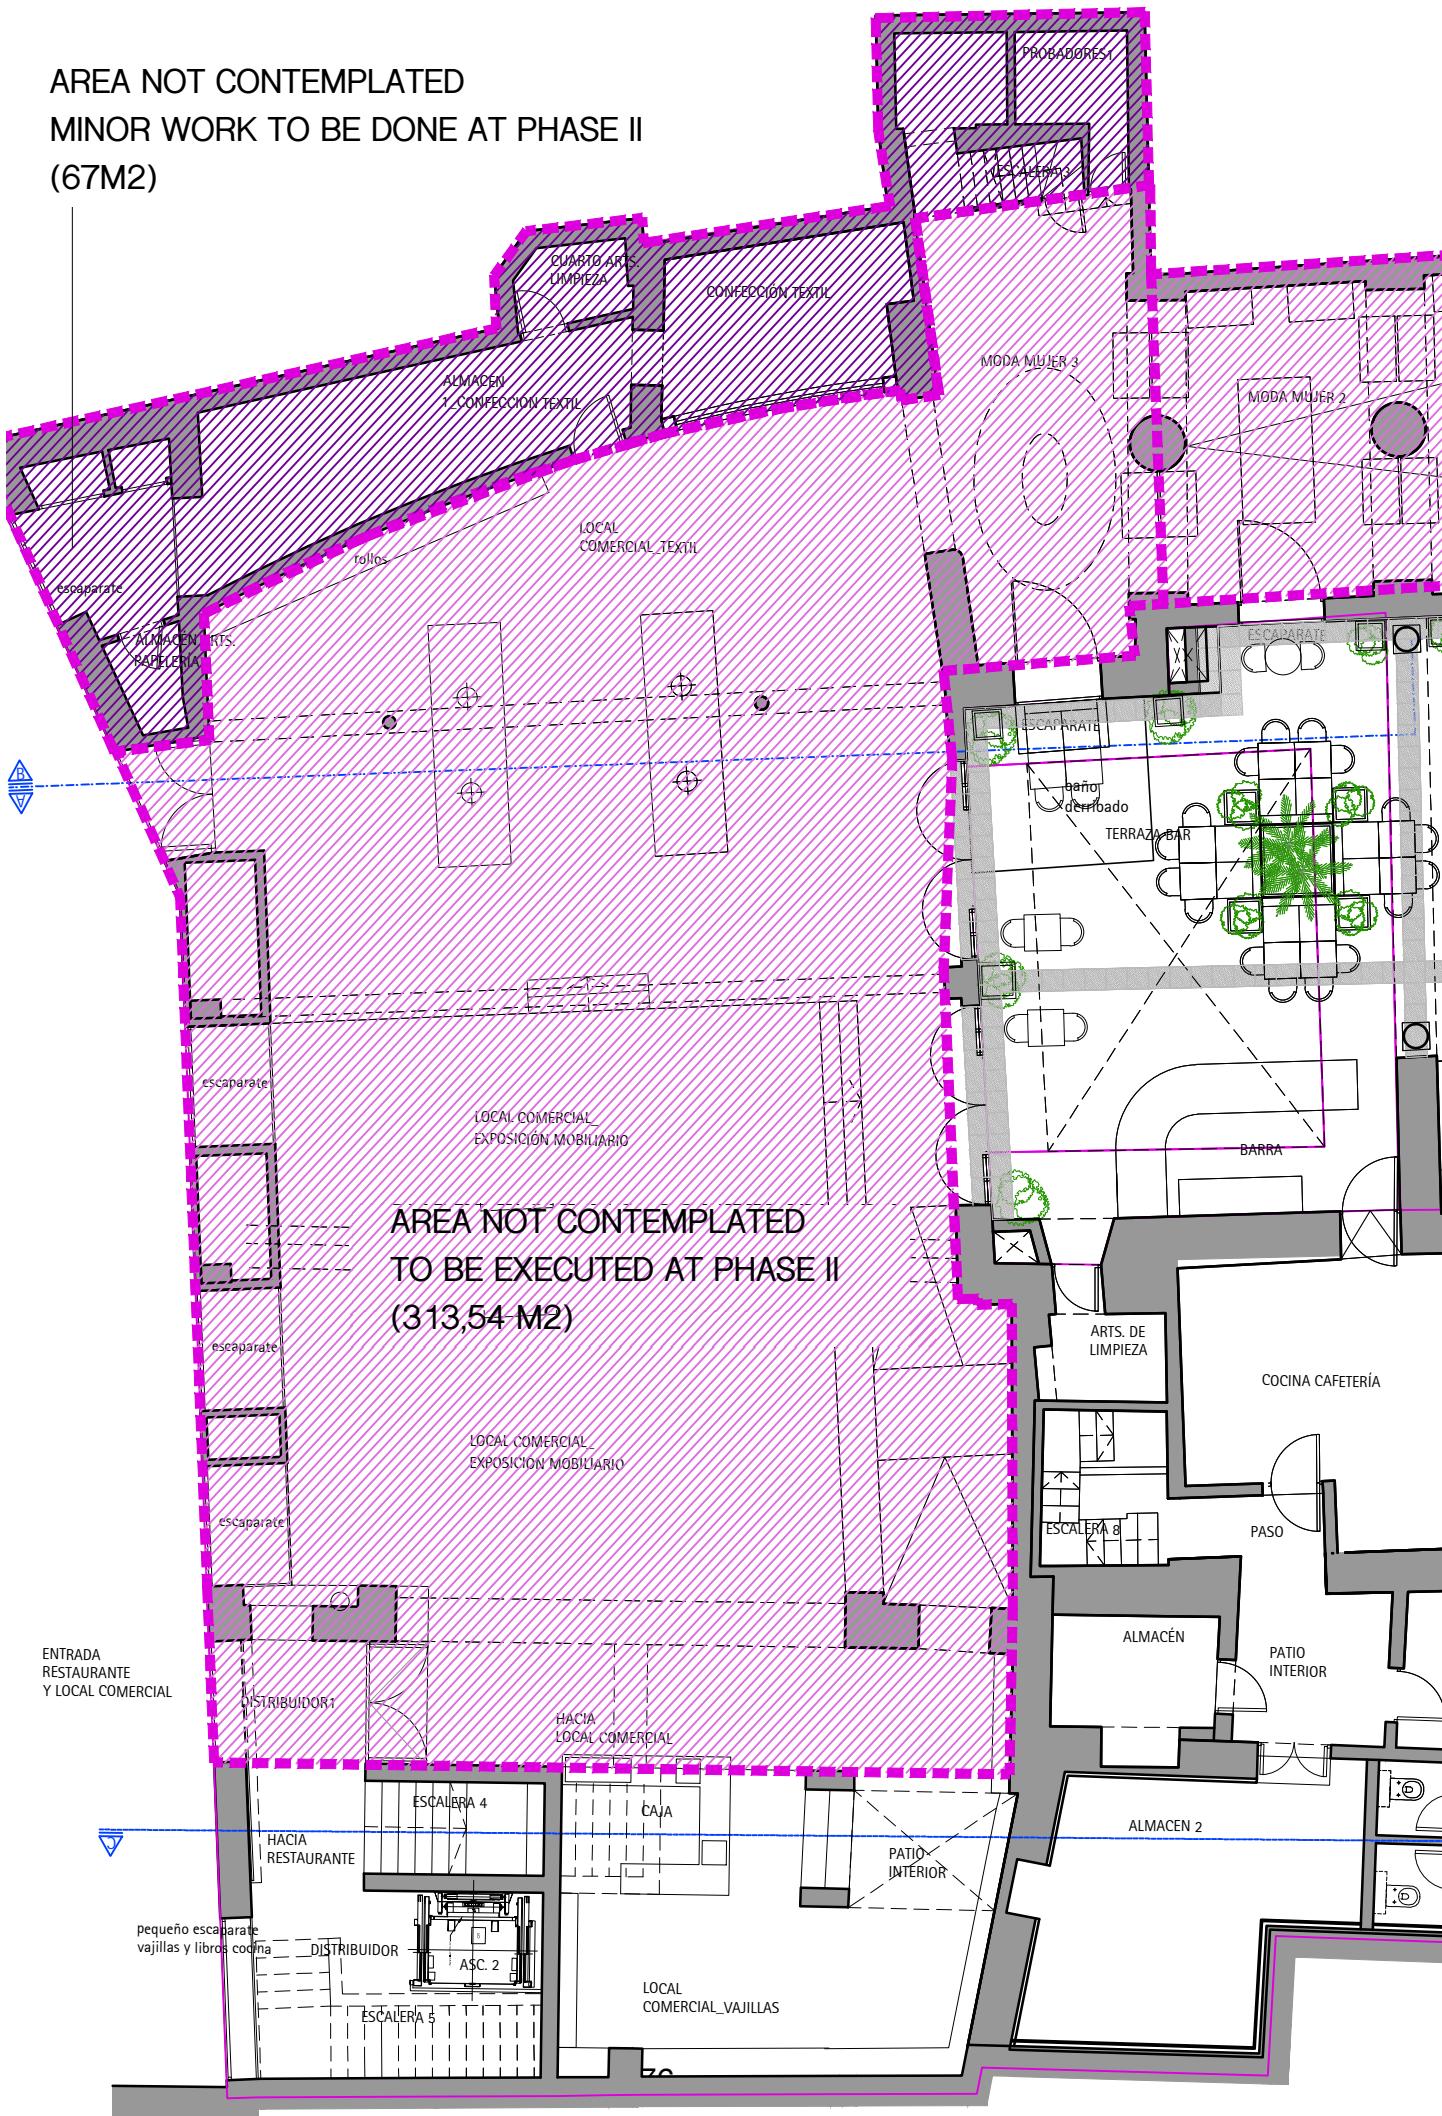
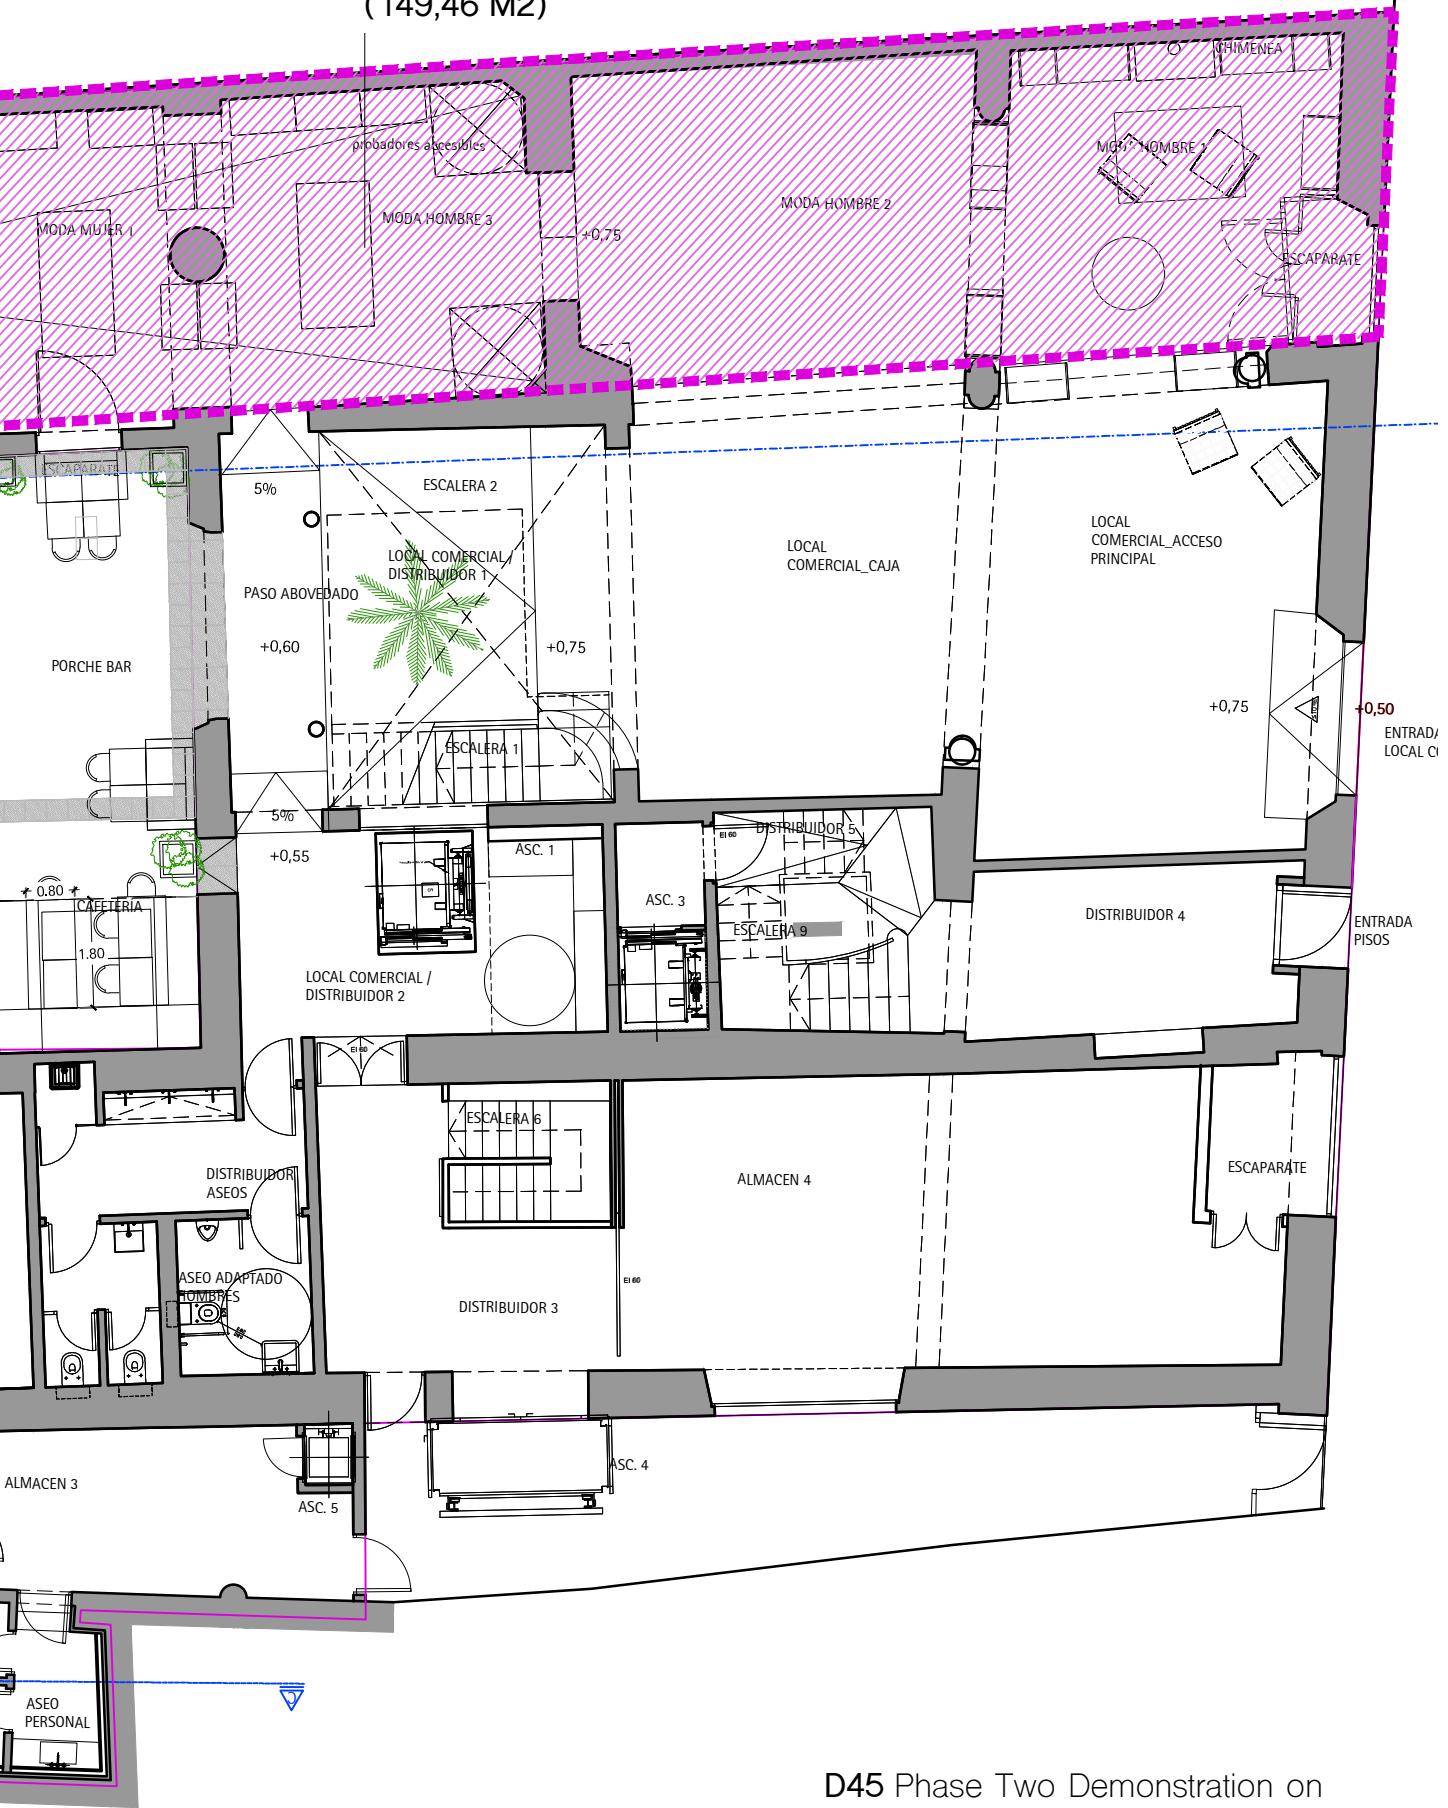
**AREA NOT CONTEMPLATED
MINOR WORK TO BE DONE AT PHASE II
(67M2)**

AREA NOT CONTEMPLATED
EXECUTED DURING PHASE I
(149,46 M²)

D45 Phase Two Demonstration on
Ground Floor (Scale:1:125)

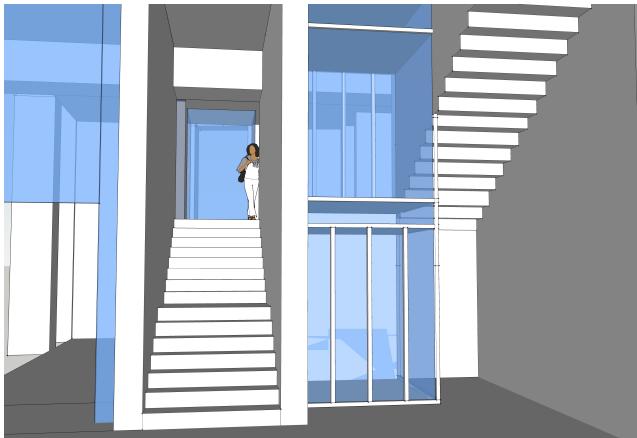
91 Model Representation of the Staircase for the Restaurant
© Bastidas Architecture

and first floor. New staircase and a glass covered elevator was built for the access to the restaurant.

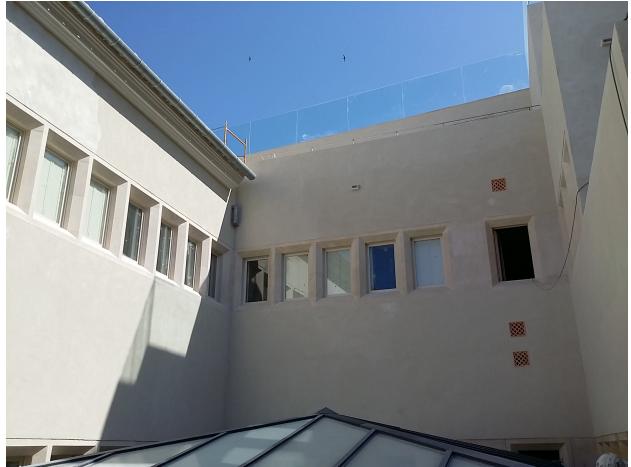
93 Internal Court Façade After Painting
© Bastidas Architecture

External painting works were carried out on the ground and second floor, and glass was installed at the variety areas of the building. Furthermore, the custom parquet that was delivered was also installed at the designated flooring.

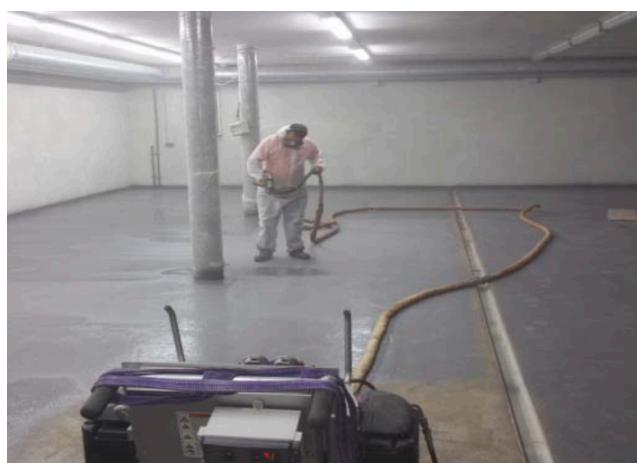
92 Spraying Polyurea to the Basement Extension
© Bastidas Architecture

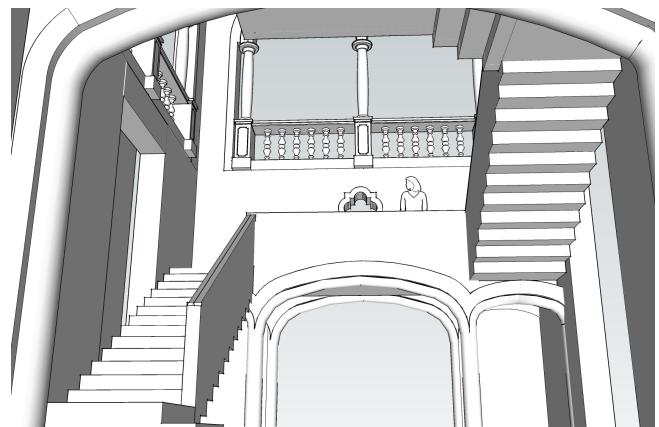
One of the standout features of the staircase is its unique riser design. The riser slopes inwards towards the lower tread, creating a visually striking and dynamic effect. Additionally, the height of the riser is 17.58cm, and the tread is 28cm, providing a comfortable and safe ascent or descent.

The upper landing, or Runway 1, and ladder are set back from the wall, creating a sense of spaciousness and openness.

94 View of the Staircase from the Architectural Model

Additionally, the upper landing has a 12% slope, which not only creates a seamless connection between levels but also adheres to building regulations.

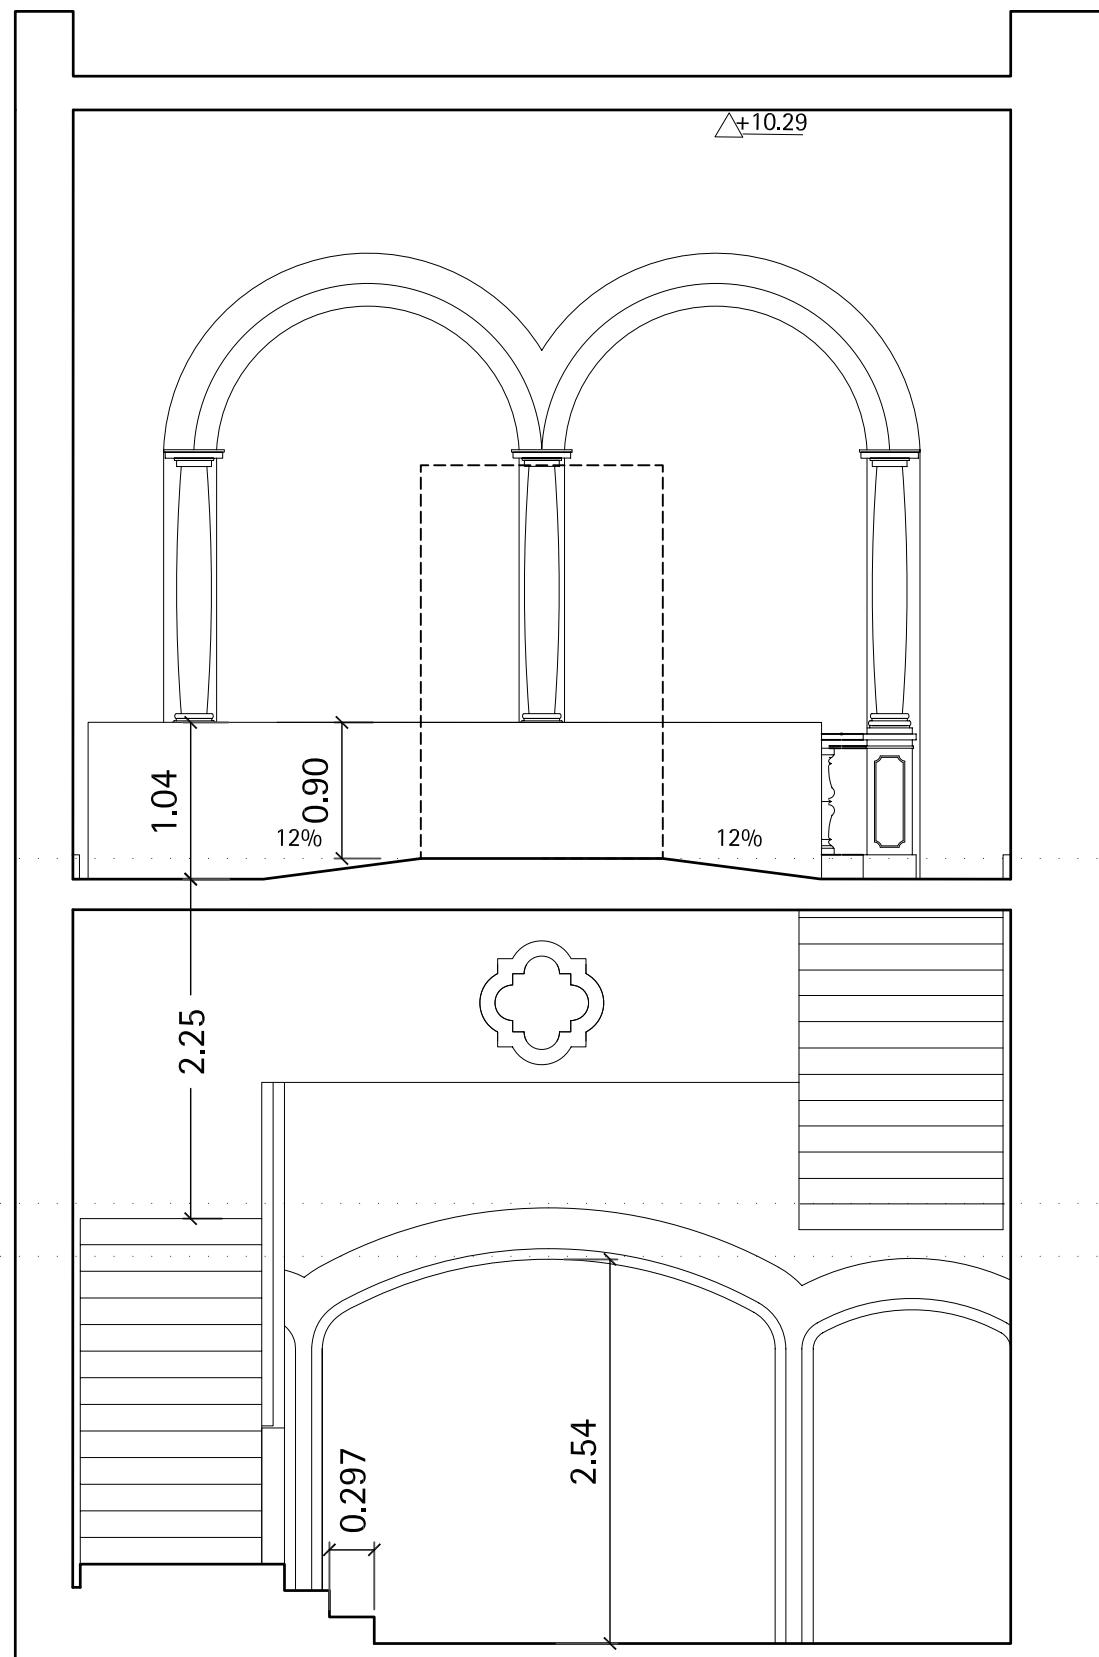
D48(Right) Central Staircase Section B-B' (Scale:1:50)

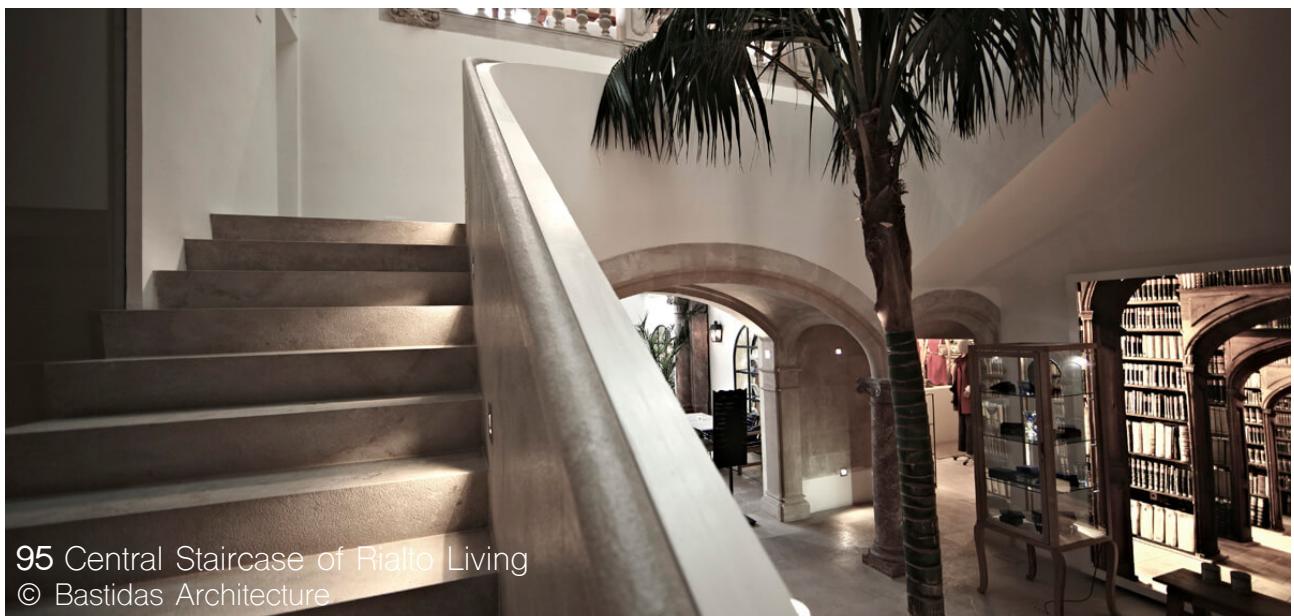
95 Central Staircase of Rialto Living
© Bastidas Architecture

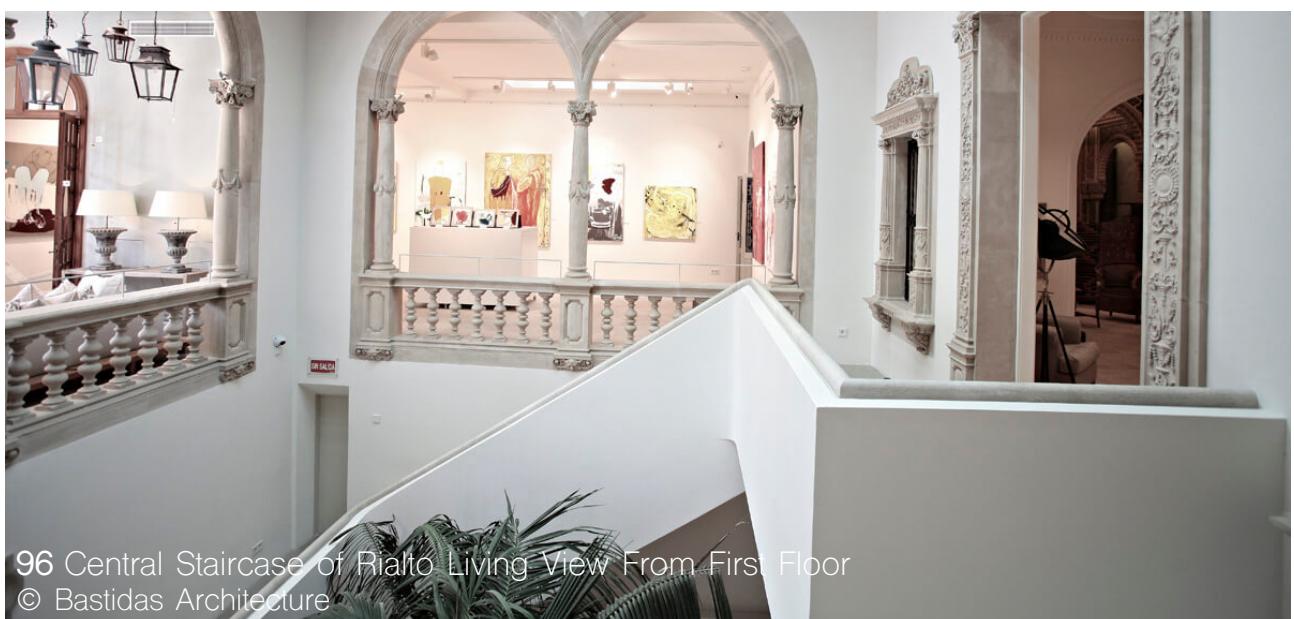
96 Central Staircase of Rialto Living View From First Floor
© Bastidas Architecture

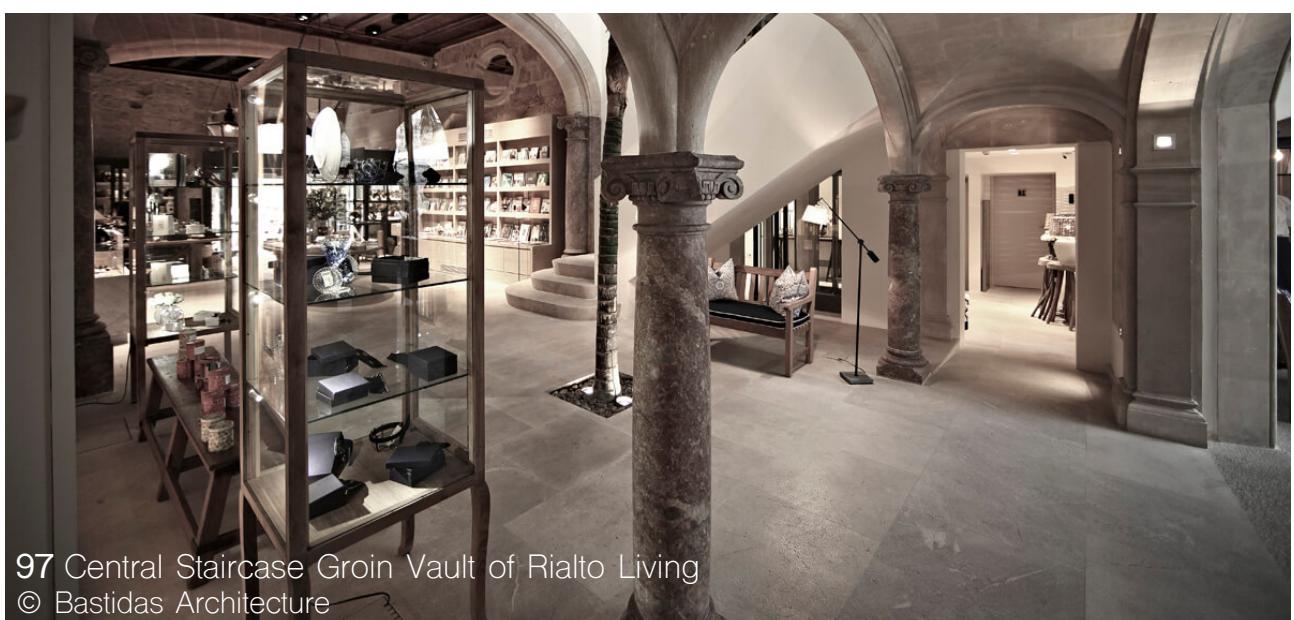
97 Central Staircase Groin Vault of Rialto Living
© Bastidas Architecture

by marble columns, which the vaulted passage leads to the Cafe Rialto.

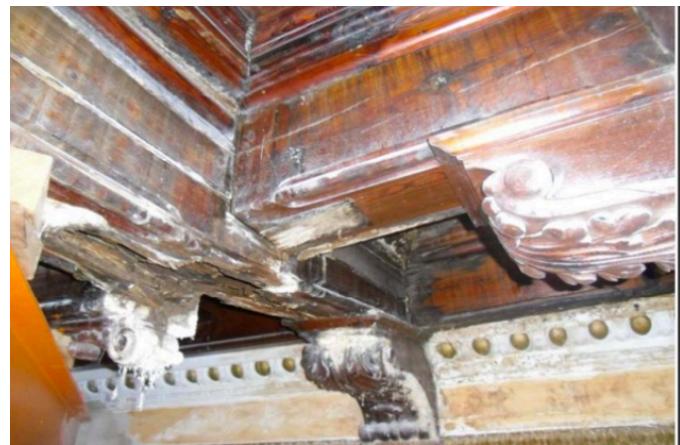
98 Deterioration on Coffered Ceiling

The restoration process of the coffered skylight began with an initial investigation of the existing wooden coffered ceiling. The focus was on an area reinforced with metal girders, which showed pronounced deterioration (98) due to moisture

infiltration. To address this issue, cracks were filled with silicone as a provisional measure until proper restoration could be carried out.

The state of the existing wooden coffered ceiling was also checked. An area can be seen, precisely the one reinforced with metal girders, where its deterioration is documented to be “very pronounced due

to moisture infiltration from the ceiling.” The work was carried out to cover cracks with silicone and apply waterproof paint (IMPER and TECNOL) on walls and floor,

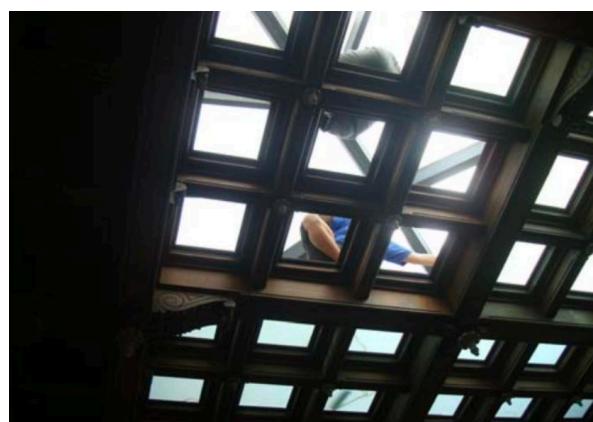
99 PVC Fabric Being Applied to Skylight
© Bastidas Architecture

The main coffered ceiling area required provisional propping, which was done on a scaffolding platform. The metal corner girders were removed and embedded finishes for wooden girders were maintained on walls, including their upper protection by means of PVC fabric.(99)

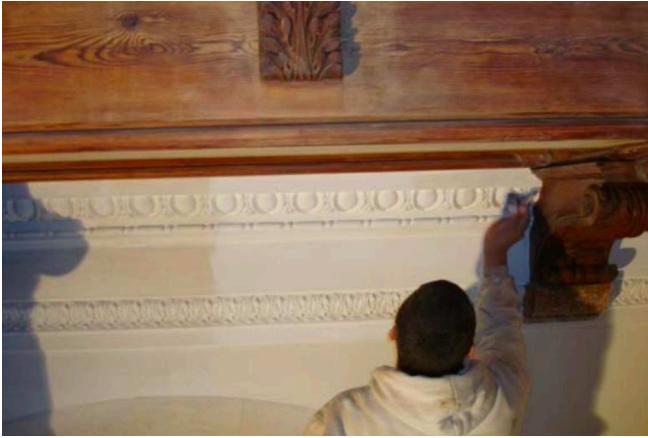
100 Painting the Molding Below Skylight
© Bastidas Architecture

was placed to receive the skylight. Paint samples were also carried out in the molding and wooden coffered area. (100)

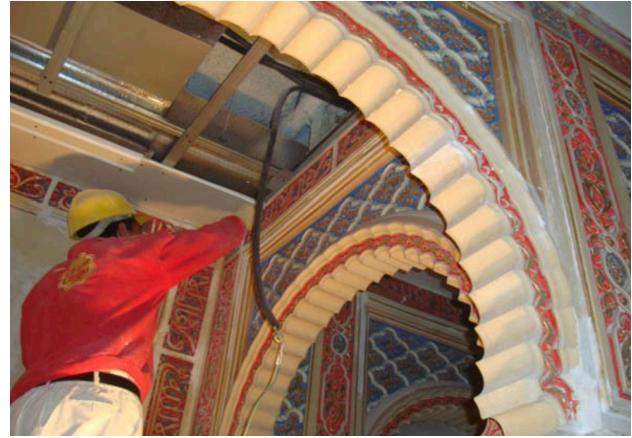
102 Reinstallation of the False Ceilings
© Bastidas Architecture

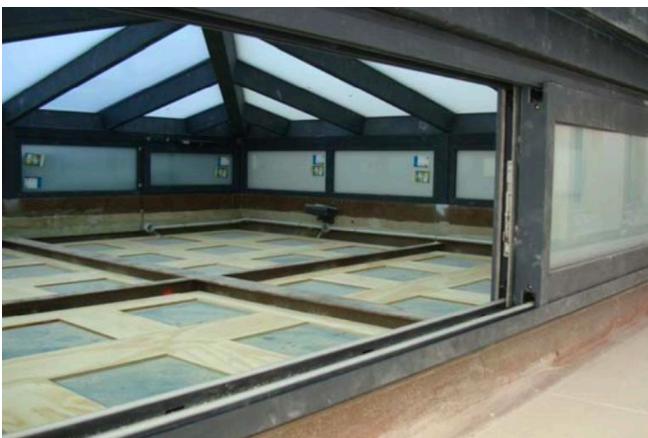
101 Final Situation of the Coffered Skylight
© Bastidas Architecture

issues, to ensure a long-lasting and visually appealing final outcome. The final structure of the coffered skylight combined with the second and third floors can be found at the subchapter 4.7.3 Detailed Sections.

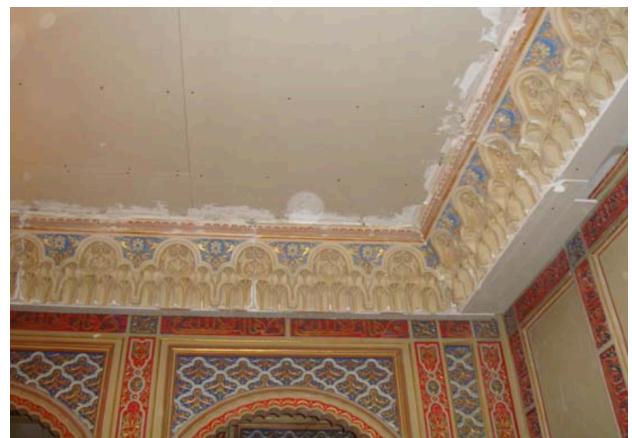
103 Mouldings at the Moroccan Room
© Bastidas Architecture

During the renovation, it was deemed necessary to reinforce the propping in the Moroccan lounge area as a precautionary measure. The arches structure was also fixed, and the metal joists were painted to give the room a polished look. Reinforcements were added and a final compression layer was concreted to ensure the structural integrity of the space.

The owner of the building, Barbara, is committed to preserving the historical and architectural significance of the space. Every existing tile and ornament was kept and reused if in good condition. Any moldings that could not be saved were painted to match the original design.

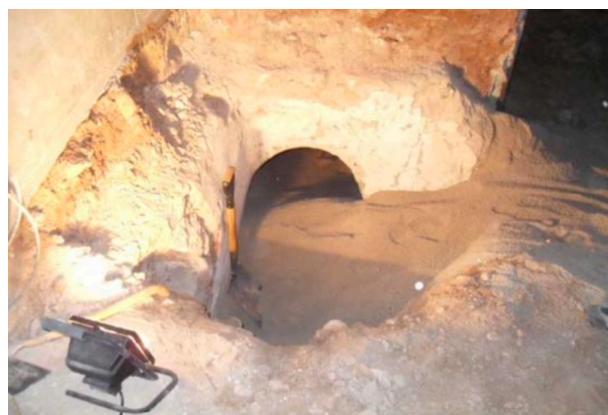
105 Debris of Compacted Sand at the Cistern Path
© Bastidas Architecture

One issue happened during the excavations was that, due to the modification in the load-bearing area of the alley wall, due to batching, one cistern path was completely filled with compacted sand during elevator shaft excavation (**105**), this issue was solved by cleaning of the area and reinforcing the walls with concrete.

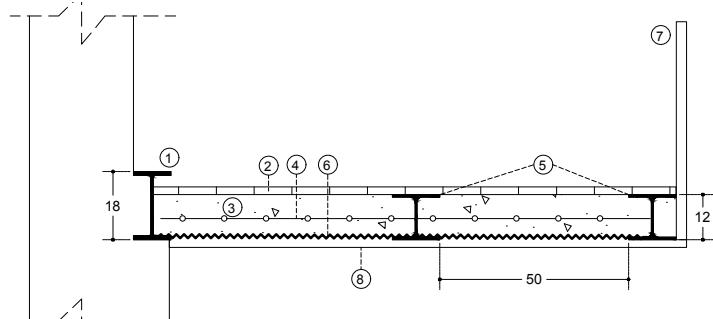
D63 Mezzanine Floor Passage 2 To Offices 1:20

1. Floor Finish (Lorca Natural Stone)
2. Concrete Slab (7 cm)
3. Rebar Steel Mesh 150.150.6
4. Placner Plate Ribbed Lath
5. IPE 120 Beams (New)

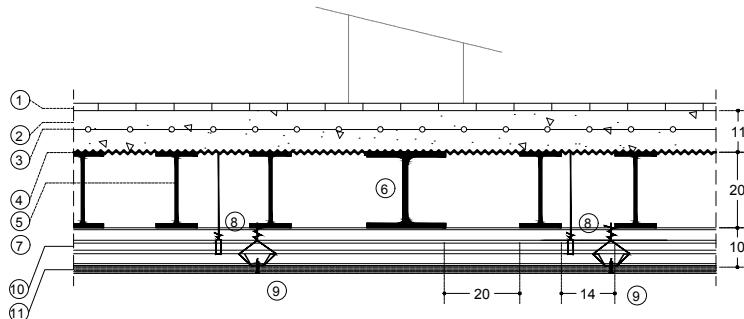
D65 Mezzanine Floor Rooms E02-E09 & E13 1:20

1. Floor Finish (Lorca Natural Stone)
2. Concrete Slab (7 cm)
3. Rebar Steel Mesh 150.150.6
4. Placner Plate Ribbed Lath
5. IPE 120 Beams (Existant)

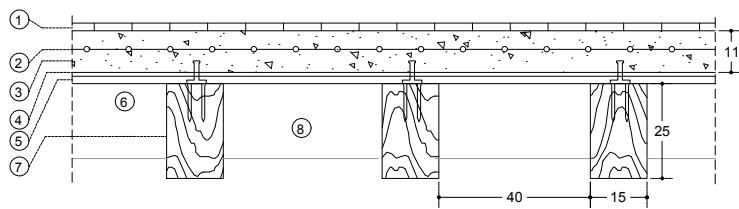
D68 First Floor Rooms 1.15 & 1.16 1:20

1. Floor Finish (Varies by the Room)
2. Concrete Slab (8 cm)
3. Rebar Steel Mesh 150.150.6
4. Placner Plate Rib Lath
5. IPE 200 Beams (New)
6. Concrete Tie Beam 4ø12 & ø6 c/20cm
7. IPE 200 Beams (Parallel to the Mounted Wall)
8. UPN 100 Beam
9. Plasterboard False Ceiling (1,25 cm)

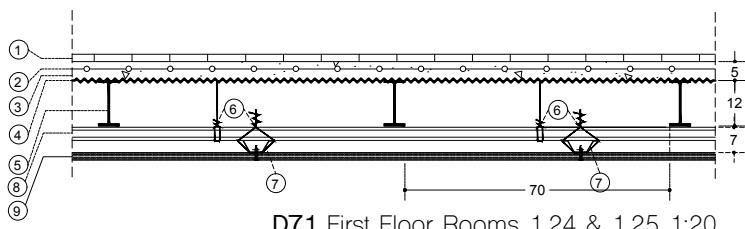
D71 First Floor Rooms 1.24 & 1.25 1:20

1. Floor Finish (Lorca Natural Stone)
2. Rebar Steel Mesh 150.150.6
3. Concrete Slab (Max:16 cm Min: 8cm)
4. UPN 100 Reinforcement Beams (New)
5. Ceramic Vault (Existant)
6. IPN 160 Beams (Existant)
7. Decorative Coffered Ceiling Planking (Existing)
8. Decorative Coffered Ceiling Beams (Existing)

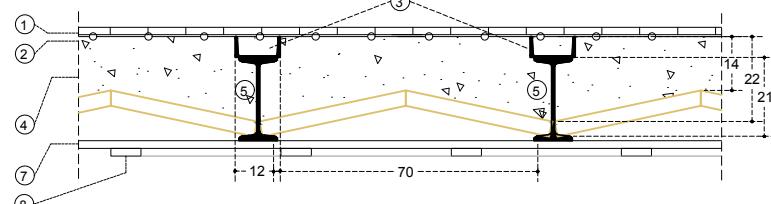
D72 First Floor Room 1.01 1:20

1. Floor Finish (Lorca Natural Stone)
2. Rebar Steel Mesh 150.150.6
3. Concrete Slab (Max:22 cm Min:14 cm)
4. UPN 120 Reinforcement Beams (New)
5. Ceramic Vault (Existant)
6. IPN 220 Beams (Existant)
7. Decorative Coffered Ceiling Planking (Existing)
8. Decorative Coffered Ceiling Beams (Existing)

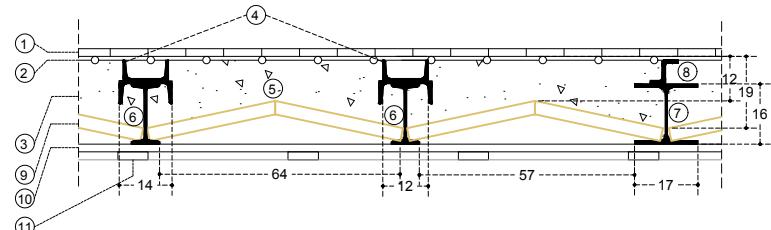
D73 First Floor Room 1.03 & 1.04 1:20

1. Floor Finish (Lorca Natural Stone)
2. Rebar Steel Mesh 150.150.6
3. Concrete Slab (Max:19 cm Min:12 cm)
4. UPN 140 Reinforcement Beams (New)
5. UPN 120 Reinforcement Beams (New)
6. IPN 220 Beams (Existant)
7. HEB 160 Reinforcement Beam (New)
8. Cold Formed Z Section Connector
9. Ceramic Vault (Existant)
10. Decorative Coffered Ceiling Planking (Existing)
11. Decorative Coffered Ceiling Beams (Existing)

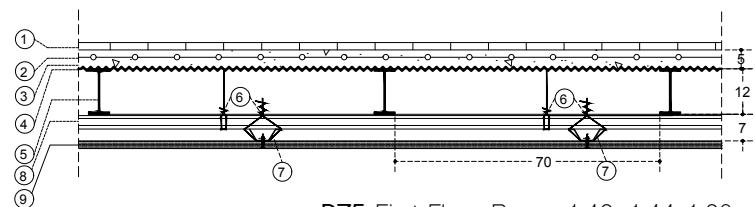
D74 First Floor Room 1.02 1:20

1. Floor Finish (Painted Ceramic)
2. Concrete Slab (5 cm)
3. Rebar Steel Mesh 150.150.6
4. Placner Plate Ribbed Lath
5. IPE 120 Beams (Existant)
6. Galvanised Wire
7. False Ceiling Frame Main "T"
8. False Ceiling Frame Cross "T"
9. Plasterboard False Ceiling (1.25 cm)

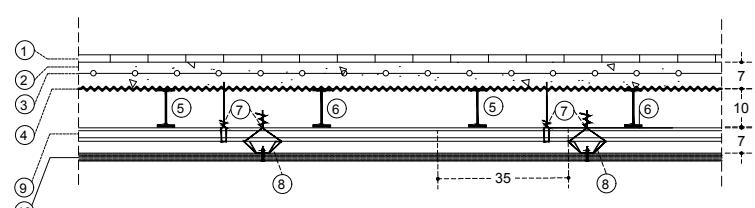
D75 First Floor Room 1.42-1.44 1:20

1. Floor Finish (Painted Ceramic)
2. Concrete Slab (7 cm)
3. Rebar Steel Mesh 150.150.6
4. Placner Plate Ribbed Lath
5. IPN 100 Beams (Existant)
6. IPN 100 Beams (New)
6. Galvanised Wire
7. False Ceiling Frame Main "T"
8. False Ceiling Frame Cross "T"
9. Plasterboard False Ceiling (1.25 cm)

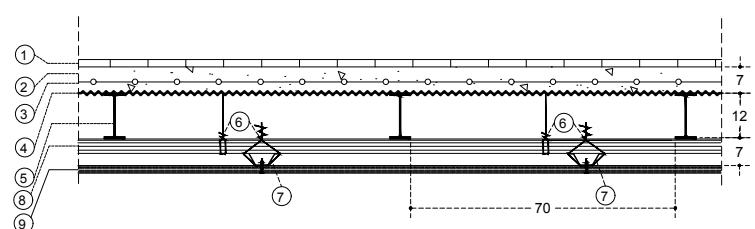
D76 First Floor Room 1.05-1.07 1:20

1. Floor Finish (Painted Ceramic)
2. Concrete Slab (7 cm)
3. Rebar Steel Mesh 150.150.6
4. Placner Plate Ribbed Lath
5. IPE 120 Beams (Existant)
6. Galvanised Wire
7. False Ceiling Frame Main "T"
8. False Ceiling Frame Cross "T"
9. Plasterboard False Ceiling (1.25 cm)
