RIALTO LIVING

Detailed Technological
Analysis of Buildings of the
Highest Environmental Quality

Detailed Technological Analysis of Buildings of the Highest Environmental Quality:

Analysis of Rialto Living, Palma de Mallorca

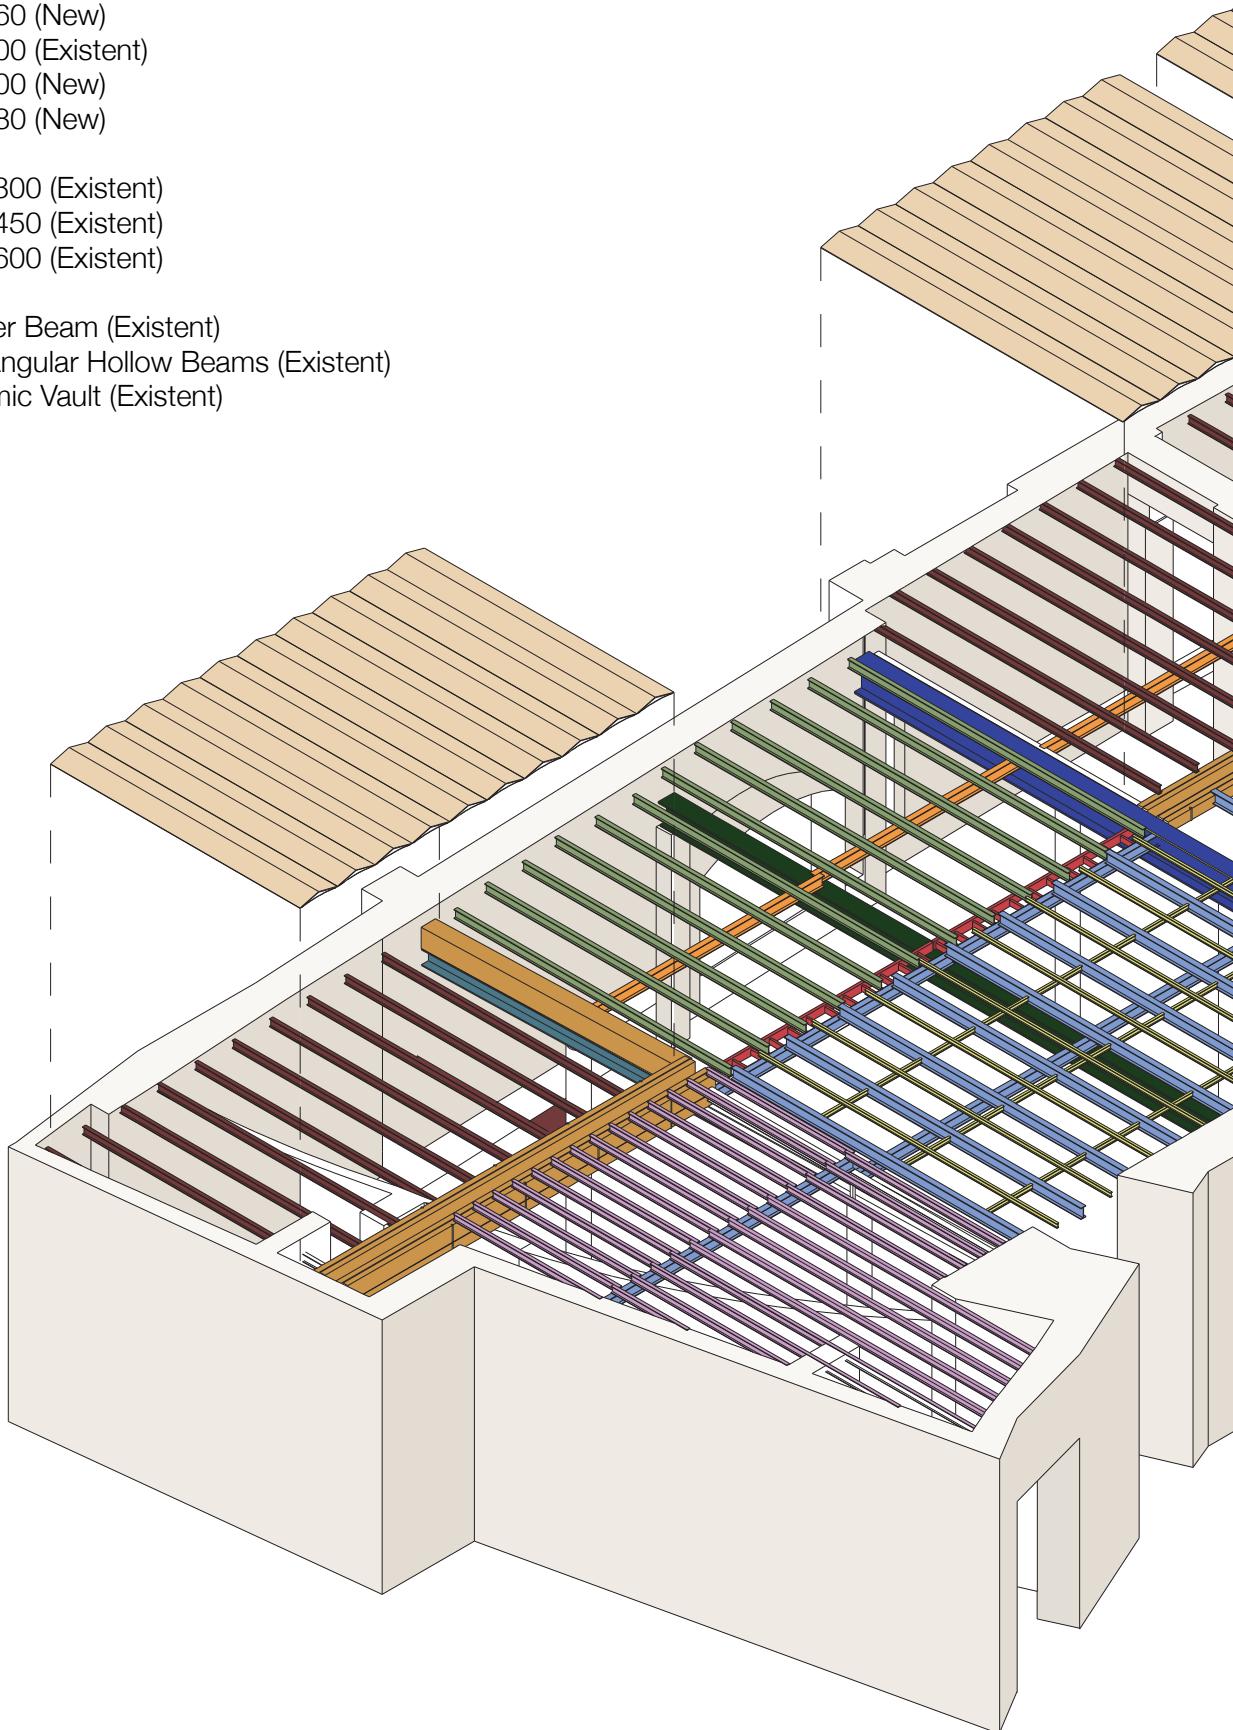
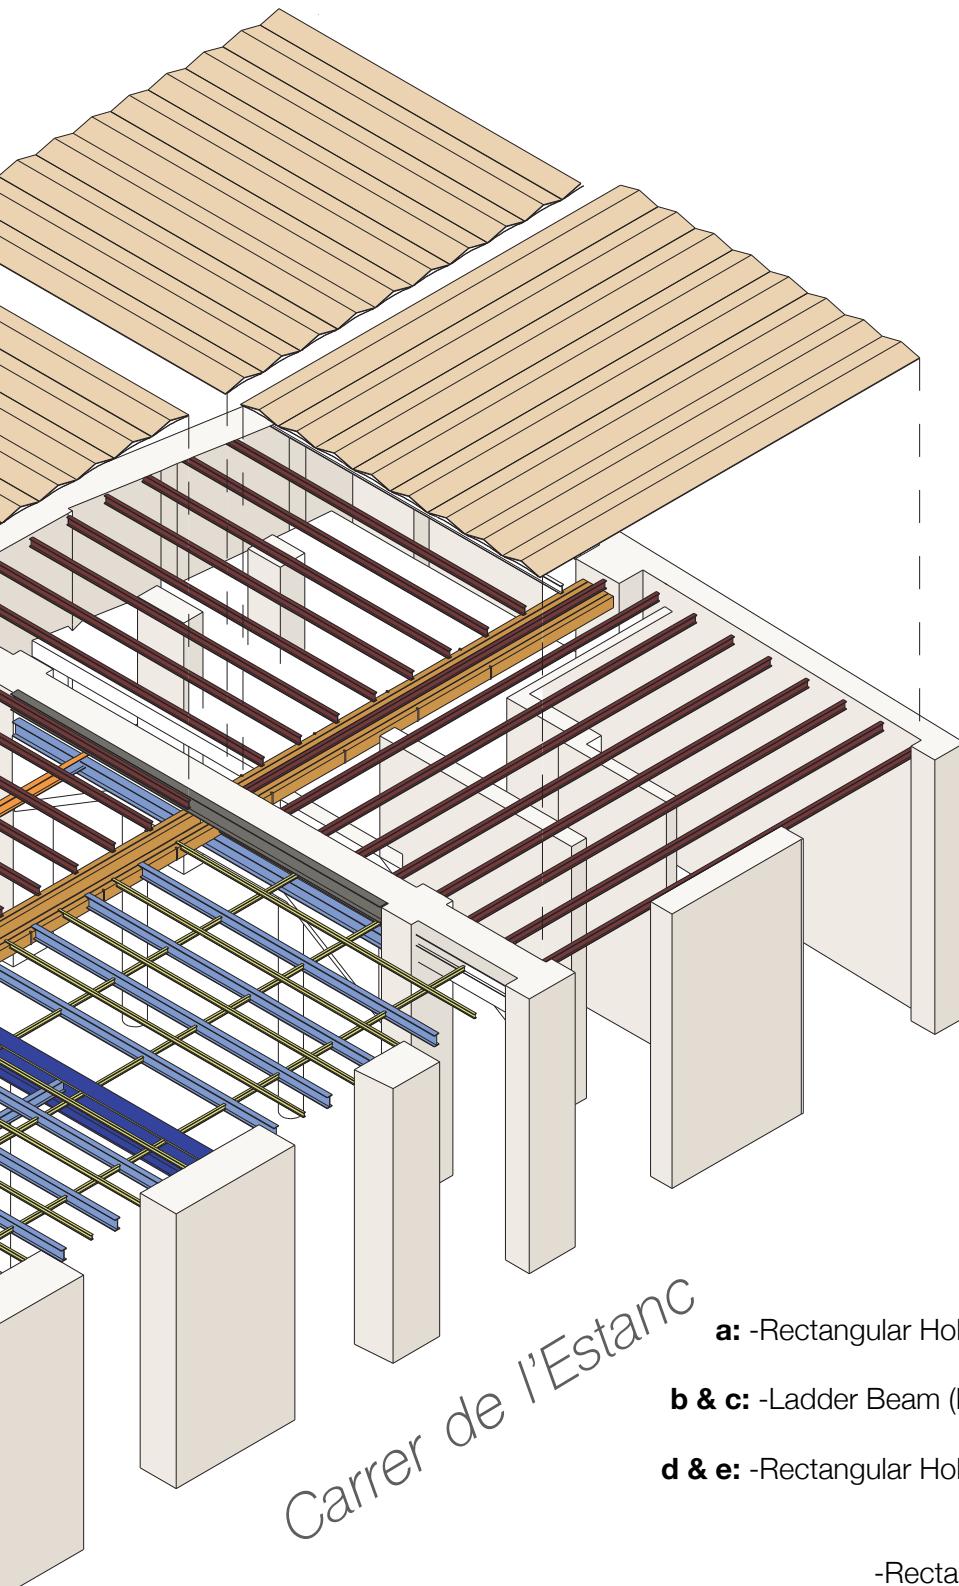
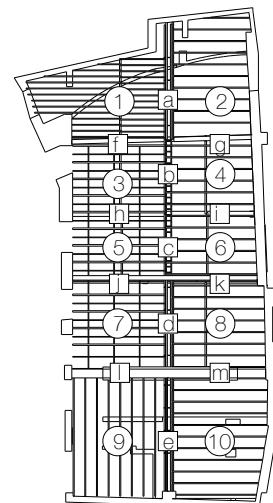
D77 First Floor Room 1.08-1.11 1:20

Beam & Joist Typology:

- █ Ladder Beam (Existent)
- █ Rectangular Hollow Beams (Existent)
- █ Ceramic Vault (Existent)

*On the areas without ceramic vault the floor is completed with Placner Plate Ribbed Lath, concrete filling, rebar steel mesh 150.150.6, polyurea waterproofing, and Lorca Natural Stone finish.

a: -Rectangular Hollow Beams (Existent) (10x30 cm) (x8)
-Marés Gravel Filling (Existent)

b & c: -Ladder Beam (Existent) (5x15 cm)(x4) (4x10cm)(x21)
-IPE 200 Beams (Existent) (x2)

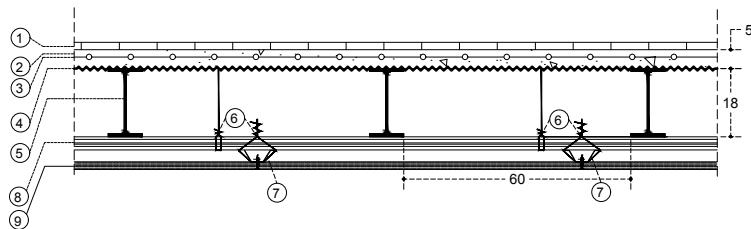
D79 Second Floor Rooms 2B01-07 & 2A14-16 1:20

1. Floor Finish (Varies by the Room)
2. Concrete Slab (5 cm)
3. Rebar Steel Mesh 150.150.6
4. Placner Plate Ribbed Lath
5. IPE 180 Beams (Existent)
6. Galvanised Wire
7. False Ceiling Frame Main "T"
8. False Ceiling Frame Cross "T"
9. Plasterboard False Ceiling (1.25 cm)

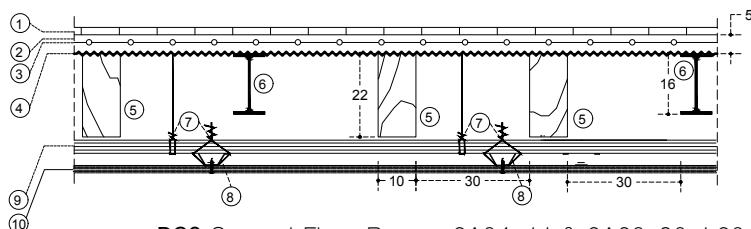
D80 Second Floor Rooms 2A04-11 & 2A28-30 1:20

1. Floor Finish (Varies by the Room)
2. Concrete Slab (5 cm)
3. Rebar Steel Mesh 150.150.6
4. Placner Plate Ribbed Lath
5. Timber Beams (Existent) (10x22cm)
6. IPE 160 Beams (New)
7. Galvanised Wire
8. False Ceiling Frame Main "T"
9. False Ceiling Frame Cross "T"
10. Plasterboard False Ceiling (1.25 cm)

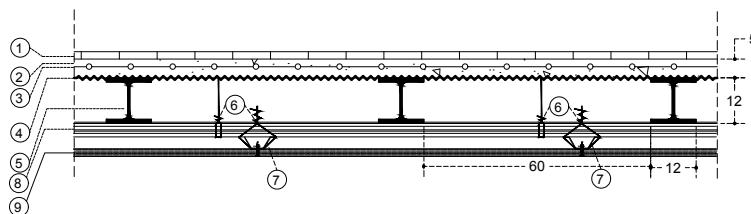
D81 Second Floor Rooms 2A32-34 1:20

1. Floor Finish (Hydraulic Tiles)
2. Concrete Slab (5 cm)
3. Rebar Steel Mesh 150.150.6
4. Placner Plate Ribbed Lath
5. HEB 120 Beams (New)
6. Galvanised Wire
7. False Ceiling Frame Main "T"
8. False Ceiling Frame Cross "T"
9. Plasterboard False Ceiling (1.25 cm)

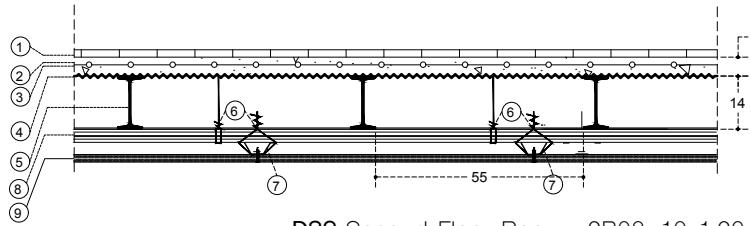
D82 Second Floor Rooms 2B08-10 1:20

1. Floor Finish (Oak Wooden Flooring)
2. Concrete Slab (5 cm)
3. Rebar Steel Mesh 150.150.6
4. Placner Plate Ribbed Lath
5. IPN 140 Beams (New)
6. Galvanised Wire
7. False Ceiling Frame Main "T"
8. False Ceiling Frame Cross "T"
9. Plasterboard False Ceiling (1.25 cm)

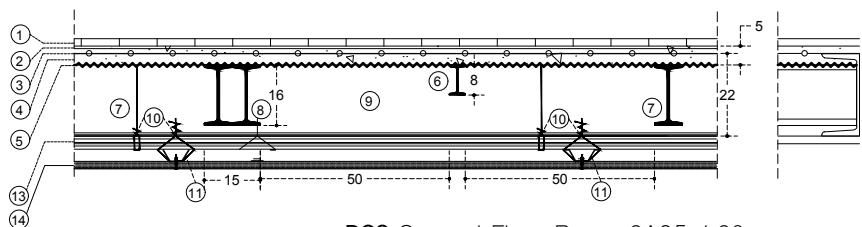
D83 Second Floor Room 2A35 1:20

1. Floor Finish (Lorca Natural Stone)
2. Polyurea Waterproofing Layer
3. Concrete Slab (5 cm)
4. Rebar Steel Mesh 150.150.6
5. Placner Plate Ribbed Lath
6. IPN 80 Beams (New)
7. IPN 160 Beams (Existent)
8. IPN 160 Reinforcement Beams (New)
9. UPN 220 Beam (Existent)
10. Galvanised Wire
11. False Ceiling Frame Main "T"
12. False Ceiling Frame Cross "T"
13. Plasterboard False Ceiling (1.25 cm)

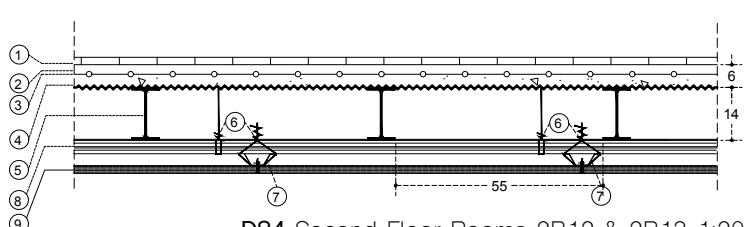
D84 Second Floor Rooms 2B12 & 2B13 1:20

1. Floor Finish (Varies by the Rooms)
2. Concrete Slab (6 cm)
3. Rebar Steel Mesh 150.150.6
4. Placner Plate Ribbed Lath
5. IPE 140 Beams (Existent)
6. Galvanised Wire
7. False Ceiling Frame Main "T"
8. False Ceiling Frame Cross "T"
9. Plasterboard False Ceiling (1.25 cm)

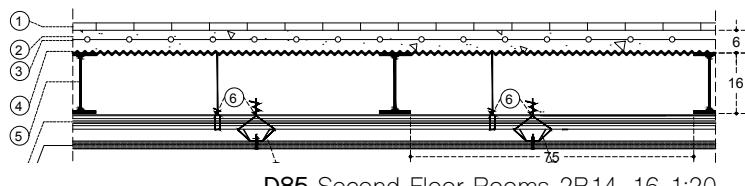
D85 Second Floor Rooms 2B14-16 1:20

1. Floor Finish (Varies by the Room)
2. Concrete Slab (6 cm)
3. Rebar Steel Mesh 150.150.6
4. Placner Plate Ribbed Lath
5. IPE 160 Beams (Existent)
6. Galvanised Wire
7. False Ceiling Frame Main "T"
8. False Ceiling Frame Cross "T"
9. Plasterboard False Ceiling (1.25 cm)

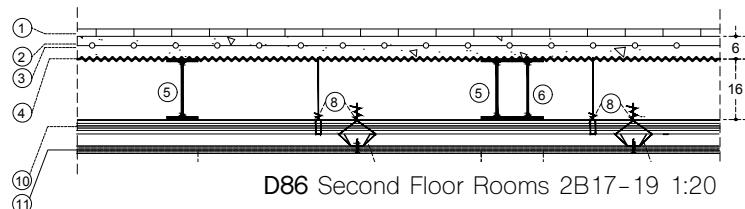
D86 Second Floor Rooms 2B17-19 1:20

1. Floor Finish (Varies by the Room)
2. Concrete Slab (6 cm)
3. Rebar Steel Mesh 150.150.6
4. Placner Plate Ribbed Lath
5. IPE 160 Beams (Existent)
6. IPE 160 Reinforcement Beams (New)
7. Galvanised Wire
8. False Ceiling Frame Main "T"
9. False Ceiling Frame Cross "T"
10. Plasterboard False Ceiling (1.25 cm)

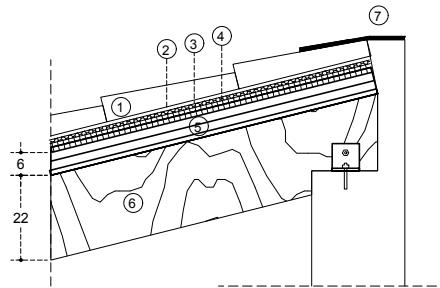
D87 Second Floor Roof Above Room 1.13 1:20

1. Ceramic Roof Tiles (Double Layer)
2. Mortar (1cm) (For Asphalt Cloth Protection)
3. Asphalt Cloth
4. Vapor Barrier
5. Thermochip® Insulated Panel
6. Timber Beams (Existent) (10 x 22 cm)
7. Zinc Plate (0.5 cm)

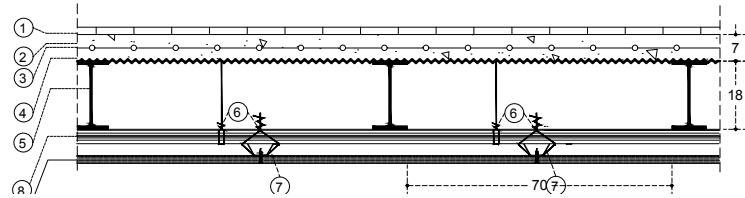
D88 Second Floor Rooms 2A25-27 1:20

1. Floor Finish (Oak Wooden Flooring)
2. Concrete Slab (7 cm)
3. Rebar Steel Mesh 150.150.6
4. Placner Plate Ribbed Lath
5. IPE 180 Beams (Existent)
6. Galvanised Wire
7. False Ceiling Frame Main "T"
8. False Ceiling Frame Cross "T"
9. Plasterboard False Ceiling (1.25 cm)

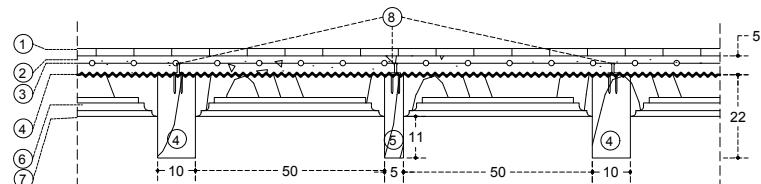
D89 Second Floor Rooms 2A17-24 1:20

1. Floor Finish (Varies by the Room)
2. Concrete Slab (5 cm)
3. Rebar Steel Mesh 150.150.6
4. Placner Plate Ribbed Lath
5. Timber Beams (10x22 cm) (Existent)
6. Coffered Ceiling (5x22) (Existent)
7. Wooden Planking
8. Decorative Coffered Ceiling Joists
9. Reinforcement Claws

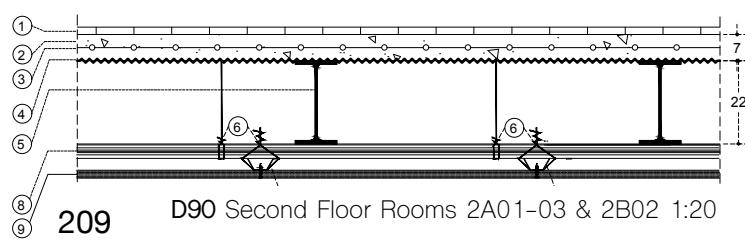
1. Floor Finish (Herringbone Parquet)
2. Concrete Slab (7 cm)
3. Rebar Steel Mesh 150.150.6
4. Placner Plate Ribbed Lath
5. IPE 220 Beams (New)
6. Galvanised Wire
7. False Ceiling Frame Main "T"
8. False Ceiling Frame Cross "T"
9. Plasterboard False Ceiling (1.25 cm)

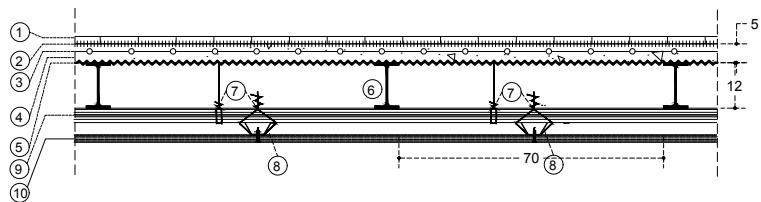
D91 Third Floor Rooms 3A23, 3A26 & 3B21 1:20

1. Floor Finish (Lorca Natural Stone)
2. Polyurea Waterproofing
3. Concrete Slab (5 cm)
4. Rebar Steel Mesh 150.150.6
5. Placner Plate Ribbed Lath
6. IPE 120 Beams (Existant)
7. Galvanised Wire
8. False Ceiling Frame Main "T"
9. False Ceiling Frame Cross "T"
10. Plasterboard False Ceiling (1.25 cm)

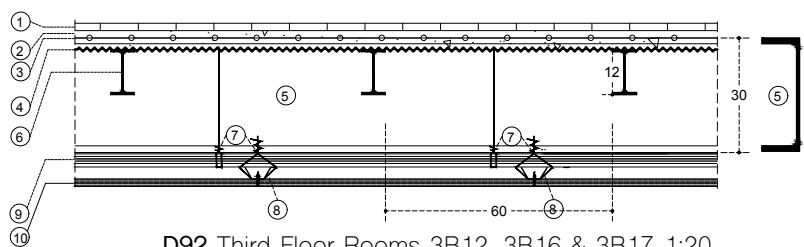
D92 Third Floor Rooms 3B12, 3B16 & 3B17 1:20

1. Floor Finish (Oak Wooden Flooring)
2. Concrete Slab (5 cm)
3. Rebar Steel Mesh 150.150.6
4. Placner Plate Ribbed Lath
5. UPE 300 Beam (New)
6. IPE 120 Beams (New)
7. Galvanised Wire
8. False Ceiling Frame Main "T"
9. False Ceiling Frame Cross "T"
10. Plasterboard False Ceiling (1.25 cm)

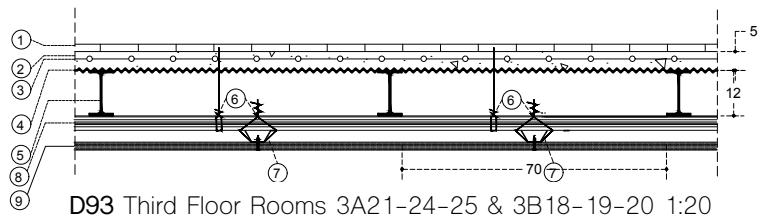
D93 Third Floor Rooms 3A21-24-25 & 3B18-19-20 1:20

1. Floor Finish (Varies by the Room)
2. Concrete Slab (5 cm)
3. Rebar Steel Mesh 150.150.6
4. Placner Plate Ribbed Lath
5. IPE 120 Beams (Existant)
6. Galvanised Wire
7. False Ceiling Frame Main "T"
8. False Ceiling Frame Cross "T"
9. Plasterboard False Ceiling (1.25 cm)

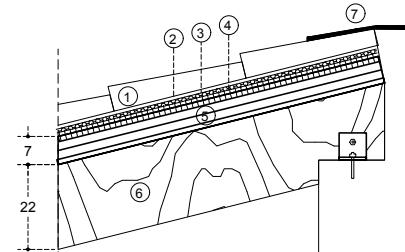
D94 Third Floor Roofs (All) 1:20

1. Ceramic Roof Tiles (Double Layer)
2. Mortar (1cm) (For Asphalt Cloth Protection)
3. Asphalt Cloth
4. Vapor Barrier
5. Thermochip® Insulated Panel
6. Timber Beams (Existant) (10 x 22 cm)
7. Zinc Plate (0.5 cm)

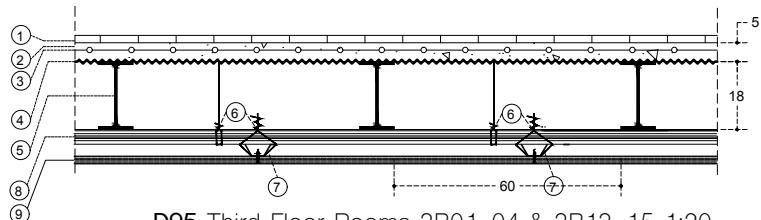
D95 Third Floor Rooms 3B01-04 & 3B13-15 1:20

1. Floor Finish (Varies by the Room)
2. Concrete Slab (5 cm)
3. Rebar Steel Mesh 150.150.6
4. Placner Plate Ribbed Lath
5. IPE 180 Beams (New)
6. Galvanised Wire
7. False Ceiling Frame Main "T"
8. False Ceiling Frame Cross "T"
9. Plasterboard False Ceiling (1.25 cm)

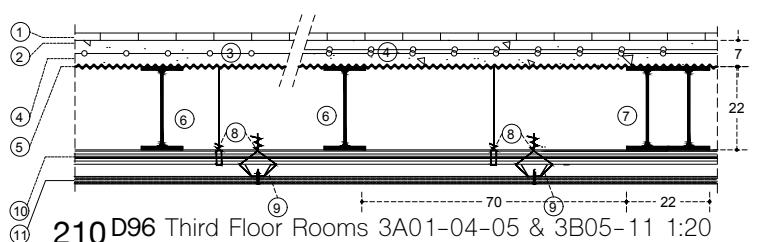
210 D96 Third Floor Rooms 3A01-04-05 & 3B05-11 1:20

1. Floor Finish (Herringbone Parquet)
2. Concrete Slab (7 cm)
3. Rebar Steel Mesh 150.150.6
4. Double Layer Rebar Steel Mesh 150.150.6
5. Placner Plate Ribbed Lath
6. IPE 220 Beams (New)
7. IPE 220 Double Beams (New)
8. Galvanised Wire
9. False Ceiling Frame Main "T"
10. False Ceiling Frame Cross "T"
11. Plasterboard False Ceiling (1.25 cm)

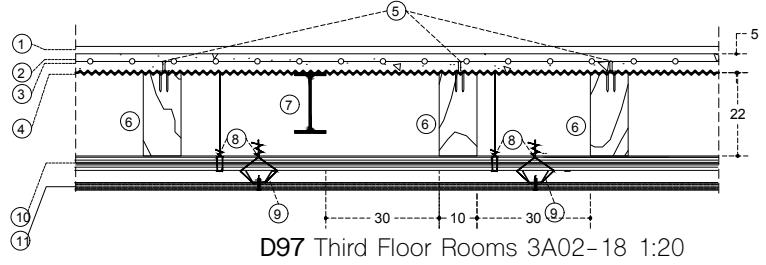
1. Floor Finish (Varies by the Room)
2. Concrete Slab (5 cm)
3. Rebar Steel Mesh 150.150.6
4. Placner Plate Ribbed Lath
5. Reinforcement Claws
6. Timber Beams (22x10cm) (Pine)
7. IPE 160 Reinforcement Beams (New)
8. Galvanised Wire
9. False Ceiling Frame Main "T"
10. False Ceiling Frame Cross "T"
11. Plasterboard False Ceiling (1.25 cm)

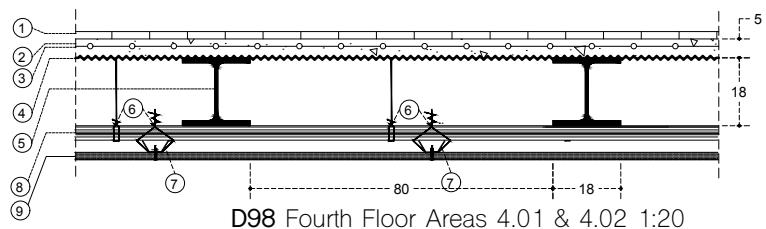
1. Floor Finish (Oak Wooden Flooring)
2. Concrete Slab (5 cm)
3. Rebar Steel Mesh 150.150.6
4. Placner Plate Ribbed Lath
5. HEB 180 Beams (New)
6. Galvanised Wire
7. False Ceiling Frame Main "T"
8. False Ceiling Frame Cross "T"
9. Plasterboard False Ceiling (1.25 cm)

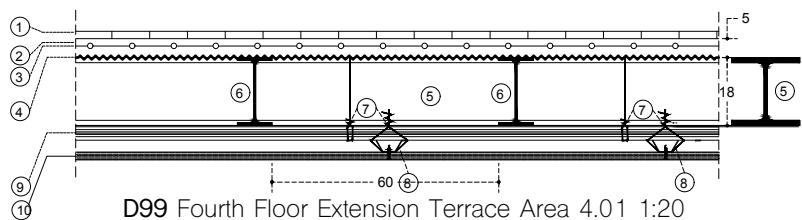
1. Floor Finish (Oak Wooden Flooring)
2. Concrete Slab (5 cm)
3. Rebar Steel Mesh 150.150.6
4. Placner Plate Ribbed Lath
5. HEB 180 Beams (New)
6. IPE 180 Beams (New)
7. Galvanised Wire
8. False Ceiling Frame Main "T"
9. False Ceiling Frame Cross "T"
10. Plasterboard False Ceiling (1.25 cm)

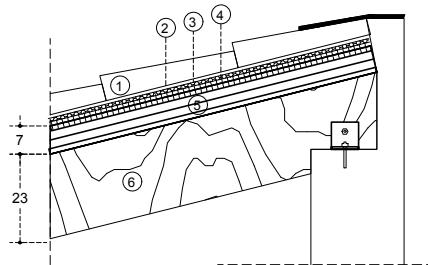
1. Ceramic Roof Tiles (Double Layer)
2. Mortar (1cm) (For Asphalt Cloth Protection)
3. Asphalt Cloth
4. Vapor Barrier
5. Thermochip® Insulated Panel
6. Timber Beams (Existent) (8 x 23 cm)
7. Zinc Plate (0.5 cm)

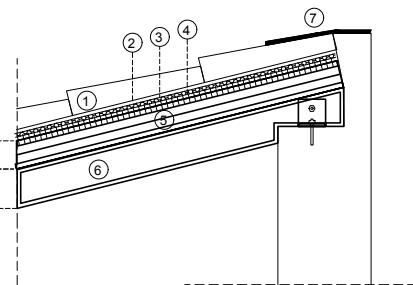
1. Ceramic Roof Tiles (Double Layer)
2. Mortar (1cm) (For Asphalt Cloth Protection)
3. Asphalt Cloth
4. Vapor Barrier
5. Thermochip® Insulated Panel
6. IPE100 Beams (New)
7. Zinc Plate (0.5 cm)

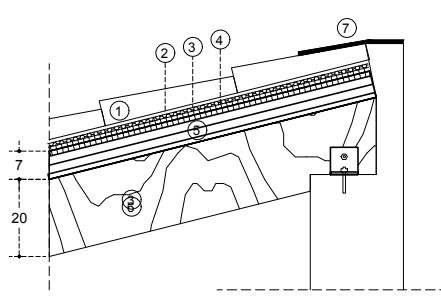
1. Ceramic Roof Tiles (Double Layer)
2. Mortar (1cm) (For Asphalt Cloth Protection)
3. Asphalt Cloth
4. Vapor Barrier
5. Thermochip® Insulated Panel
6. Timber Beams (Existent) (10 x 20 cm)
7. Zinc Plate (0.5 cm)

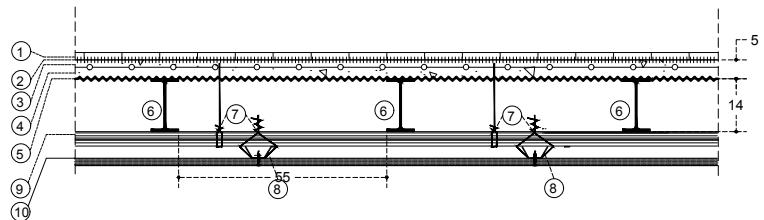
D103 Fourth Floor Terrace 4TER 1:20

1. Floor Finish (Lorca Natural Stone)
2. Polyurea Waterproofing
3. Concrete Slab (5cm)
4. Rebar Steel Mesh 150.150.6
5. Placner Plate Ribbed Lath
6. IPE 140 Beams (New)
7. Galvanised Wire
8. False Ceiling Frame Main "T"
9. False Ceiling Frame Cross "T"
10. Plasterboard False Ceiling (1.25 cm)

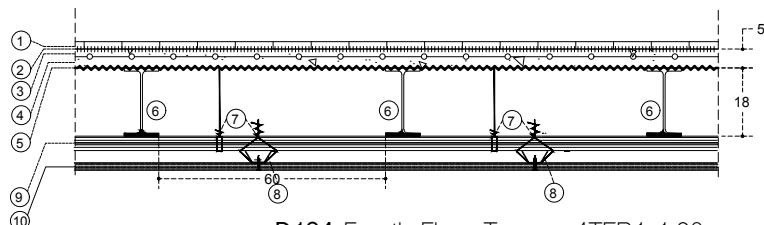
D104 Fourth Floor Terrace 4TER1 1:20

1. Floor Finish (Lorca Natural Stone)
2. Polyurea Waterproofing
3. Concrete Slab (5cm)
4. Rebar Steel Mesh 150.150.6
5. Placner Plate Ribbed Lath
6. IPE 180 Beams (New)
7. Galvanised Wire
8. False Ceiling Frame Main "T"
9. False Ceiling Frame Cross "T"
10. Plasterboard False Ceiling (1.25 cm)

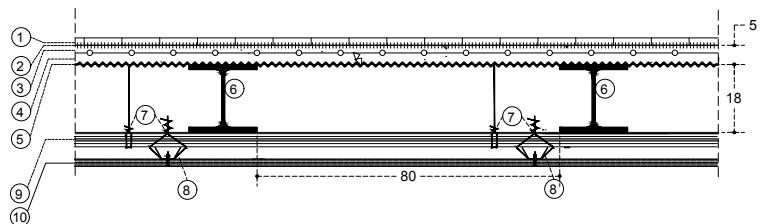
D105 Fourth Floor Terrace 4TER2 1:20

1. Floor Finish (Lorca Natural Stone)
2. Polyurea Waterproofing
3. Concrete Slab (5cm)
4. Rebar Steel Mesh 150.150.6
5. Placner Plate Ribbed Lath
6. HEB 180 Beams (New)
7. Galvanised Wire
8. False Ceiling Frame Main "T"
9. False Ceiling Frame Cross "T"
10. Plasterboard False Ceiling (1.25 cm)

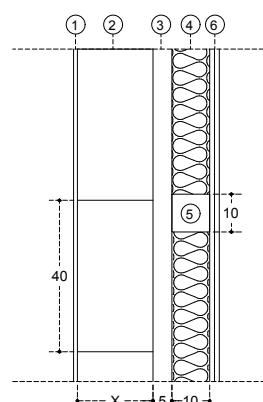
D106 Wall Type A: External Walls with Marés 1:20

1. Kerakoll Biocalce® Intonaco Plaster (Varies by the Surface)
2. Marés Stone Wall (Existent) (Thickness Varies)
3. Air Gap
4. Insulation (Mineral Wool)
5. Fixing to Support
6. Pladur® Layer (Double Layer of 1.25 cm)

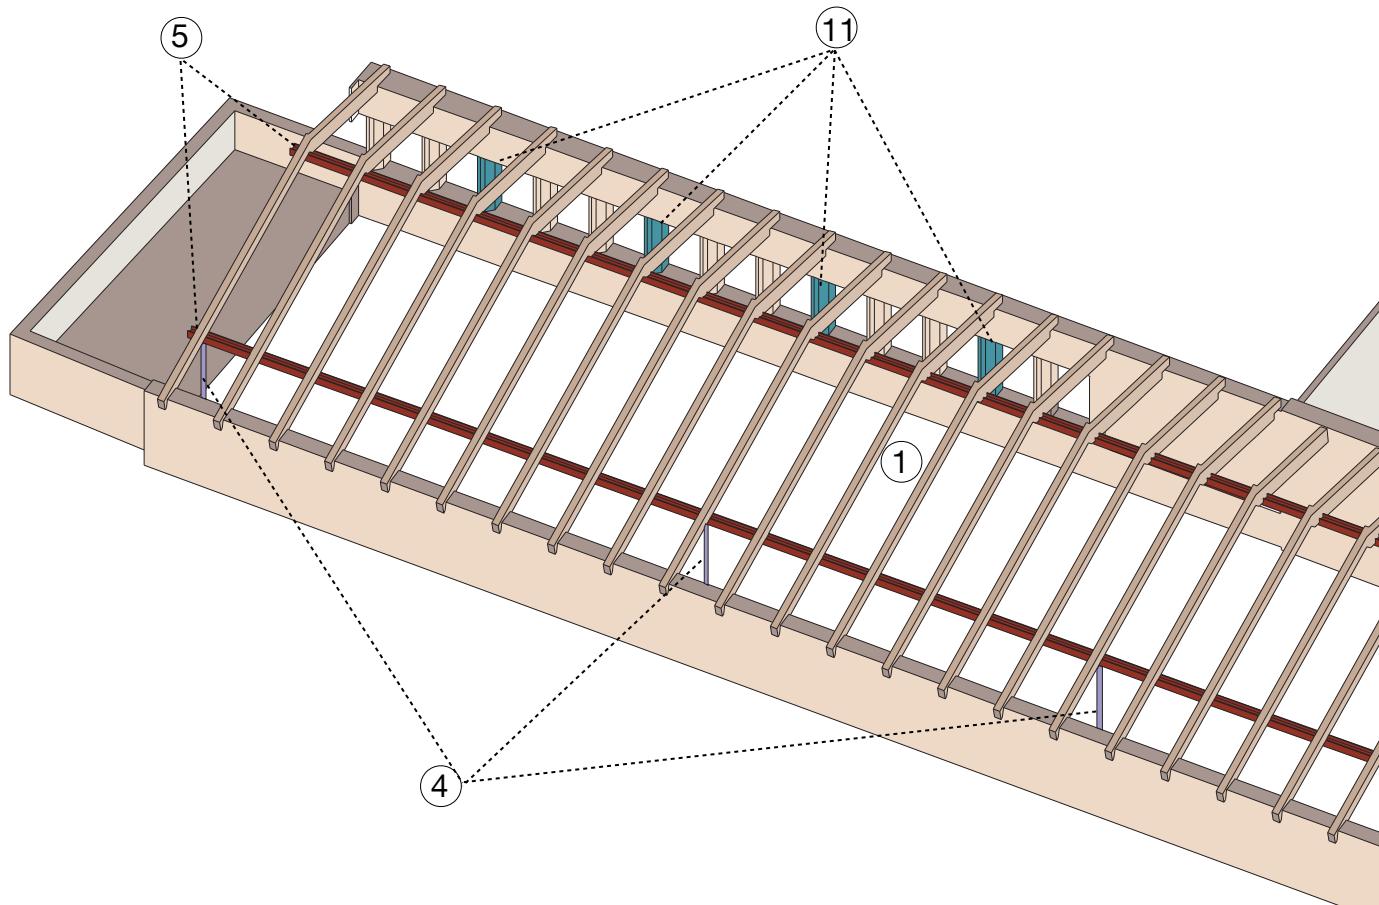
- 1. Timber Joists (Recovered) (10x23cm)
- 2. Timber Joists (New) (12x20cm)
- 3. Timber Joists (Recovered) (8x20cm)
- 4. HEB100 Support Columns (New)
- 5. HEB120 Beams (New)
- 6. HEB140 Columns (New)
- 7. HEB 320 Beam (New)
- 8. UPN 80 Column (New) (x2)
- 9. UPE 220 Beam (New)
- 10. UPE400 Beam (New)
- 11. Tube Pillar Inside the Mares Window (70.70.4)
- 12. Timber Decorative Roof Extensions (Recovered)

*The roof is completed with Thermochip® Insulated Panel, Vapour Barrier, Asphalt Cloth, 1cm Mortar and Ceramic Roof Tiles, except for the area indicated at drawing D111.

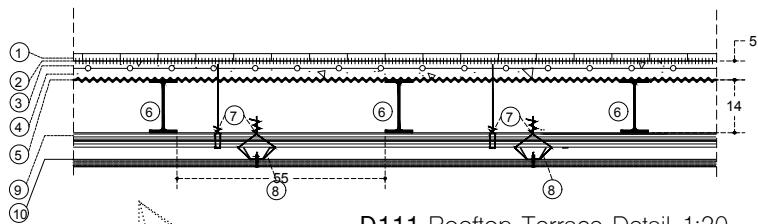
D111 Rooftop Terrace Detail 1:20

1. Floor Finish (Lorca Natural Stone)
2. Polyurea Waterproofing
3. Concrete Slab (5cm)
4. Rebar Steel Mesh 150.150.6
5. Placner Plate Ribbed Lath
6. Timber Beams (8x20cm)
7. Galvanised Wire
8. False Ceiling Frame Main "T"
9. False Ceiling Frame Cross "T"
10. Plasterboard False Ceiling (1.25 cm)

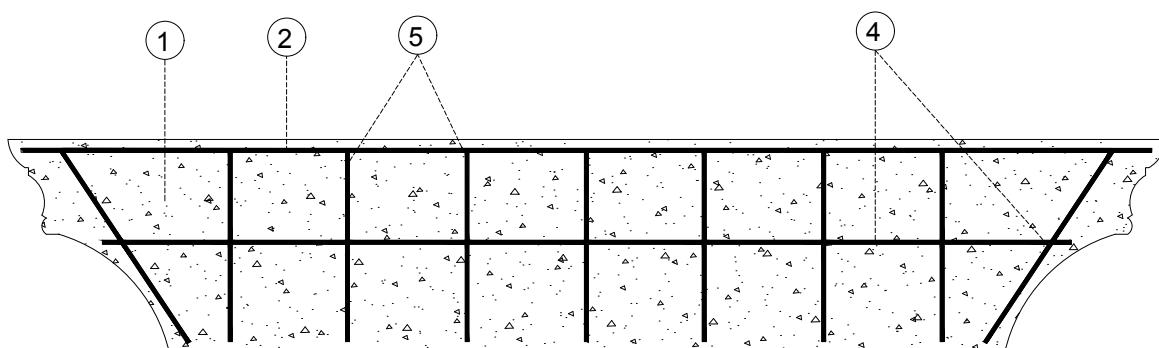
D114 Balconies Frontal Section 1:20

1. Concrete Compression Layer (Varies by the Room)
2. Concrete Tie Beam $\varnothing 10$
3. Concrete Tie Beam $\varnothing 10C/30$
4. Concrete Tie Beam $\varnothing 8$
5. Concrete Tie Beam $\varnothing 8c/30$
6. $\varnothing 12$ mm Drill Hole Filled With Epoxy Resin
7. Existing Wall
8. Existing Floor Slab

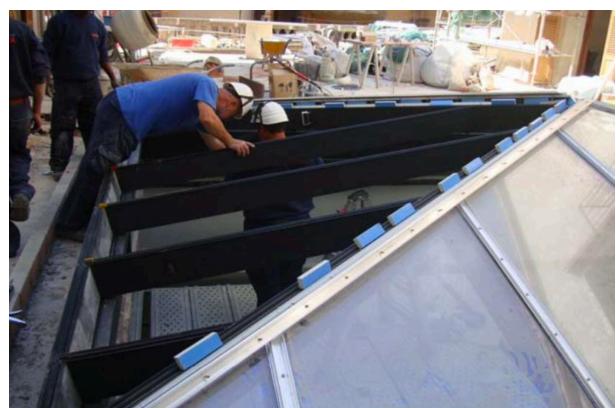
106 Installation of the Skylight Glass Panels
© Bastidas Architecture

sunlight and preventing the Cafe area from getting too warm. According to the owner of the building, Barbara Bergman, this film discolours after a period of time and becomes a shade of sepia. As a result, the film has to be removed every winter and replaced with a new one each summer. The film is likely a solar control film, which is commonly used in architecture to regulate the amount of sunlight that enters a building. Although this film provides a quick solution to overheating, the constant renewal of the film is not sustainable and may result in long-term damage to the skylight.

An alternative solution to this problem could be to install a shading system that operates automatically. For example, a louvred roof system that adjusts based on the sun's angle could be implemented. Another option is to install a dynamic glazing system, where the level of transparency can be adjusted depending on the amount of sunlight entering the building. This type of system would not only reduce the need for a shading film, but also increase the energy efficiency of the building.

Ultimately, the constant renewal of the shading film is not a sustainable solution. Alternative solutions, such as an automatic shading system or dynamic glazing, should be considered to increase the longevity and energy efficiency of the building.

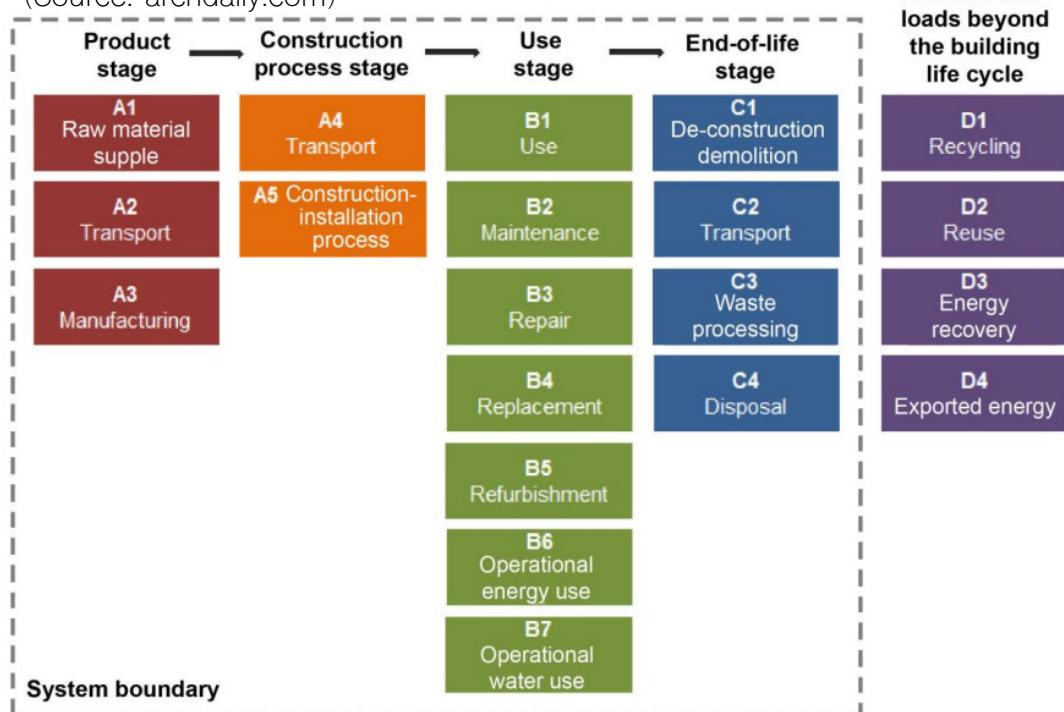
S9 Life Cycle of a Building Material
(Source: archdaily.com)

The analysis comprises three distinct phases known as A1-A3, which encompass the product stages of raw material extraction, its transportation, and manufacturing. To ensure reliable data for the majority of materials, the Öekobaudat database is primarily utilized. However, for specific or hard-to-find materials such as marés sandstone, Kerakoll BioCalce Plaster, Pladur Partition Wall, and

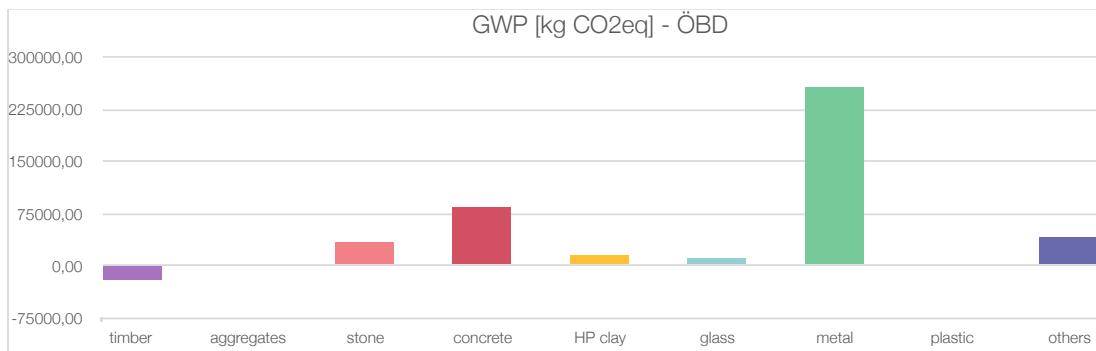
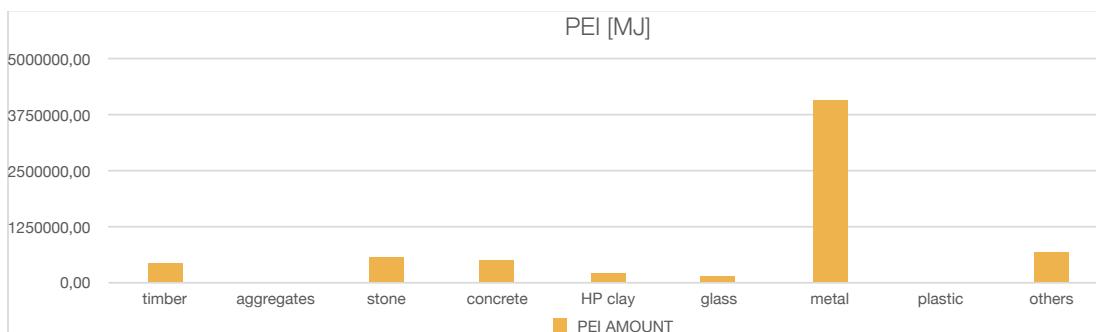
T6 GWP &PEI Values of Each Typology of Material

The refurbishment project involved replacing the floor slabs with concrete while retaining the existing stone walls.

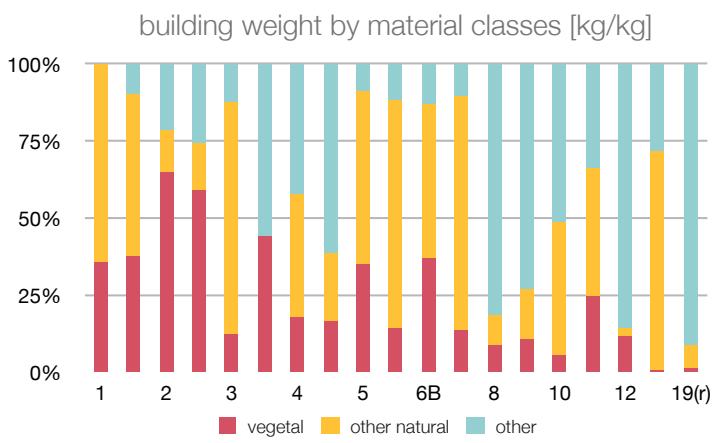
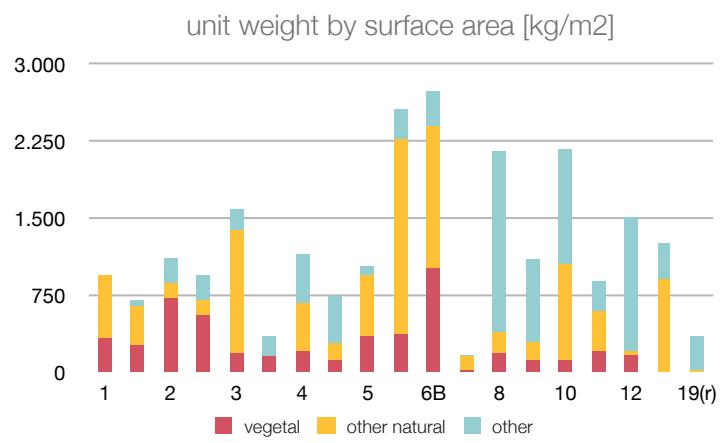
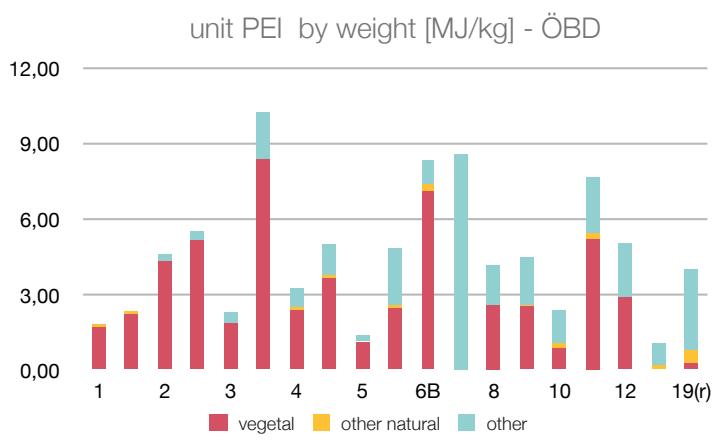
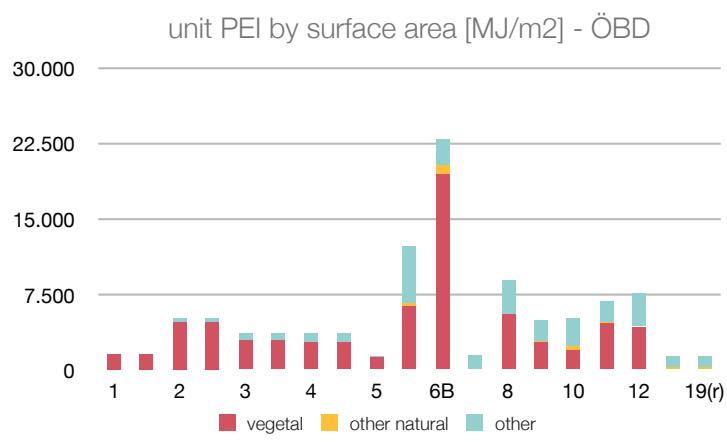
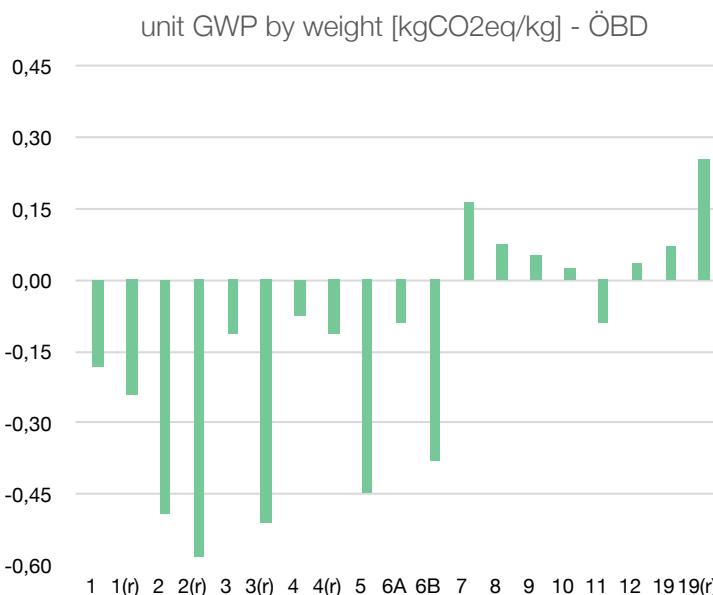
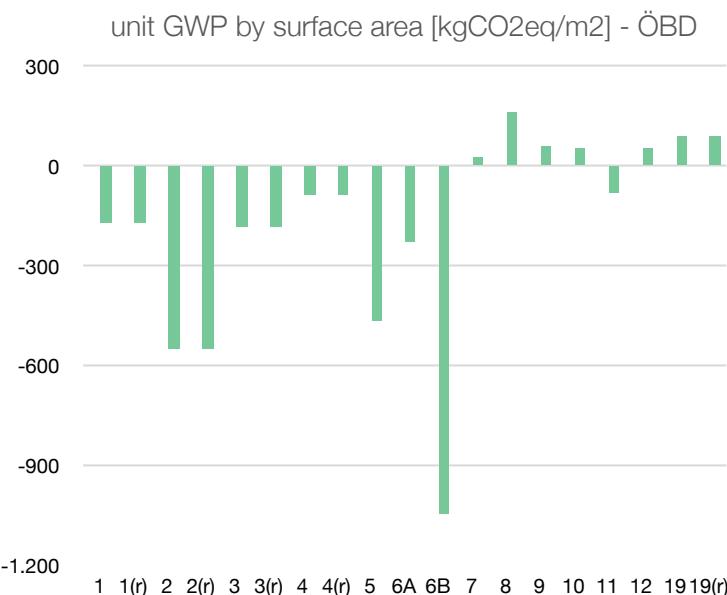
T8 Weight, GWP, and PEI Value Comparisons of the Case Study Building and Reference Buildings from ‘Vegetarian Architecture by Andrea Bocco Guarneri

"The building materials used are analysed in detail but are presented in the charts aggregated in three macro-categories vegetal materials: all other natural materials; man-made. For the sake of comparison, these categories are used to describe all the case studies.

The environmental impacts of buildings are both expressed in absolute values and in values per kilogram per square meter and per capita. The surface area is consistently defined as gross internal area (GIA) that is as the sum total of surface areas measured at the inner face of perimeter walls. This choice was due to the fact that what counts is the amount of space available for living, and also to the fact that in buildings where the envelope is insulated with natural materials such as straw bales, the thickness of perimeter walls can be significant and heavily affects the gross floor area (GFA), that is, the sum total of surface area measured at the outer face of perimeter walls. Similarly, GIV (gross internal volume) was considered, not the whole built volume. (A.B. Guarneri, 2020)

When analysing the unit Global Warming Potential (GWP) by surface area, it becomes evident that the value for the studied building is positive, indicating the emission of greenhouse gases during its life cycle. However, in comparison to other buildings that extensively employed natural and vegetal materials in their construction, the observed GWP value is relatively lower. This finding suggests that despite utilising fewer sustainable materials, the refurbishment of an existing building has the potential to significantly reduce the overall GWP associated with its construction. This reduction in greenhouse gas emissions can be attributed to the reuse and preservation of the building's original materials, which inherently lowers the demand for energy-intensive production processes.

A similar trend is observed when examining the unit Primary Energy Input (PEI) by weight compared to the unit PEI by surface area. Notably, there is a substantial decrease in the PEI value per unit surface area, a reduction that is primarily evident in refurbishment projects. This decrease can be attributed to the fact

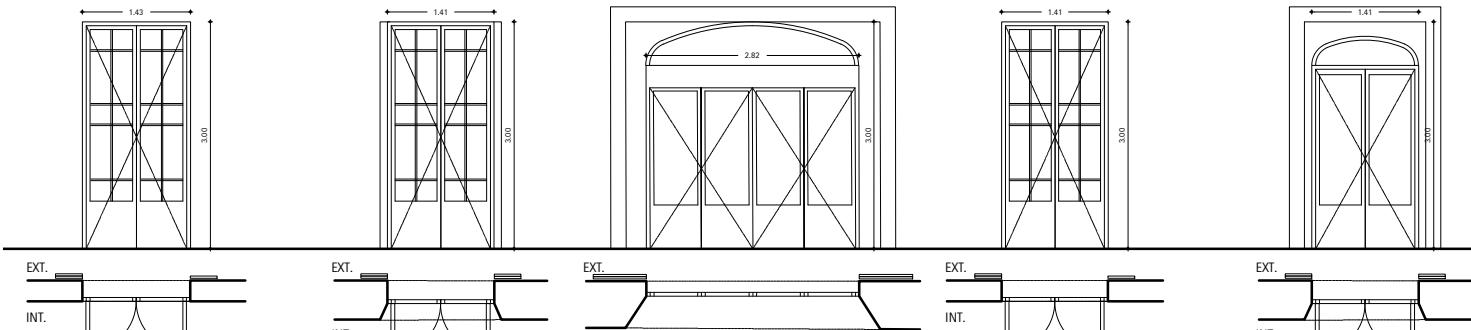
CE 6

PUERTA EXISTENTE A RECUPERAR,
MADERA EN SU COLOR.
LAS MEDIDAS SON DE HUECO.

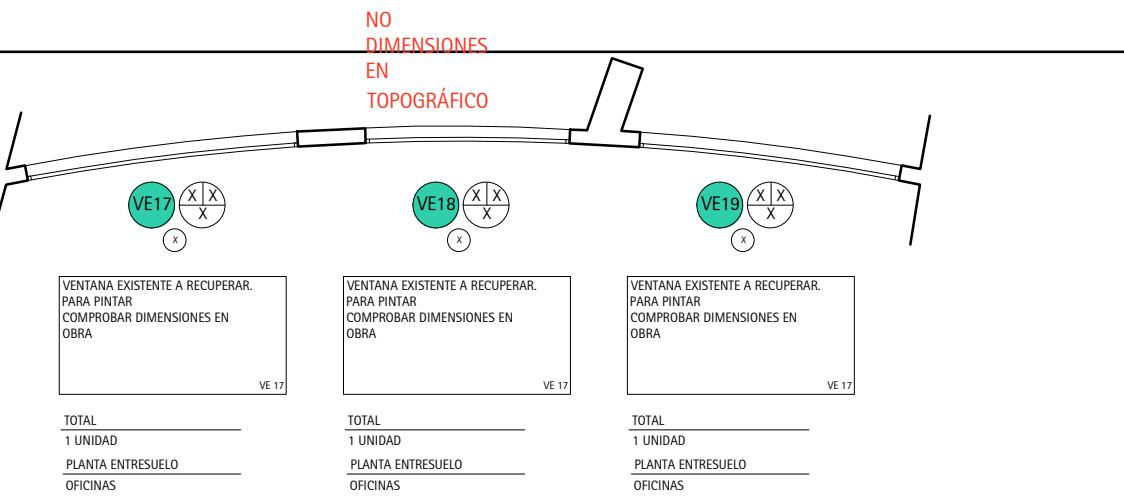
VENTANA A RECUPERAR.
DE MÁQUINAS
DIMENSIONES EN
VE 16

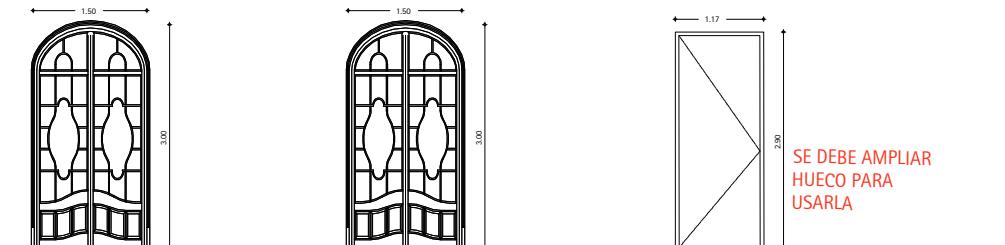
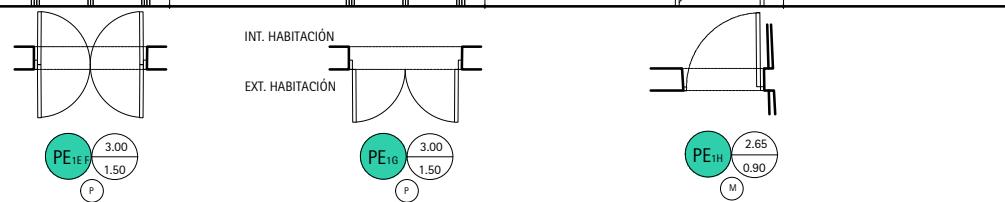
VENTA A RECUPERAR,
PINTAR
CON MARCO SEGÚN
PE 1C

PUERTA EXISTENTE A RECUPERAR,
MADERA PARA PINTAR. VIDRIO NUEVO
LAS MEDIDAS SON DE HUECO
TRANSFORMADAS EN PUERTAS DE
VAIVEN
SEGÚN DOSIER FASE I:
1.27-1.43/1.43-1.12
PE 1 EF

PUERTA EXISTENTE A RECUPERAR,
MADERA PARA PINTAR. VIDRIO NUEVO
LAS MEDIDAS SON DE HUECO
SEGÚN DOSIER FASE I:
1.03-1.05
PE 1G

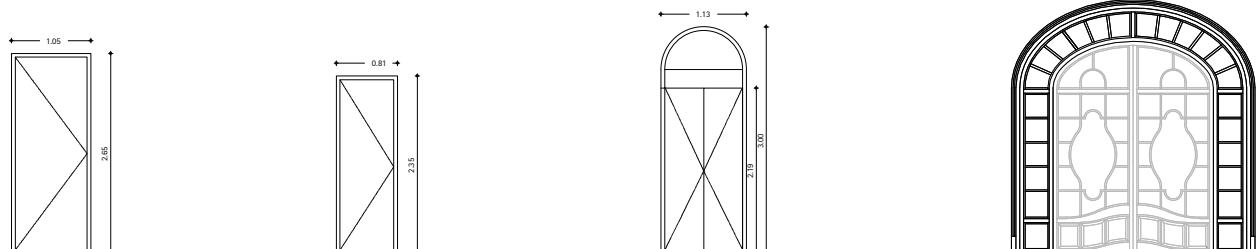
PE 1M

PUERTA EXISTENTE A RECUPERAR,
ADERA PARA PINTAR
LAS MEDIDAS SON CON MARCO SEGÚN
DOSIER FASE 1:
1.11-1.12

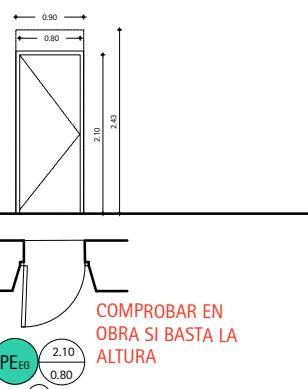
PE ED

ENTRE A RECUPERAR,
MADERA PARA PINTAR.
LAS MEDIDAS SON DE HOJA
DOSIER FASE 1:
1.12-1.23
ADAPTAR ALTURA

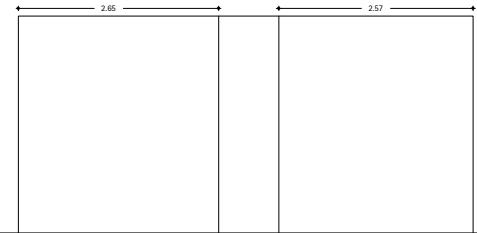
CRISTALERA METÁLICA. OSCILOBATIENTE.
PARA PINTAR.
CRISTAL CLIMALIT
MANETA A DEFINIR
LAS MEDIDAS SON DE HUECO
CM15

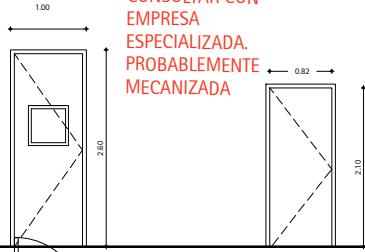
PUERTA ESPECIAL
CONSULTAR CON
EMPRESA
ESPECIALIZADA.
PROBABLEMENTE
MECANIZADA

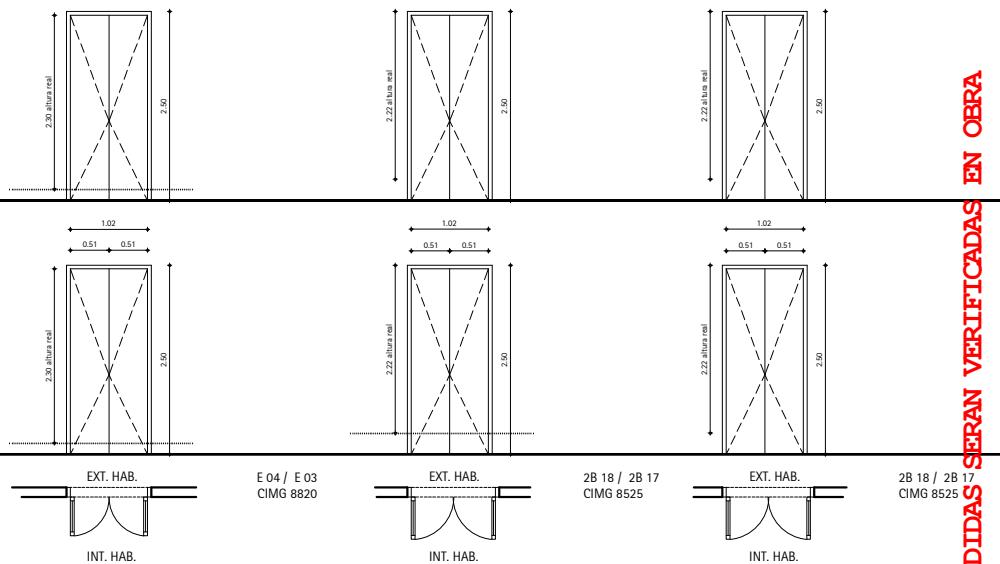
CRISTALERA EXISTENTE A RECUPERAR, PARA PINTAR.
LAS MEDIDAS NO INCLUYEN LOS MARCOS. LA ALTURA FINAL SERÁ DE 2.50 m (INCLUYENDO MARCOS). SERÁ NECESARIO AGREGAR PLAFÓN INFERIOR. CE 2c

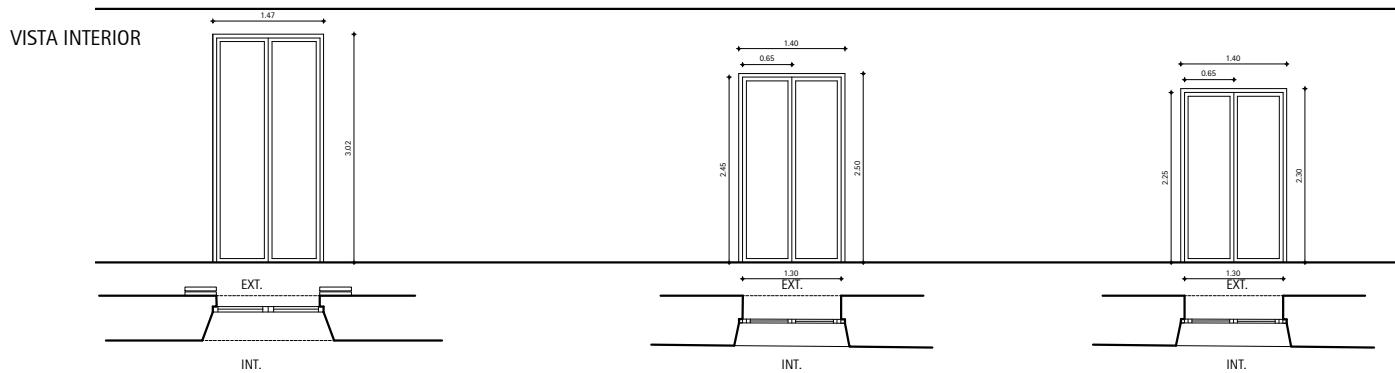
CE1
3.02
1.47
(M)

CRISTALERA EXISTENTE A RECUPERAR,
PARA PINTAR.
COMPROBAR TODAS LAS MEDIDAS EN
OBRA.

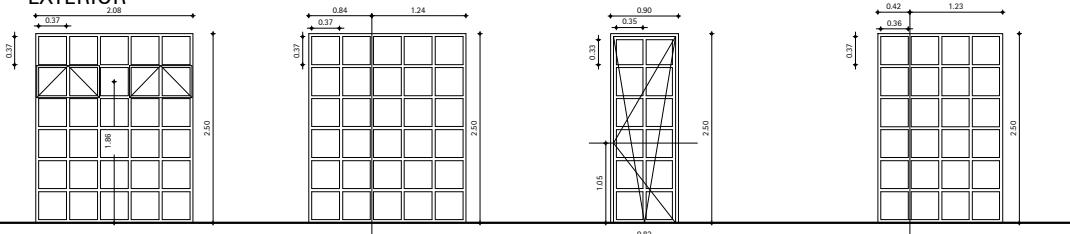
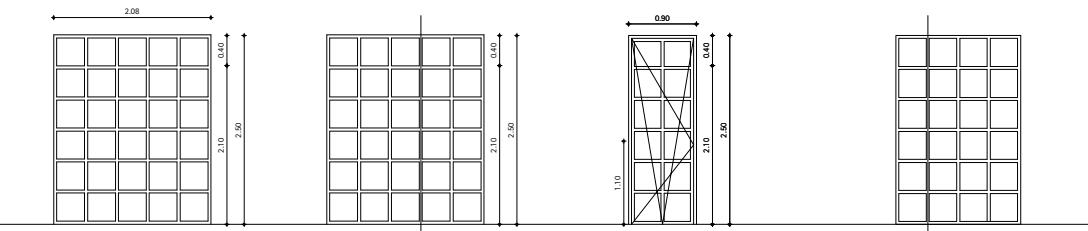
CRISTALERA METÁLICA, FIJA, PARA PINTAR.
CRISTAL CLIMALIT
DETALLES DE PERFILETURA A TRATAR CON HERRERO
CM 1

CRISTALERA METÁLICA, PIVOTANTE, PARA PINTAR.
CRISTAL CLIMALIT
MANETA A DEFINIR.
CM 1'

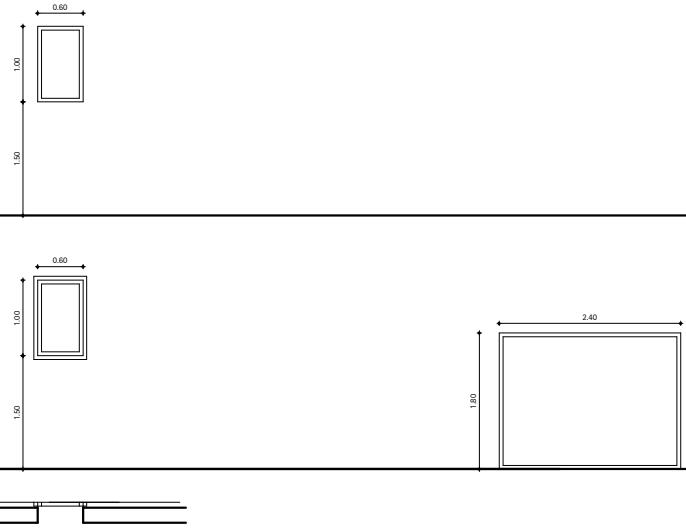
V 4

VENTANA NUEVA, EN HUECO EXISTENTE, PARA PINTAR. LAS MEDIDAS SON SEGÚN PROYECTO.
OSCILOBATIENTE
ATENCIÓN! EN ZONAS HÚMEDAS MANETAS Y HERRAJES, NUEVOS.
