RIALTO LIVING

Detailed Technological
Analysis of Buildings of the
Highest Environmental Quality

Detailed Technological Analysis of Buildings of the Highest Environmental Quality:

Analysis of Rialto Living, Palma de Mallorca

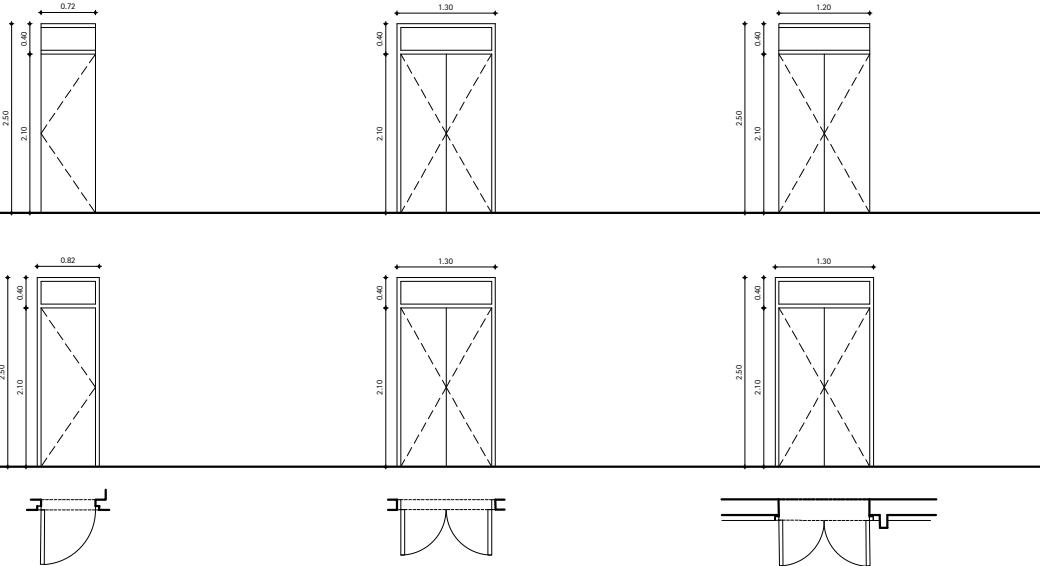
P4
2.50
0.72
(x)

PUERTA NUEVA, PARA PINTAR.
LAS MEDIDAS SON DE HOJA.
MANETAS Y HERRAJES, NUEVOS.
