Master's degree Course in Civil Engineering

Master's Degree Thesis

**Analysis of existing tunnel Italian guidelines:
segmental lining and fire induced damages**

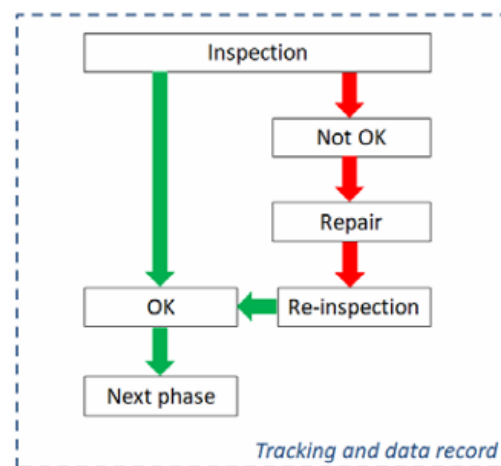
Figure 2 Segment Quality Acceptance Process (SIG WG2, 2019)

The quality control involves 3 detailed fundamental operations starting from traceability and data record, inspections, acceptance and/or repairs, transportation and delivery on site. Each segment undergoes these activities at every phase of its life and cannot be moved to the next stage of the process until all the quality criteria are fulfilled according to Figure 2.

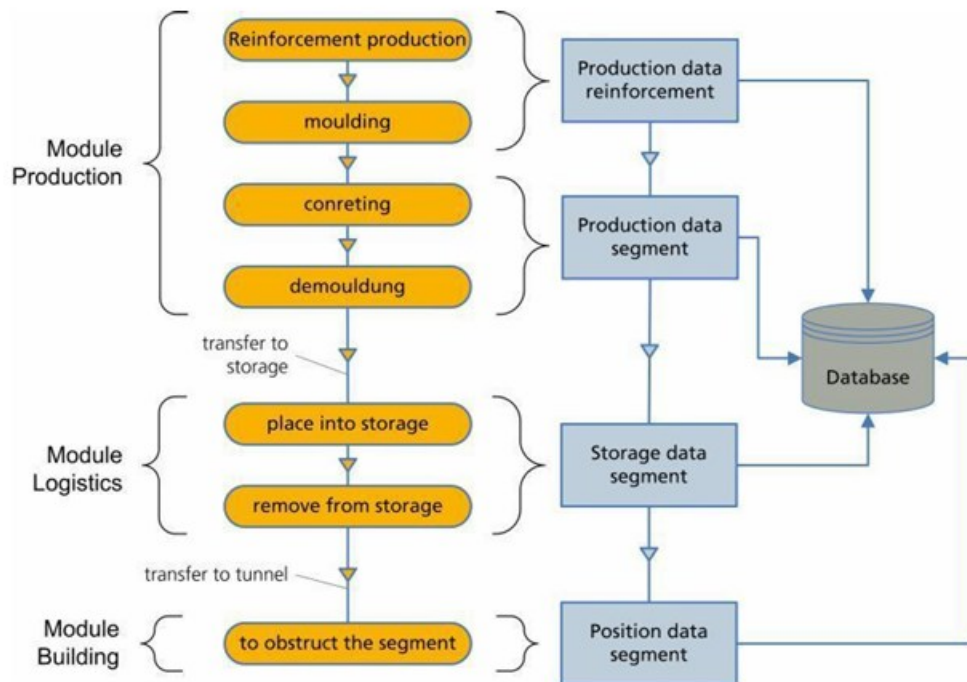
Figure 3 Database structure (SIG WG2, 2019)

To ensure effective traceability and long-term data record management during transportation and delivery on site, it is essential to maintain a systematic database of all segment deliveries and related documentation. This includes the shipping request, shipping list, and loading pack, which should be accurately shared among the Manufacturer, Main Contractor, and Transport Company. Each segment must be tracked using a unique reference number, ensuring alignment with historical production and delivery data. As shown in Figure 3, this structured approach supports quality control, accountability, and efficient logistics across all stages from production to installation.

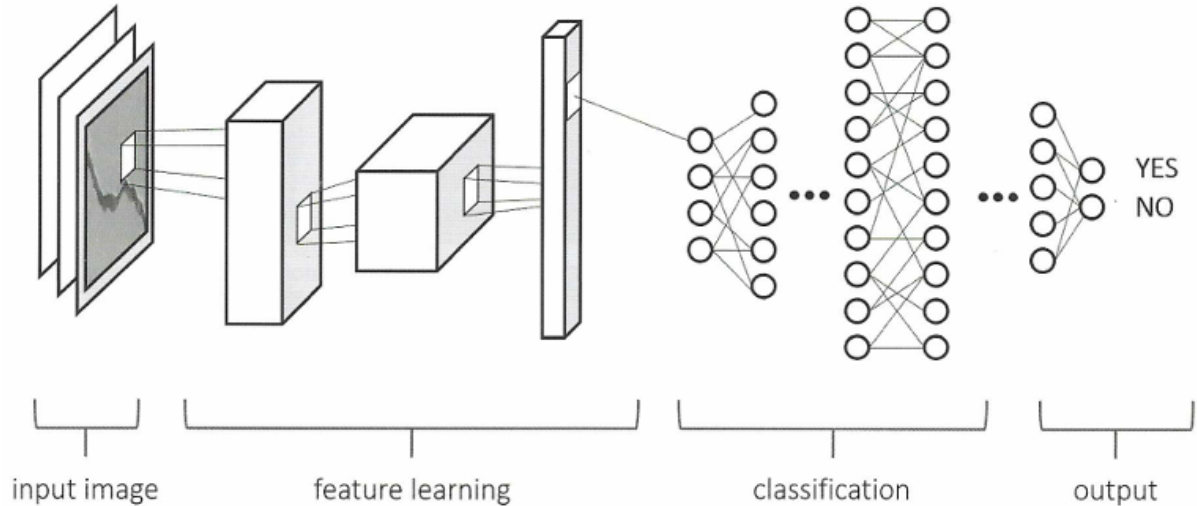
Figure 6 Neural network process for image classification and anomaly detection (Valentini and Faini, 2024)

To enhance interpretability, an attention mechanism was integrated which allowed the model to focus on the most relevant parts of the image and produce an intermediate output indicating the likelihood of defect presence. The final model output was a probability matrix representing the presence or absence of defects across the image as illustrated in Figure 6. This map uses parts of the neural network that are trained to differentiate between defective and non-defective items, employing a simple yes-or-no method. These advanced visual tools make it possible to not only detect defects but also estimate their size and spread allowing for an easier and smarter process results, allowing for more efficient decision making.

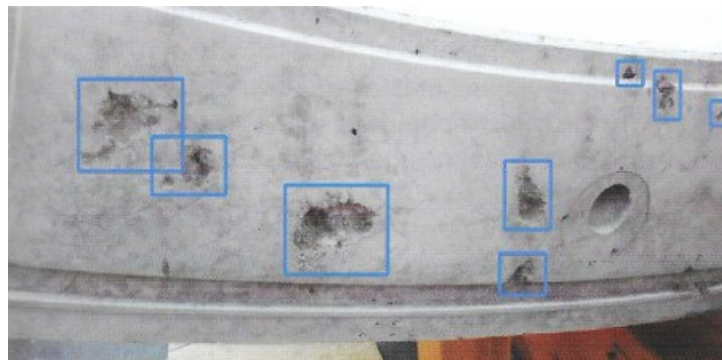
Figure 7 Expected anomalies in concrete segment defects (Valentini and Faini, 2024)

The final model was tested on over 10,000 images and showed strong results in detecting various defects. A useful feature was the probability map, which highlighted accurately areas most likely to have issues. As shown in Figure 7, this feature helps in focusing attention on potential problem zones, making inspection faster and more consistent.

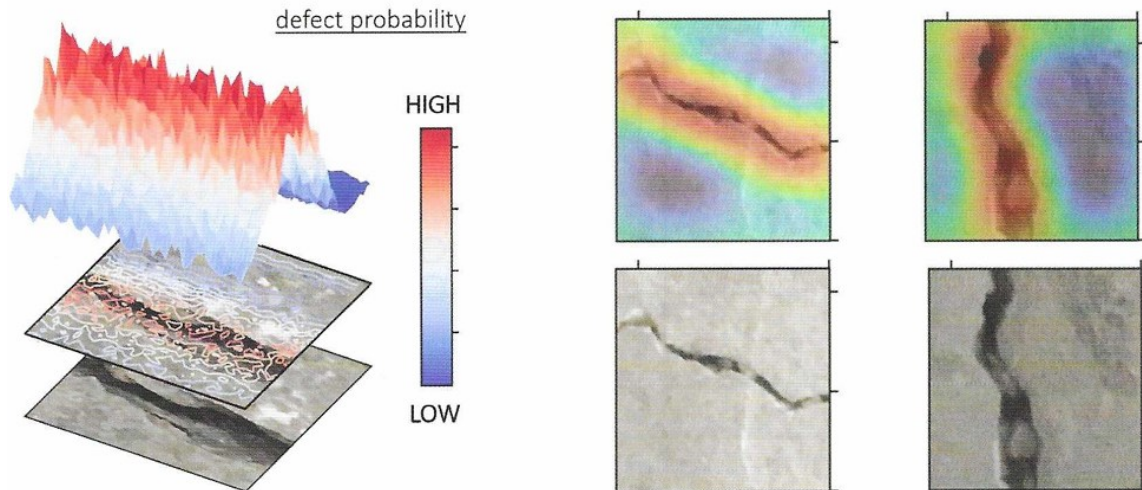
Figure 8 Anomaly detection probability distribution output (Valentini and Faini, 2024)

In the process of identifying defects, a neural network creates a probability map that shows where defects are likely to be in a picture. Figure 8 illustrates these using shades of red, where lighter red means a higher chance of defects. This map is then combined with the original photo of the object to help experts and automated systems to concentrate on areas that might have defects, speeding up the inspection process.

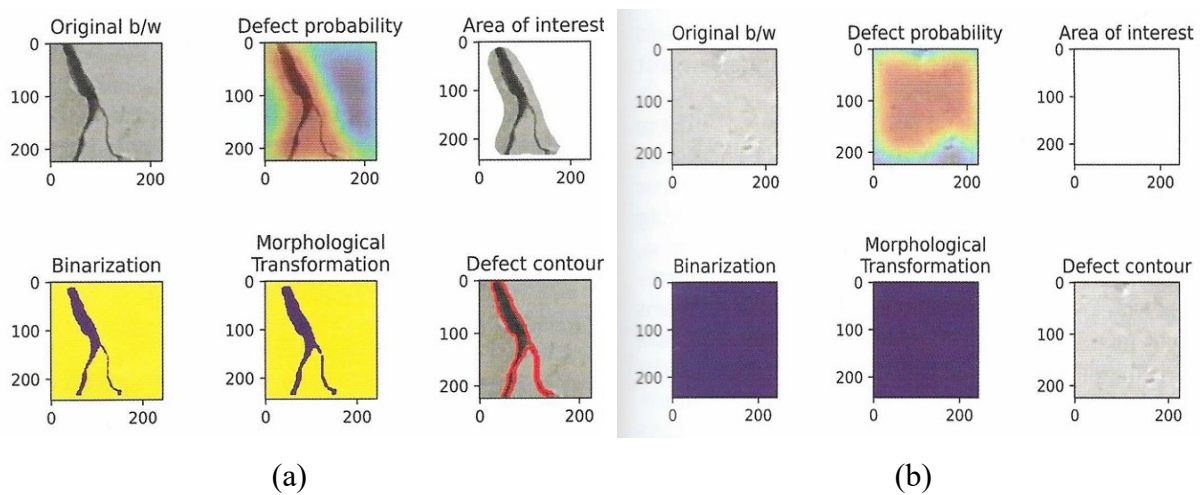
Figure 9 a) Image classification and anomaly detection detail, b) same process but for no defect anomaly results (Valentini and Faini, 2024)

Based on the binary (yes/no) neural network prediction, a mission vision algorithm is applied to accurately identify the real defect boundary and locate cracks, as clearly shown in Figure 9a. In addition, when no defect is detected, the system generates an output image indicating the absence of defects, as illustrated in Figure 9b.

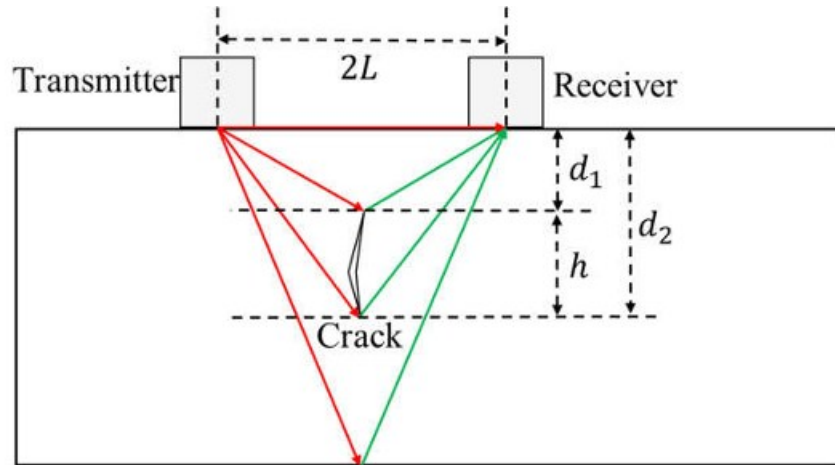
Figure 11 TOFD principle (Jiang et al., 2023)

The Time-of-Flight Diffraction (TOFD) method is effective in identifying the diffraction of ultrasonic waves at the edges of cracks, which allows the determination of their location and size as illustrated in Figure 11, when the transmitter emits an ultrasonic pulse, part of the wave is diffracted by the crack tips.

This diffracted signal is captured by the receiver, and its arrival time is recorded. Using this data, and knowing the speed of signal (c), half length (L) between the transmitter and the receiver, travel time of the ultrasound beam (Δt), the depth (d) and dimensions of the crack (h) can be calculated using the following equation.

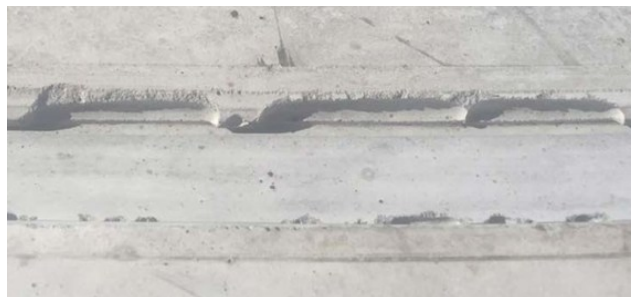
Figure 13 Example of hollows (SIG WG2, 2019)

Hollows consist of a small void on the surface or within the structure as shown in Figure 13. They are considered defects if they exceed 5 mm at extrados, intrados and perimetric surfaces and considered non-conformities if they exceed 1 mm on gasket groove. Hollows occur due to incomplete air expulsion during concrete pouring and segment casting. Air can be trapped between the mould and concrete or absorbed during transport between different containers (e.g., mixer to hopper). Hollows could be caused by poor vibration distribution and improper mix design.

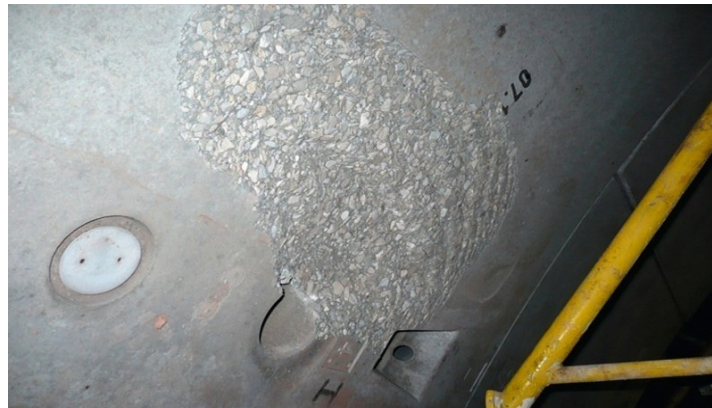
Exposed aggregates (Figure 14) occur when large aggregate particles become visible on the segment surface due to a lack of fine materials like cement, sand, and additives. This typically happens because of:

- washout, i.e. excess water or overly fluid concrete can cause finer particles to be washed away, leaving behind only coarse aggregates.
- poor mixing, if concrete is not mixed properly, coarse particles can clump together, forming voids or nests. These conglomerates may not break apart during transport and casting, leading to uneven distribution in the segment.

Figure 14 Exposed Aggregates (SIG WG2, 2019)

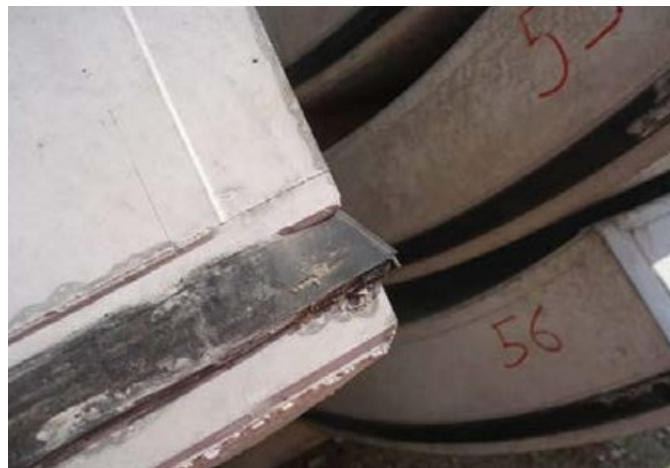
Anchored gaskets defects: One of the most common defects that could happen in anchored gaskets is the gasket sinking in the concrete longitudinal and circumferential joints and corners (Figure 15). The sinking is mainly due to incorrect gasket installation in its groove during casting,

as they could come over the groove not maintaining its correct position in the segment during moulding, also during installation or during casting as the gasket could deform forming a crease being forced inside the groove at one of its sides without being distributed all over the segment corner or longitudinal side. Another cause is the inadequate anchoring system, where there is no sufficient connection force applied at the mould during casting. Other causes that lead to corner sinking of the gasket in the concrete is the length of the gasket not sufficient in one or more of the sides of the segment, improper coupling of the gasket with the mould leading to gasket installation defects, as well as design mistakes of the gasket groove at the corner

Figure 15 Corner Gasket Damage (SIG WG2, 2019)

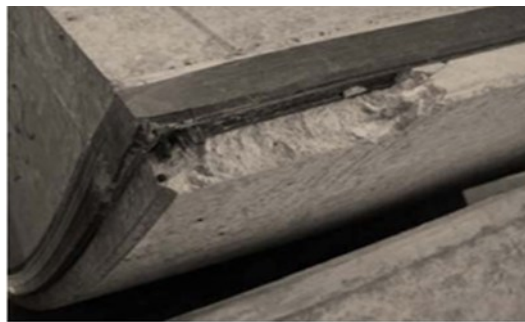
Chipping (Figure 16) usually happens during casting due to incorrect distribution of demoulding agent either because of insufficient agent to cover all sides or the agent not being distributed uniformly along the sides and corners. Another cause is the collisions that happen during the casting. Segment chipping during demoulding is also caused by misalignment and excessive concrete cover thickness, making them more prone to damage.

Figure 16 Example of corner breaking (SIG WG2, 2019)

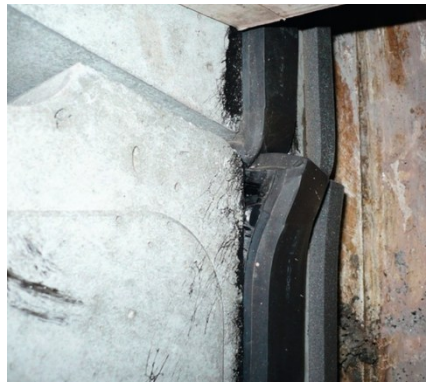
handling. For what concern ring installation phase, when installing a segment to an already installed segment, the gasket of the incoming segment may be expelled from its longitudinal side (Figure 17). During installation, gasket damage can be influenced by the longitudinal cut angle and the connection system. For instance, rectangular segments with a cut angle close to 0° increase the risk of gasket expulsion. Add to it gasket anchoring and adhesion issues including poor gasket lubrication where friction between the gaskets of adjacent segments can cause expulsion or displacement from the groove upon installation, and poor anchoring or poor gluing force.

Figure 17 Expulsion of gasket from one side SIG WG2, 2019)

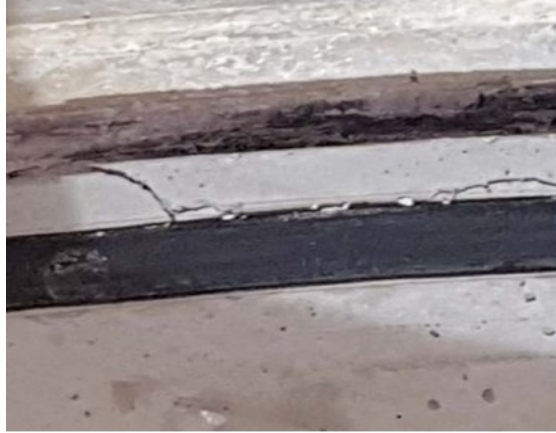
Chipping of edges and corners during installation: Edges chipping (Figure 18) happen due to jack plate presses on the gasket during installation, it can cause concrete breakage or detachment between the gasket and the segment edge. Damage to gaskets can result from improper positioning due to smaller distance from the segment edge. Weakness in the segment edge due to poor concrete properties or lack of reinforcement which causes different mechanical properties that make areas at edges weaker than other surrounding concrete. Additionally, failure to comply with the design specifications, including joint gap limits and load distribution, can subject the gasket to excessive forces, causing the segment edges to break or the gasket to exceed the concrete's resistance.

Figure 18 Chipping of edge during installation (SIG WG2, 2019)

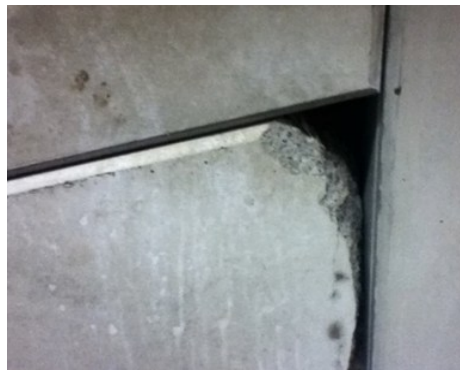
Additionally, corner chipping (Figure 19) during installation occurs when cracks form at the intrados or extrados corners, leading to concrete detachment. Main causes include collisions, weak concrete properties at the corner due to lack of reinforcement, gasket loads exceeding the concrete's strength, and improperly designed gasket corners with discontinuities causing excessive stress on the concrete during compression, leading to breakage.

Figure 19 Chipping of corners during installation (SIG WG2, 2019)

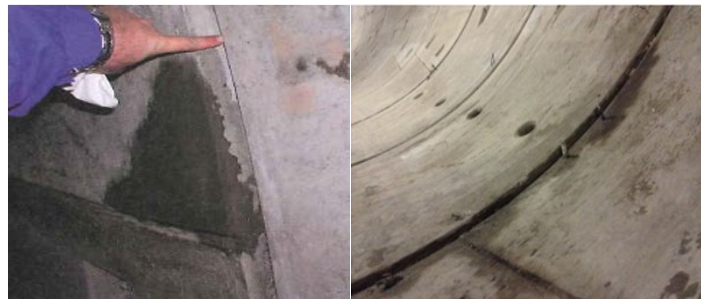
It is clearly visible that there is a slight bump in the segment towards the outer side, caused by an offset at the joint as shown in Figure 23. Additionally, there is a noticeable gap between the segments, which is likely due to improper alignment or inadequate gasket compression.

Figure 23 from left offset, from right a gap (SIG WG2, 2019)

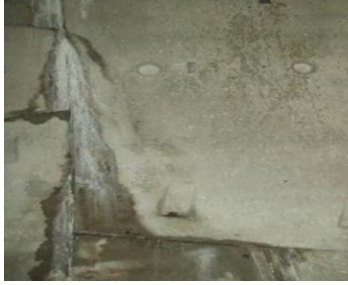
Water leakage from joints and bolt holes: Water leakage (Figure 24) occurs when the waterproofing system fails to provide an adequate seal due to insufficient hydraulic sealing by the gaskets, which may not fully prevent water infiltration. In some cases, structural fissures extending through the entire segment thickness create pathways for water to bypass the gaskets and penetrate the tunnel lining. These issues can arise from improper gasket selection, installation errors, or concrete defects.

Figure 24 Water leakage from joints (SIG WG2, 2019)

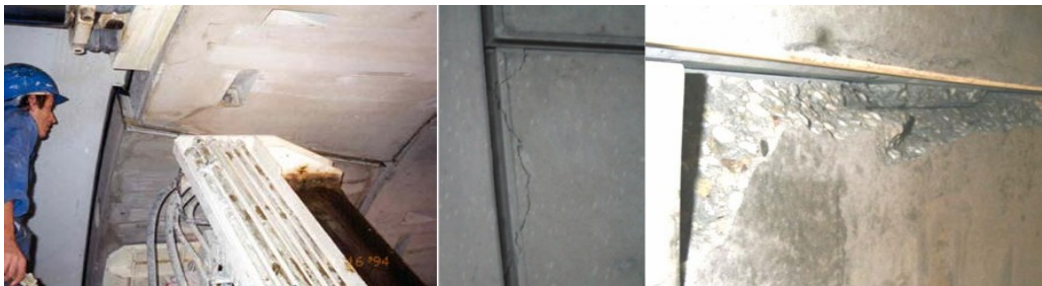
During handling and installation of the ring, segments are placed together to form rings using an erector in which they experience various loads, such as those from the segment crane, gasket compression, and collisions. Due to the complexity of handling and installation, stress-induced cracks and fissures are the most common damages in this phase. The same specifications for cracks apply as in the previous stages. Cracks can result from improper handling or installation, and they are classified based on their width: less than 0.2 mm, between 0.2 mm and 0.3 mm, and more than 0.3 mm.

Figure 26 Segment cracks during erection (left) and ring erection (right) (SIG WG2, 2019)

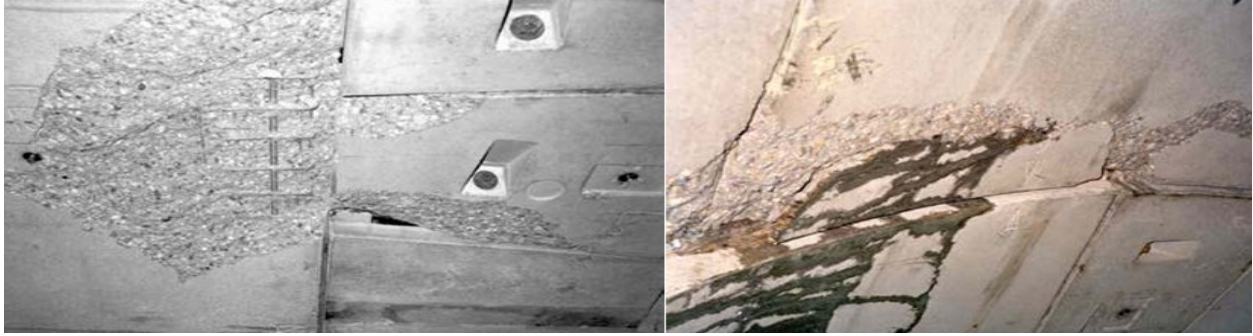
A critical factor contributing to structural damage is the effect of jack thrust during construction due to excessive or uneven jack thrust. The huge load of concentrated stresses by thrust cylinders during TBM process backed with poor design in the segment can lead to splitting transversal cracks perpendicular to the thrust force (Figure 27). These cracks are smaller than 0.2 mm and are found around the area where the surface meets the concrete cover and make the waterproofing ineffective if damage is severed.

Figure 27 Splitting transversal cracks (SIG WG2, 2019)

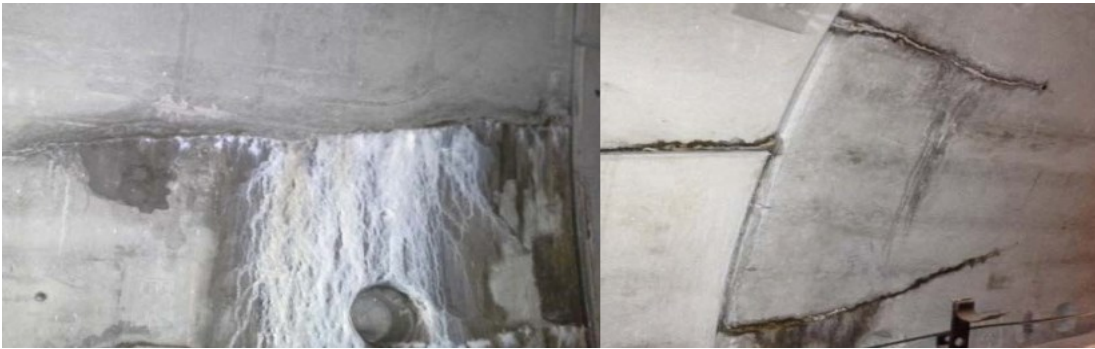
It could lead also to longitudinal cracks along the tunnel as well as spalling cracks affecting the entire segment length and hindering leaks (Figure 28).

Figure 28 Longitudinal cracks along the tunnel and spalling cracks (SIG WG2, 2019)

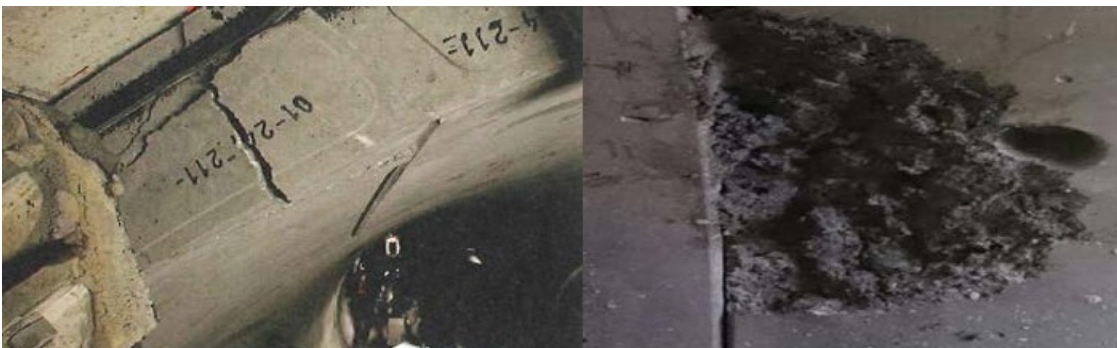
Another serious effect is chipping of sides and corners, where rebars could be visible and when visible, corrosion is easy to occur disturbing.

Figure 29 chippings in the corners (SIG WG2, 2019)

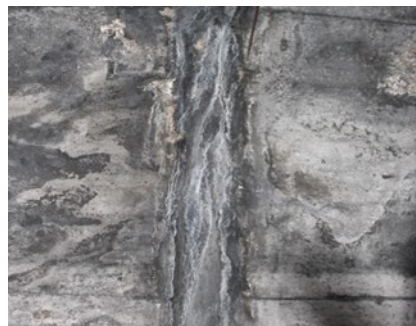
Water infiltration (Stillicides) is a common defect in tunnel linings. It is the presence of stillicides (Figure 32), which result from the repeated passage of small amounts of water over the tunnel surface. This defect appears as discoloration in areas where water infiltrates through cracks, joints, or construction discontinuities. This phenomenon may be due to other defects that may be present, such as geological discontinuities, leaks in waterproofing systems, obstruction and/or deterioration of drainage discharges.

Figure 32 Stillicides (Ministero delle Infrastrutture e della Mobilità Sostenibili, 2022)

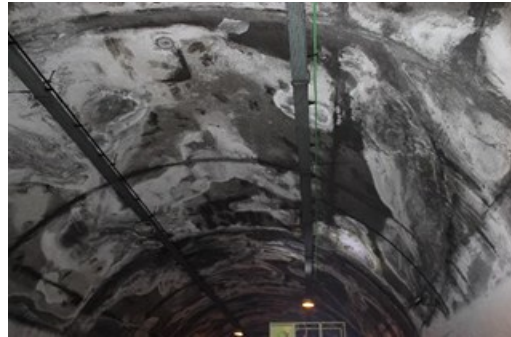
Effects of frost (traces of salts) is another defect where frost appears at the surface of segments in ice sheets form or stalactites and is mainly due to freeze-thaw cycles (Figure 33). Freeze-thaw cycles over further period could lead to flaking and detachments of small portions of surface.

Figure 33 Frost (salt traces on surface) (Ministero delle Infrastrutture e della Mobilità Sostenibili, 2022)

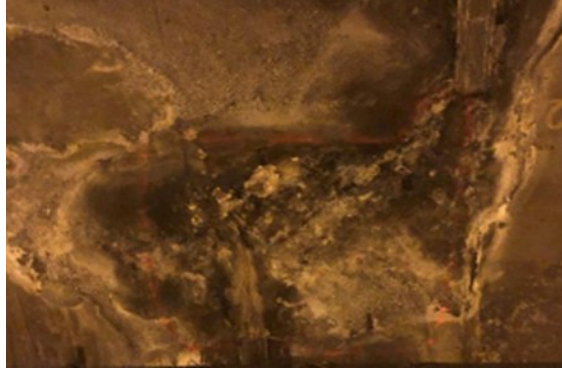
Efflorescence on concrete shows up on concrete as white, powdery spots or thin, fragile filaments caused by salt coming to the surface (Figure 34). It usually happens with older or sprayed concrete and mortar coatings. In which, it can point to deeper problems like coating damage, cracks, or material peeling off.

Figure 34 White coatings on surface of concrete (MIMS, 2022)

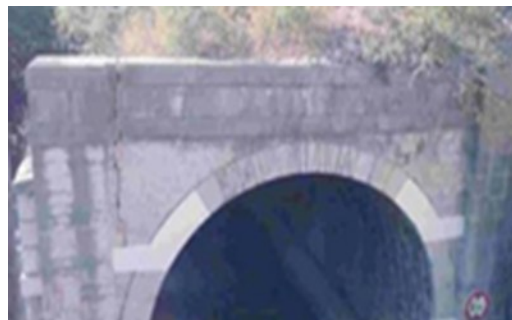
Deterioration of the tunnel entrance portals show signs of deterioration such as cracking, surface degradation, waterproofing issues, or movement of cladding panels, all caused by pressure from surrounding soil or shifting ground (Figure 35). These problems can be linked to the rotation of the arch's tympanum or instability in the terrain above. These issues may also indicate larger underlying problems like slope instability or water infiltration.

Figure 35 Deterioration of the entrance portals (MIMS, 2022)

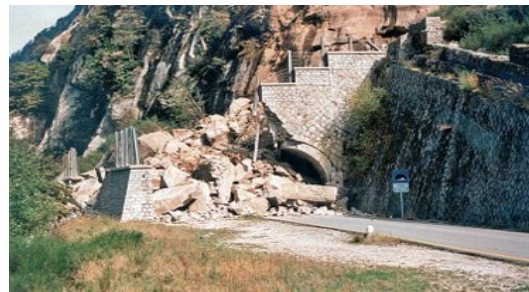
Instability of Slopes happens when soil or rocks from natural slopes shift or collapse, often pushing debris toward or near tunnel entrances (Figure 36). This can be caused by things like fractures in the ground, water runoff, or even vegetation being disturbed.

Figure 36 slope instability causing debris flow & structural damage on tunnel entrance (MIMS, 2022)

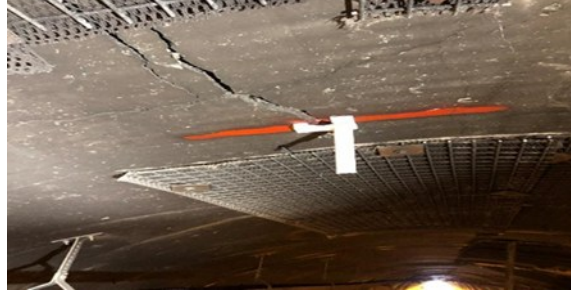
Lesions and Detachments due to Compressive Load is a type of defects that can be seen as cracks along the tunnel lining, with pieces of concrete detaching especially in cast-in-place concrete happening in different sections of the tunnel (Figure 37). During inspection, you can use lighting and sound tapping to locate and evaluate the damage, checking how widespread it is and whether the cracks are recent or have signs of aging.

Figure 37 Visible cracking and material detachment on a tunnel ceiling caused by compressive stress (MIMS, 2022)

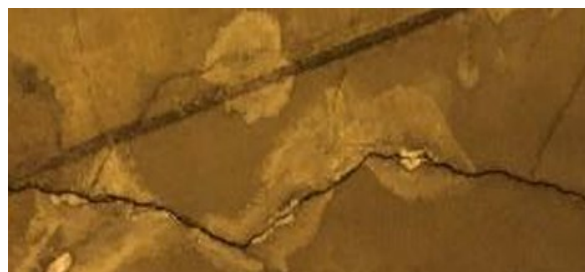
Figure 41 longitudinal cracks along the tunnel coating, aligned with the tunnel axis (MIMS, 2022)

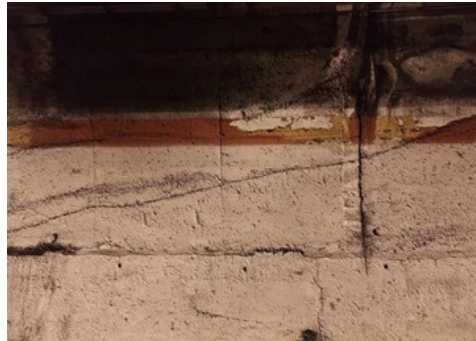
Diagonal cracks, also called oblique cracks, form at an angle to the tunnel axis and usually appear in sequences (Figure 42). They're common in cast concrete where they tend to be wider than typical shrinkage cracks.

Figure 42 Diagonal Cracking (MIMS, 2022)

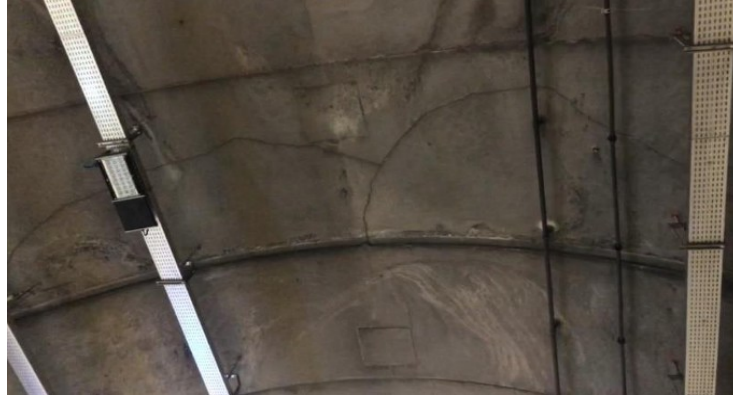
Curvilinear cracks are characterized by their uniformly curved, crescent-like shape, appearing between construction joints (Figure 43). These cracks can indicate localized stress concentrations or detachment of thin lining panels, particularly in tunnel claddings. During inspections, they are assessed by their surface extent and intensity using a standard rating table. Their detection may

also involve tapping methods to locate voids, suggesting hollow-sounding areas due to detachment. Associated degradation phenomena include separation of thin panels from the tunnel lining.

Figure 43 Curvilinear cracks observed in the tunnel lining (MIMS, 2022)

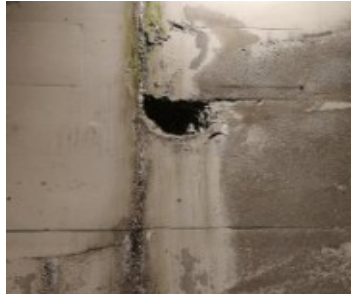
Presence of voids near the intrados of the lining refer to gaps or empty spaces that form behind the interior surface of the tunnel structure (Figure 47). These gaps can develop due to factors like poor construction practices, material shrinkage, or ongoing deterioration. If left unaddressed, they may compromise structural integrity by reducing the effective thickness of the lining and allowing water or other corrosive agents to penetrate.

Figure 47 void formation behind the intrados of the tunnel lining. (MIMS,2022)

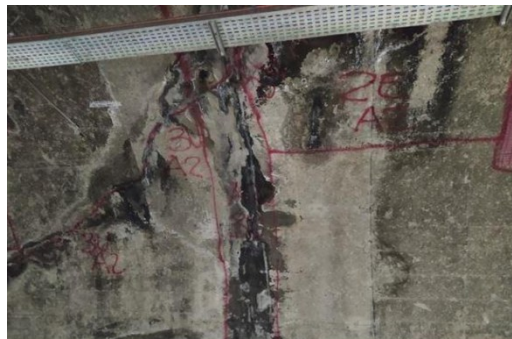
Deterioration of concrete joints is a defect commonly observed at the interface between adjacent segment rings, often manifesting as cracks, surface flaking, or loss of joint filling (Figure 48). These forms of degradation affect continuity and integrity of the concrete ring and are usually accompanied by detached aggregates or filler separation. In precast segmental linings, such issues are typically due to poor joint filling or improper assembly. Degradation is often associated with the presence of moisture, which boosts the deterioration process through microcracking and surface disintegration. Inspection should verify whether the joint is adequately filled and if disintegration is isolated or widespread.

Figure 48 Deterioration of concrete joints. (MIMS,2022)

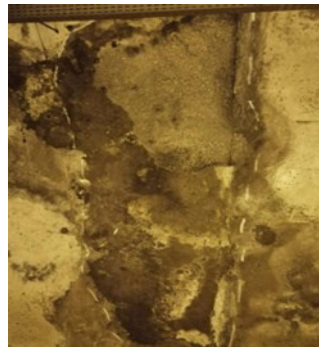
Surface defects in concrete are characterized by irregularities in color, texture, or pattern, primarily affecting the underside of the tunnel lining (Figure 49). Common signs include water surfacing, localized rust stains, traces of reinforcement outlines, and formwork deformations. These defects may indicate underlying issues such as poor material compaction, segregation, or exposure to moisture. They are commonly assessed visually and confirmed through tactile inspection and surface hardness measurements (e.g., sclerometer tests). When accompanied by dull acoustic responses or cracking, these defects may signal more serious degradation like voids or localized delamination.

Figure 49 Surface Defects (MIMS,2022)

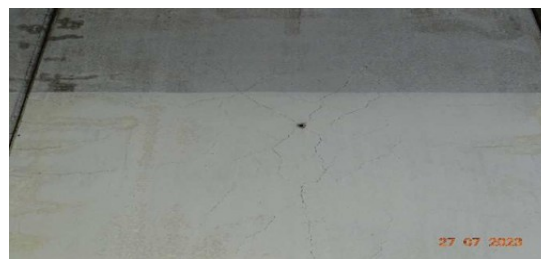
Shrinkage cracks are thin cracks (visible from 0.1 mm) that occur in unreinforced concrete castings, with widths typically not exceeding 1-2 mm (Figure 51). These cracks are caused by the loss of moisture during the curing process, leading to volume reduction and cracking. Shrinkage cracks develop in prefabricated or cast-in-place elements. However, if the tunnel profile deforms, some cracks may form due to structural reasons rather than shrinkage. In such cases, these cracks should be classified as horizontal, diagonal, or vertical structural cracks rather than shrinkage cracks.

Figure 51 shrinkage cracks on a segment surface

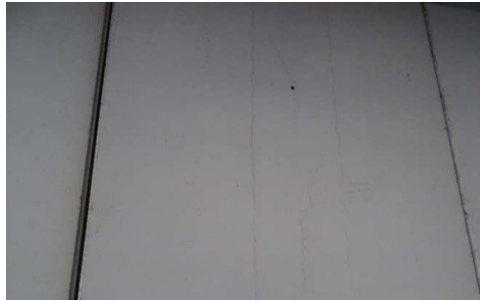
Vertical Cracks in Tunnel Linings form perpendicular to the tunnel's length and can appear anywhere in the structure. In prefabricated sidewalls, they usually develop at segment joints, while

in cast-in-place concrete, they are more irregular and wider due to material shrinkage and construction conditions. Monitoring these cracks helps assess structural stability.

Figure 52 vertical cracks

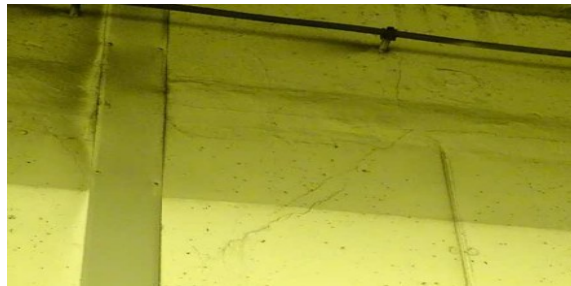
Figure 54 Diagonal crack

Diagonal Cracks, also called oblique cracks, form at an angle to the tunnel’s axis (Figure 54). They often appear in a series rather than as single cracks. Their characteristics depend on the type of lining. In cast-in-place concrete, these cracks are usually wider than shrinkage cracks.

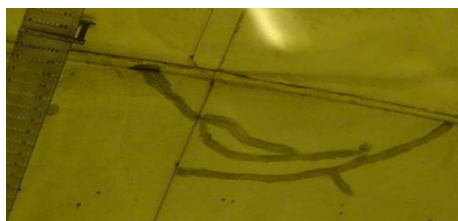
Figure 55 curvilinear cracks

Curvilinear cracks have a smooth, crescent-shaped path and usually start and end at a construction joint (Figure 55). They are often found in segmental lining tunnels and can indicate structural movement or weaknesses in the material.

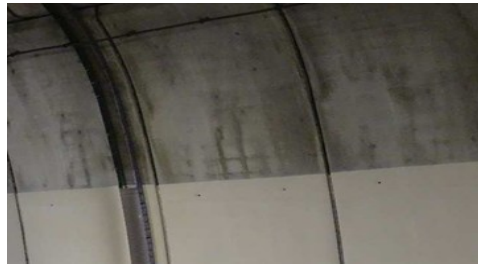
Figure 57 Exposed Reinforcement

Visible Reinforcement due to insufficient concrete cover in tunnels constructed with prefabricated segments, an inadequate concrete cover over the reinforcement can lead to visible rebar on the surface, exposing the reinforcement to potential corrosion and reducing the overall lifespan of the tunnel (Figure 57).

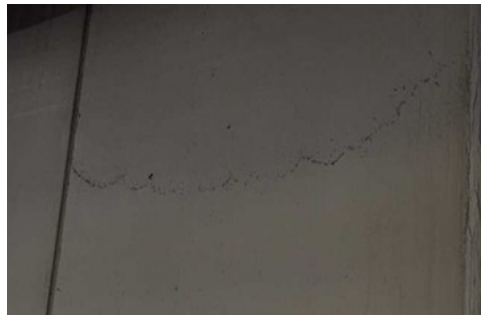
Figure 59 surface defects

Concrete surface defects include all defects that affect the appearance, color, or uniformity of the tunnel's intrados surface (Figure 59). Common issues include bubbles, water seepage, color variations, visible reinforcement outlines, rust stains, and localized formwork deformations. These defects may not always impact structural integrity but can indicate deeper problems or poor construction quality.

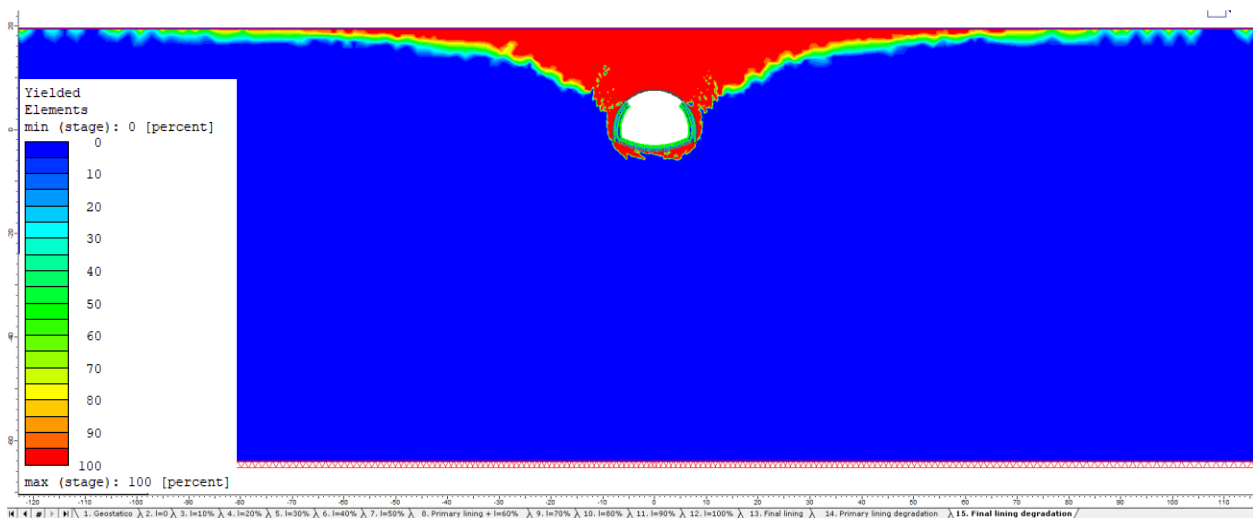
Figure 94 plastic zone ID_limit_30 model

Yielding is concentrated immediately around the excavation boundary, propagating from the crown and sidewalls. The yielded zone extends continuously upward toward the ground surface,

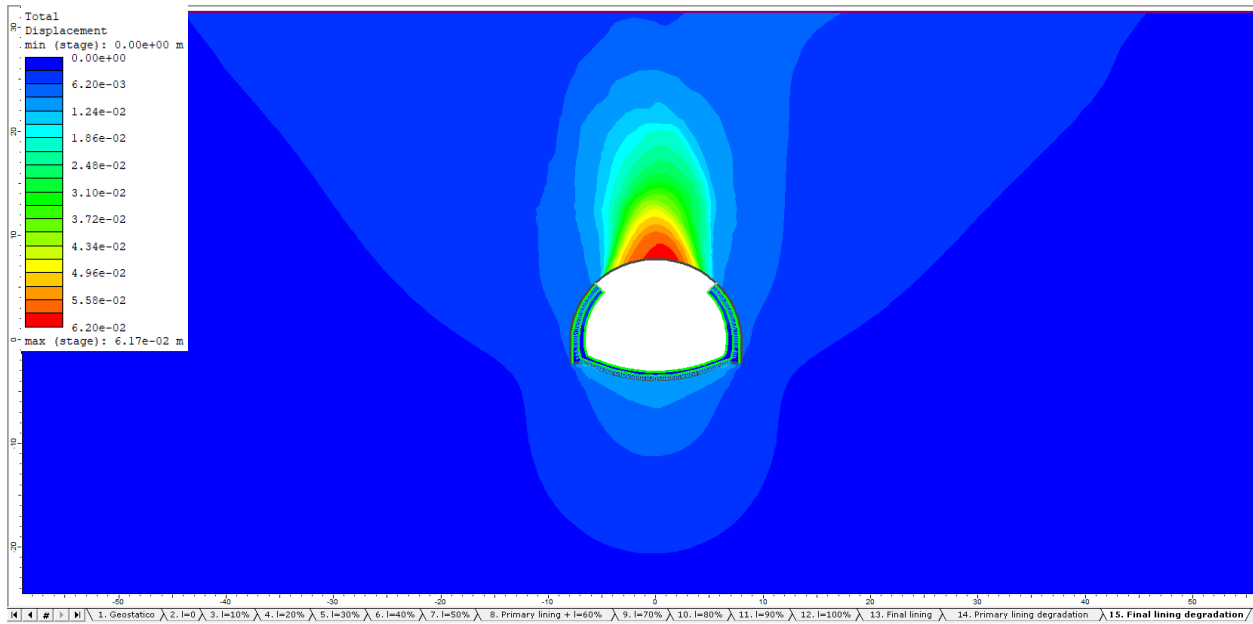
Figure 95 Total displacement at stage 15 of '2D_Limit_30 model'

At depth of 2 times the tunnel diameter having same properties, the displacement still exists, however it does not reach completely the ground surface (Figure 95).
