POLYTECHNIC OF TORINO  
FACULTY OF ARCHITECTURE  
Degree in Architecture  
**Honors theses**

**Galfione's Spinning-Mill at Pianezze di Camandona (in the outskirts of Biella): a hypothesis of consolidation**

PROJECT: A study of the structures, consolidation and renovation for specific use such as the

Archaeological Industrial Museum.

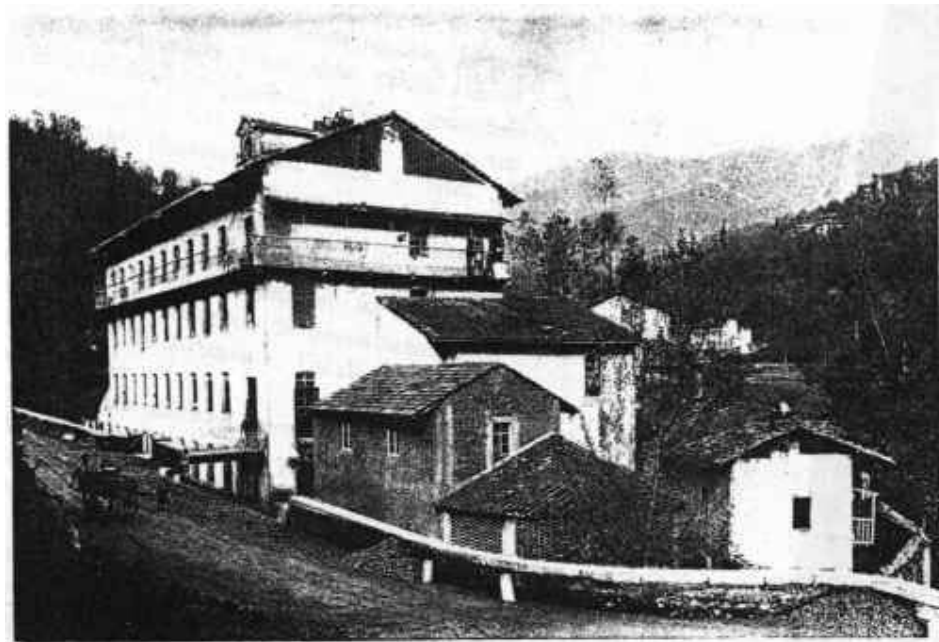
The Spinning-Mill in the oldest photograph found, showing the original aspect of the building in 1896.

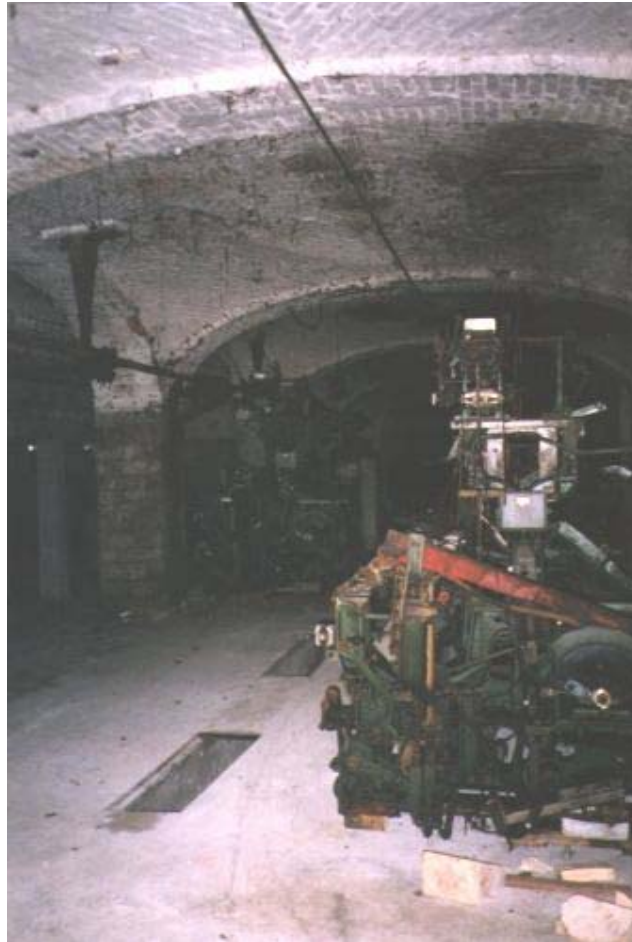
The Spinning-Mill, ground-floor workshop with pendentive dome.

The first and second vault are made in a pendentive dome structure, while the third one is made with iron ribbing and hollow brick decking.

The test carried out on the pendentive dome of the first and second floor shows that there is a situation of global stability, nevertheless there are signs of admissible load stress.
