## **The degradation of concrete between diagnosis and therapy**

by Paolo Bona

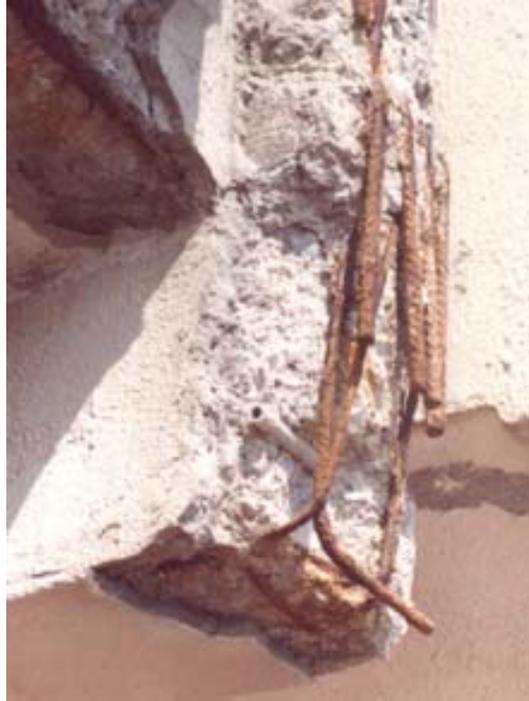
The most degraded zones are the irons of the reinforcement that are uncovered for over the 50% of their extension; the corrosion is distributed in a unvaryng way, with light localized reductions of the diameter.

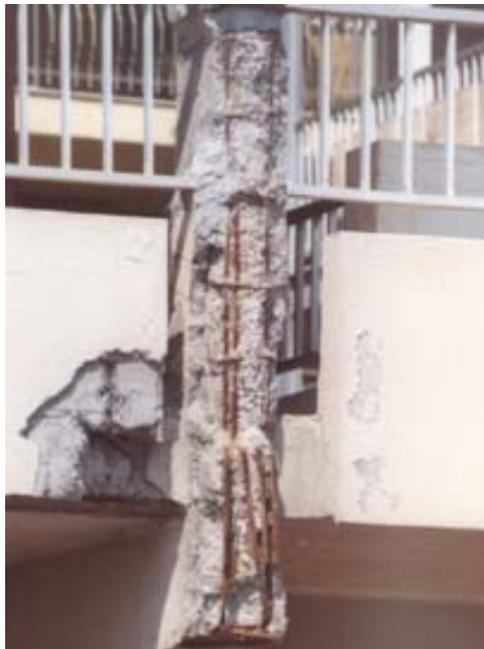
A sampling has been made to carry out chemical analysis (at Torggler Chimica) and single samples were drawn from three different elements; a former series of samples is made of two fragments of concrete lightened with expansible clay which was drawn from the parapet of the sea front balcony, the second series of samples is drawn from the parapet of the western lateral balcony; finally the last sample is a portion of the cover of the iron drawn from an intermediate zone between the two balconies.

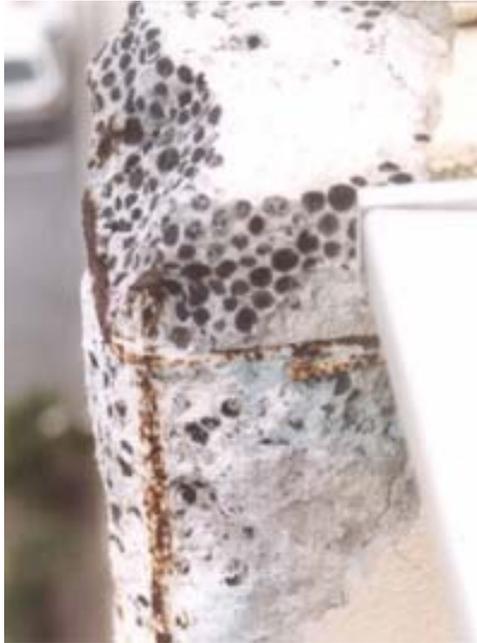
Chemical analyses were required to verify carbonation depth, and a qualitative and quantitative research on the salts present into the material.

The analyses results have shown the complete carbonation of the cover of the iron and a negligible amount of  $\text{Cl}^-$ ,  $\text{SO}_4^{2-}$  e  $\text{NO}_3^-$ , with the exception of the sea front parapet, invested by the marine air. The main cause of degradation is the presence of a very porous concrete, not the penetration of salts. According to the results, to have a correct restoration of the building, epox resin materials to protect the irons, reinforced mortar with resins in dispersion to integrate the missing portions and a transparent pictoric acrylic pellicle to create a protective barrier against the degrading agents are recommended.
