**The walls of Chieri: analysis and planning for the conservation of mine's rampart.
Relationships between artificial structures and self-vegetation**

by Sabrina Ricca, Simone Ronfetto, Sabina Zinni

Our paper investigates the current state of conservation of a Sixteen Century rampart belonging to the second town wall of Chieri (Torino) and explores the range of possibility of restoration and strengthening of the structure in order to end the current decays.

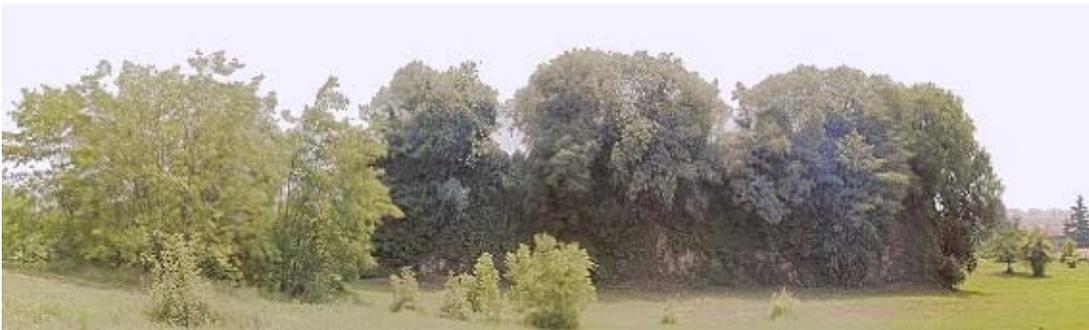
We need a vegetation classification in order to know the real dangerousness of each type of plant and consequently develop an action planning, developed in three steps: correction, turning and maintenance.

The glyphosate salt has been chosen to eliminate the undesired plants, but not all the died plants will be removed from their site.

In fact, for structural needs, the major roots developed inside the brick walls will be kept in their place as if they were wood beams. So it will be necessary to curb the moistness, using electro-osmosis, in order to avoid mushrooms infestation

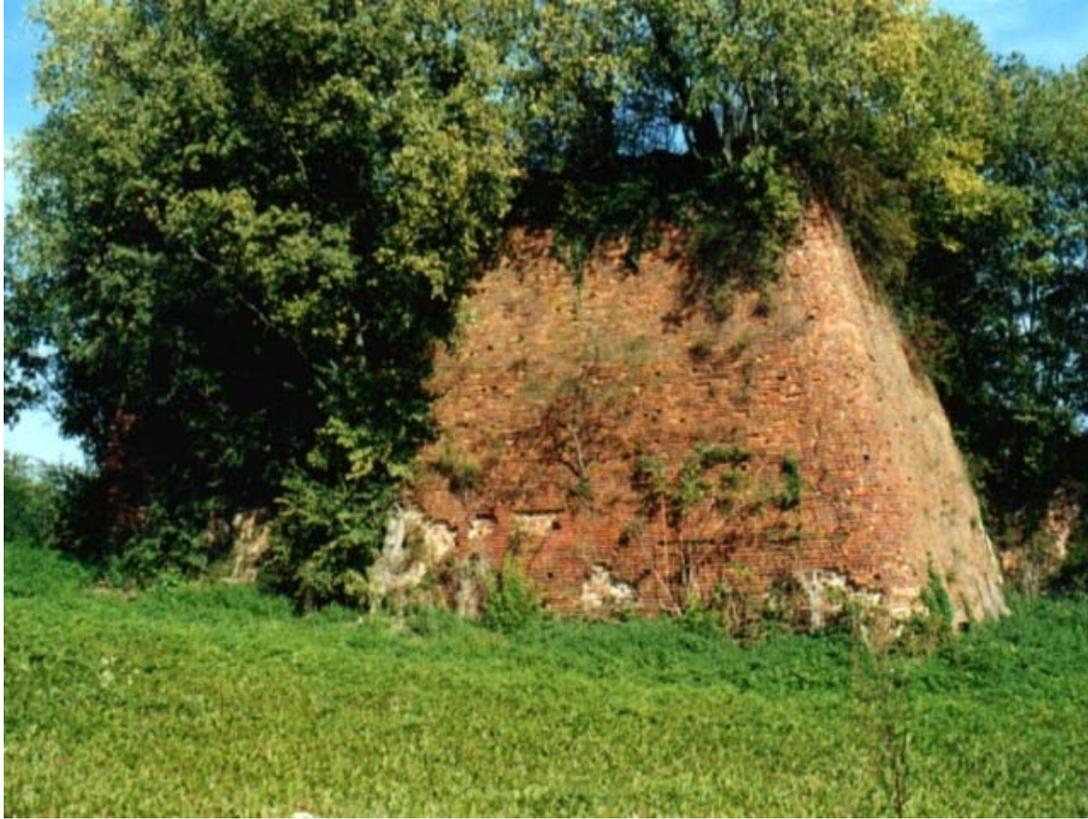
The turning phase will consist in the elimination of new born vegetation in springtime.

After all it will be necessary a constant maintenance and care of the whole structure, of the fields around and of the electro-osmosis system.

At the same time the walls will be cleaned and detached bricks put back. Afterwards the structure will be reinforced using ethyl-silicate and the walls finally cleaned. The diagnostics surveys will be now possible, no more hampered by self-vegetation, and it will be finally possible to restore the structure and proceed with final reinforcement and protection.
