POLITECNICO DI TORINO SECOND SCHOOL OF ARCHITECTURE Master of Science in Architecture *Honors theses*

Palazzo Mathis in Bra: hypothesis for restoration and consolidation

by Stefania Leto

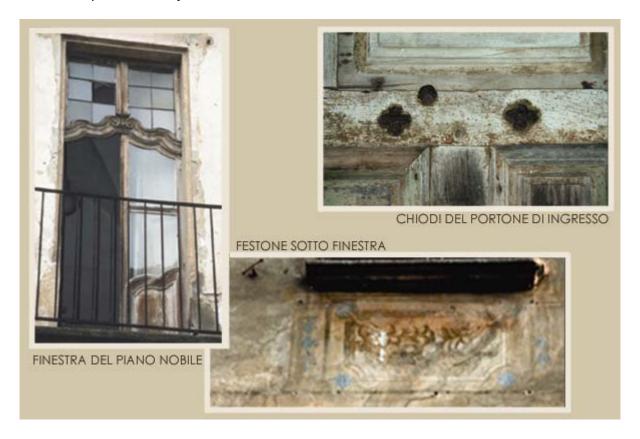
After a geometric survey of the present condition, I transferred on the tables the wall frameworks, the floorings and the ground projection of arching and vaults. A set of photo cards comes with the tables to portray the Palazzo in every smallest detail in order to report the story and the handcraft tradition of each manufacture.

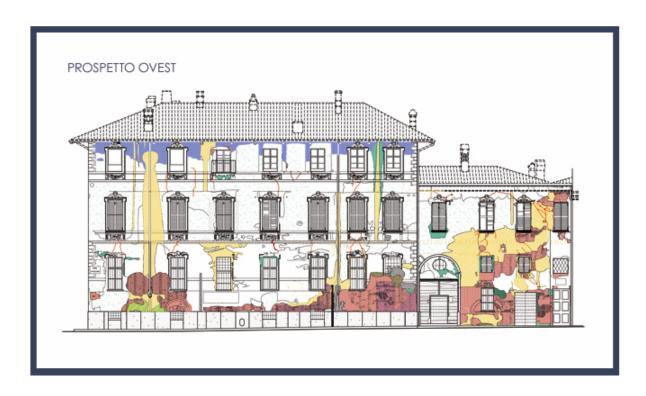
I was induced by the high presence of degradation on the different fronts of the building to adopt a special portrayal procedure that combines a coloured cross-hatching system, which highlights the wider areas of deteriorations (such as weathering, exfoliation, plaster detaching, presence of vegetation, pulverization), with an icons system for punctual degradations (from Dalla Costa Mario, Il progetto di restauro per la conservazione del costruito, edit by Celid, Torino 2000).

As last step, I considered the interventions required to stop, or at least to reduce, the deterioration process, following a conservative stance based on the interventions' reversibility; the results have been reported on the same charts used for the degradation analysis so that a deterioration/intervention cross-reading could be possible.
